Inspection Photos
Location Name: Schneider 1414 PAD
Location ID: 432178

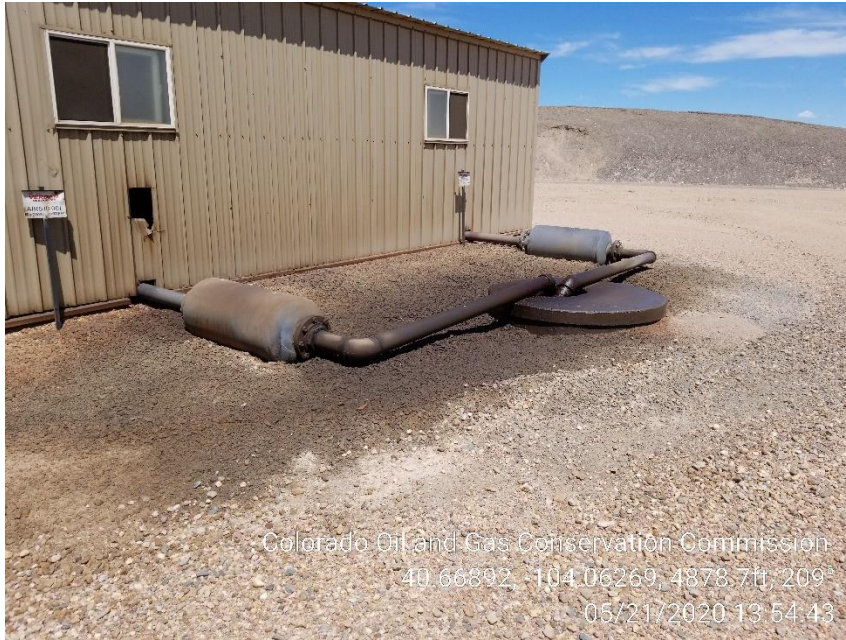
Photo 1 – Stained Soil at Engine Exhaust

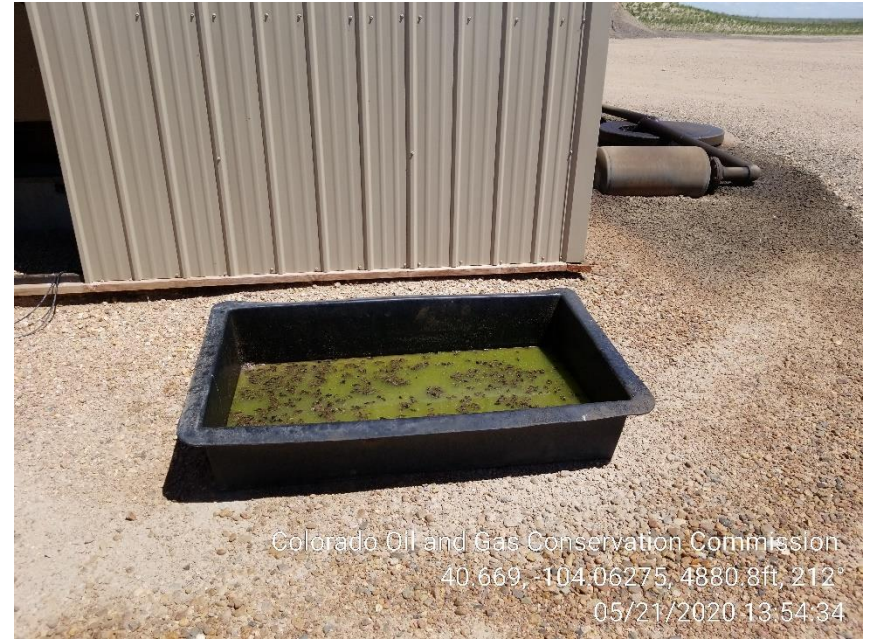
Photo 2 – Unused Secondary Containment at Pumping Units

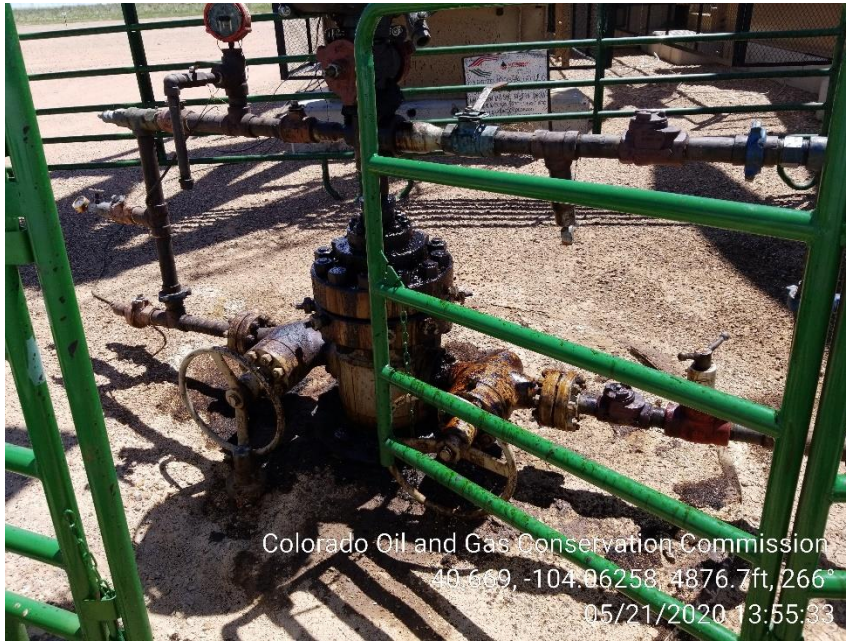
Photo 3 – Stained Soil at 2-14-8-60 Wellhead

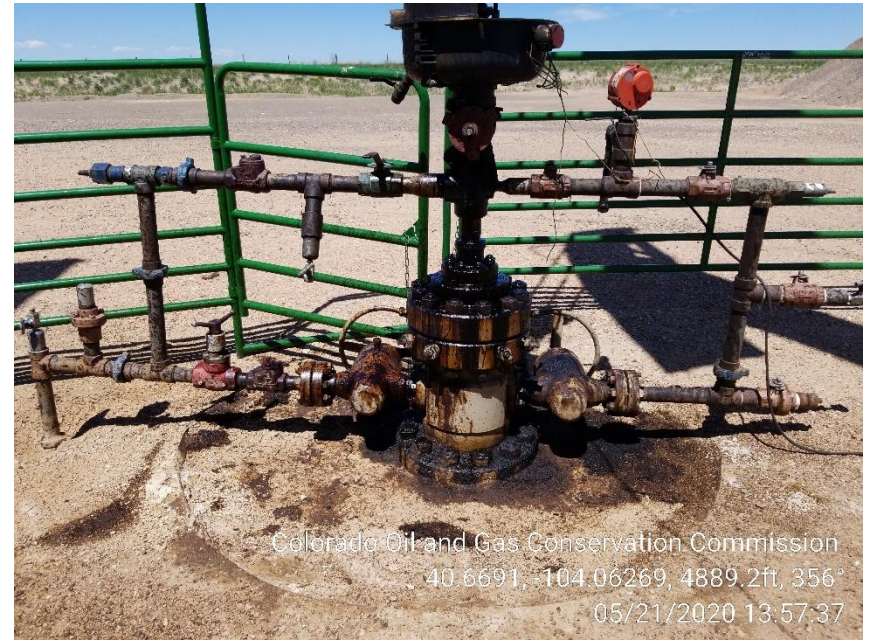
Photo 4 – Stained Soil at 2-14-8-60 Wellhead

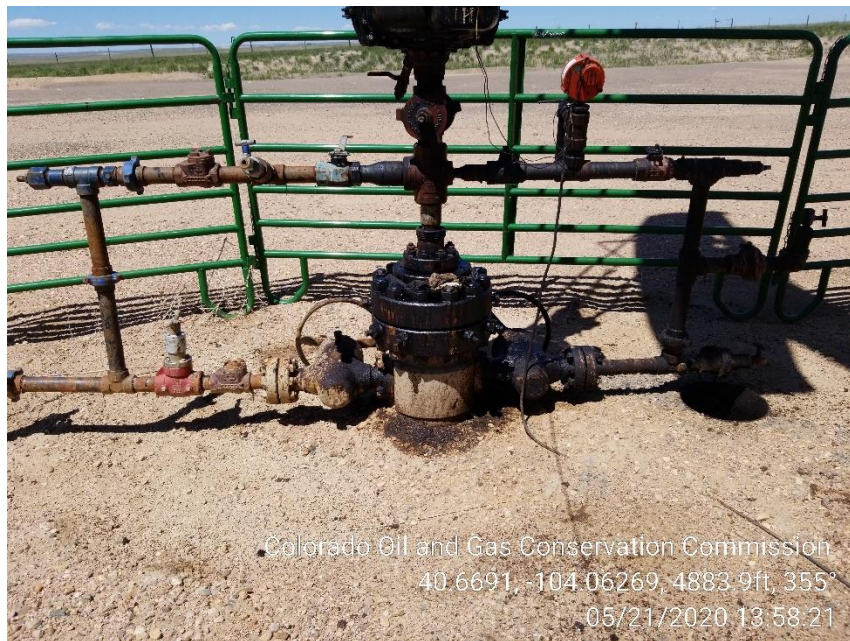
Photo 5 – Stained Soil at 1-14-8-60 Wellhead

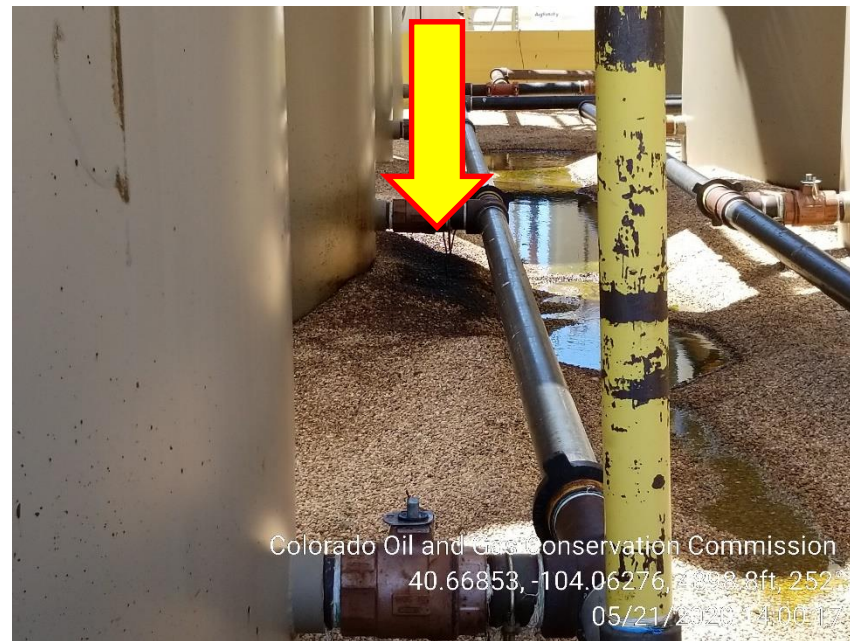
Photo 6 – Stained Soil at South Middle-East Loadline
