Inspection Photos

API: 055-06153

Operator: PETROGLYPH OPERATING CO

Inspection Date: 5/20/2020

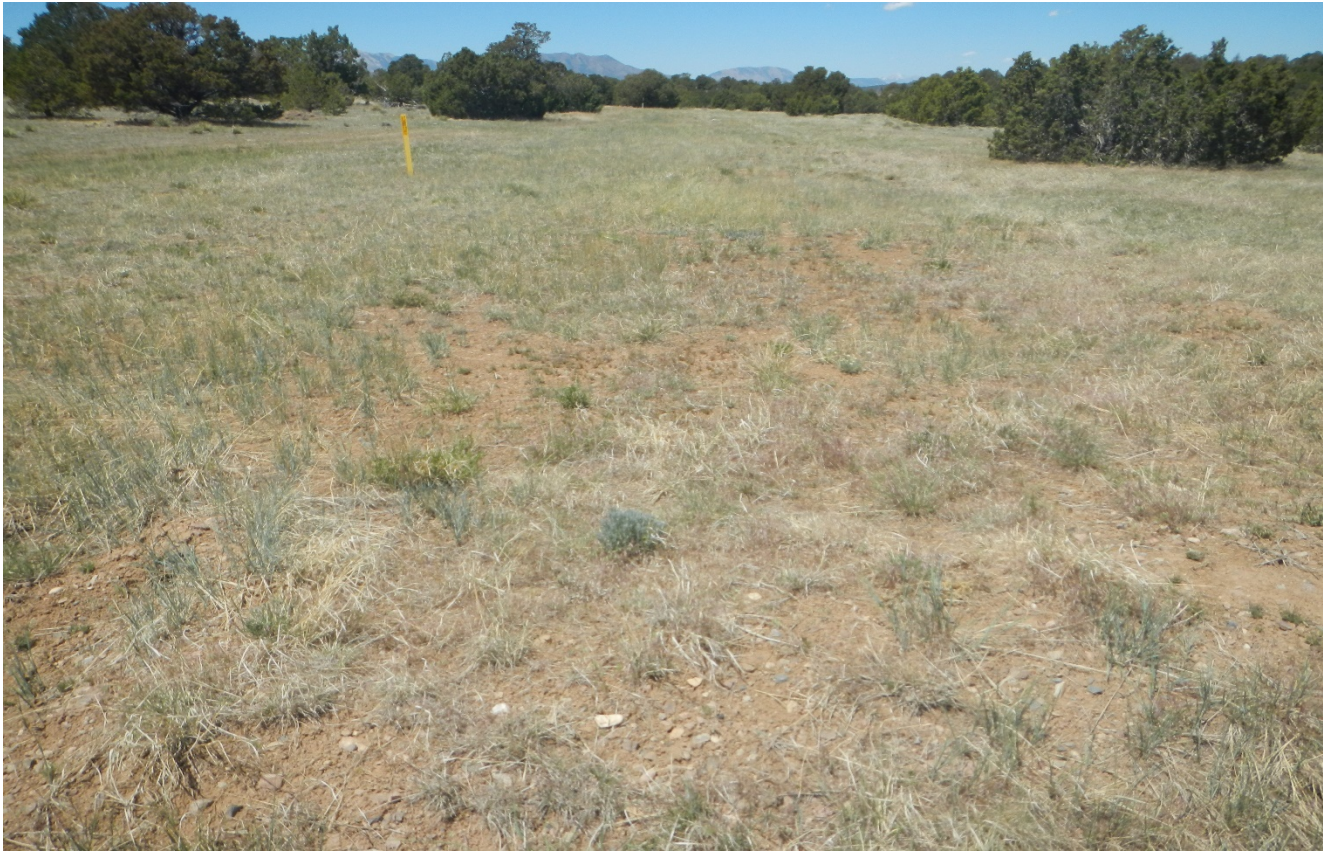
Photo 1. Facing west along the reclaimed access road. The vegetation has uniformly established along the reclaimed road.

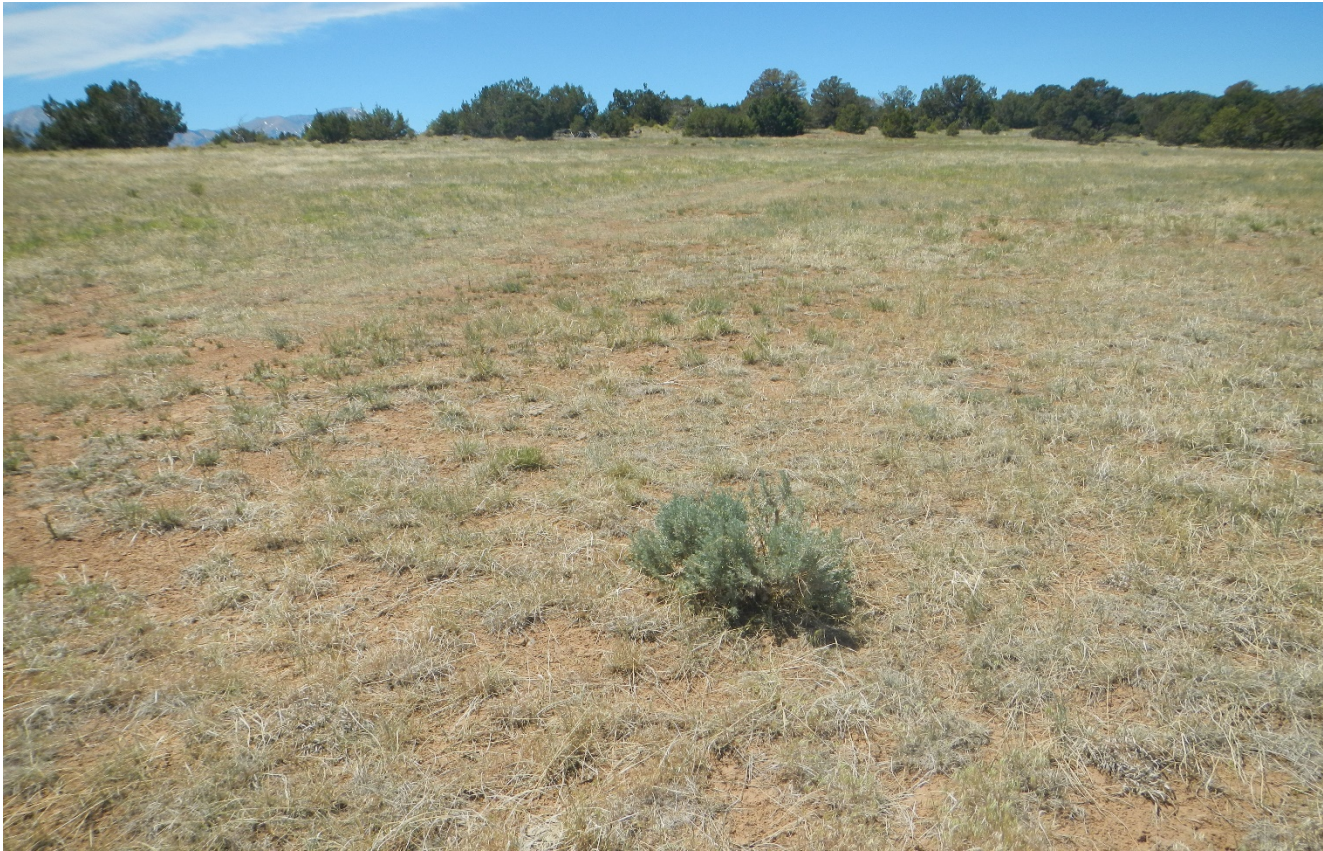
Photo 2. Facing southwest toward the location. The location is reclaimed and revegetated.

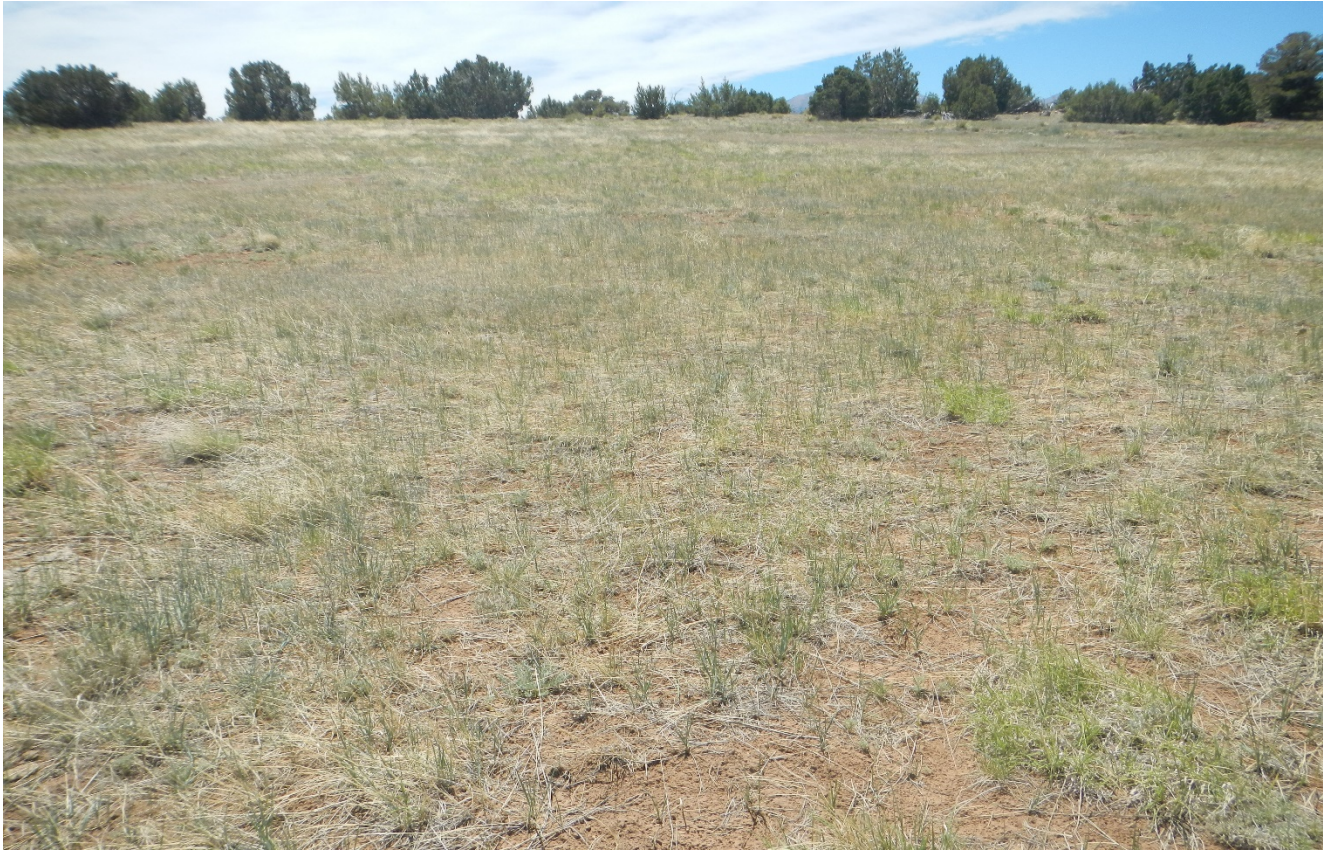
Photo 3. Facing east at the location. Perennial vegetation is well established throughout the location and consists of Western wheat grass, Sand dropseed, Blue grama among other species.

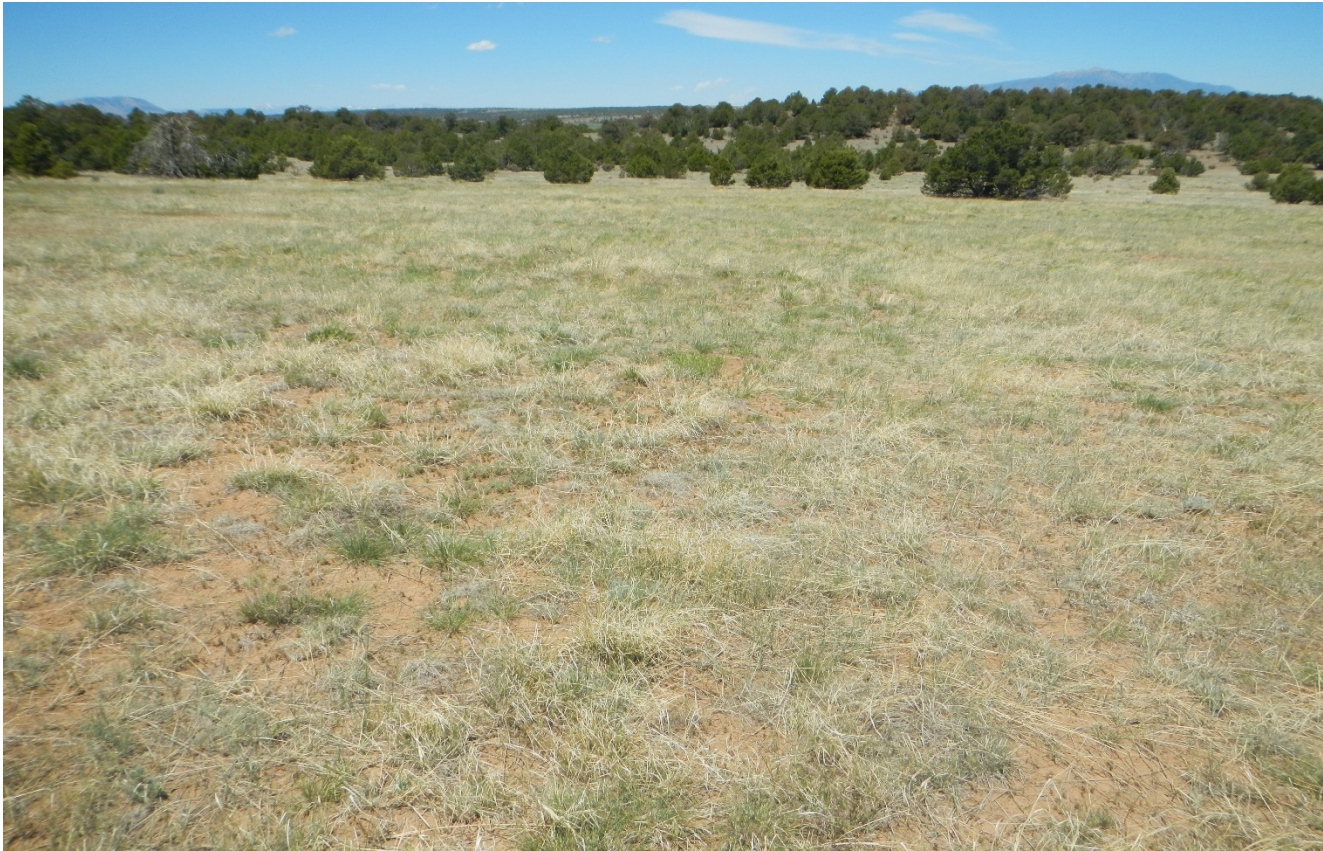
Photo 4. Facing east at the location. Perennial vegetation is well established throughout the location and consists of Western wheat grass, Sand dropseed, Blue grama among other species.

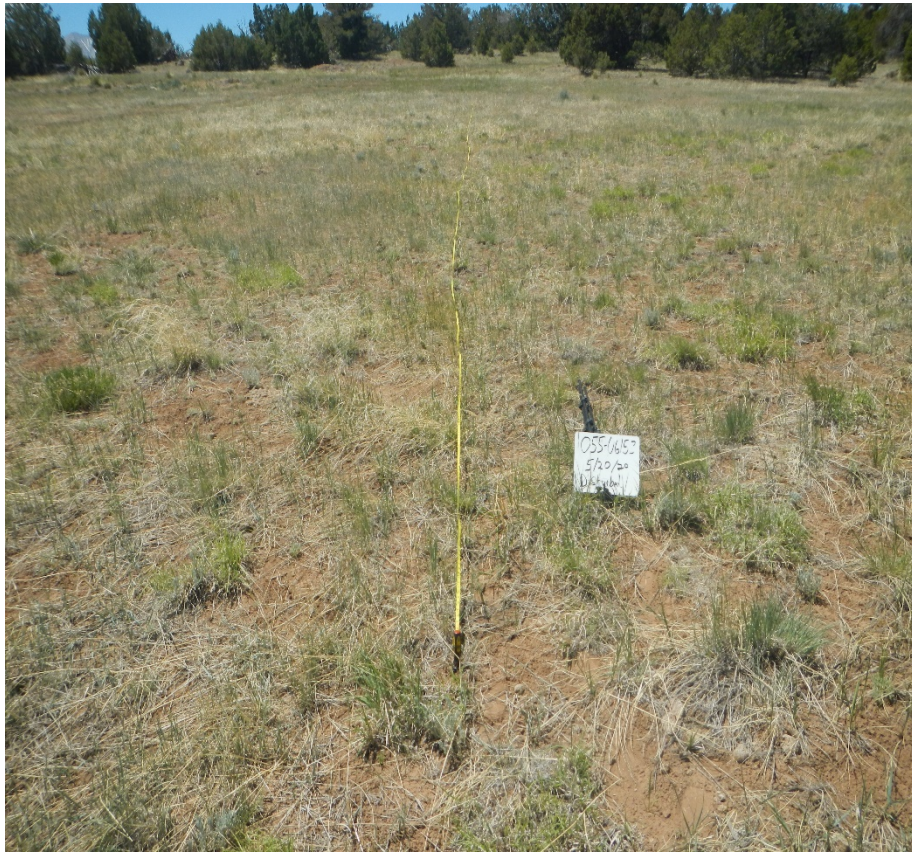
Photo 5. Facing southwest at the beginning of the vegetation transect performed at the disturbed location.

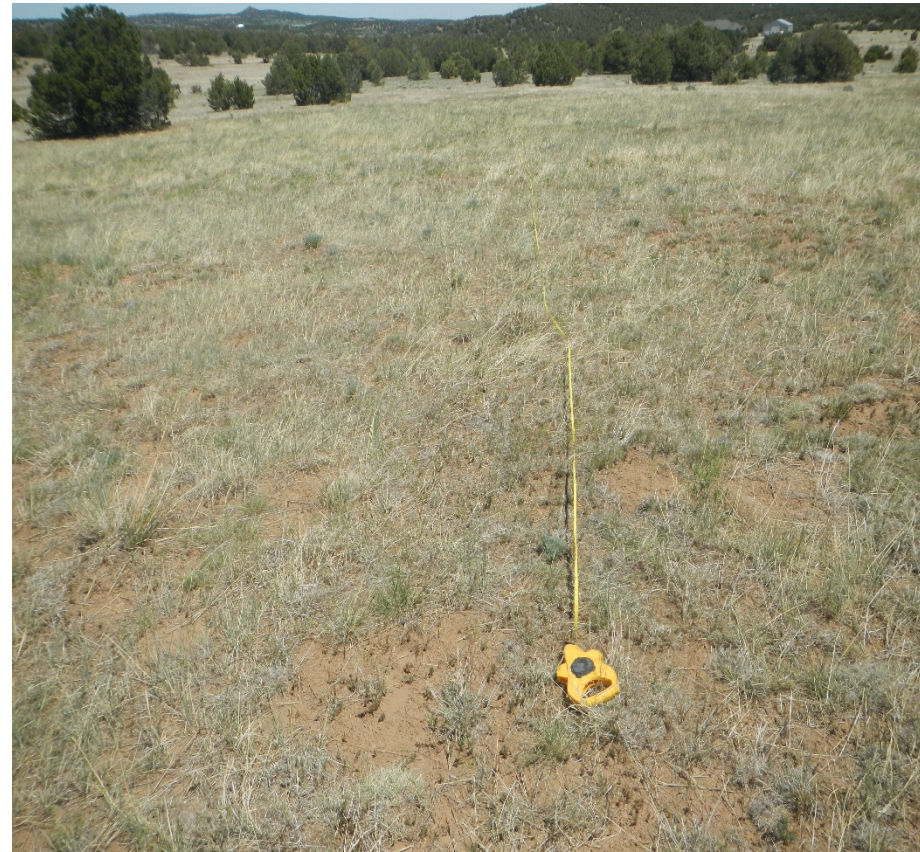
Photo 6. Facing northeast at the end of the vegetation transect performed at the disturbed location.

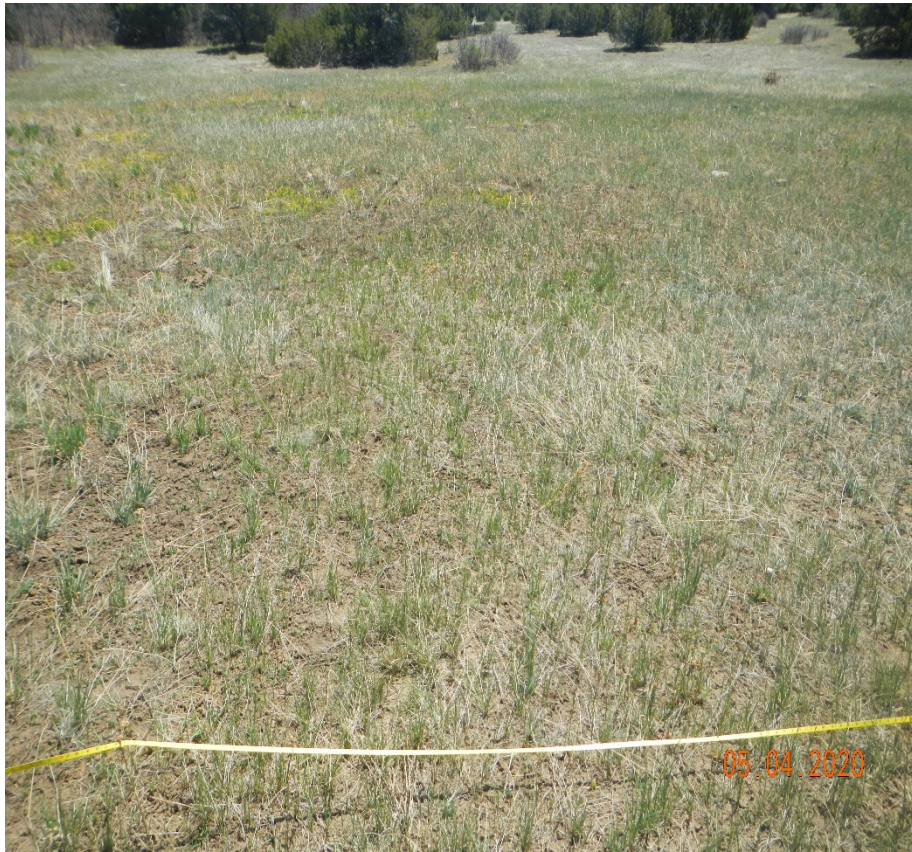
Photo 7. Facing southeast at the midpoint of the vegetation transect performed at the disturbed location.

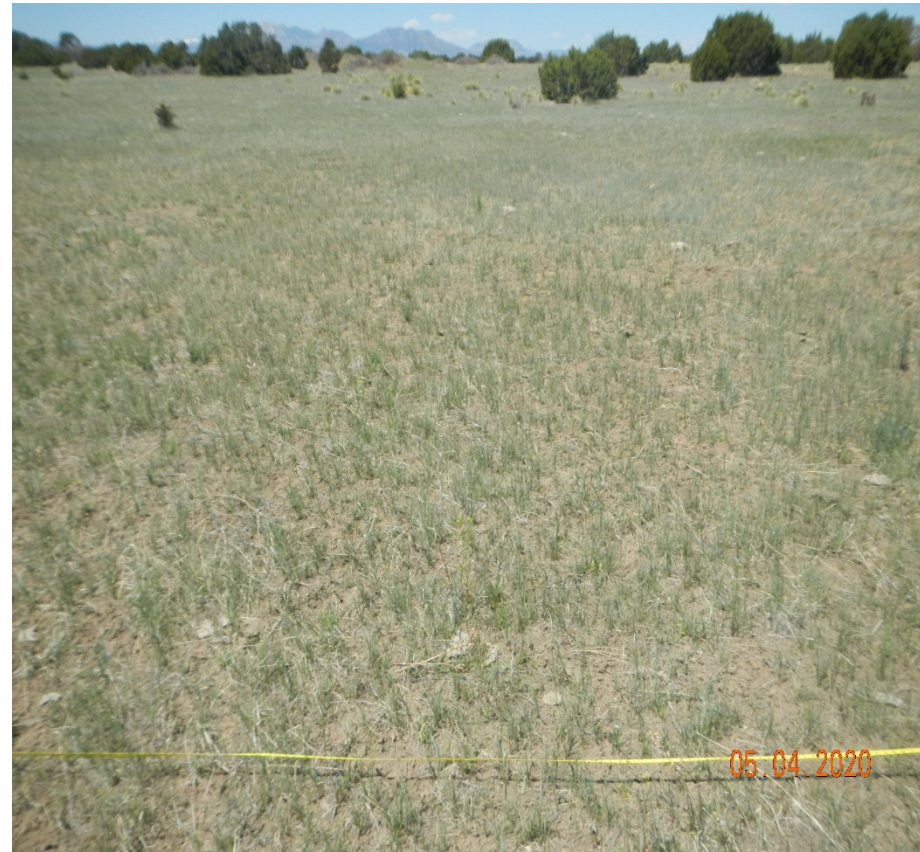
Photo 8. Facing northwest at the midpoint of the vegetation transect performed at the disturbed location.

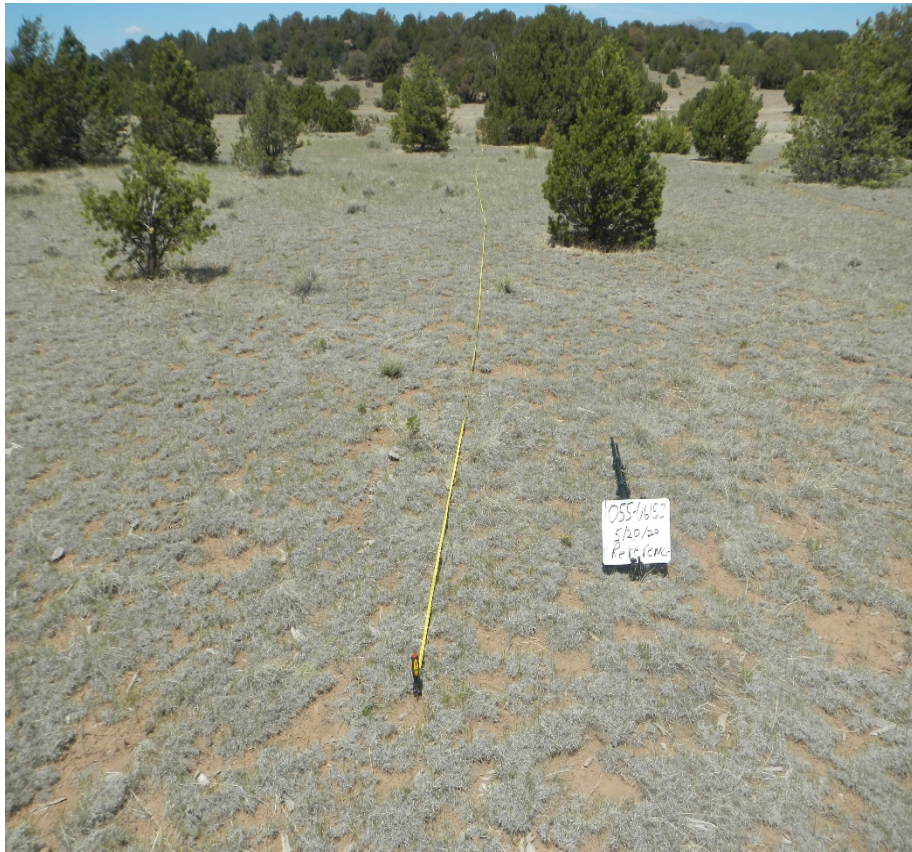
Photo 9. Facing northwest at the beginning of the vegetation transect performed at the reference area.

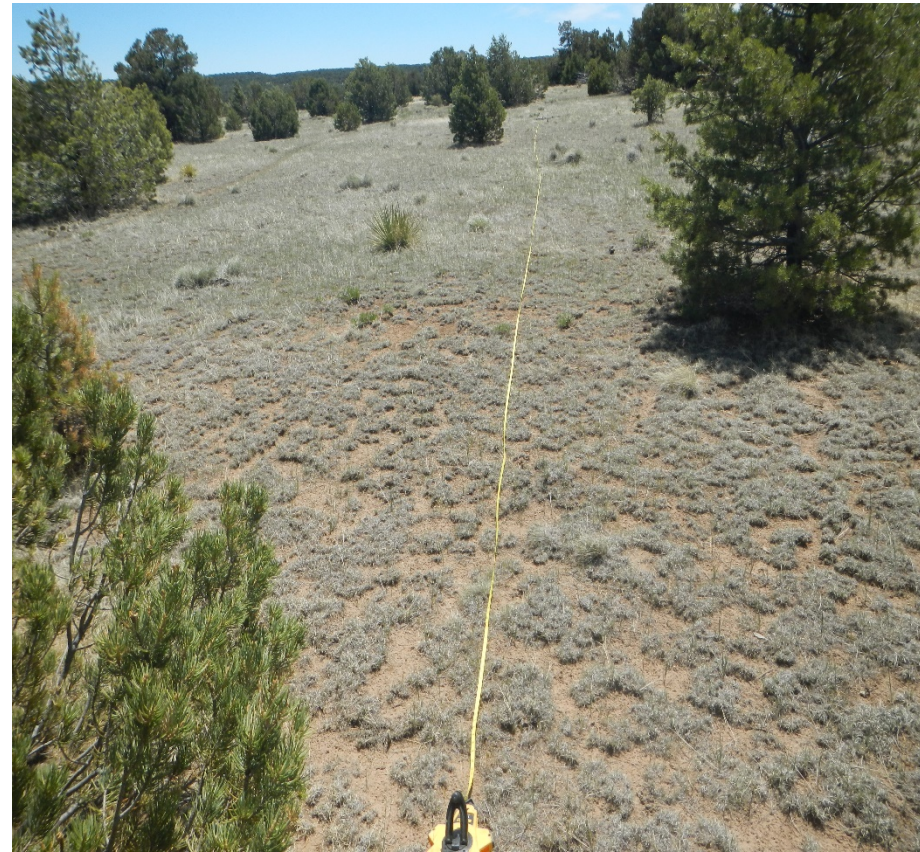
Photo 10. Facing southeast at the end of the vegetation transect performed at the reference area.

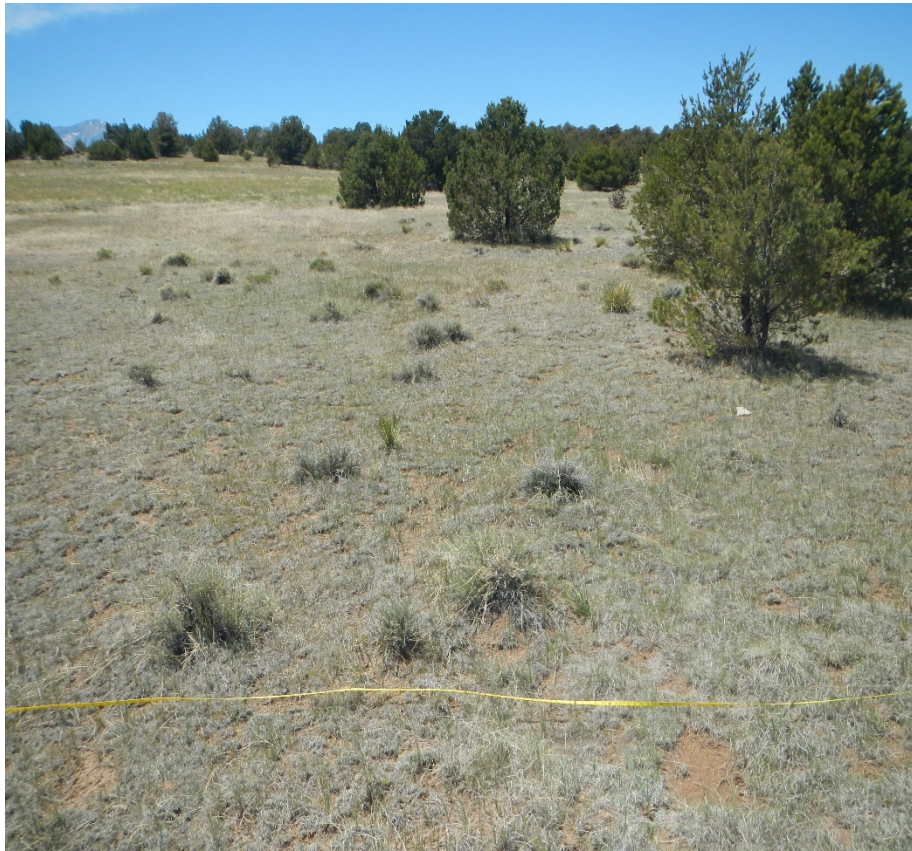
Photo 11. Facing southwest at the midpoint of the vegetation transect performed at the reference area.

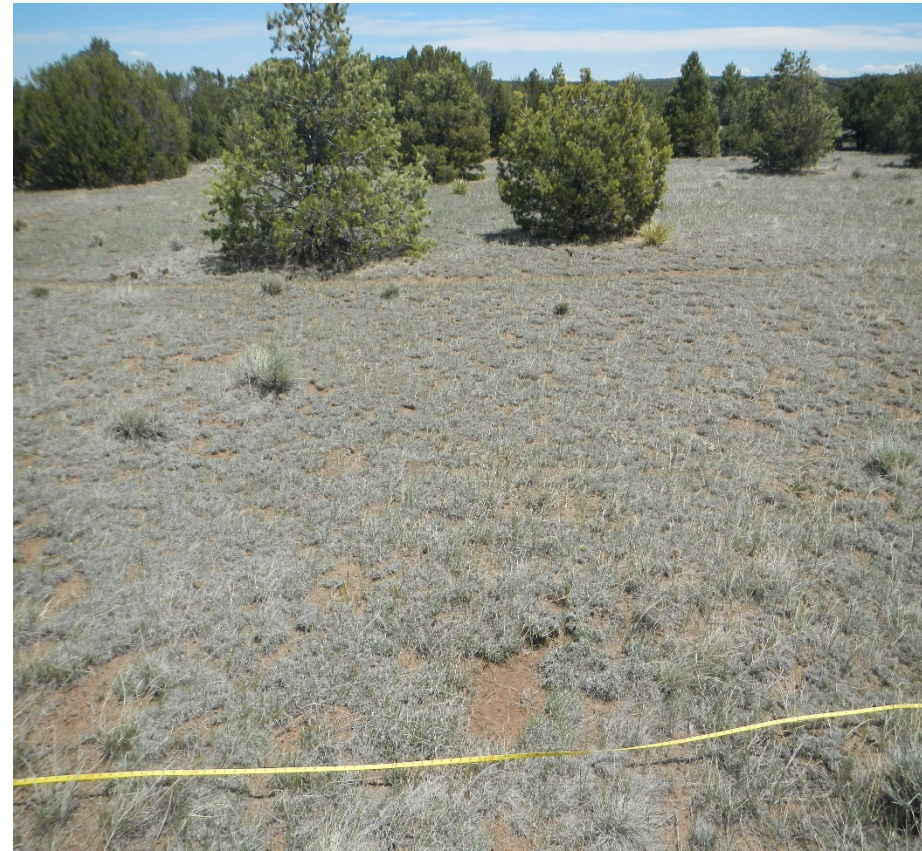
Photo 12. Facing northeast at the midpoint of the vegetation transect performed at the reference area.
