Inspection Photos
Operator: BP America
API#: 067-06944
Date: 5/20/2020

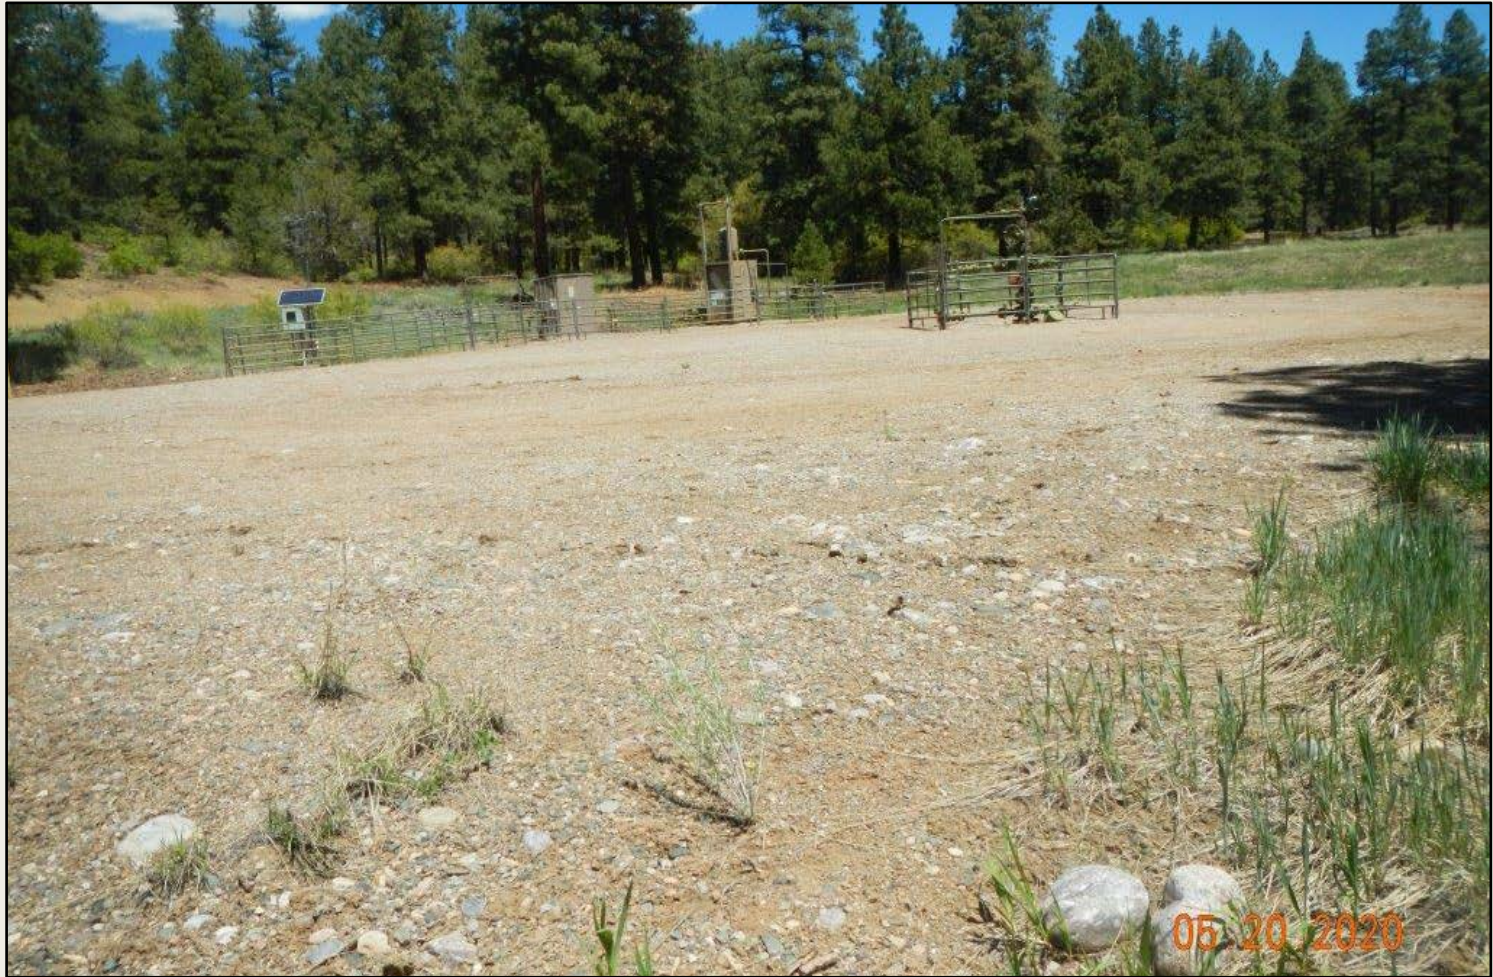
Photo 1. View of the project area from the southeastern corner facing center.

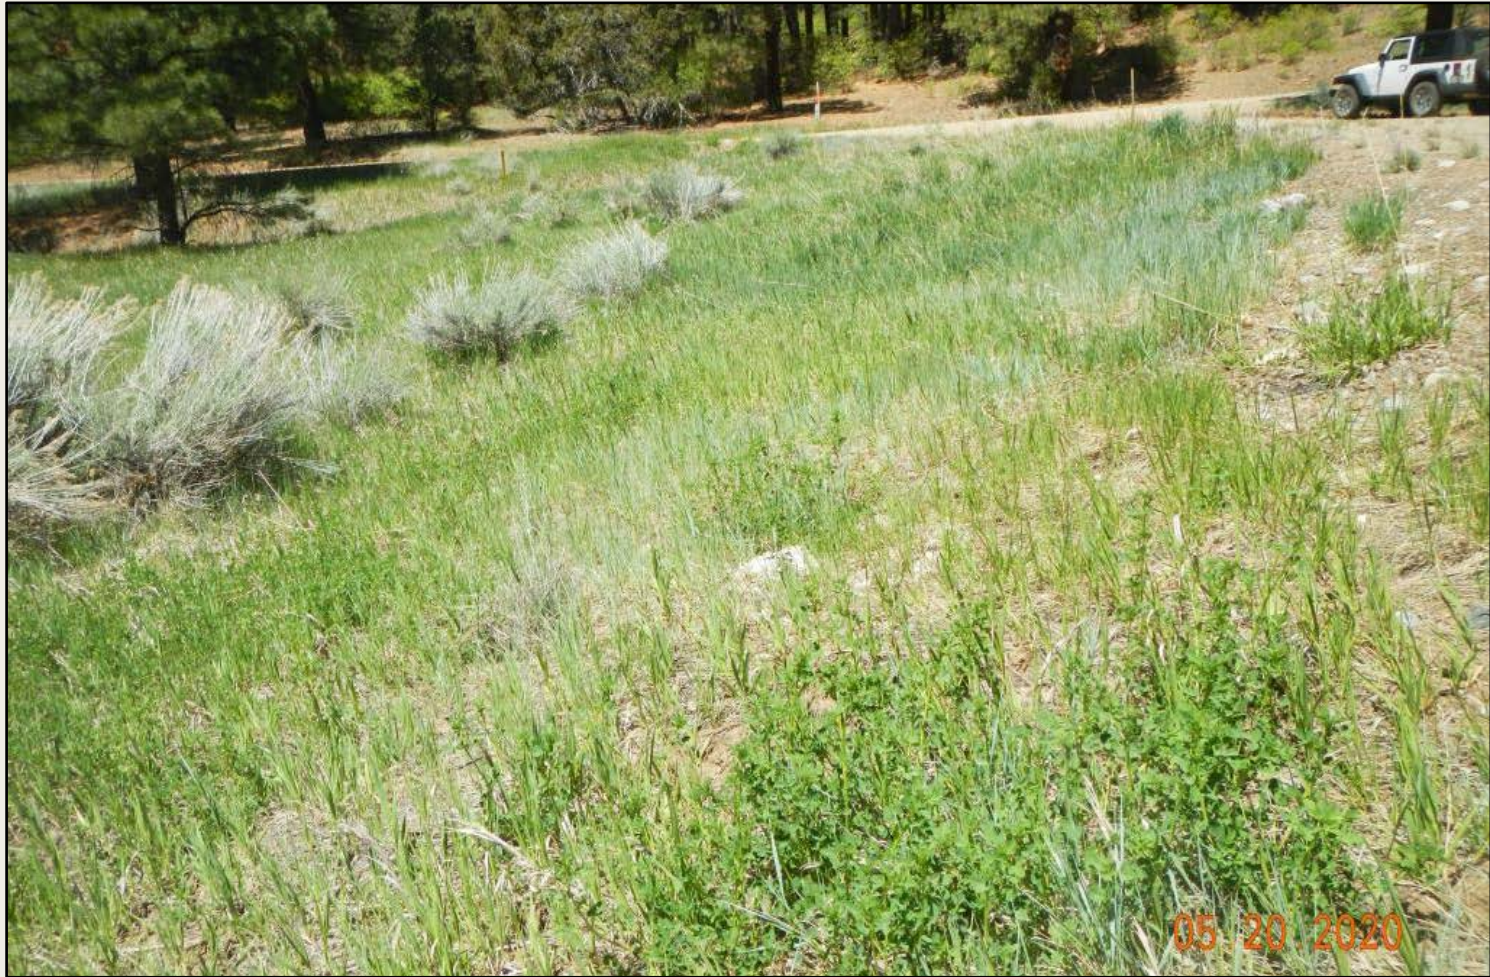
Photo 2. View of the southern fill slope from the southeastern corner facing westward. Revegetation is progressing on the slope with grasses such as western wheatgrass and smooth brome.

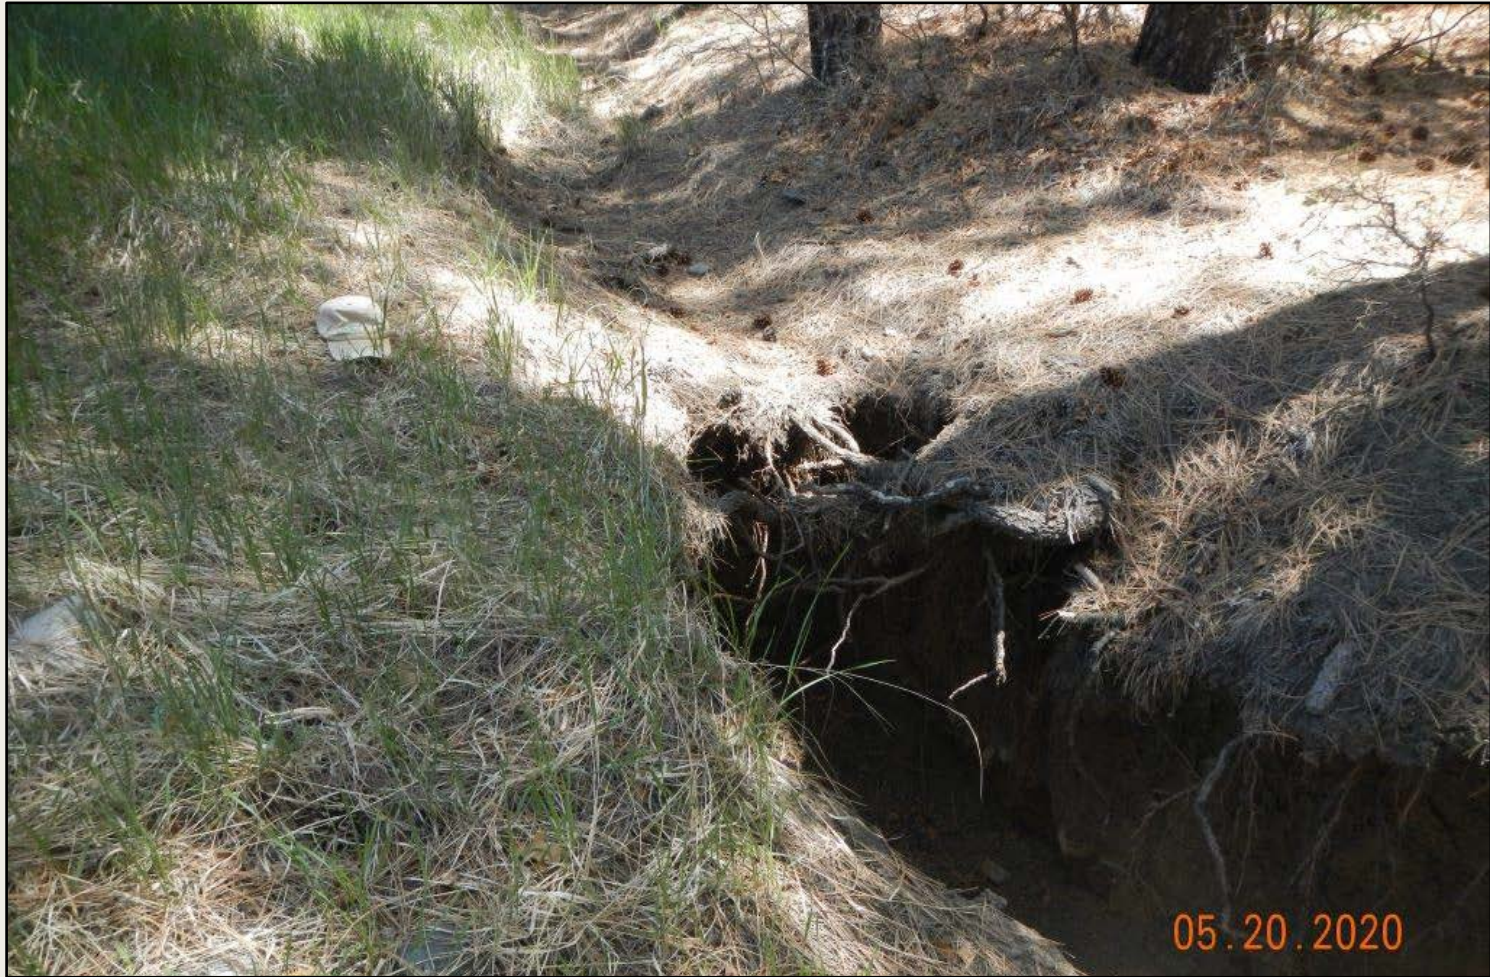
Photo 3. View of erosional head-cut approximately 4 feet wide and 6 feet deep, at the eastern edge of the project area (facing up-slope).

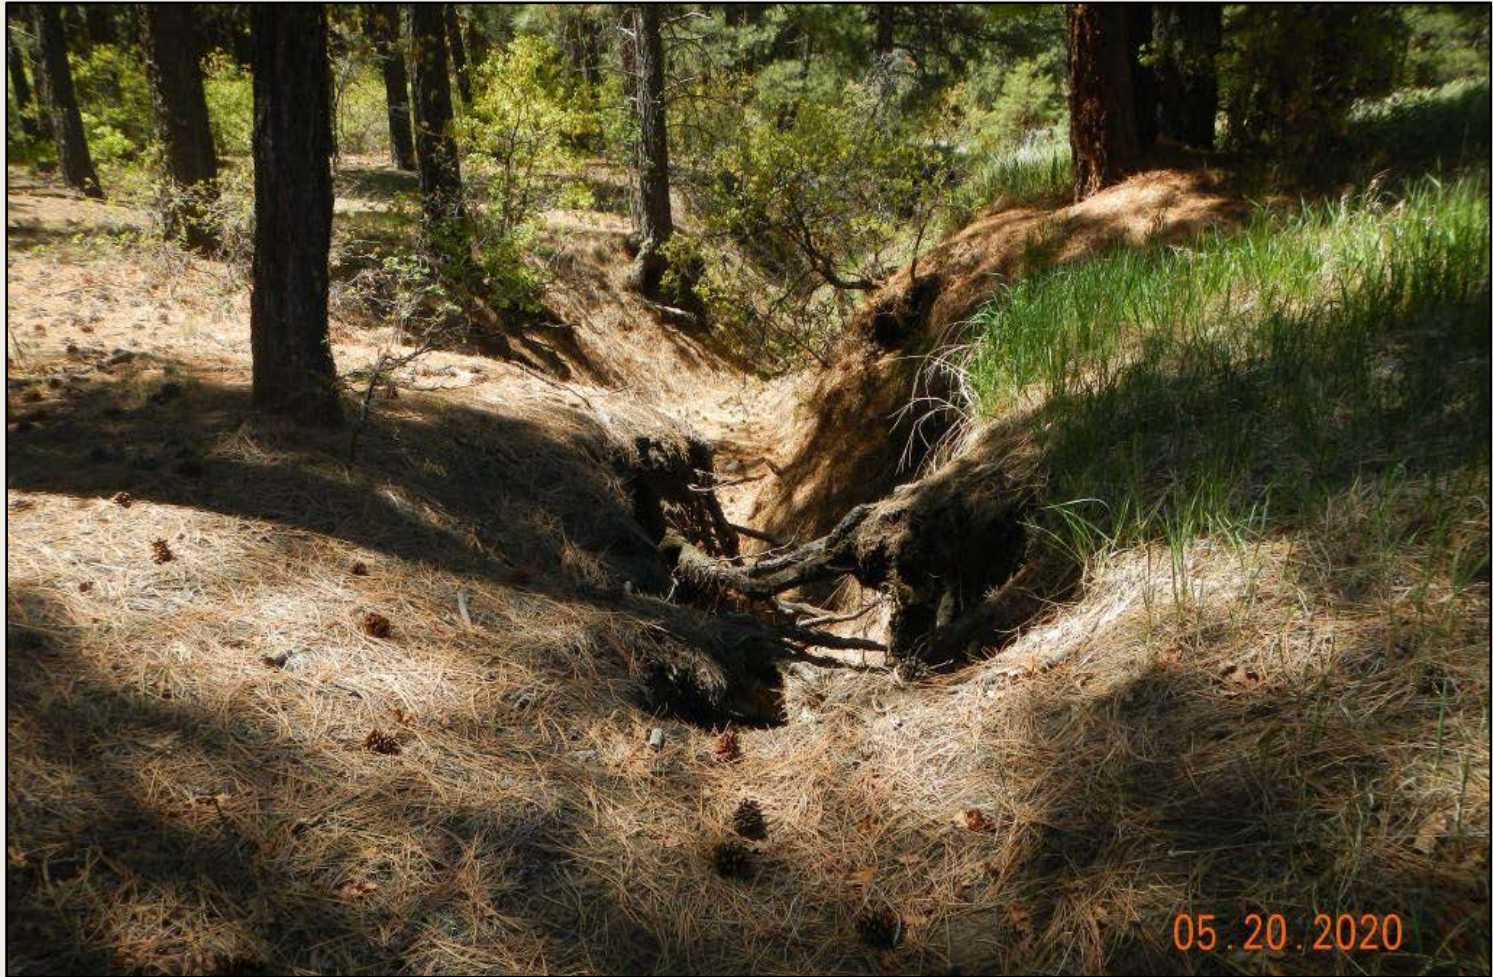
Photo 4. View of erosional headcut, and exposed roots downstream of headcut, facing downstream.

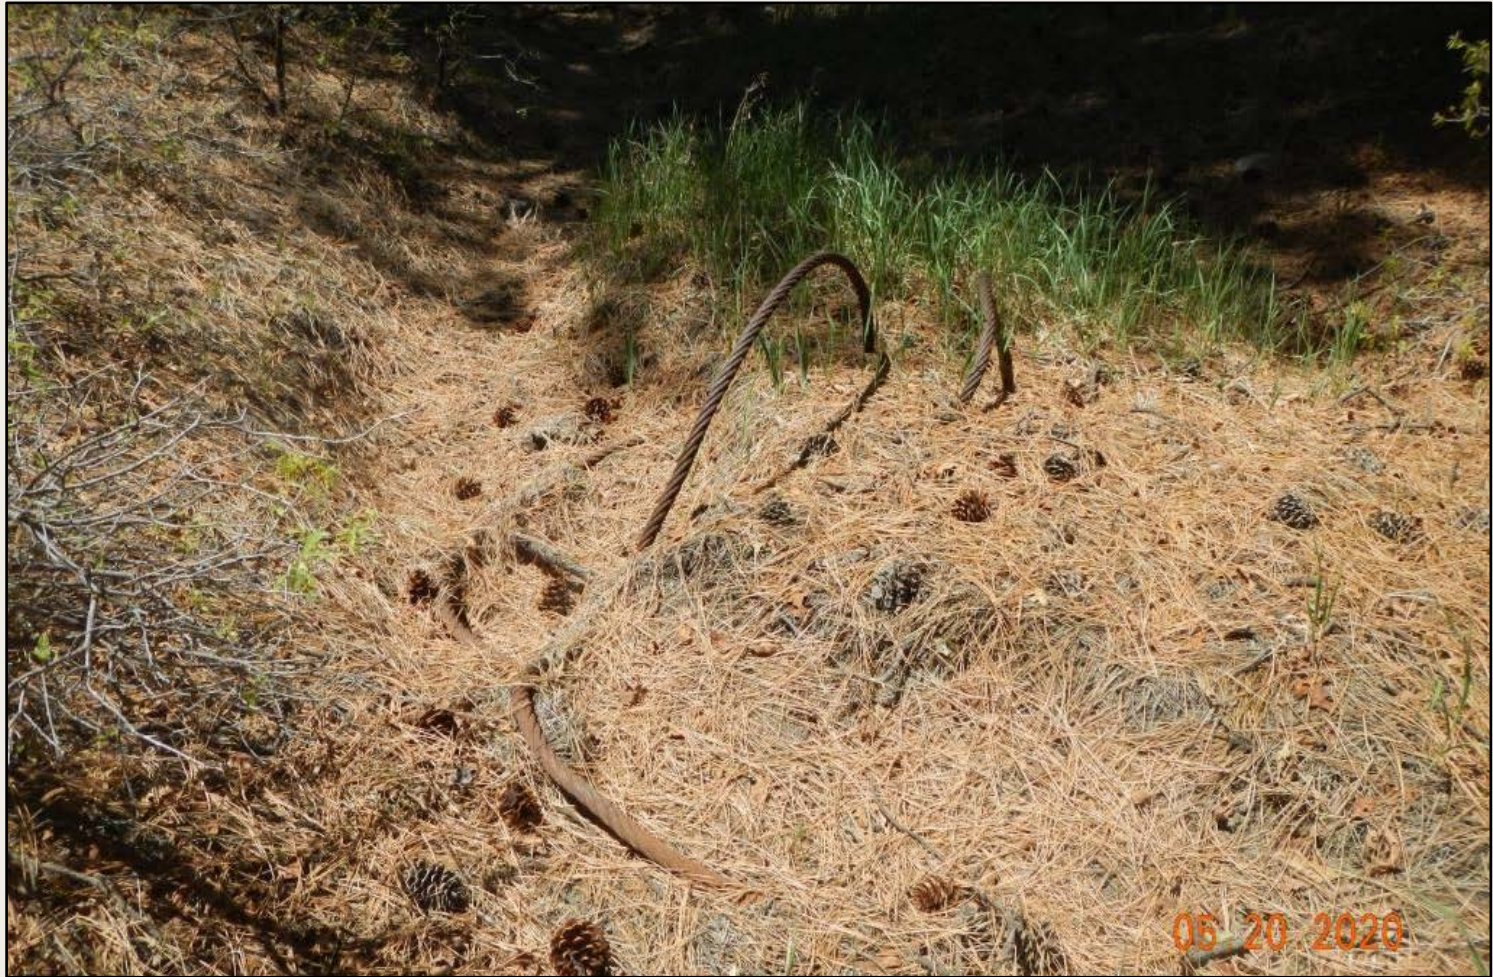
Photo 5. View of rig cable in the drainage, adjacent to the eastern edge of the project area.

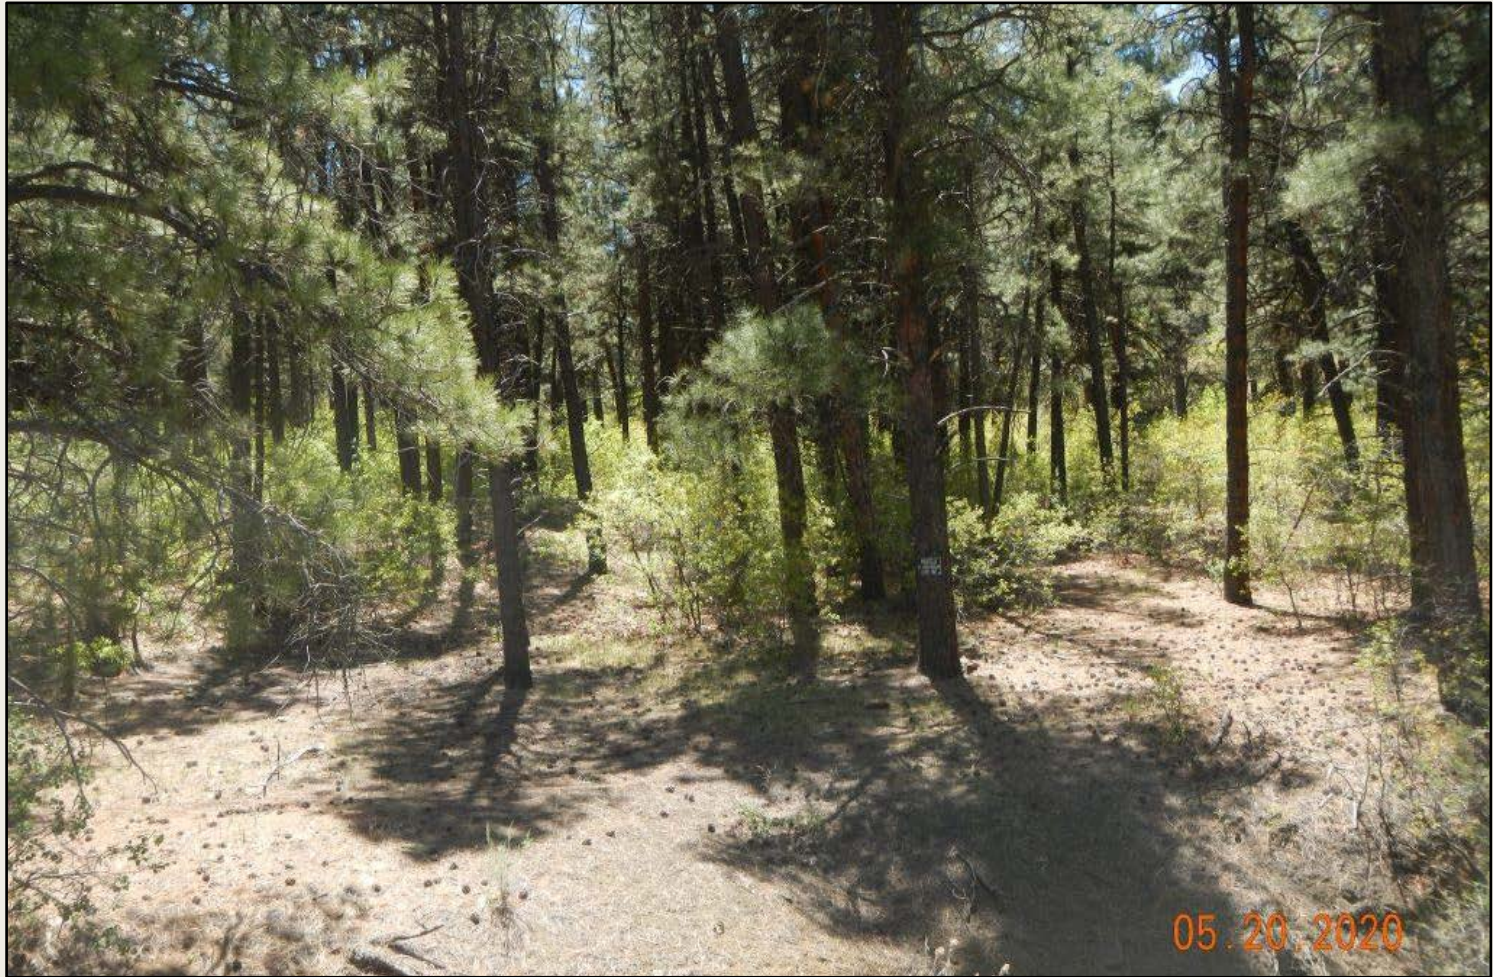
Photo 6. View of reference area vegetation comprised of pinyon-juniper forest with understory of gambel oak, muhlygrass, and penstemon.
