# Interim Reclamation and Stormwater Inspection

May 26, 2020

Operator: EXTRACTION OIL & GAS INC #10459

Location Name: Trout /32-M Pad

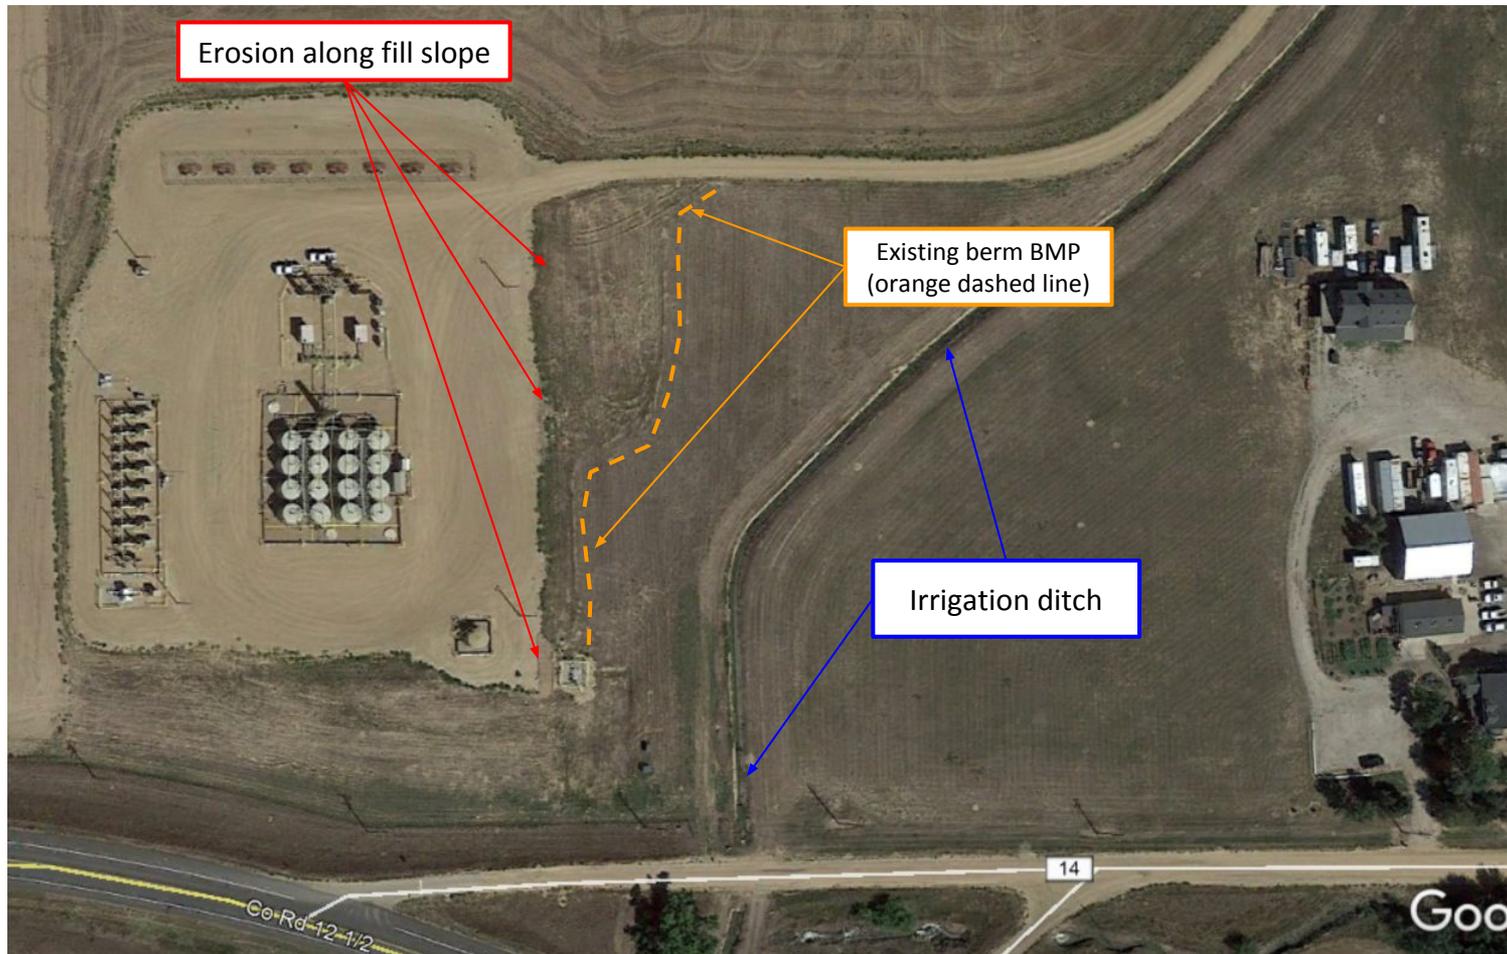
**Photo 1.** Google Earth aerial imagery taken 9/12/2019. Imagery illustrates a berm BMP that remains from construction operations along the eastern perimeter of the interim reclamation area.

At the time of this inspection on 5/26/2020, erosion was observed along the eastern fill slope of the well pad. Sediment discharge was observed within the interim reclamation areas but has not gone beyond the berm BMP.

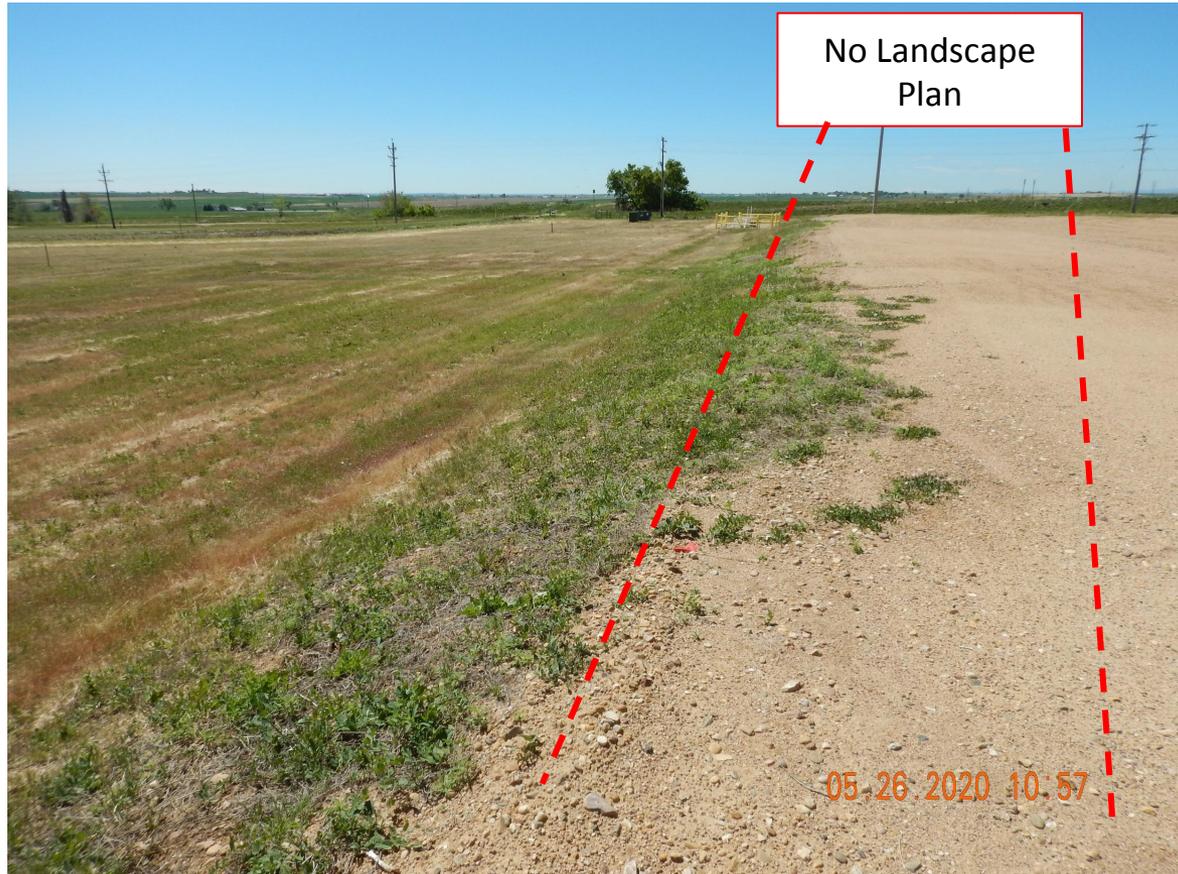
**Photo 2.** Photo taken from the northeastern location, facing South. Operator has failed to comply with the terms of the permit to conduct a final Landscape Plan (bermed and landscaped) along the eastern edge of location in order to mask the wellheads and facility from the nearby building unit owner. This should have been done as part of the Interim Reclamation process.

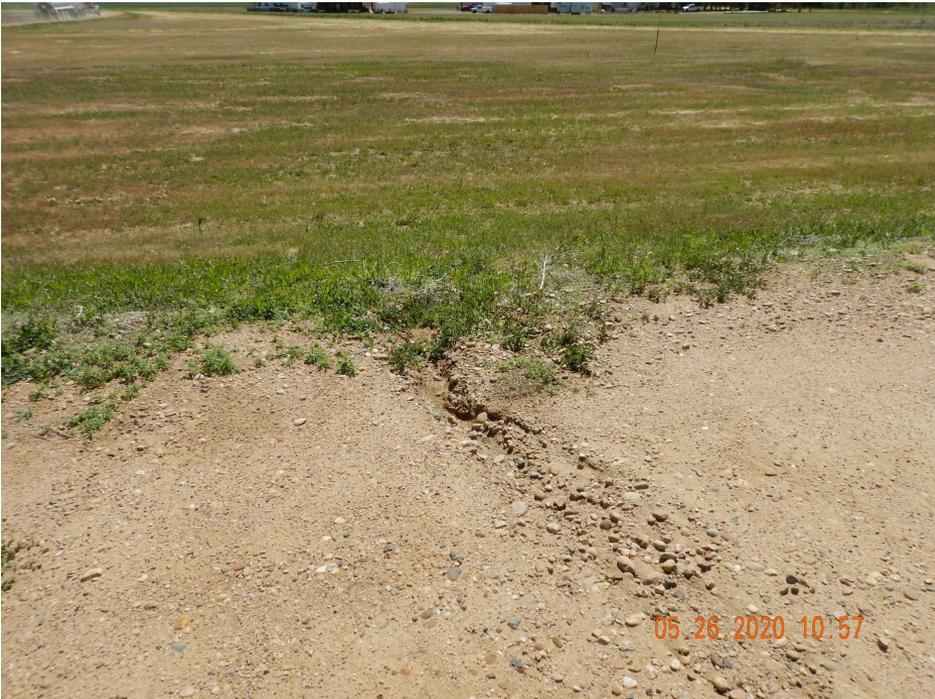
**Photo 3.** Photo taken from the eastern location, facing East. Photo illustrates rill erosion along the eastern fill slope. More erosion off other portions of the eastern location were observed.

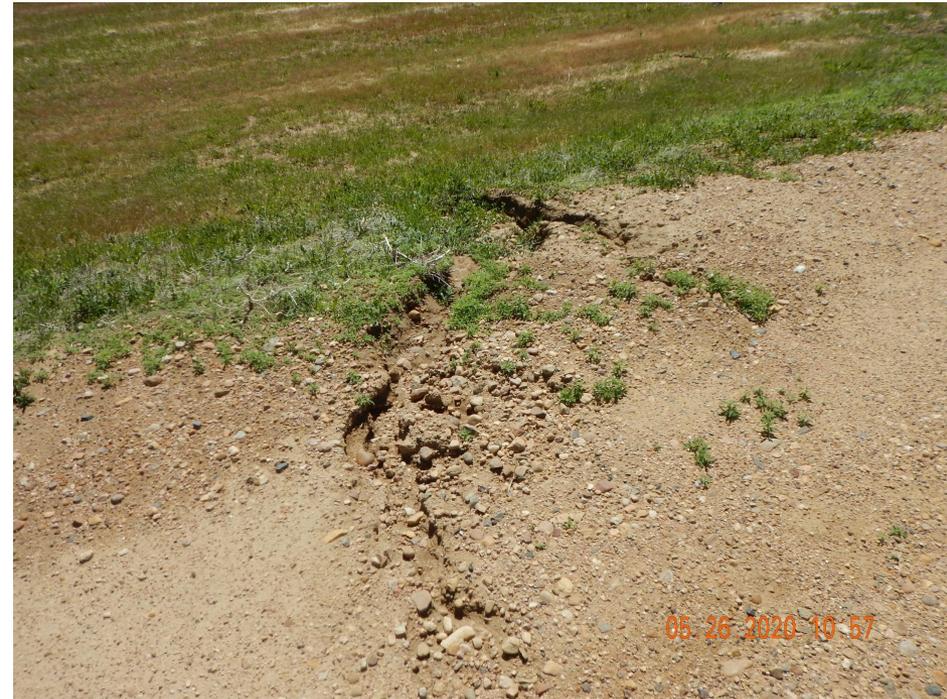
**Photo 4.** Photo taken from another portion of the eastern location, facing East. See comments under Photo 3.

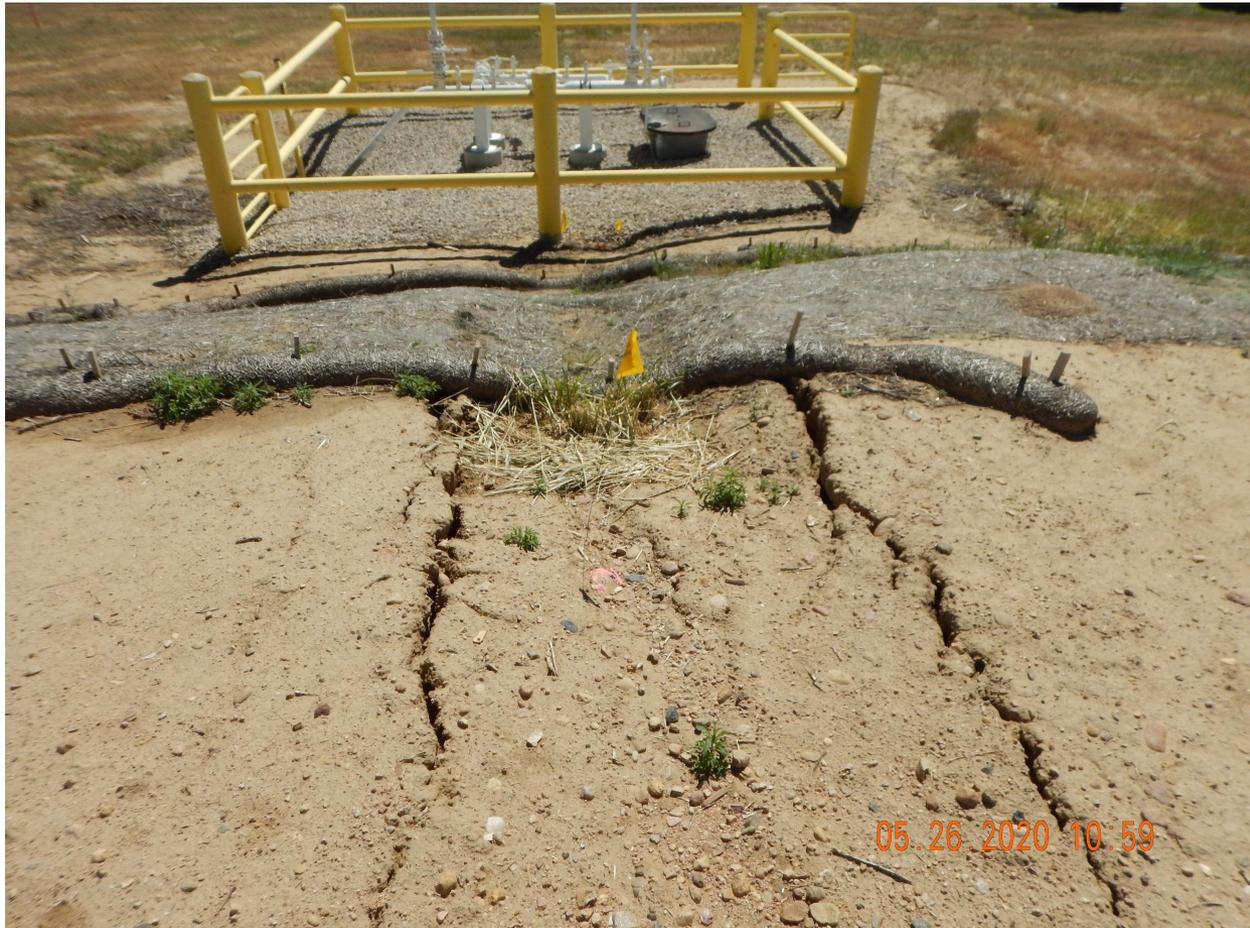
**Photo 5.** Photo taken from the southeastern location, facing East. Photo illustrates erosion and stormwater BMP maintenance required.

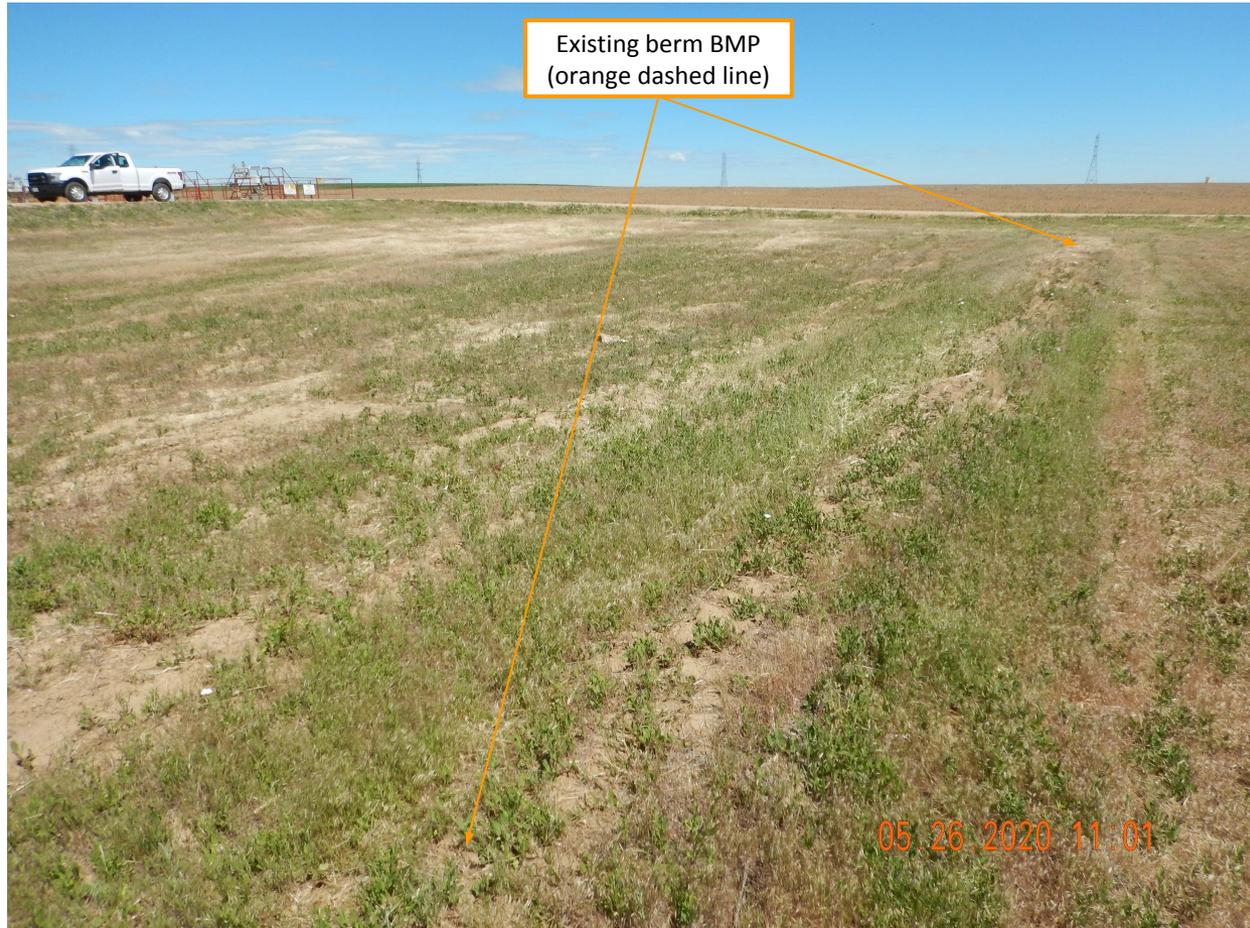
**Photo 6.** Photo taken from the eastern interim reclamation area, facing North. Photo illustrates a berm BMP that remains from construction operations along the eastern perimeter of the interim reclamation area. Sediment discharge has not gone beyond the berm BMP.

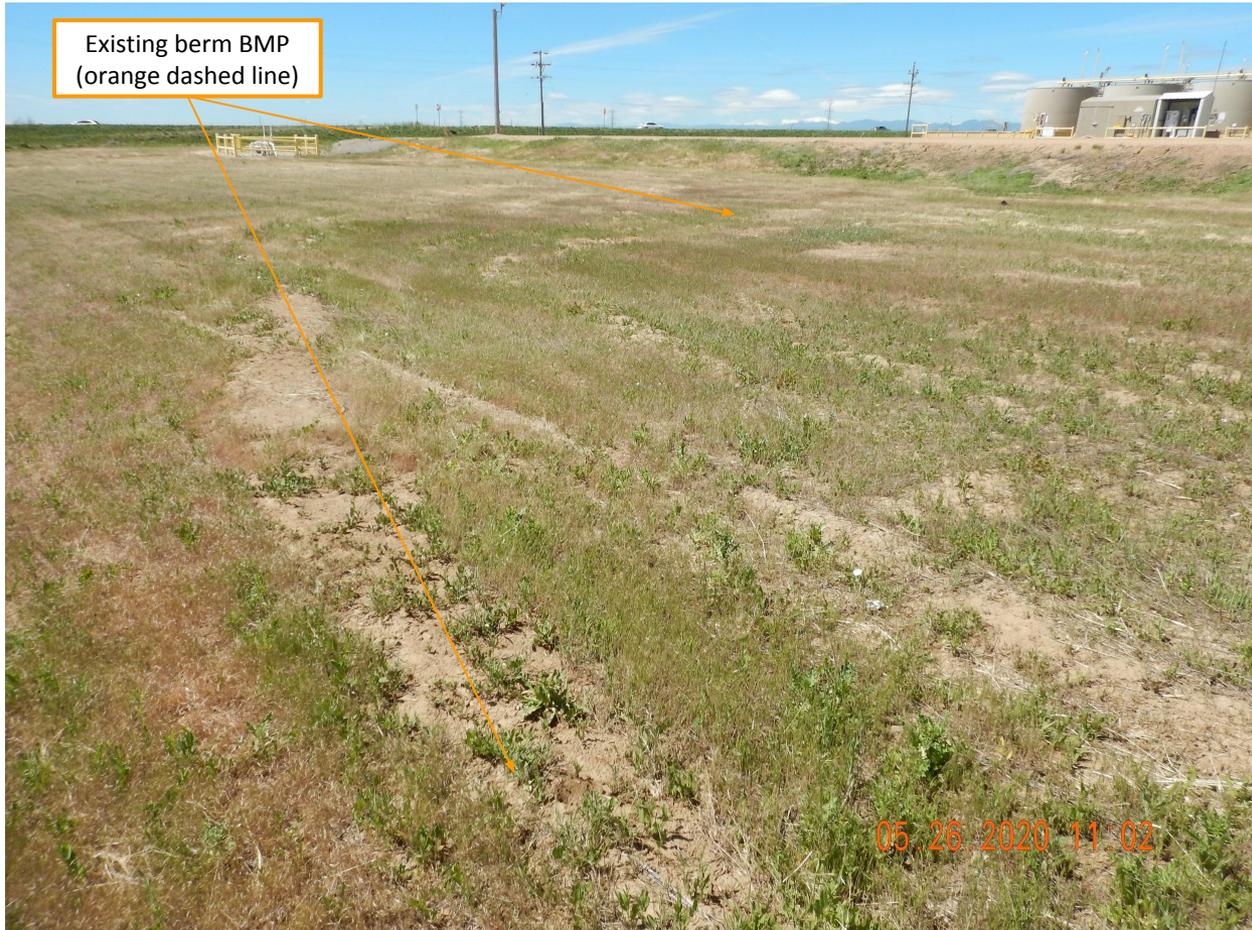
**Photo 7.** Photo taken from the eastern interim reclamation area, facing South. See comments under Photo 6.
