Inspection Photos

API: 061-06271

Operator: SAMSON OIL COMPANY

Inspection Date: 5/26/2020

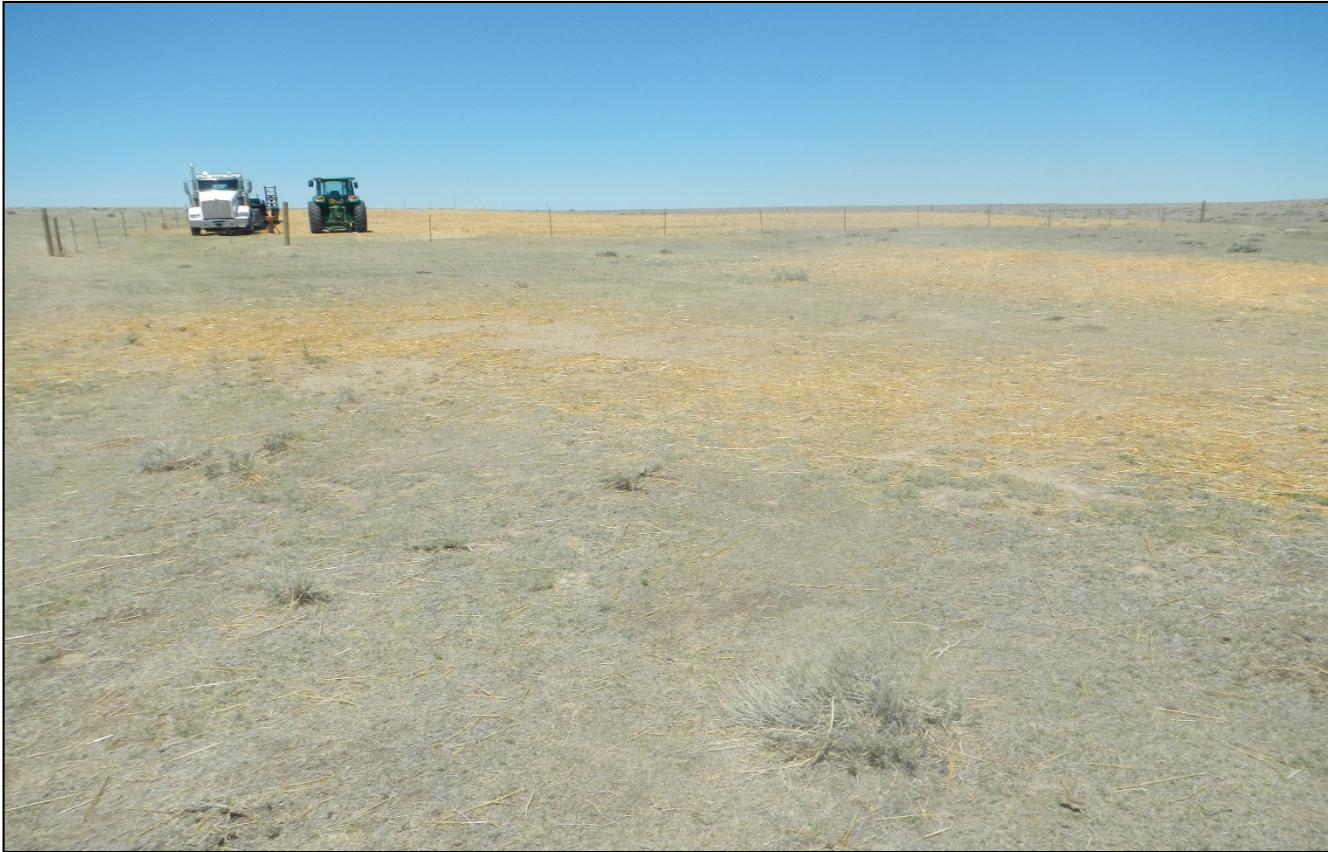
Photo 1. Facing west toward the location. There has been recent reclamation work performed and the location has been fenced.

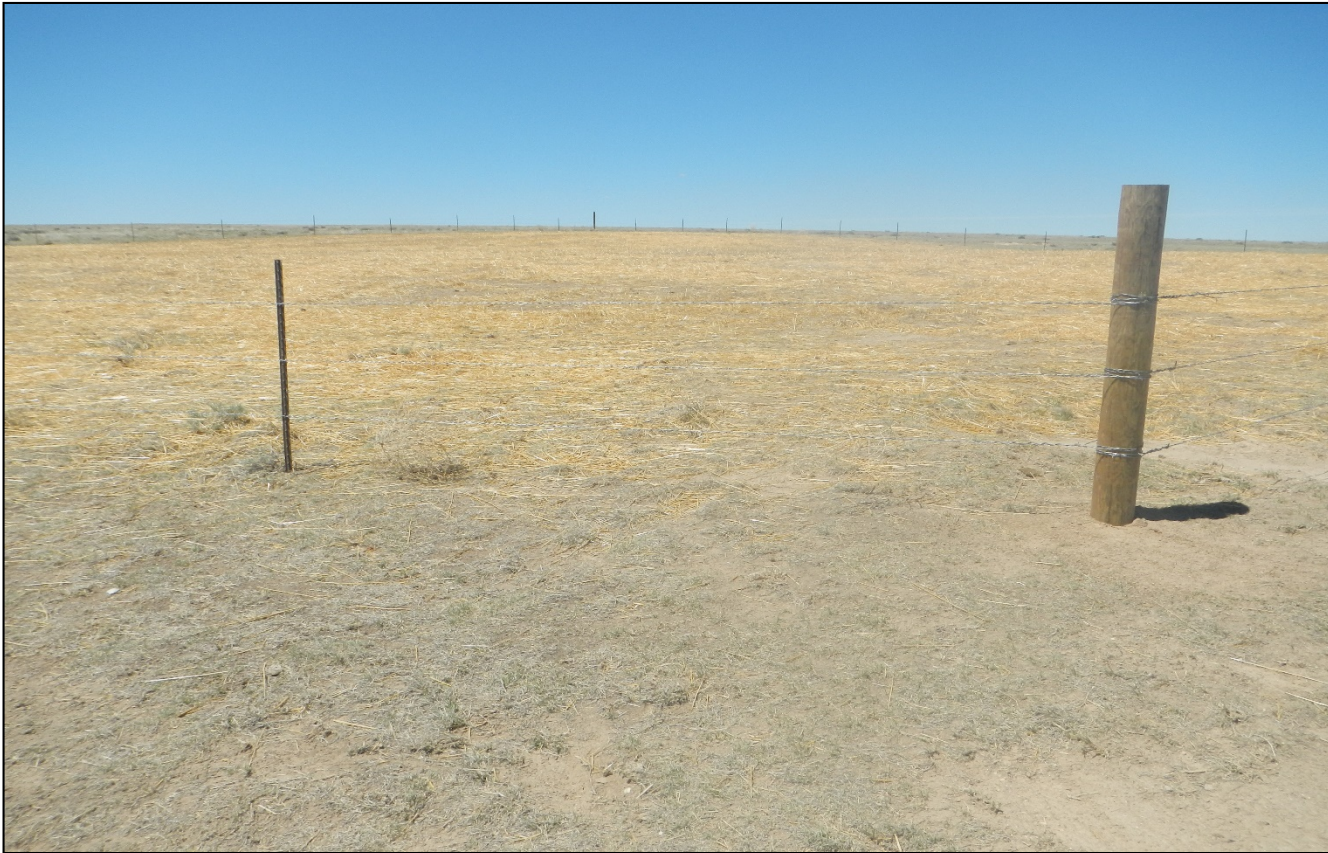
Photo 2. A perimeter fence has been installed around the location.

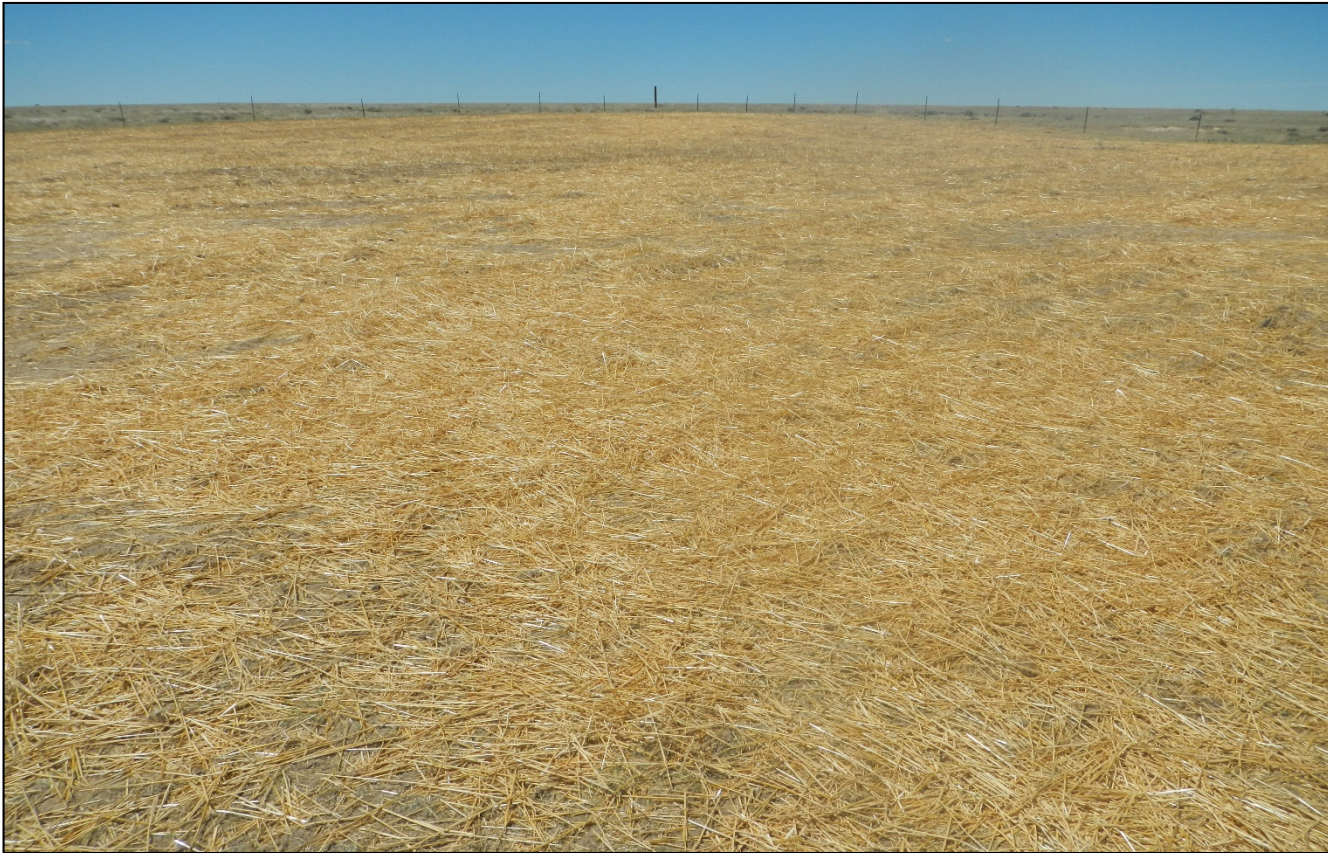
Photo 3. Center of the location facing west. Straw mulch has been applied at the location.

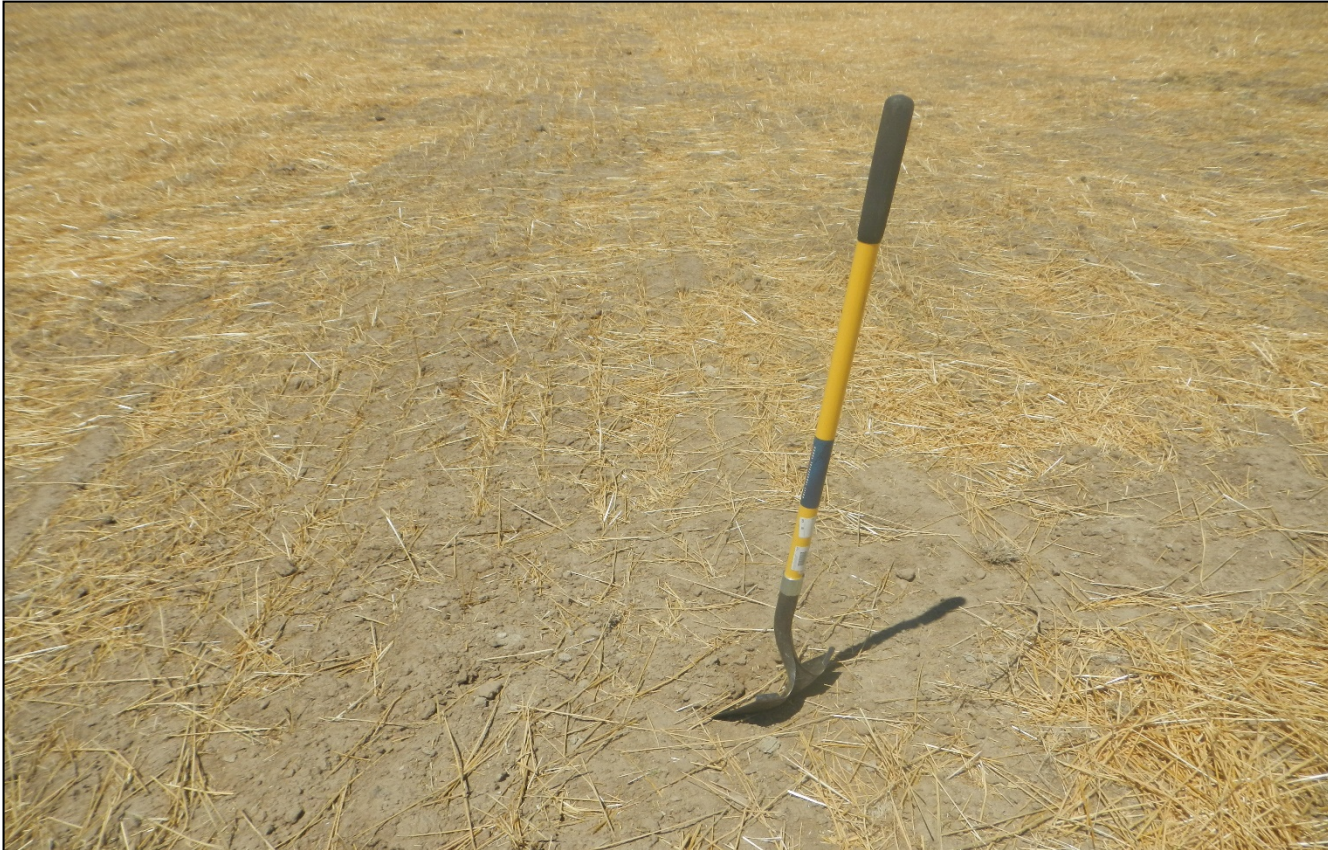
Photo 4. The shovel was used to test soil compaction. Soils seem to have been decompacted in areas of the location however, it is uncertain if decompaction was performed to 18 inches.
