Inspection Photos

API: 071-06609

Operator: EVERGREEN NATURAL RESOURCES

Inspection Date: 5/29/2020

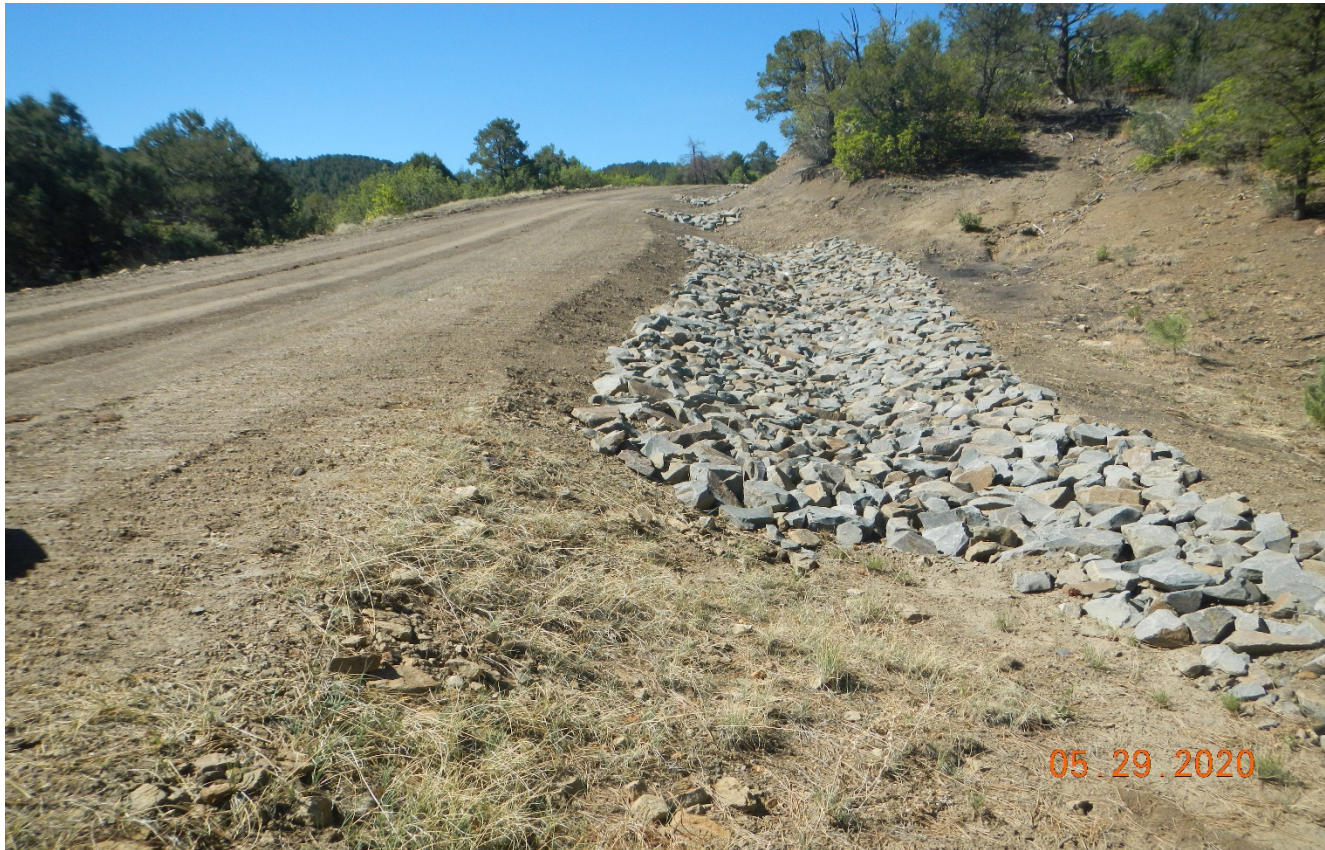
Photo 1. The erosion gully observed in previous inspection has been repaired and rock rip/rap has been installed.

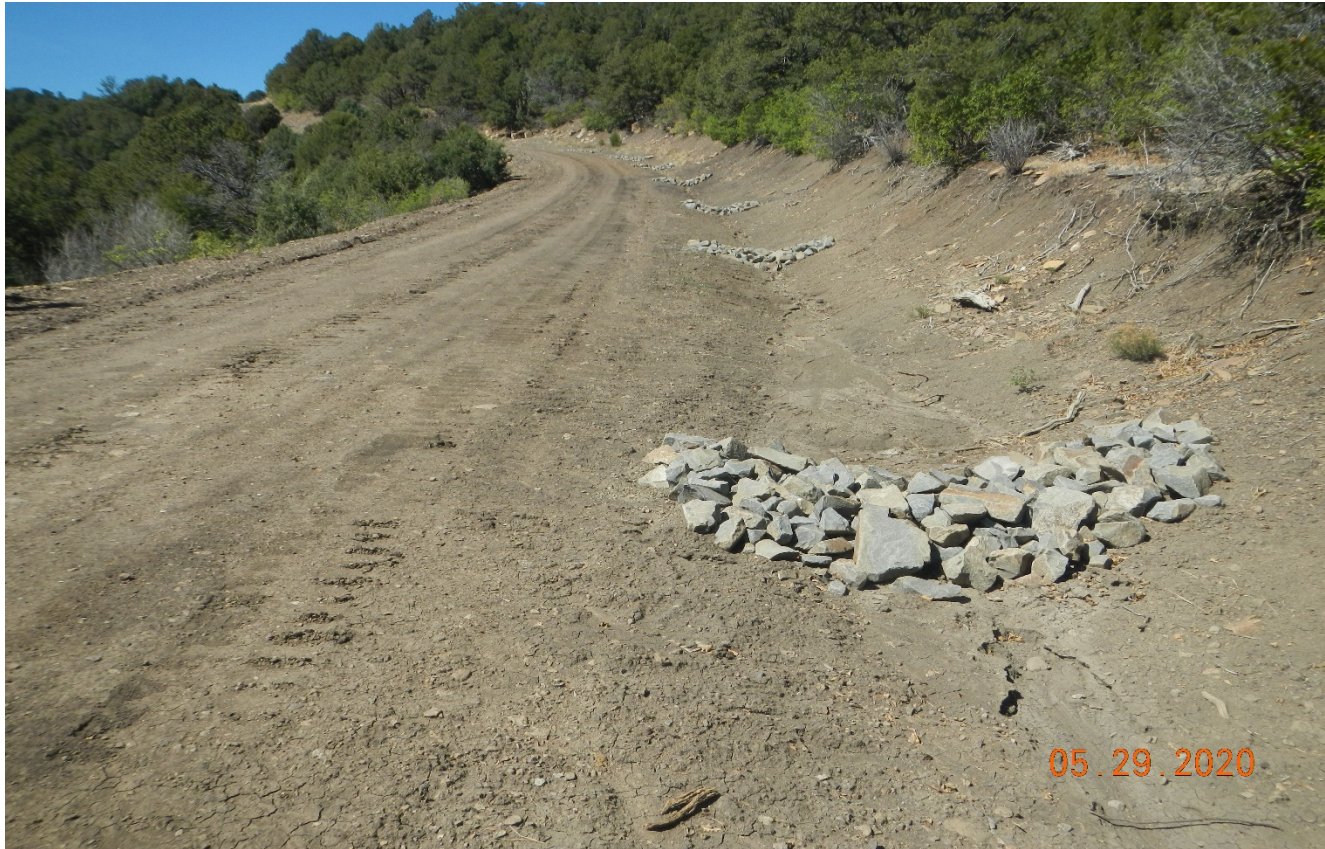
Photo 2. Facing southwest along the main road ascending the hill. Rock check dams have been installed along the road to the location.

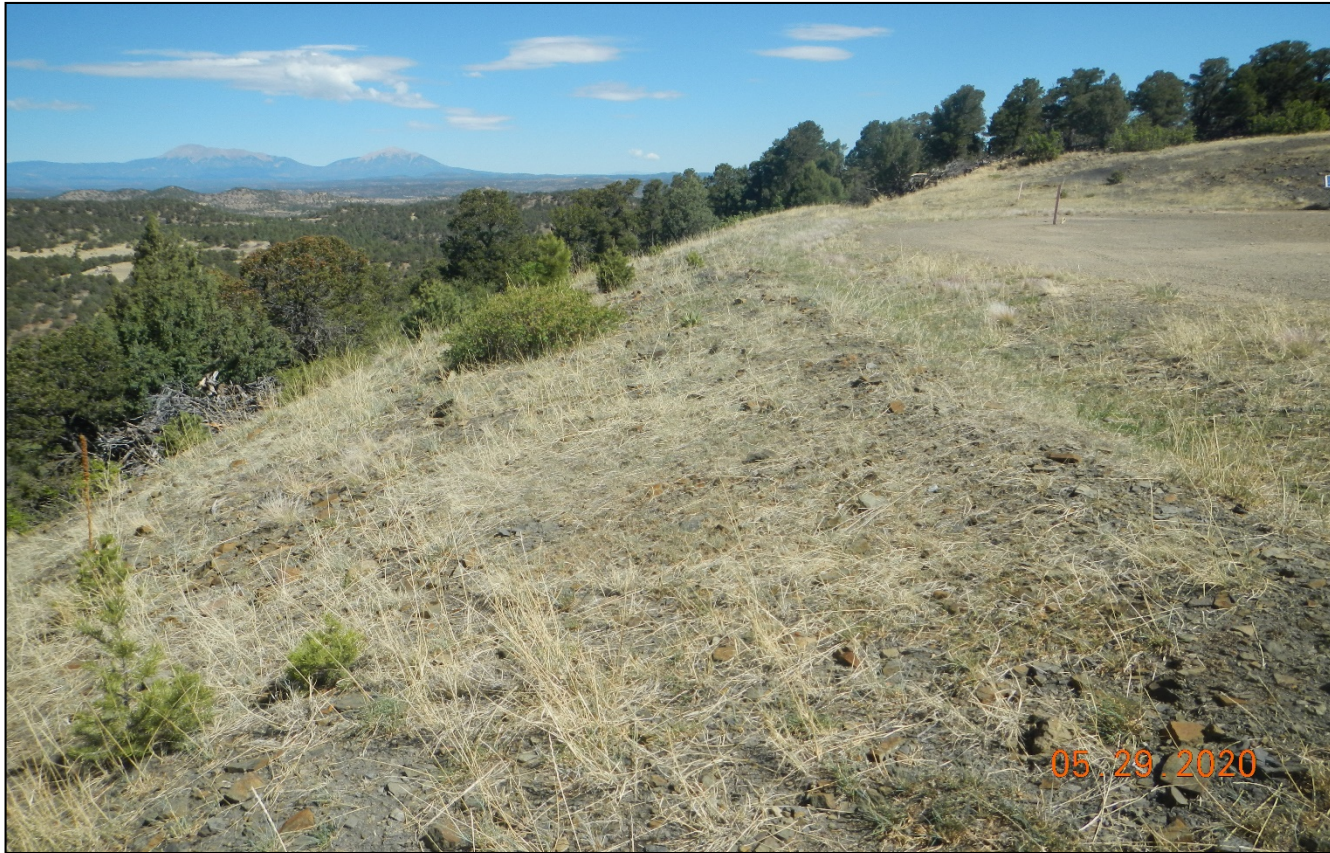
Photo 4. Facing north toward the fill slope. Vegetation is well established in the interim reclamation areas.
