Inspection Photos

Location Name: CVR /5-63-32_33 NWSW

Location #: 449306

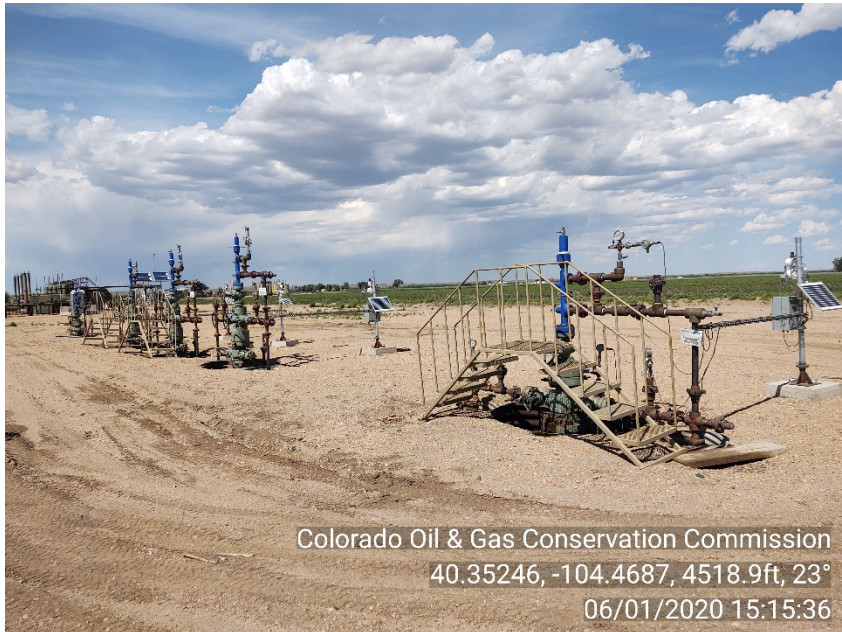
Photo #1

CVR 5-63-32-4841B2 (05-123-44255)
CVR 5-63-32-4841C2 (05-123-44257)
CVR 5-63-32-4956B2 (05-123-44256)
CVR 5-63-32-6457D2 (05-123-44253)
CVR 5-63-32-6457B2B (05-123-44254)

Wellsites **Producing | PR**

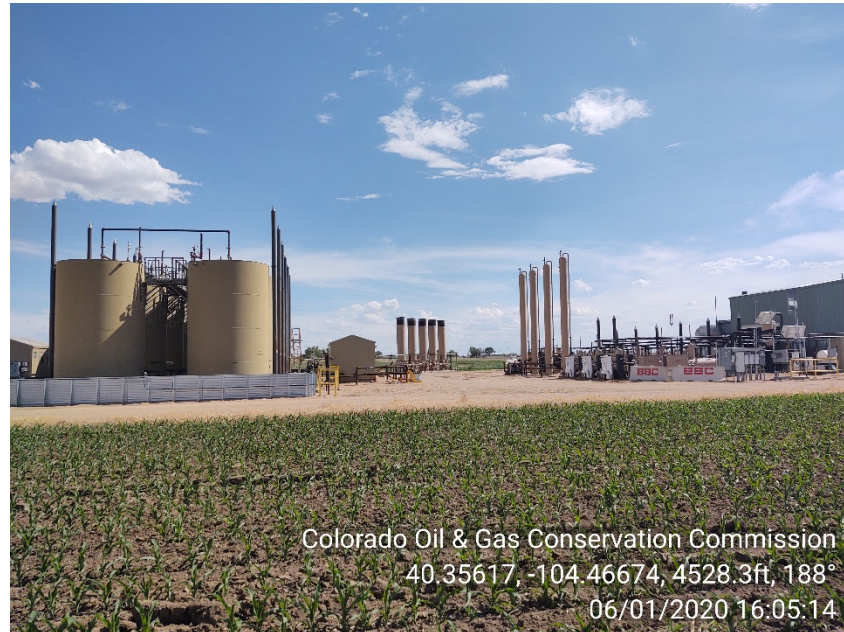
Photo #2

CVR 5-63-32-1609CH, CVR 5-63-32-1609CDH,
CVR 5-63-32-1724BH, CVR 5-63-32-3225CH,
CVR 5-63-32-3225CDH, CVR 5-63-32-3340BH,
CVR 5-63-32-4841B2, CVR 5-63-32-4841C2,
CVR 5-63-32-4956B2, CVR 5-63-32-6457D2,
CVR 5-63-32-6457B2B (11: wells)

Battery site

Active

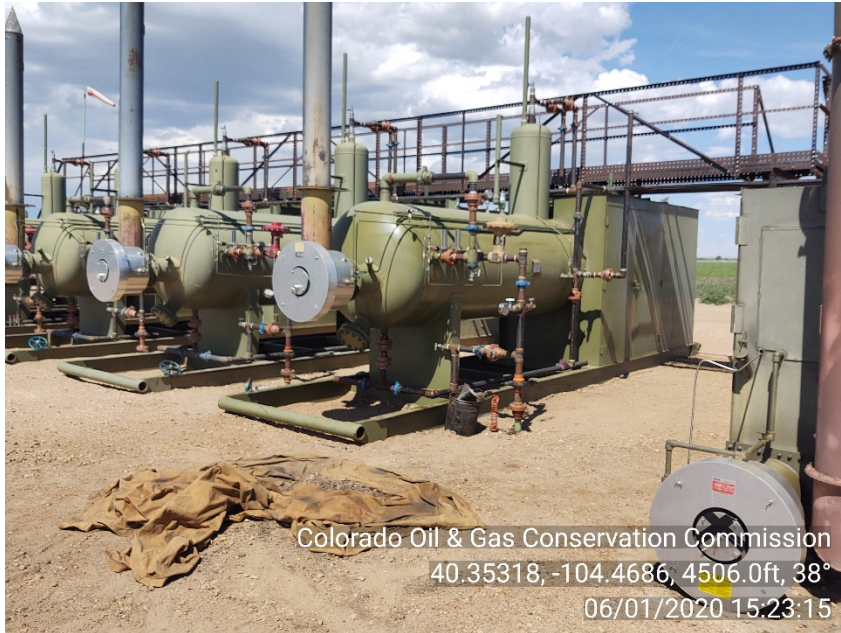
Photo #3

CVR 5-63-32-6457B2B

Wellsite separator (South pad)

Incident: Post release.

No Equipment Damage.

Stained soil contained on tarp.

Remediation progressing.
