Inspection Photos
Operator: Catamount Energy
API#: 067-05362
Date: 6/1/2020

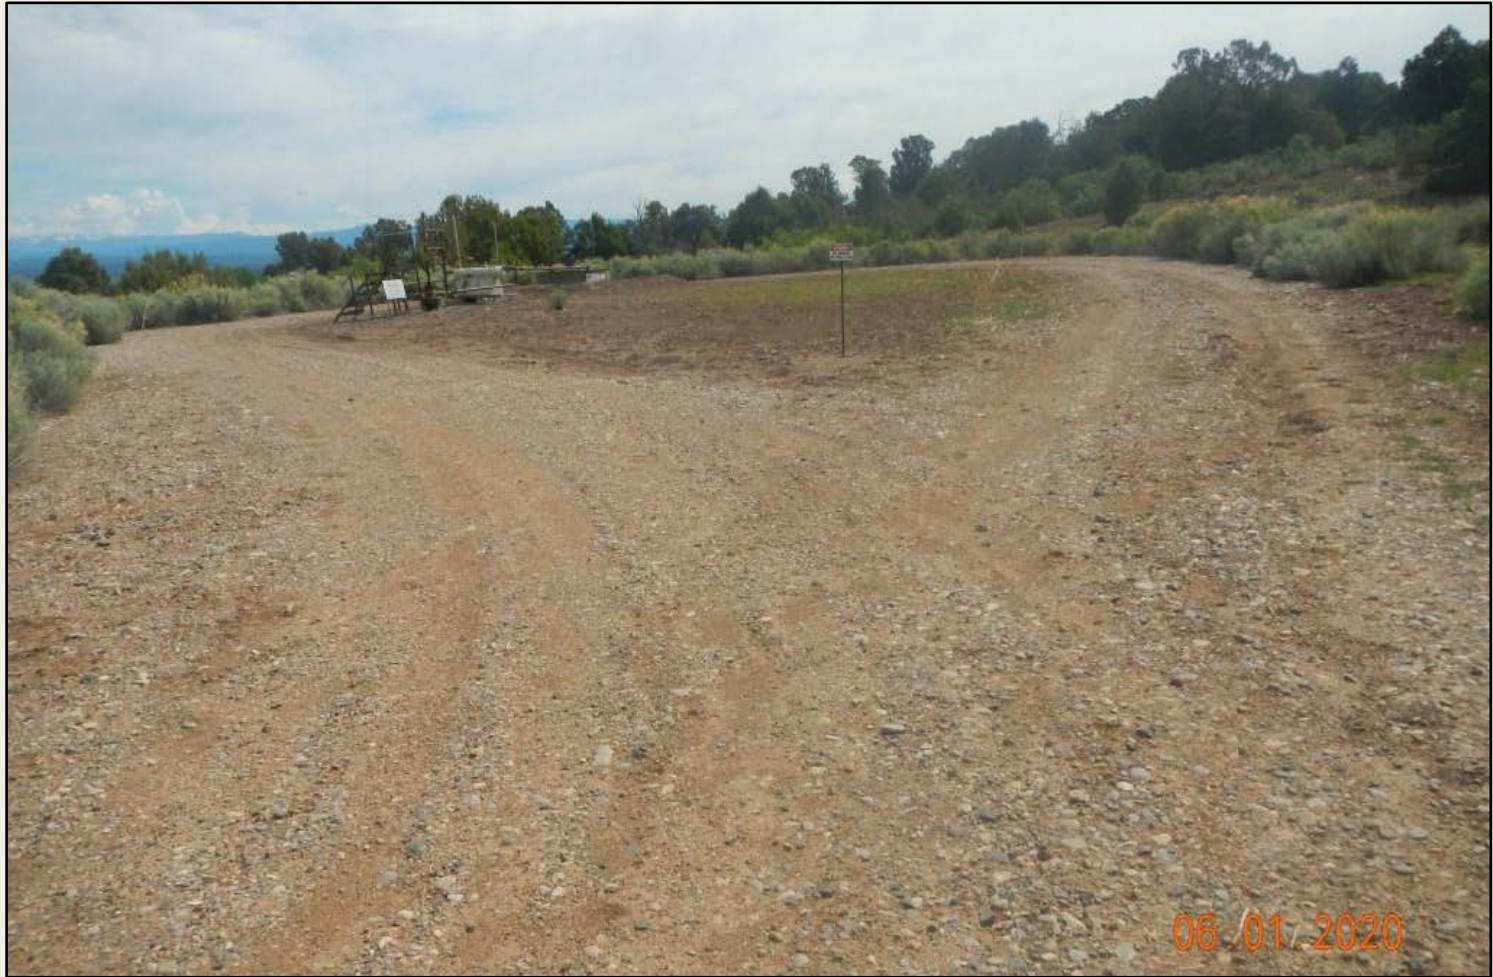
Photo 1. View of the project area from the well pad entrance facing center.

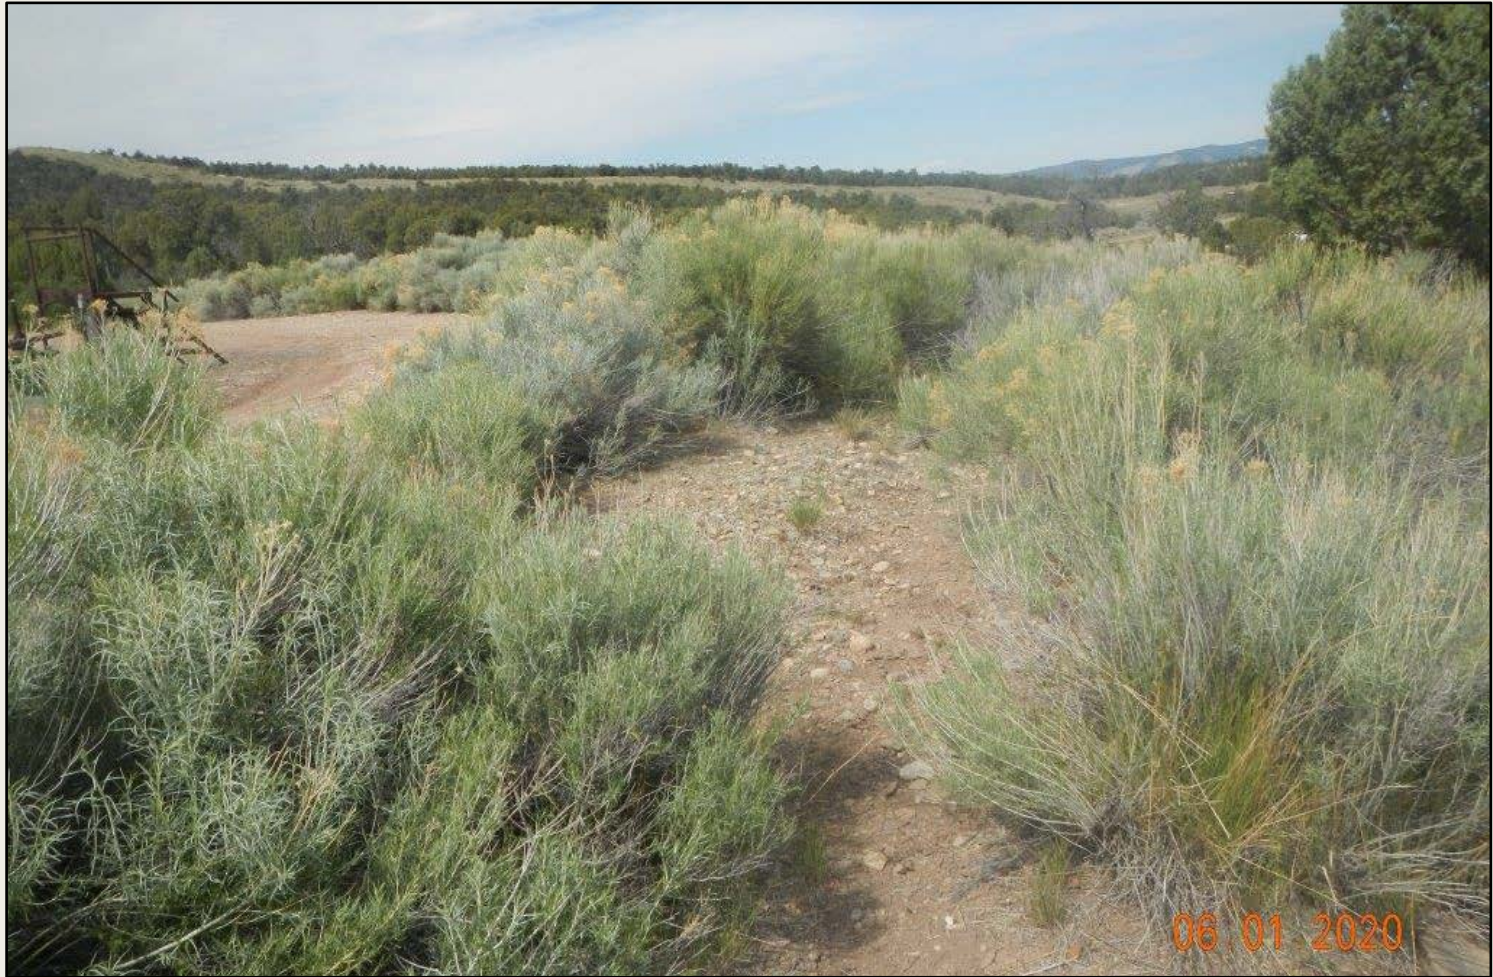
Photo 2. View of the northern project area from the northeastern corner facing westward. Revegetation is progressing with rubber rabbitbrush, smooth brome, and Indian ricegrass.

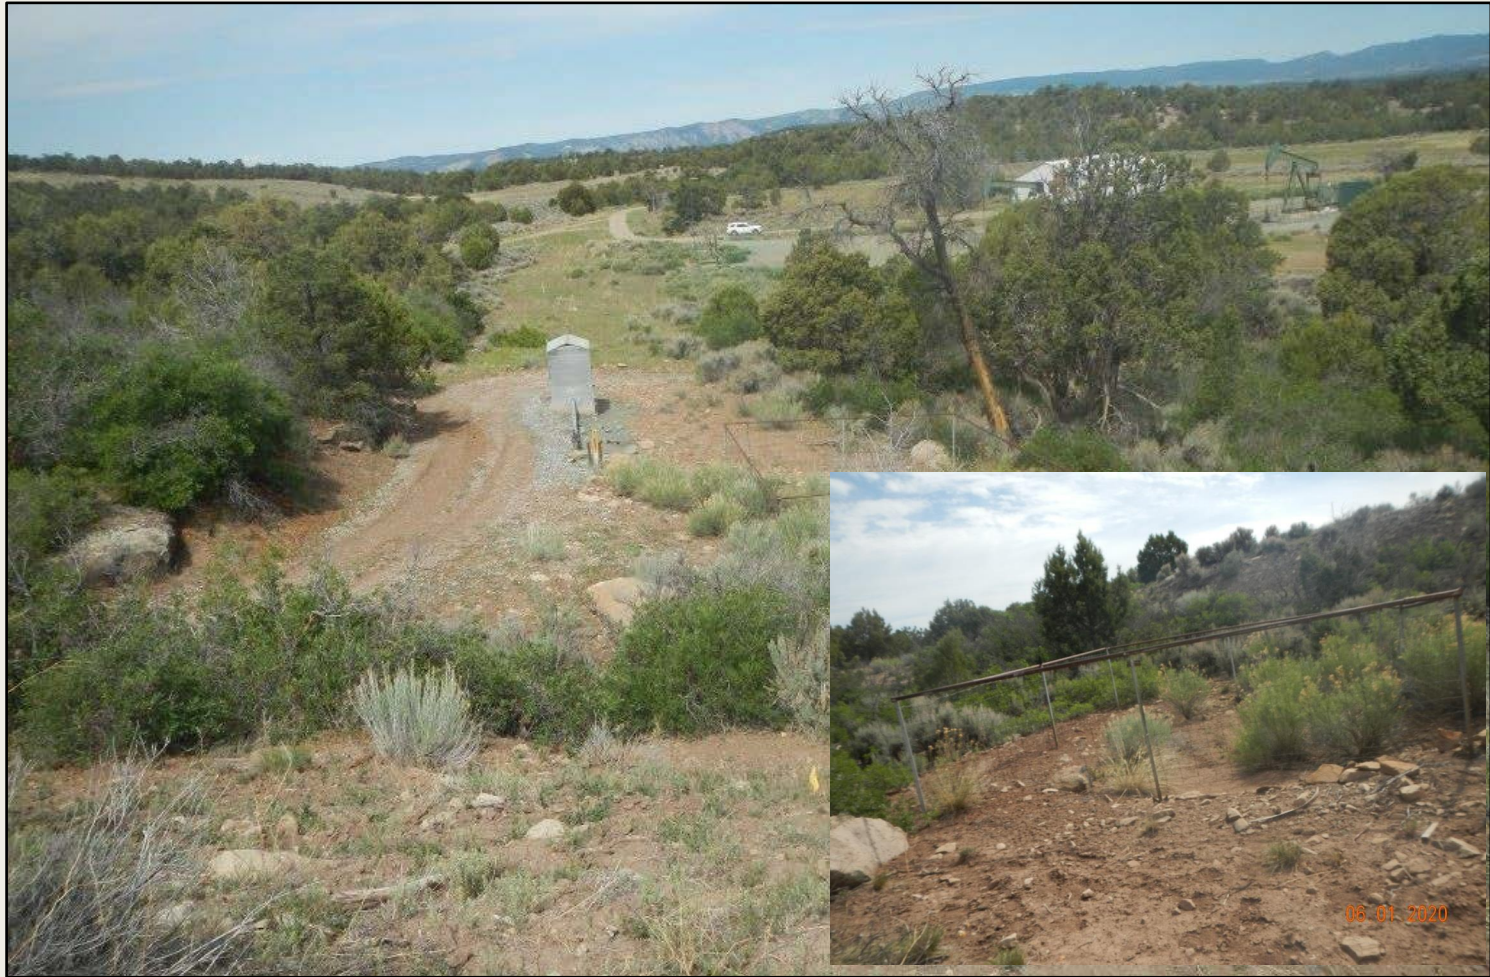
Photo 3. View of project facilities down-slope and northwest of the wellpad shown in Photo 1. Pit with unknown status adjacent to facilities (see inset).

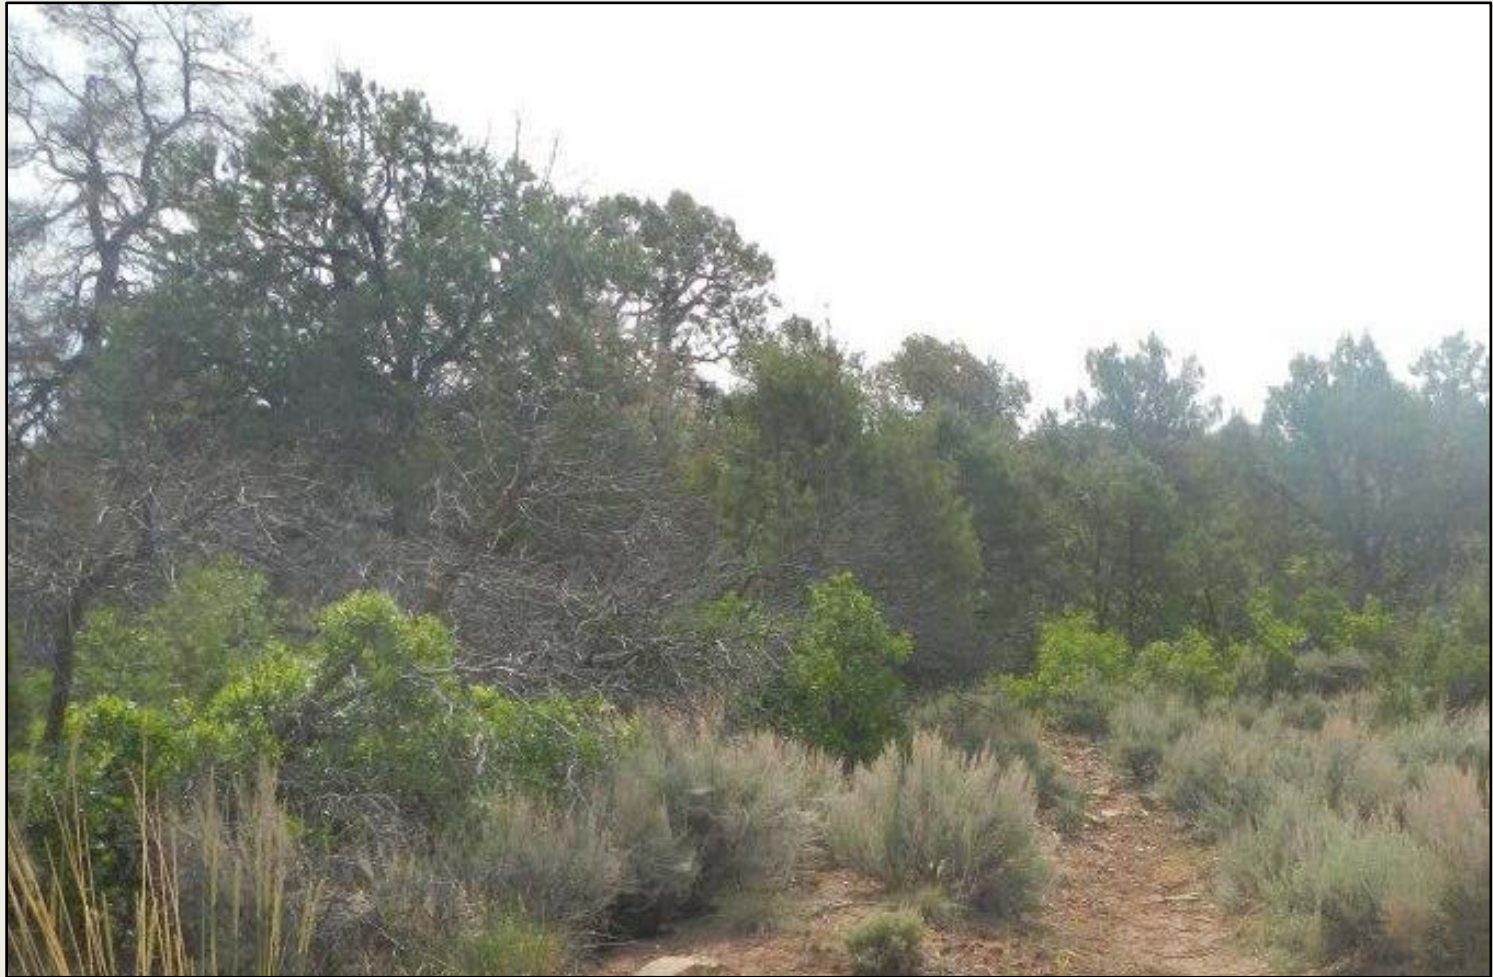
Photo 4. View of reference area comprised of pinyon and juniper woodland with gambel oak, sagebrush, and mixed grasses and forbs such as penstemon and Indian ricegrass.
