Inspection Photos
Operator: Catamount Energy
API#: 067-05373
Date: 6/1/2020

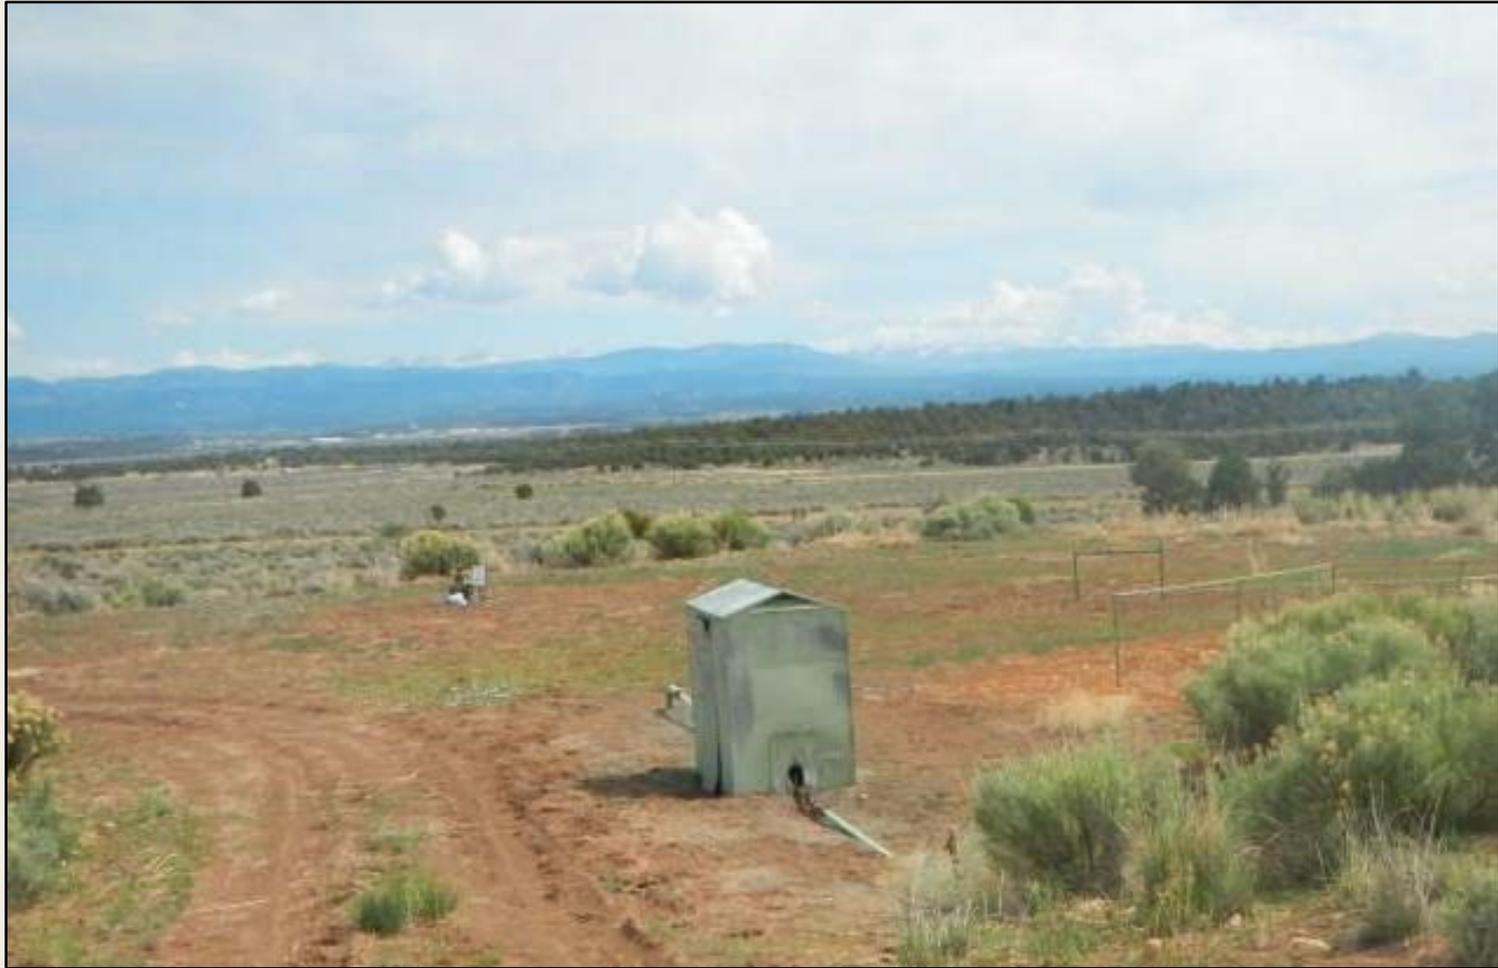
Photo 1. View of the project area from the southern edge facing center.

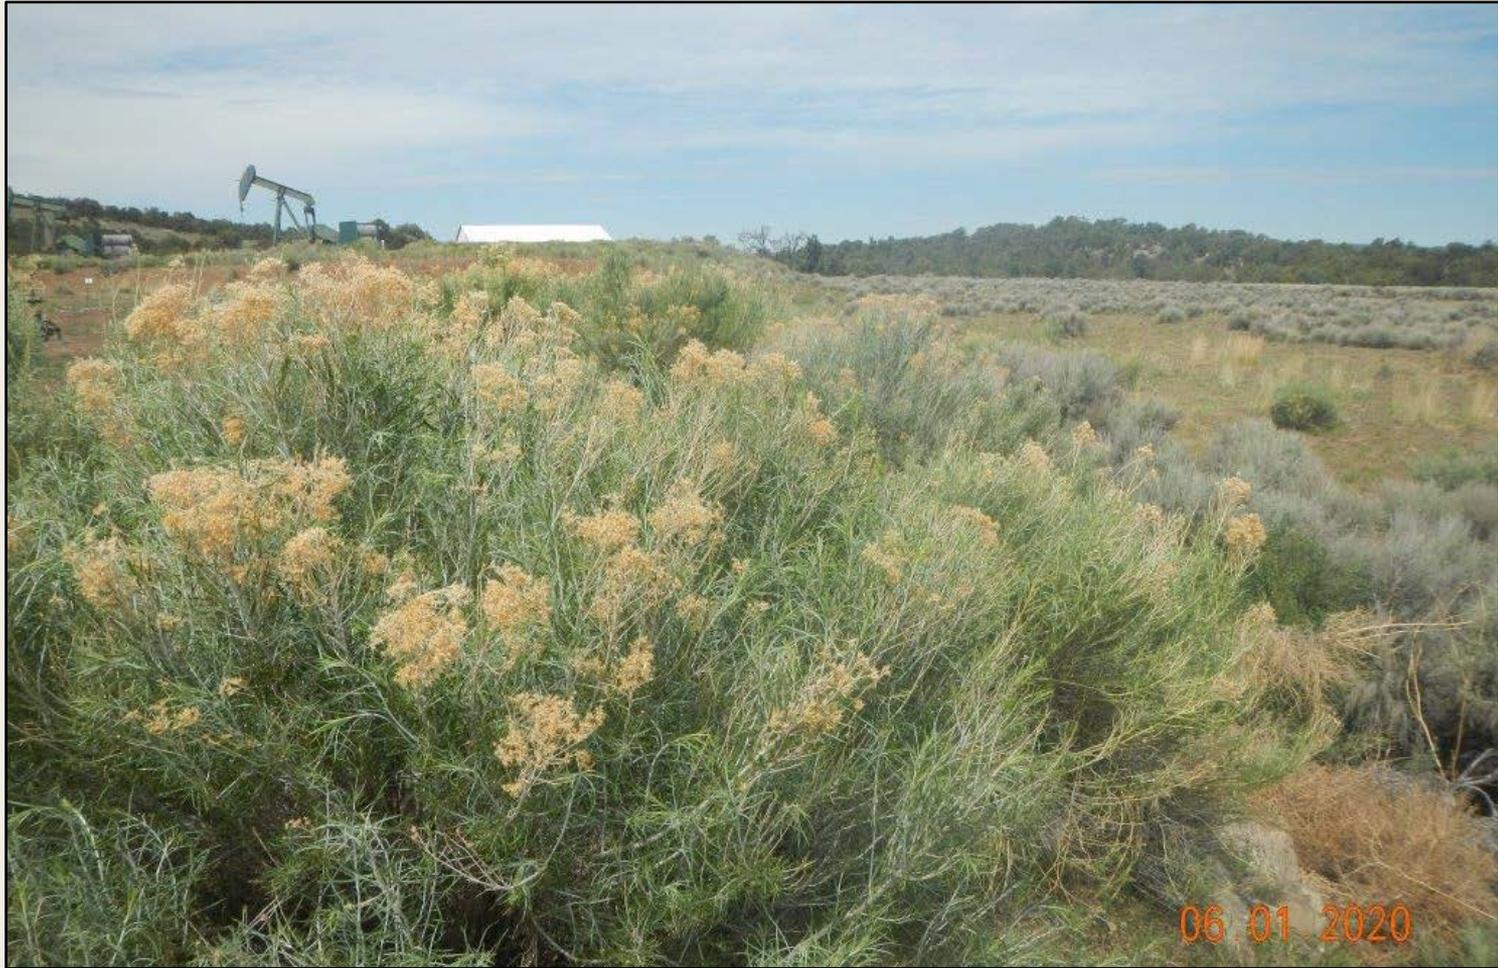
Photo 2. View of the northern project area from the northeastern corner facing westward. Revegetation is progressing with rubber rabbitbrush, smooth brome, and Indian ricegrass.

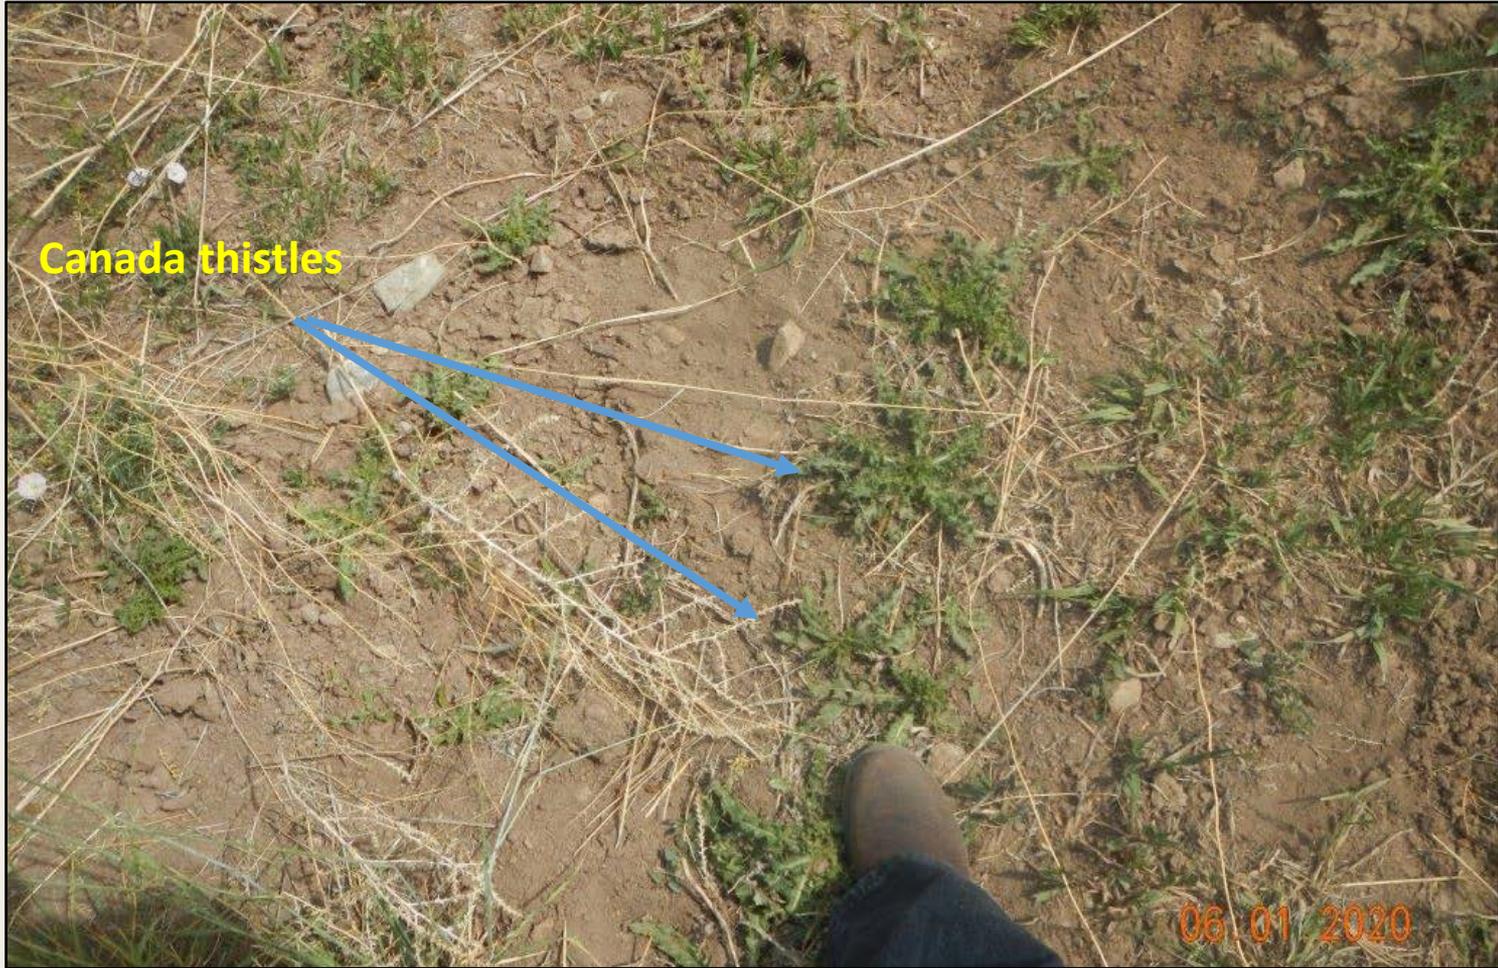
Photo 3. View of Canada thistles within the eastern project area.

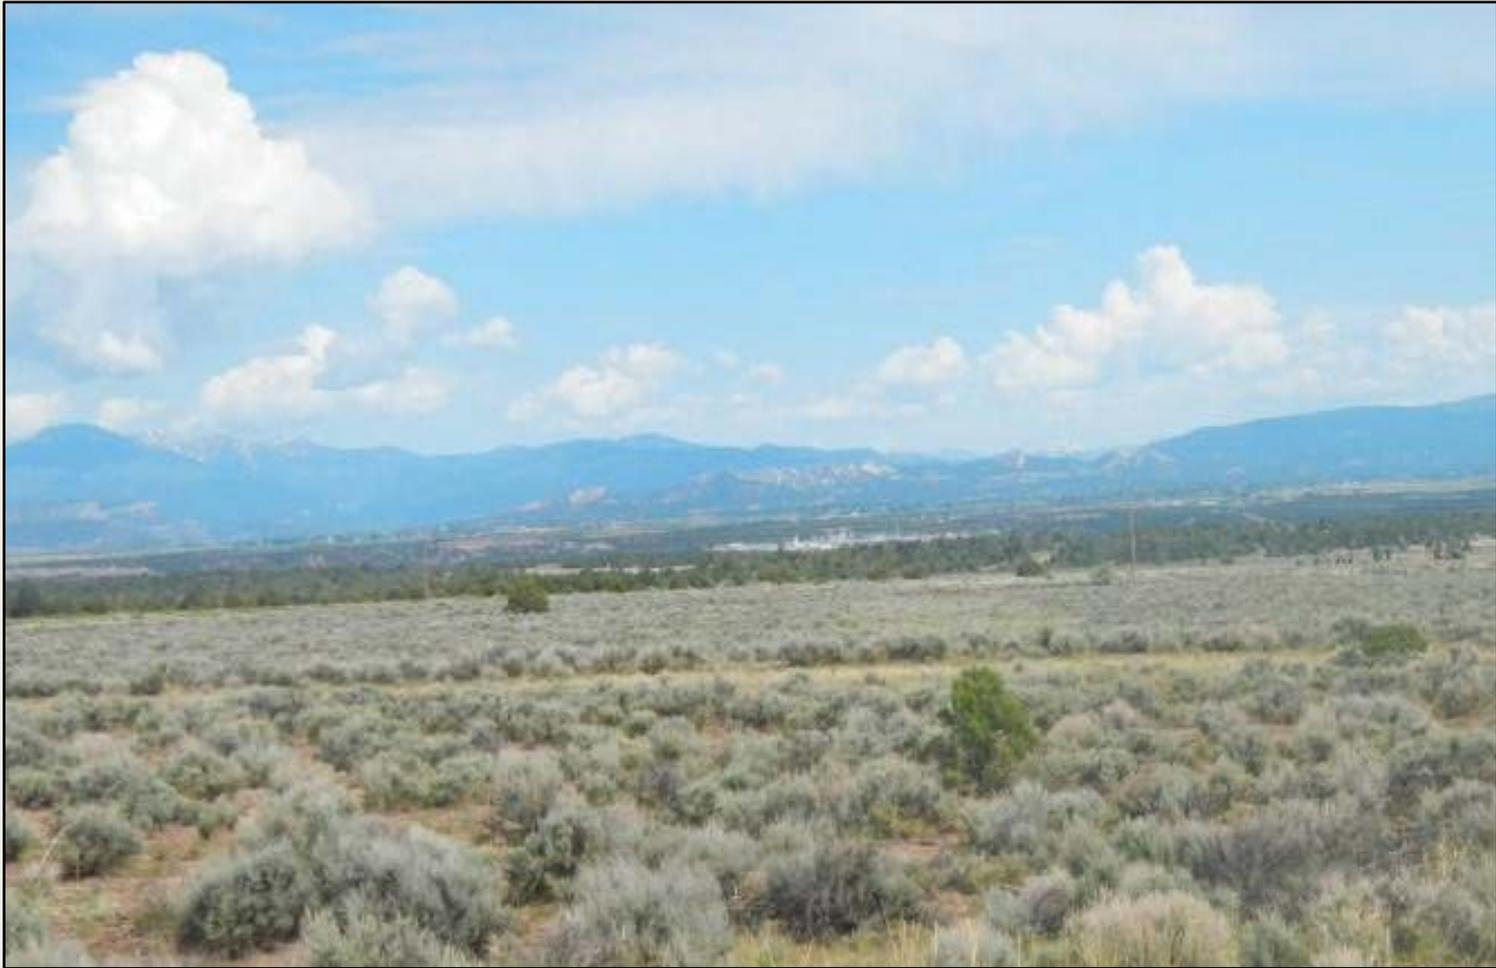
Photo 4. View of the reference area comprised of sagebrush shrubland with an understory of grasses such as squirreltail and forbs such as penstemon.
