**Inspection Photos**  
**Operator: Catamount Energy**  
**API#: 067-09073**  
**Date: 6/1/2020**

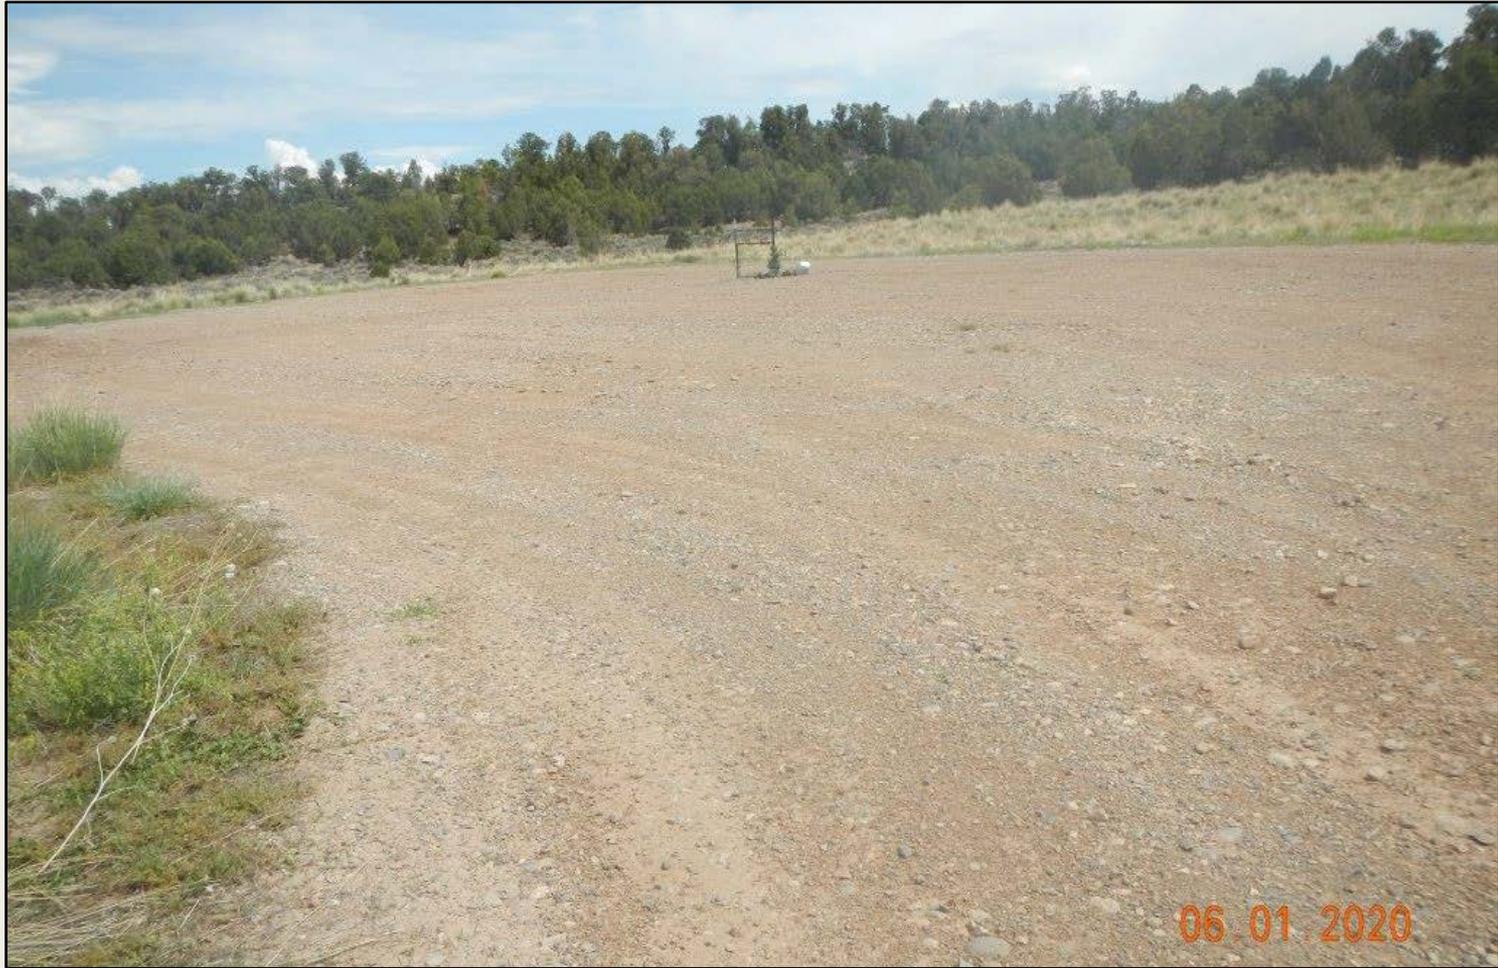
Photo 1. View of the project area from the well pad entrance facing center.

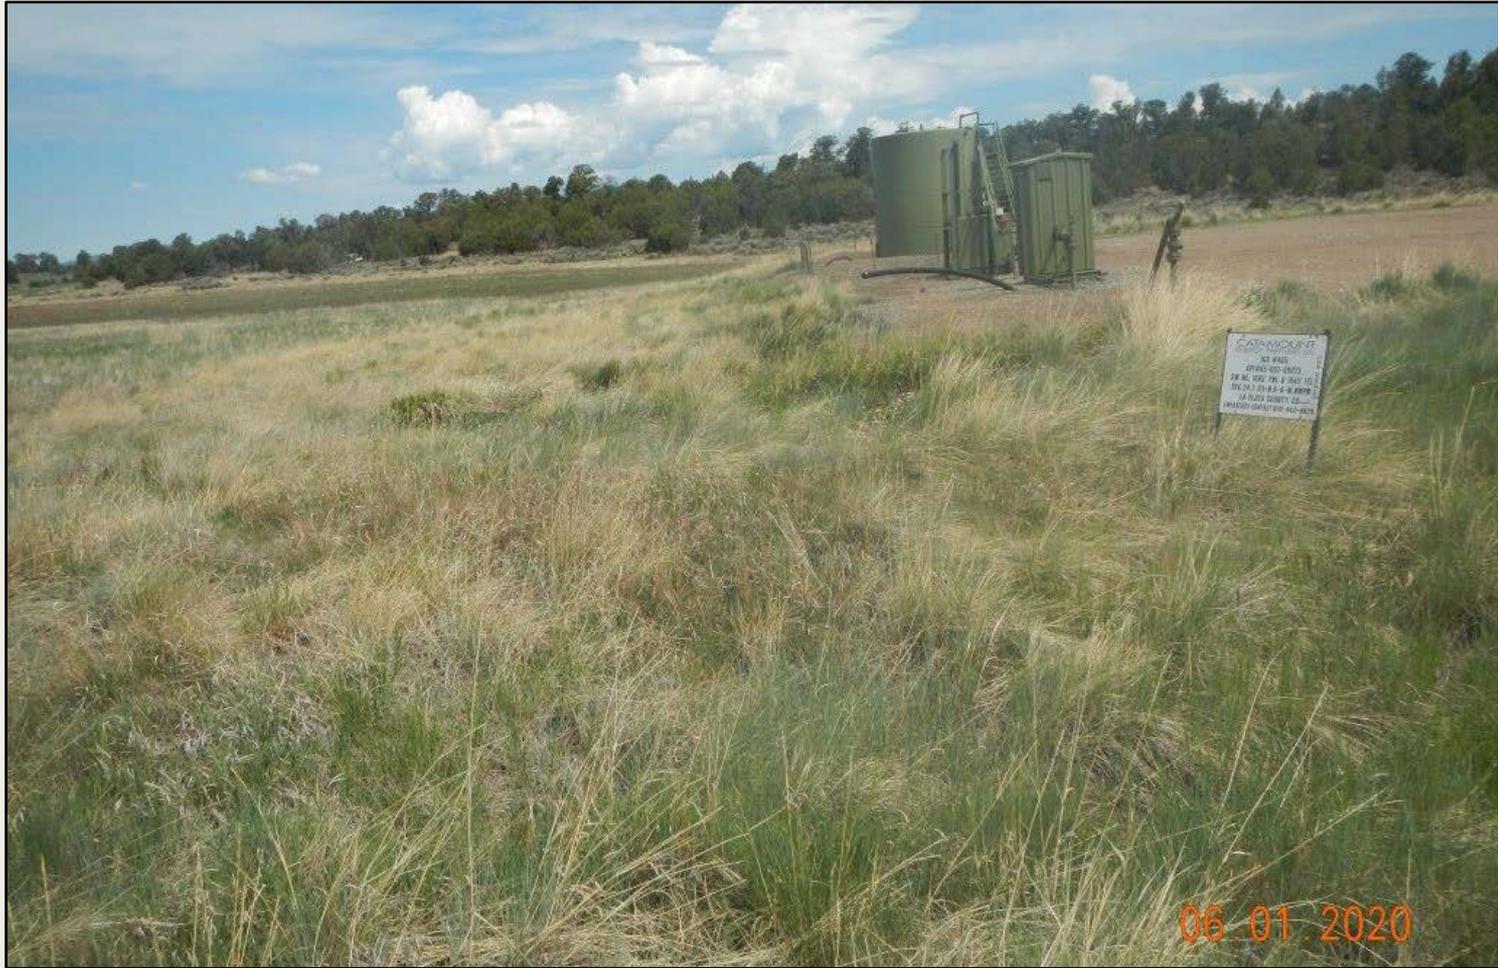
Photo 2. View of the western project area from the southwestern corner facing northward. Revegetation is progressing with smooth brome, crested wheatgrass, and western wheatgrass.

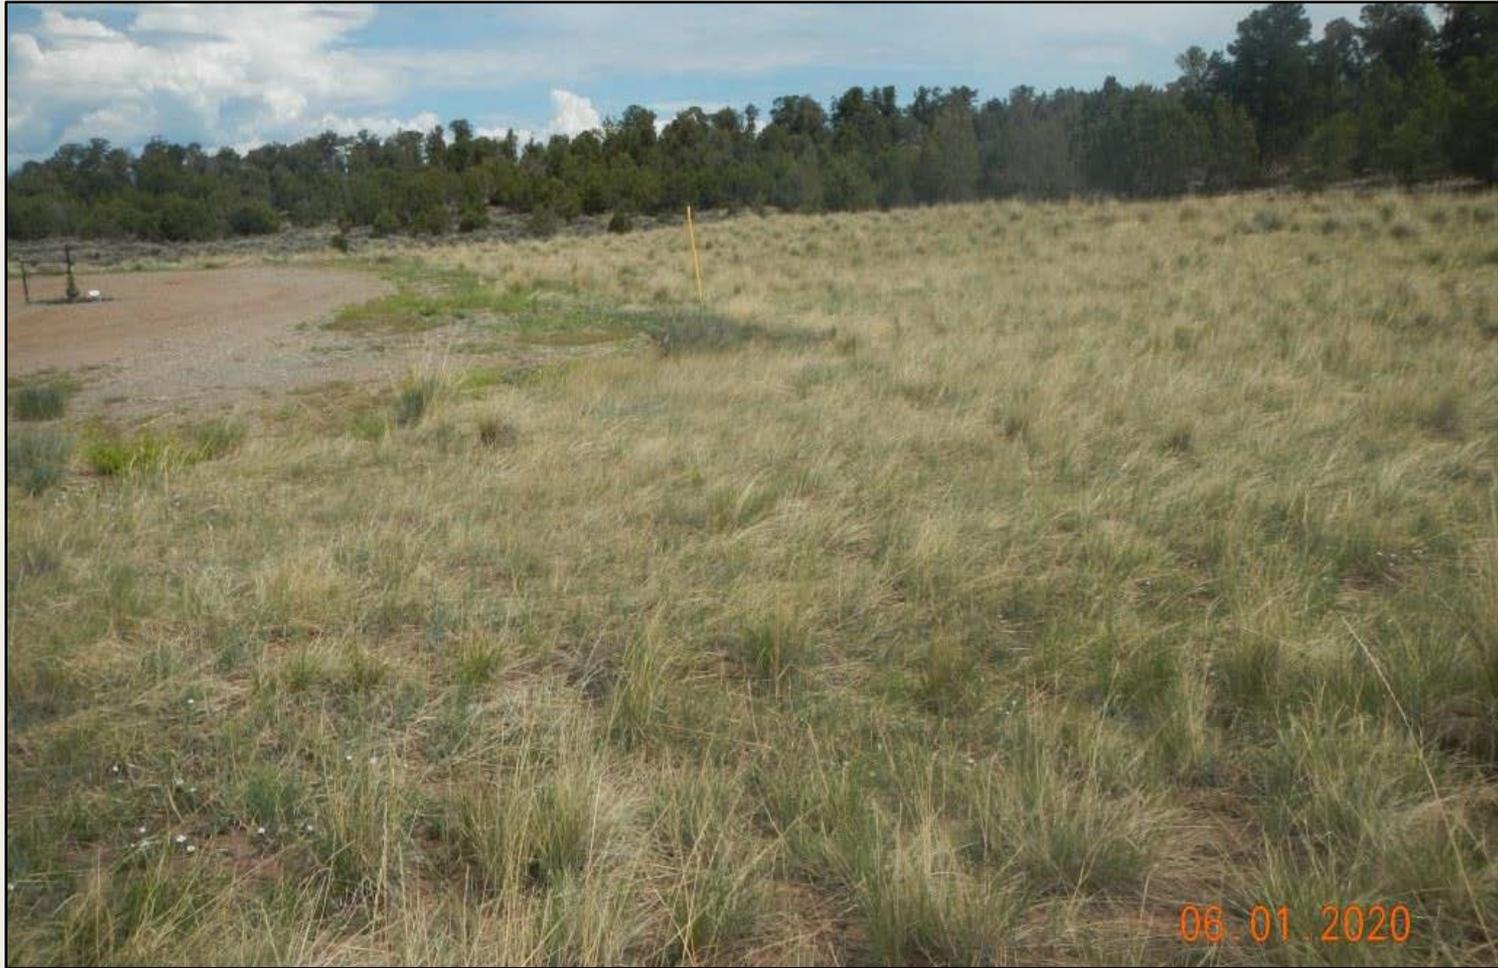
Photo 3. View of the eastern project area from the northeastern corner facing westward.

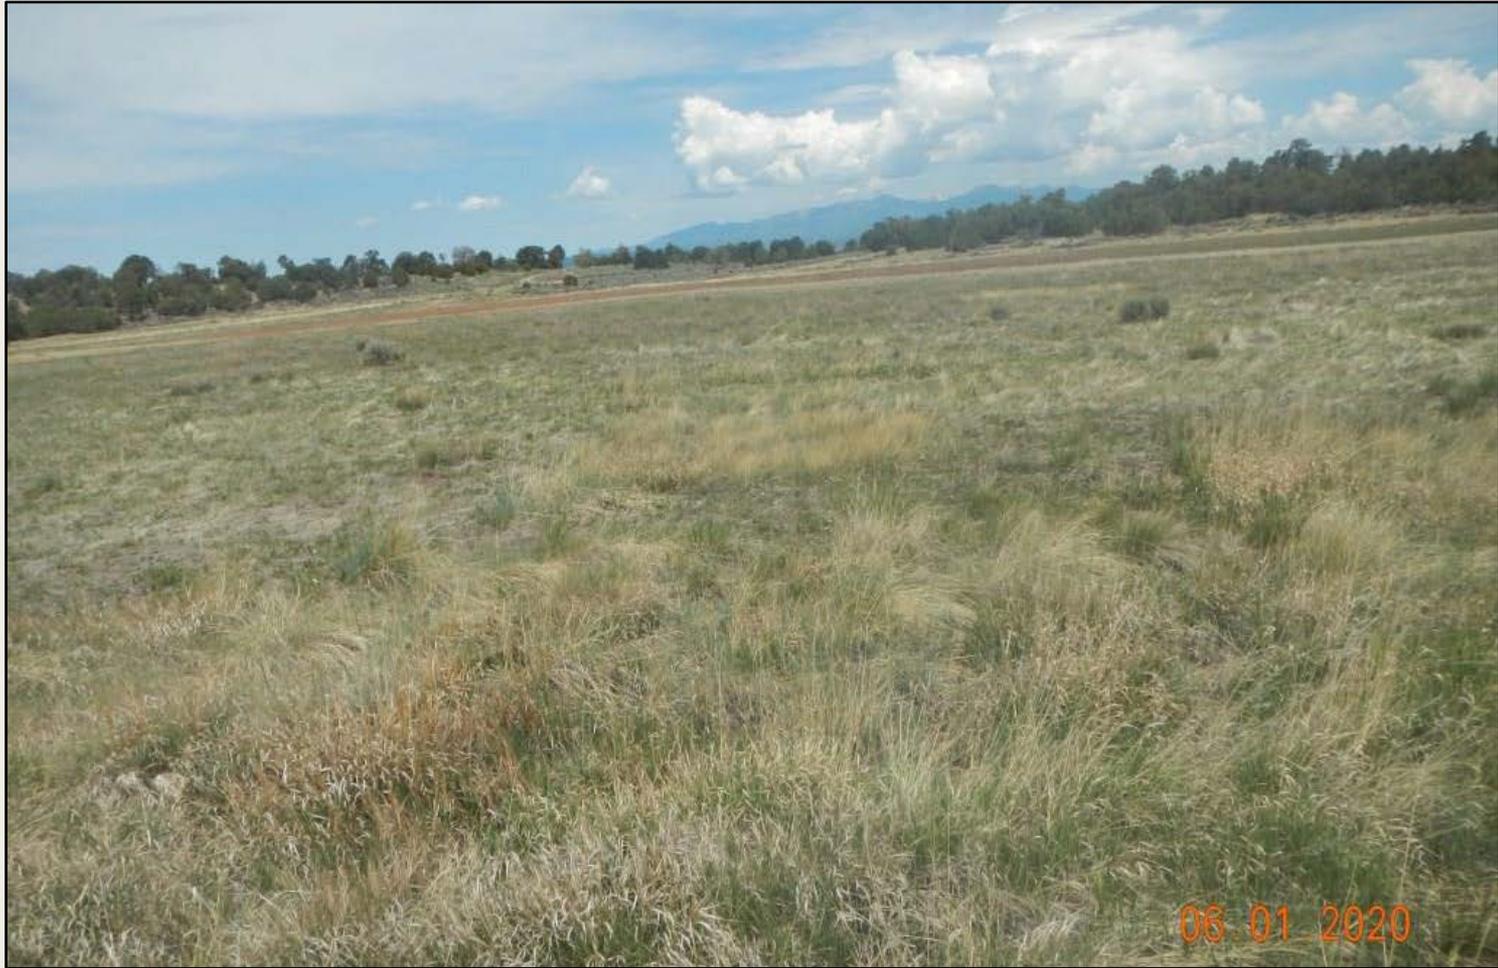
Photo 4. View of reference area comprised of open grass field with grasses such as smooth brome and western wheatgrass.
