Inspection Photos  
Operator: Logos Operating  
API#: 067-05371  
Date: 6/3/2020

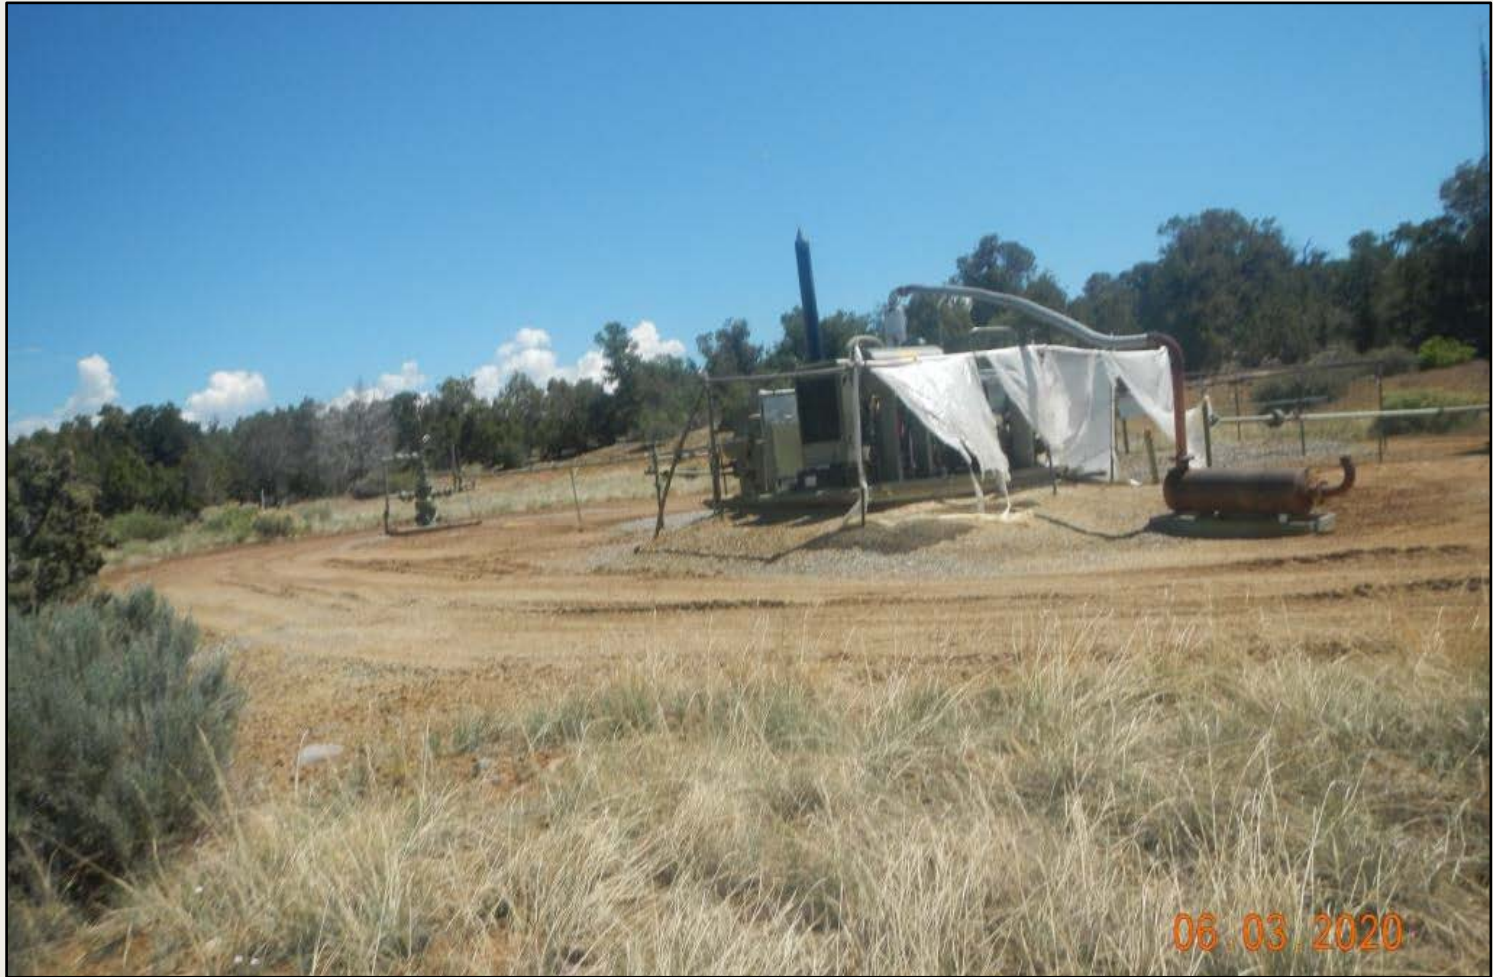
Photo 1. View of the project area from the southwestern corner facing center.

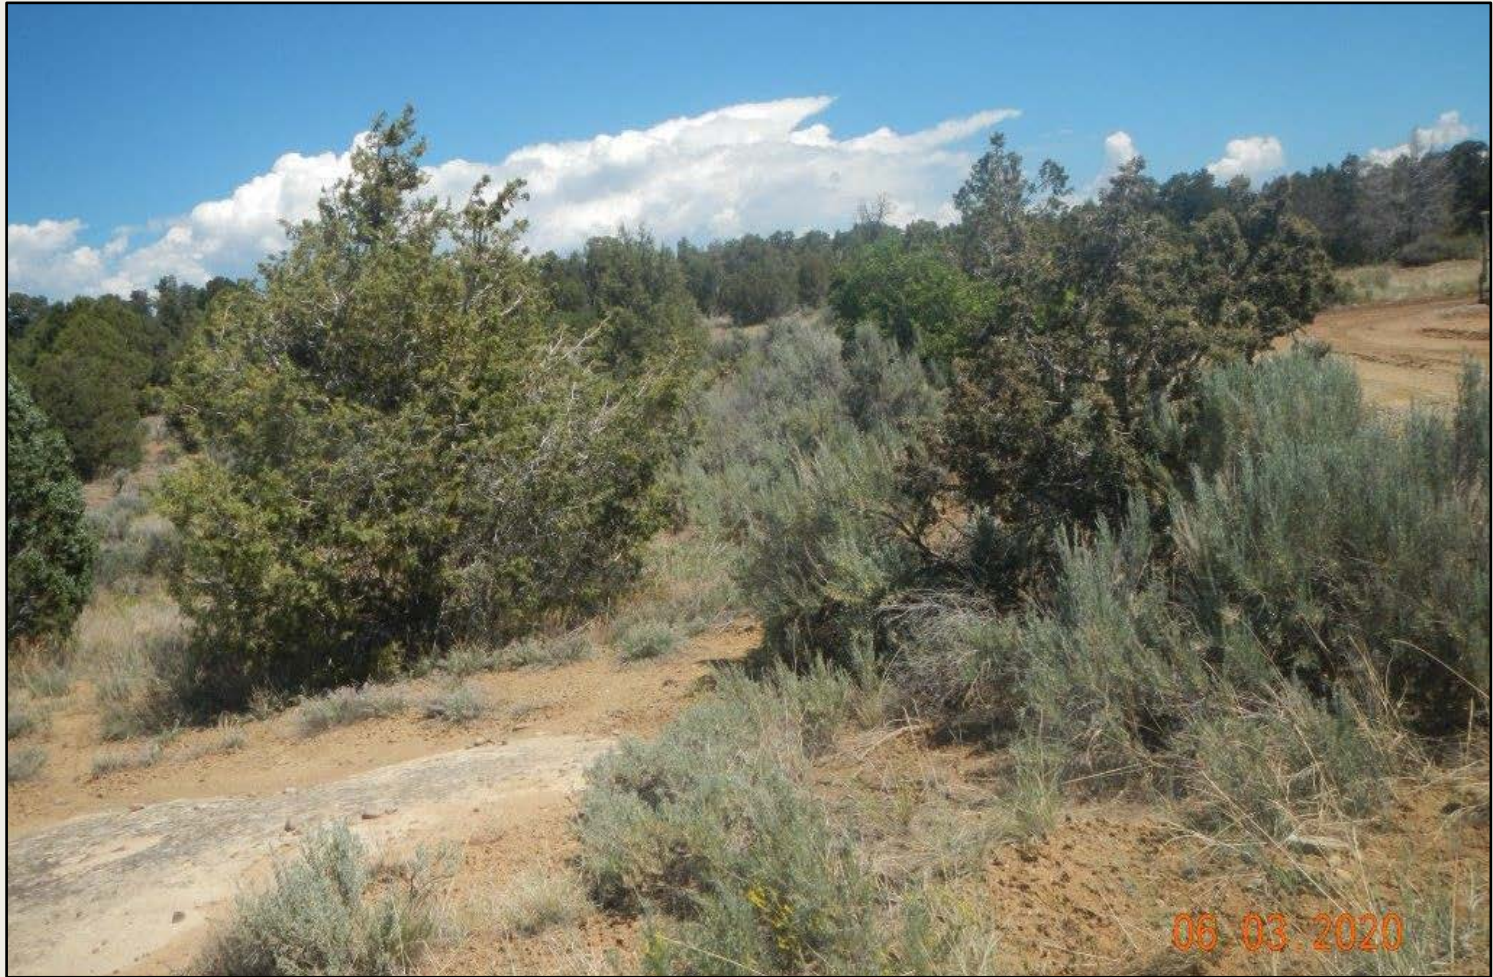
Photo 2. View of the western fill slope from the southwestern corner facing northward. Revegetation is progressing with sagebrush, Indian ricegrass, and rubber rabbitbrush.

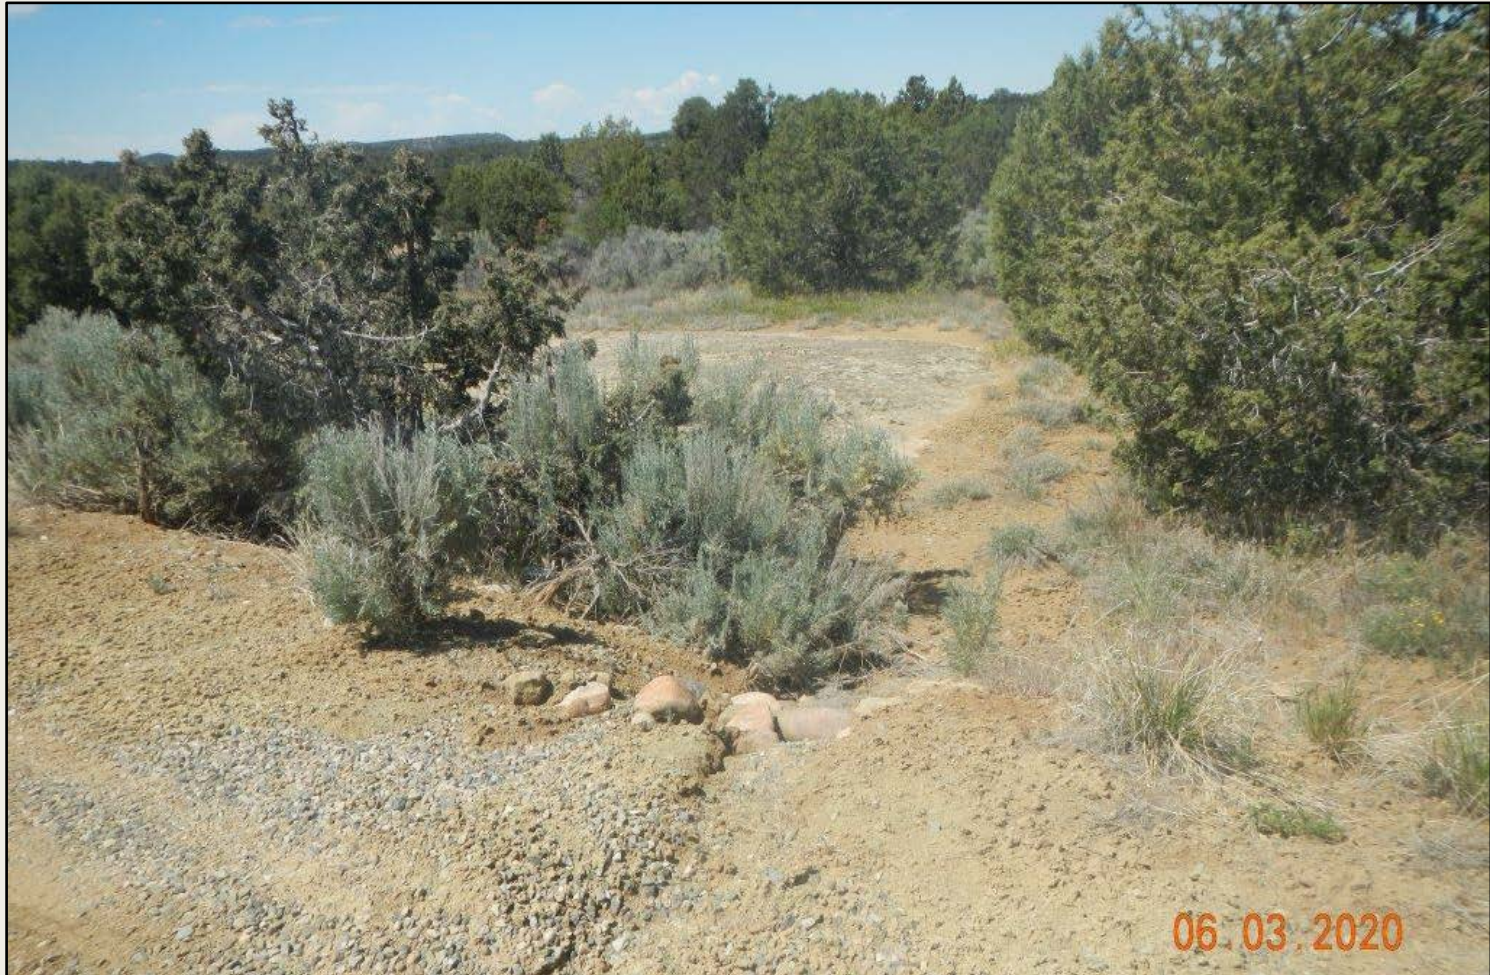
Photo 3. View of area in the southwestern project area where erosion was identified in 2016, it appears that cobbles were placed, and is evident that erosion continues here.

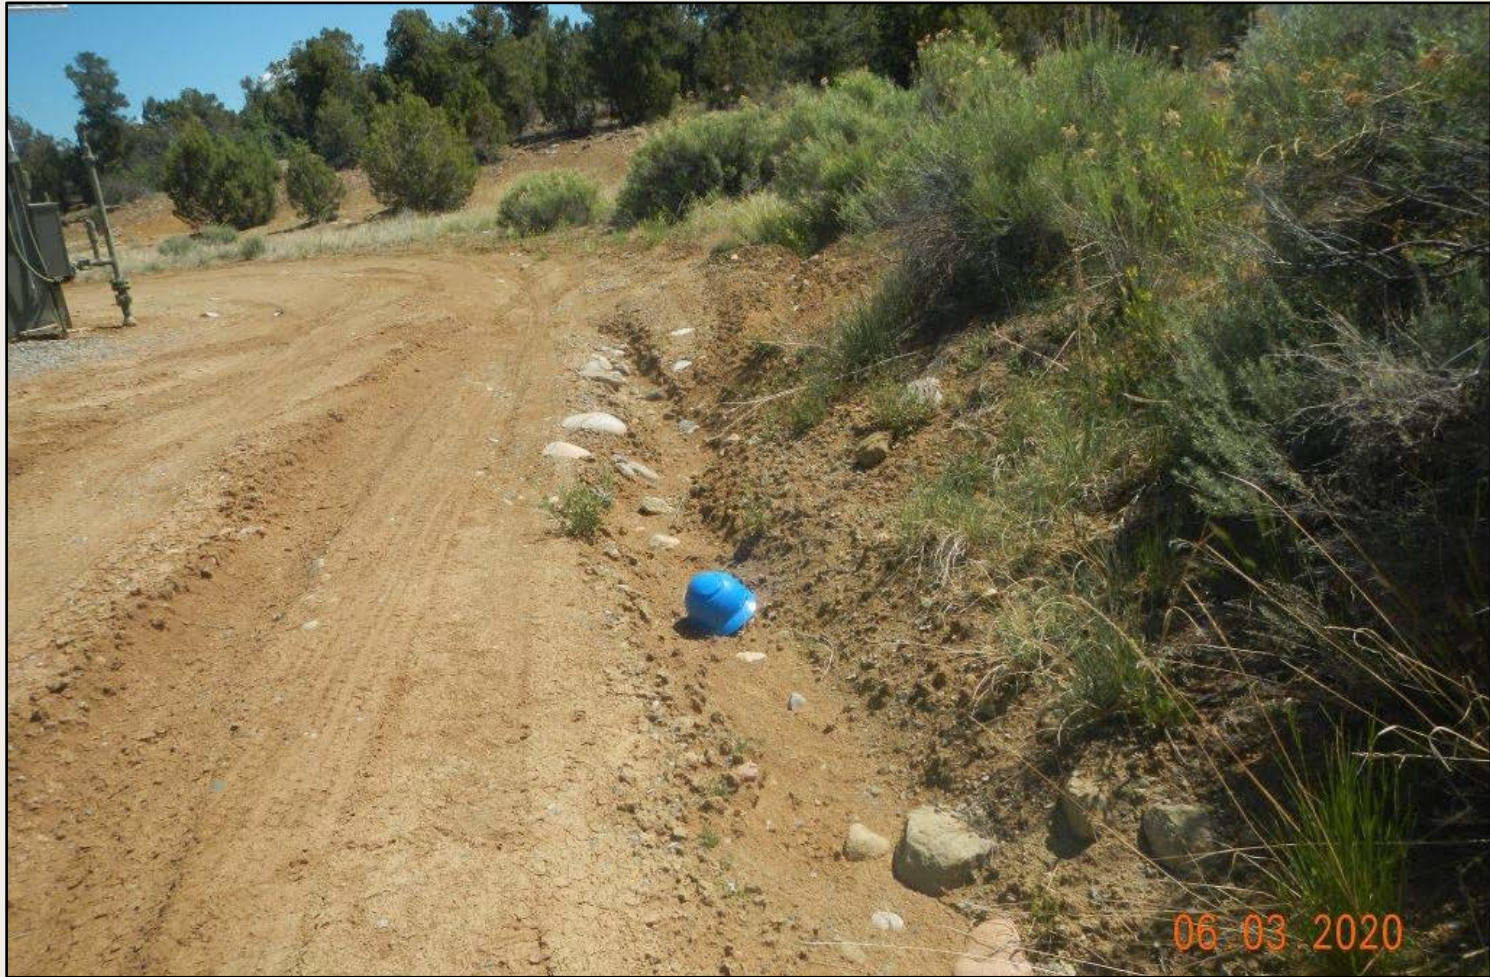
Photo 4. View of erosional channel at the well pad entrance, approximately 18 inches wide and deep (hard had in place for scale). Area of erosion was identified during 2016 reclamation inspection.

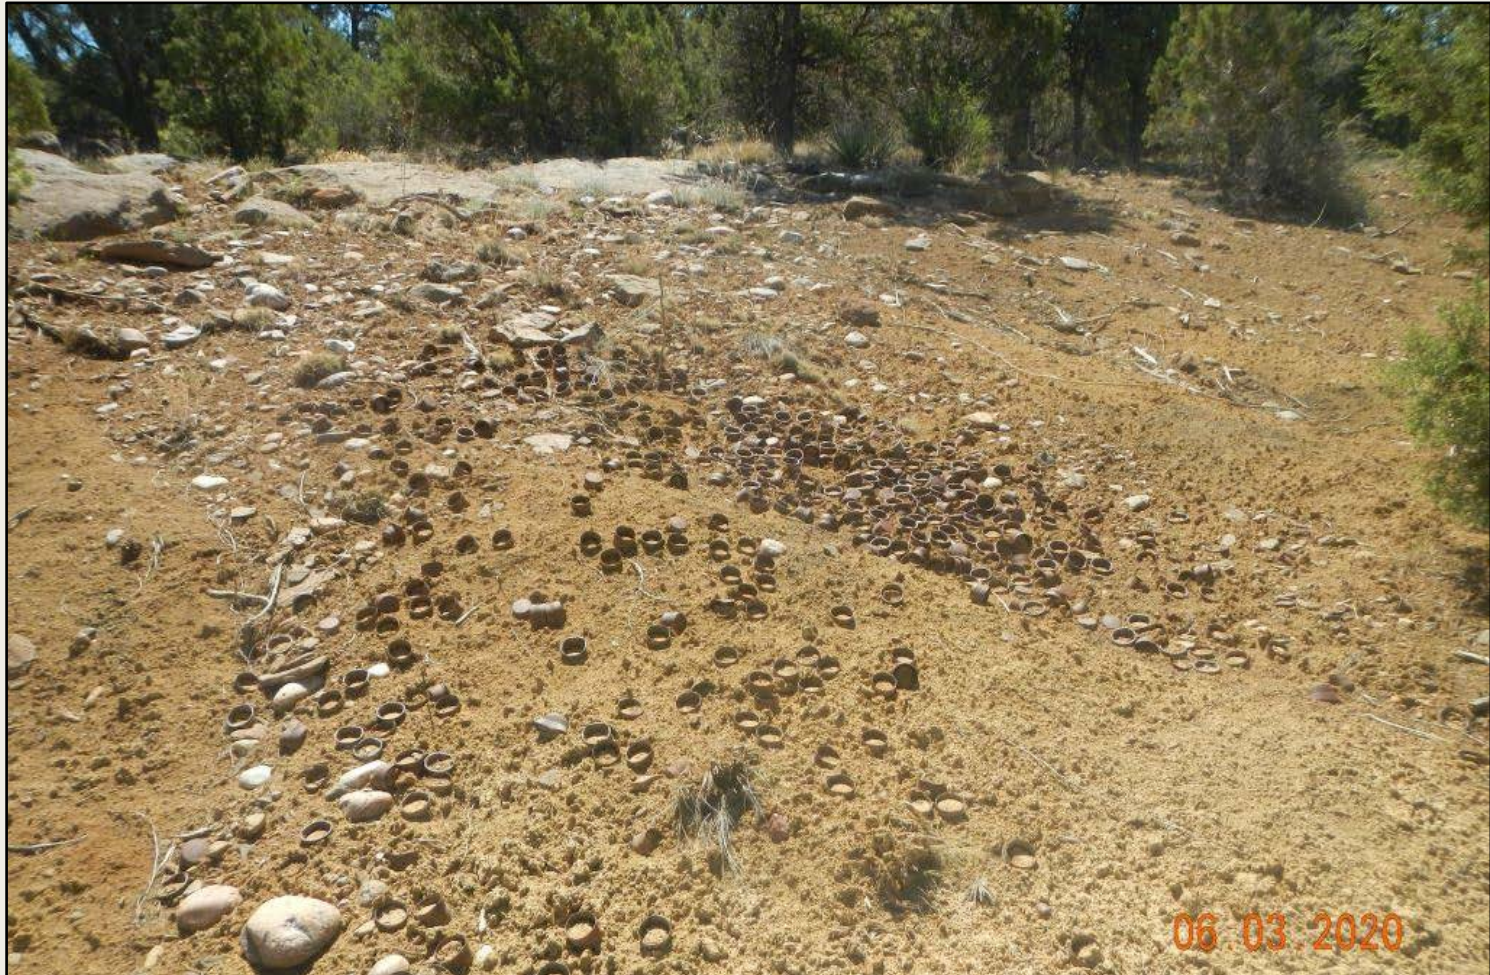
Photo 5. View of numerous metal rings that appear to have been exposed from erosion on the well pad cut-slope. Debris needs to be removed. Cut-slope needs stabilization.

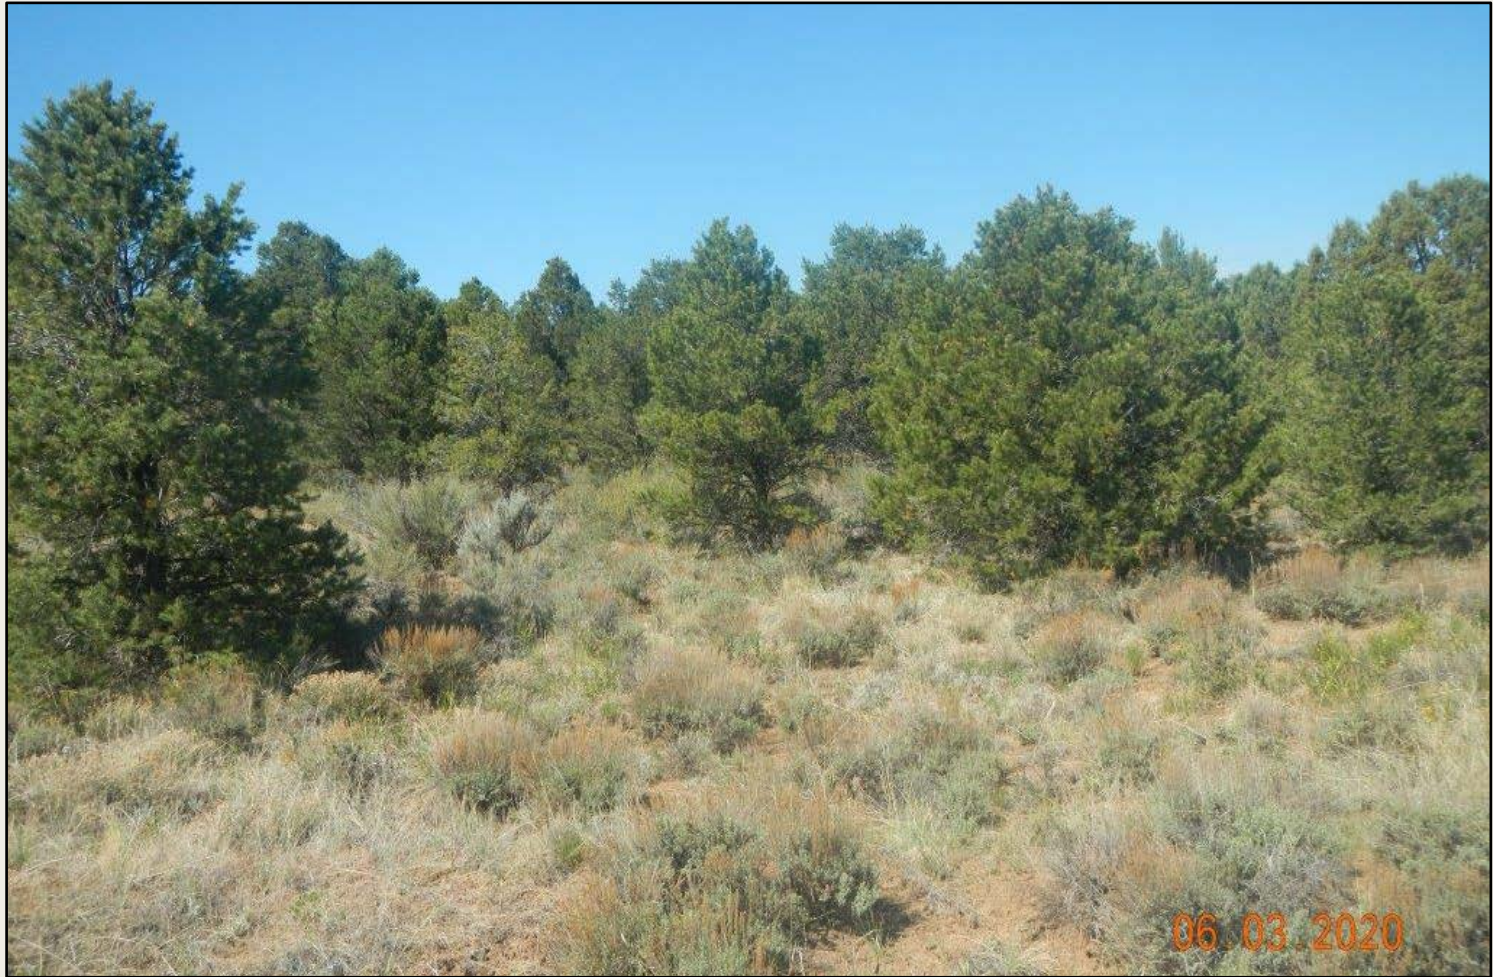
Photo 6. View of reference area comprised of pinyon and juniper woodland with understory of black sage, squirreltail, and Navajo tea.
