Inspection Photos

API: 05-071-09402

Operator: EVERGREEN NATURAL RESOURCES

Inspection Date: 6/2/2020

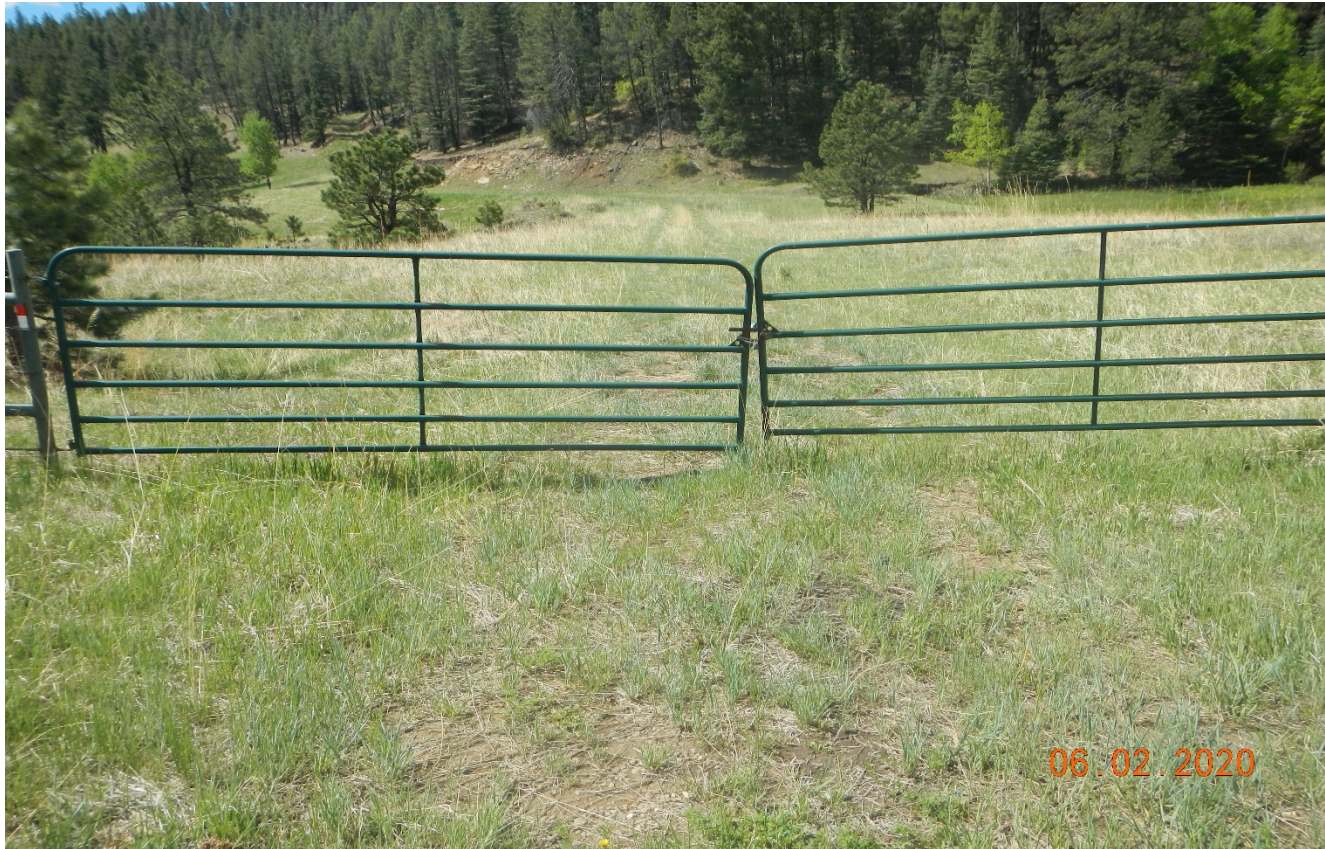
Photo 1. Facing south at the beginning of the access road which was approved by variance to remain.

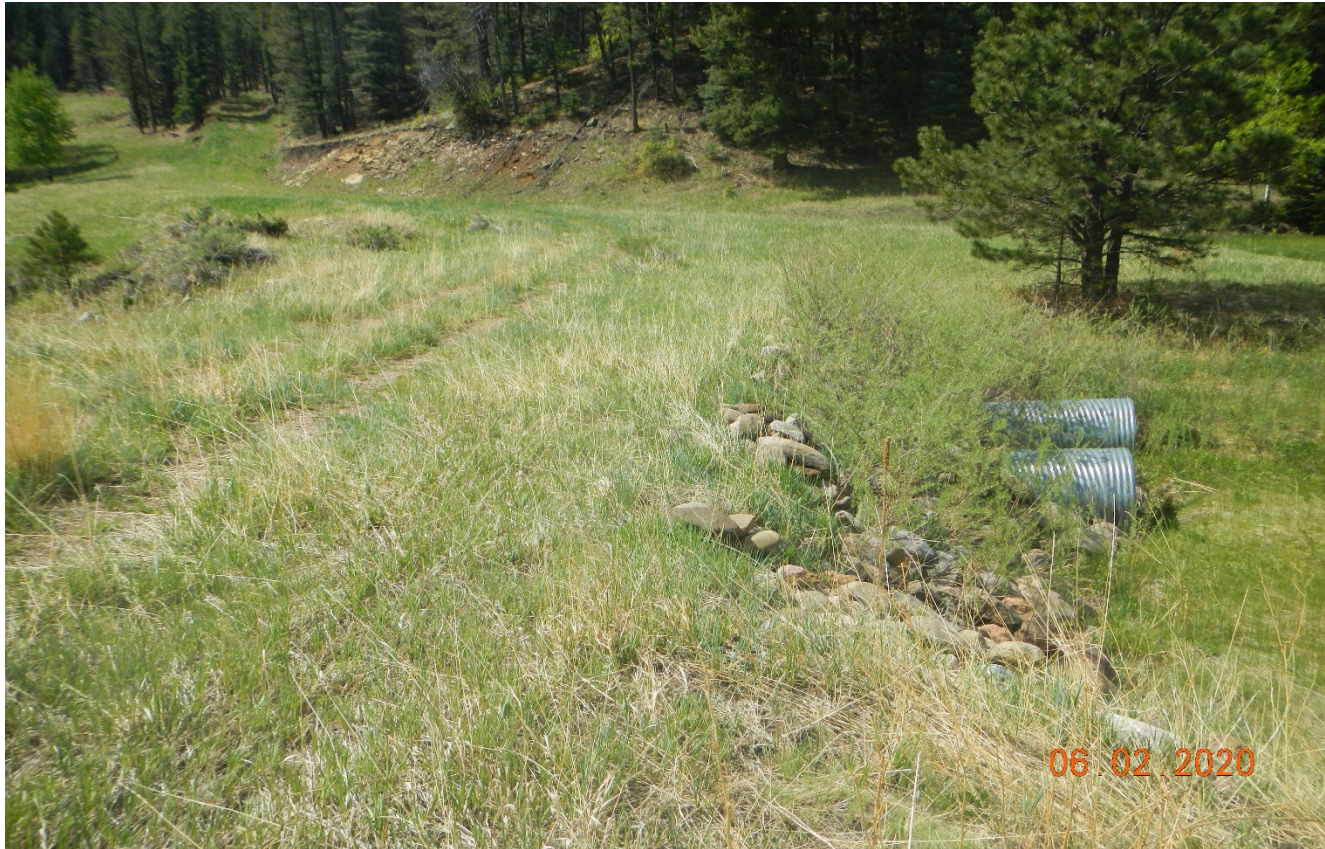
Photo 2. Facing south along the drainage crossing. There are two large culverts installed in the drainage crossing. There was no stormwater issues observed in this area.

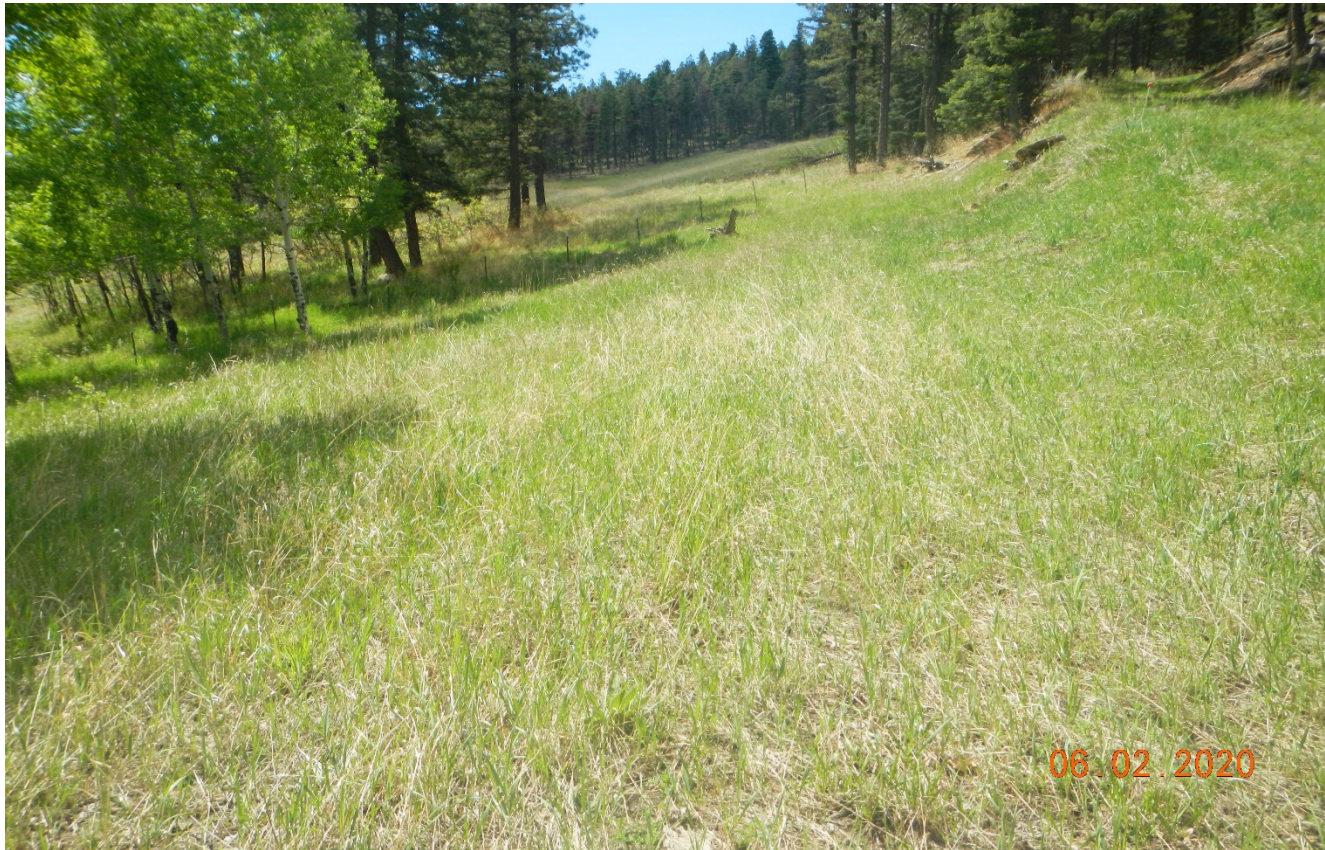
Photo 3. Facing east along the reclaimed portion of the access road. Perineal vegetation is uniformly established.

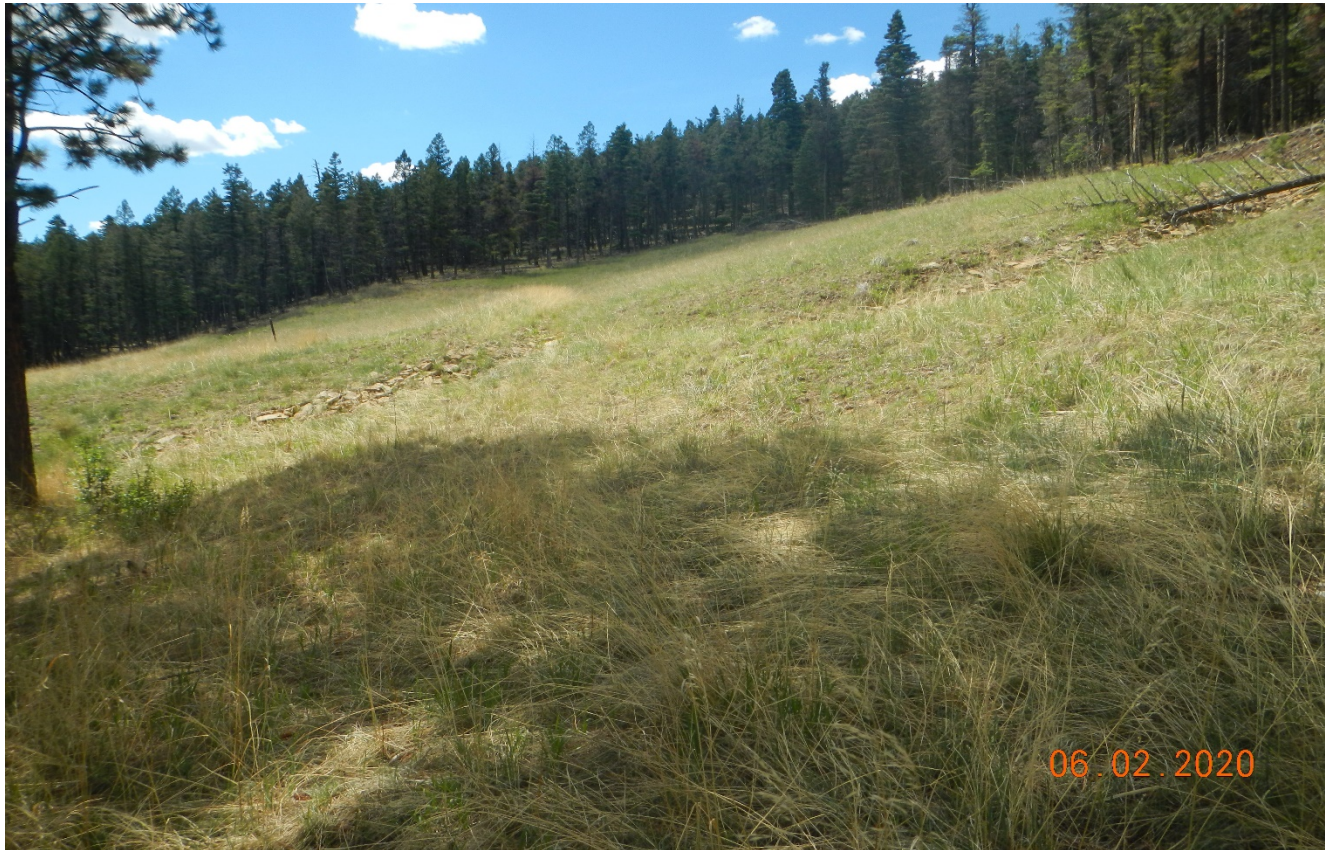
Photo 4. Facing southeast toward the location.

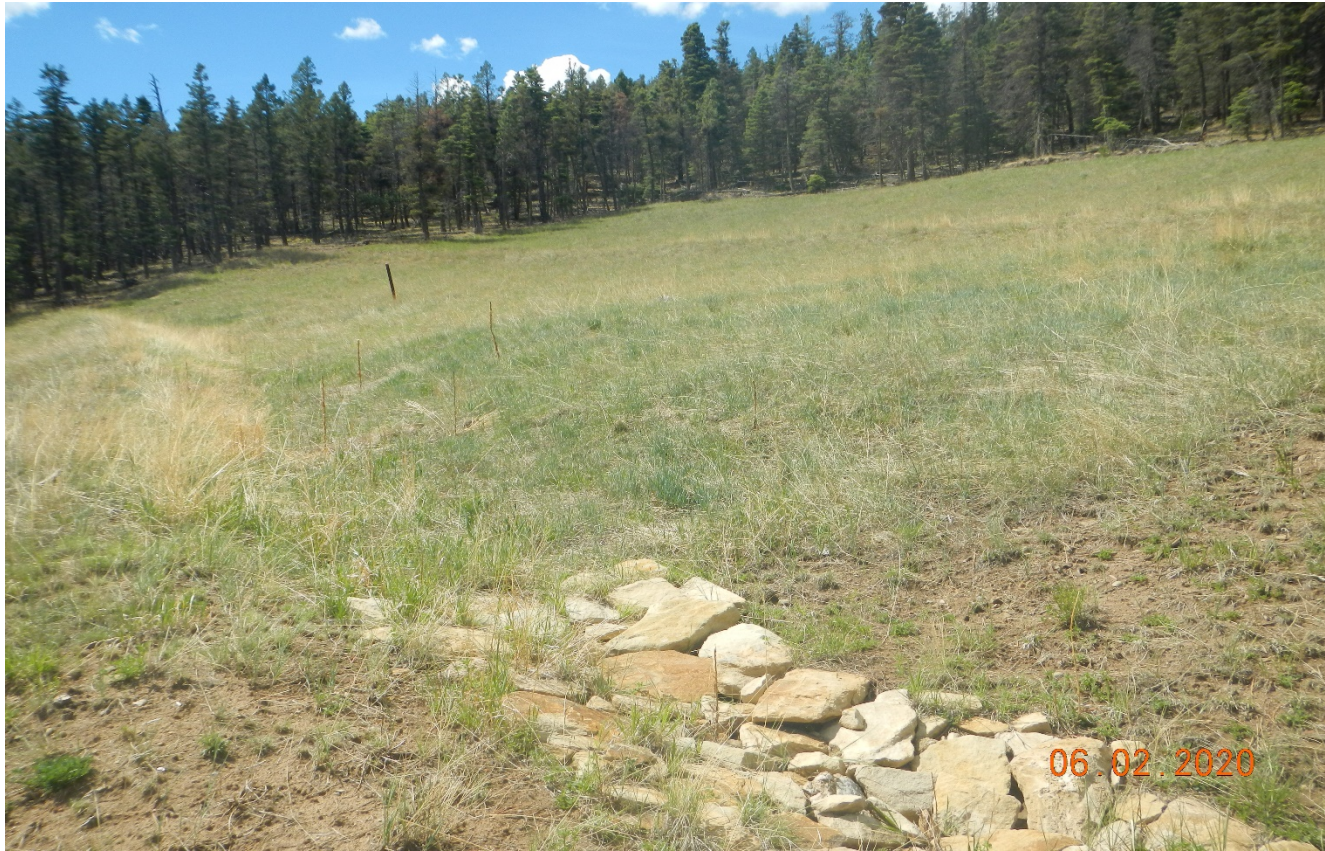
Photo 5. Facing southeast toward the location. There is a berm installed along the contour of the slope with rock rip/rap outlet protection. Berm can be seen In left side of photo.

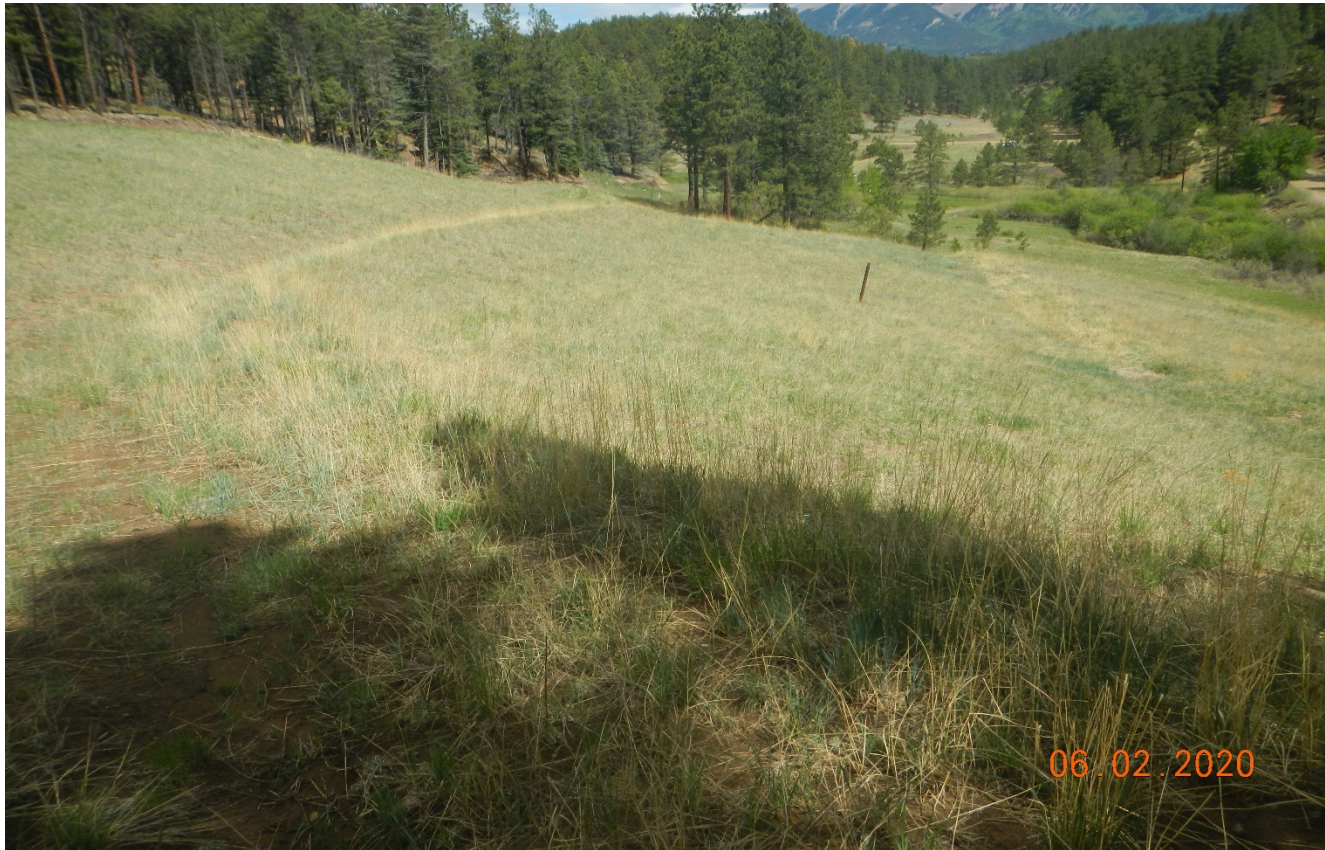
Photo 6. Facing northwest toward the location.

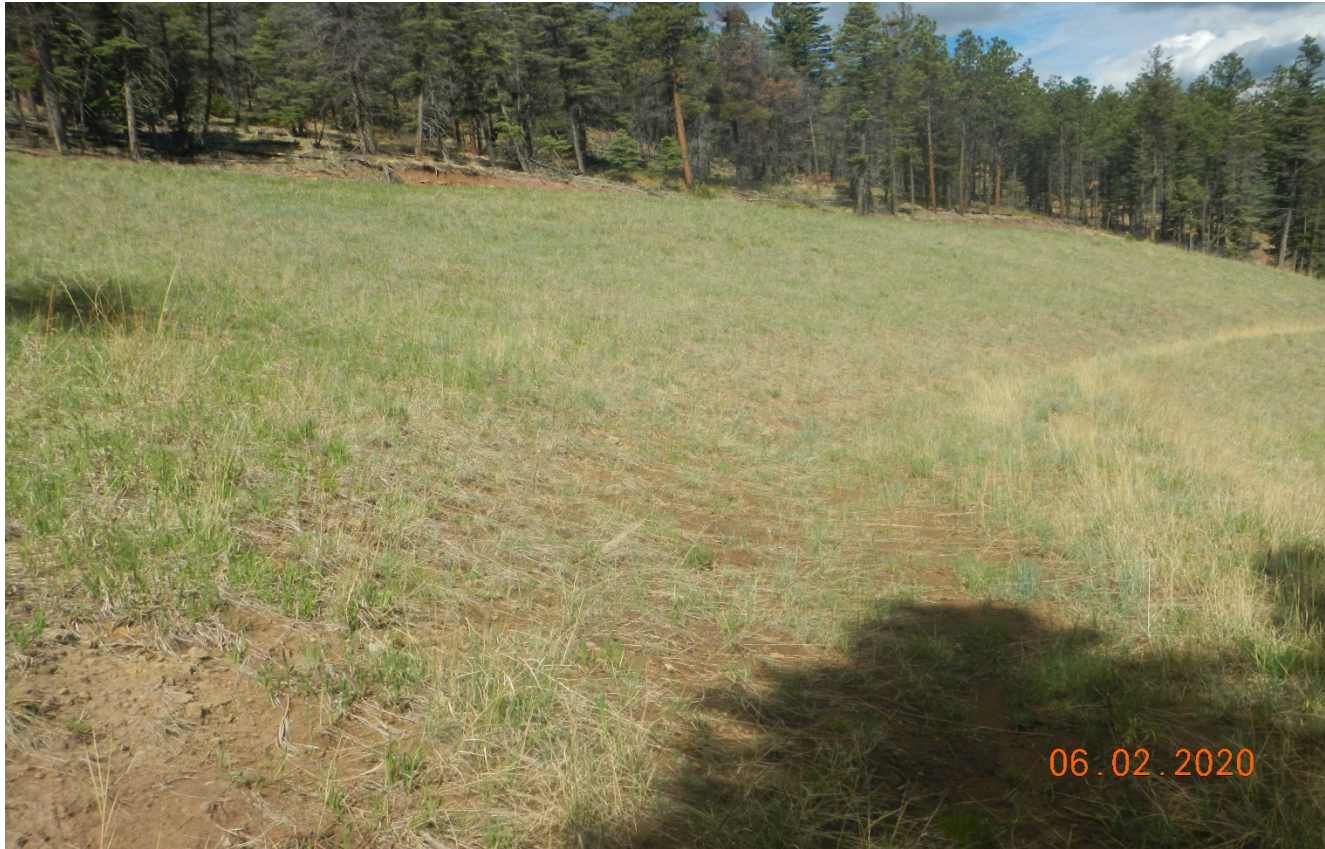
Photo 7. Facing west toward the upper portion of the reclaimed location.

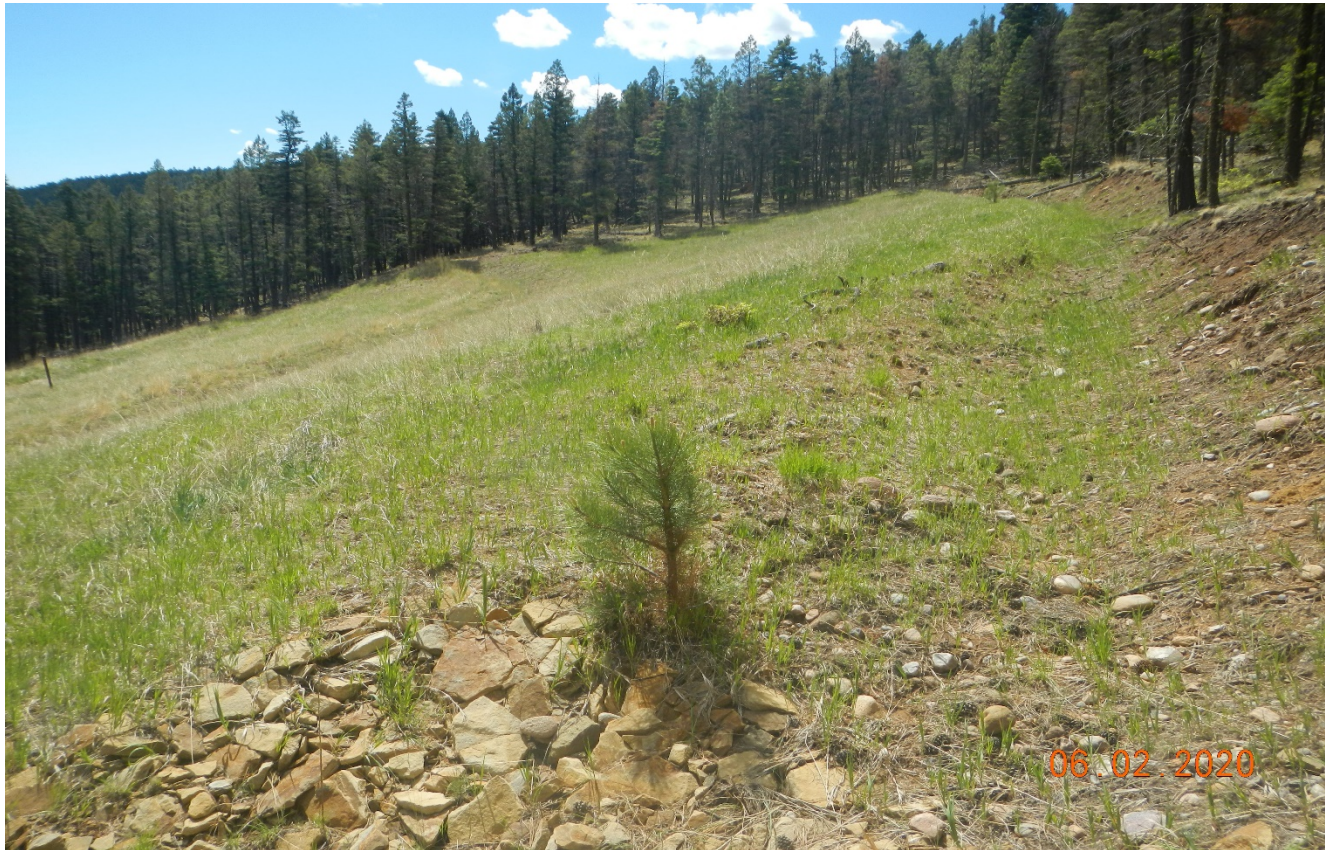
Photo 8. Facing southeast at the top portion of the location. There is a perimeter run-on ditch at the top portion of the location. This area should have been fully contoured into the terrain in order to fully reclaim this area.

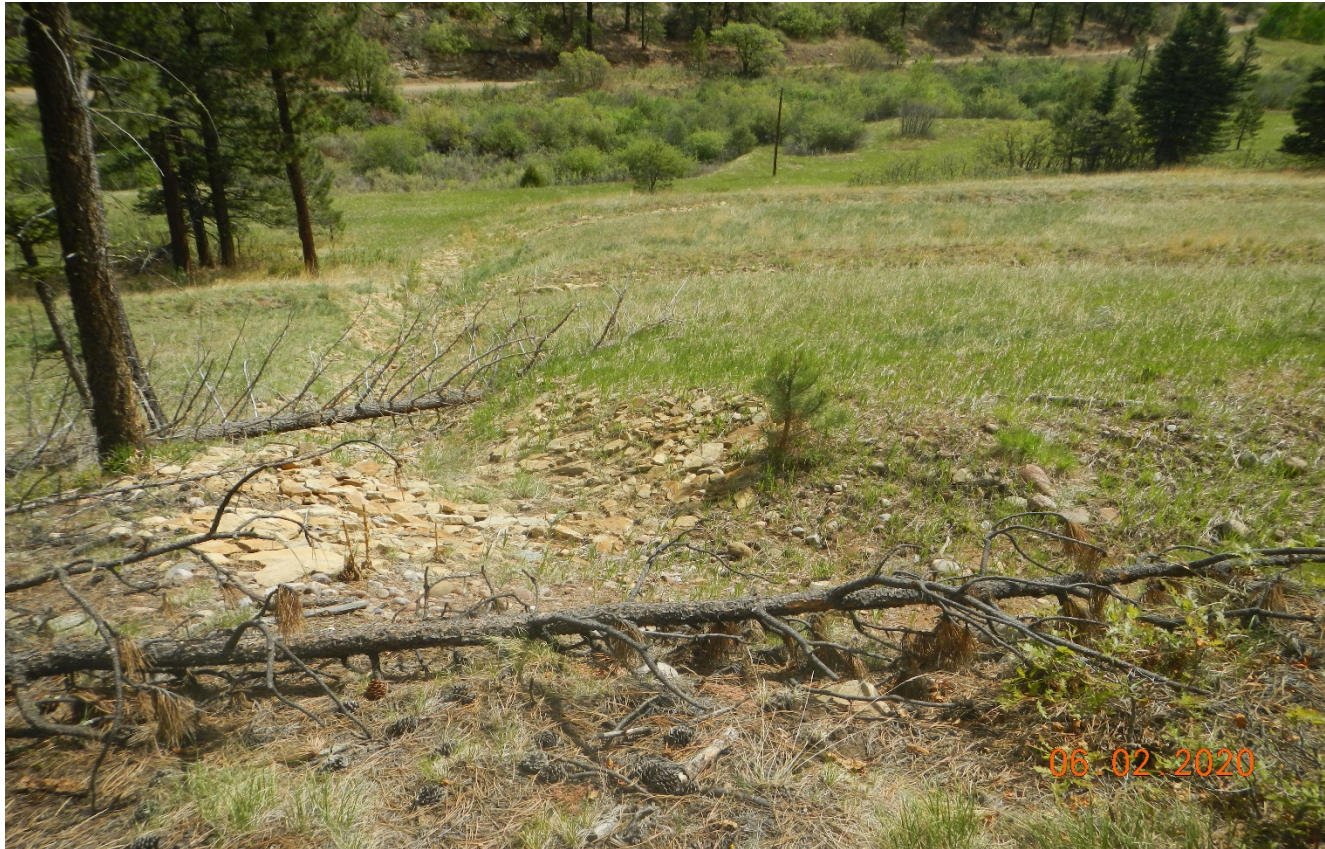
Photo 9. Facing northeast at the location. The upper run-on ditch and berms are directed toward the riprap drainage area. No stormwater issues were observed.
