Inspection Photos

6/03/2020

Operator: WINDSOR ENERGY GROUP LLC -
10081

Location ID: 315696

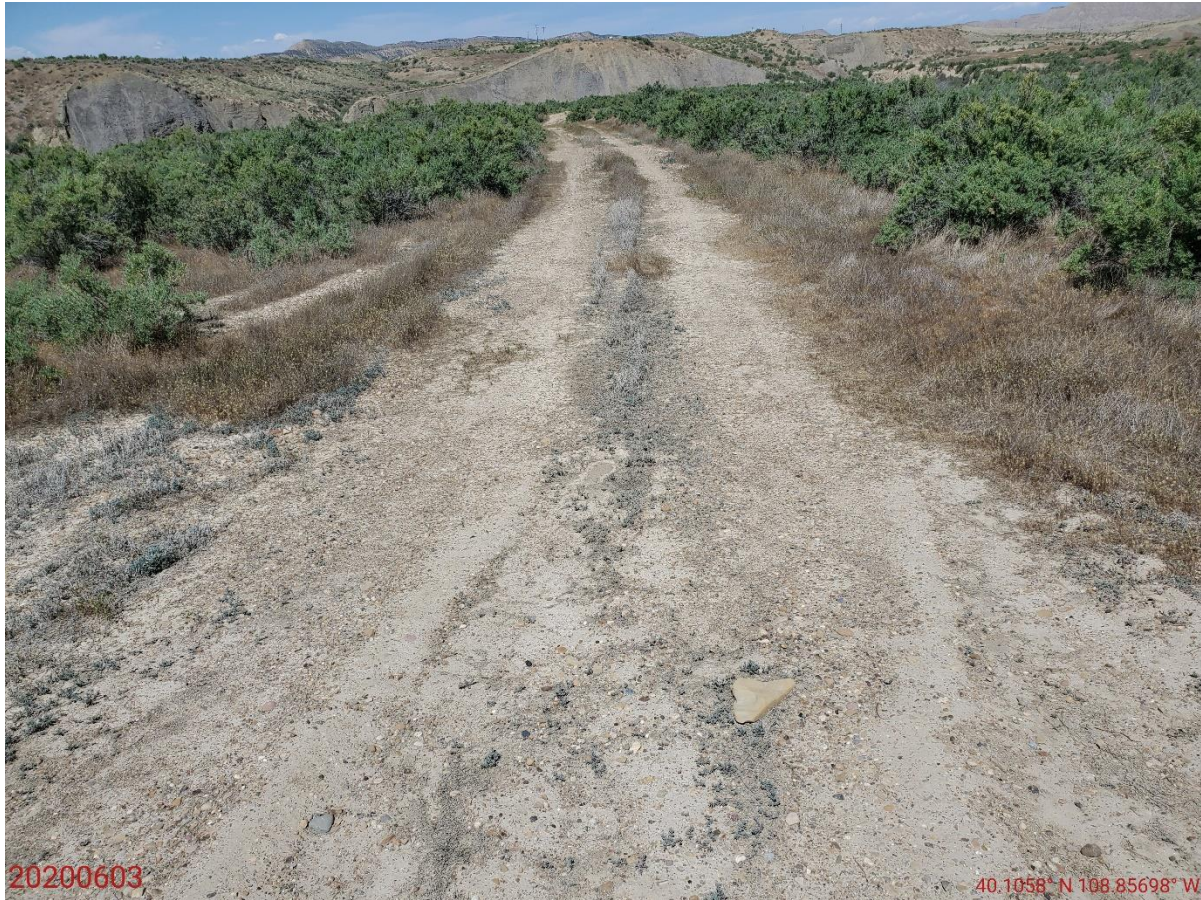
Photo 2: Photo taken from the northern portion of the access road, facing west. Unable to observe evidence that reclamation has been conducted on access road pursuant to 1004 Rules.

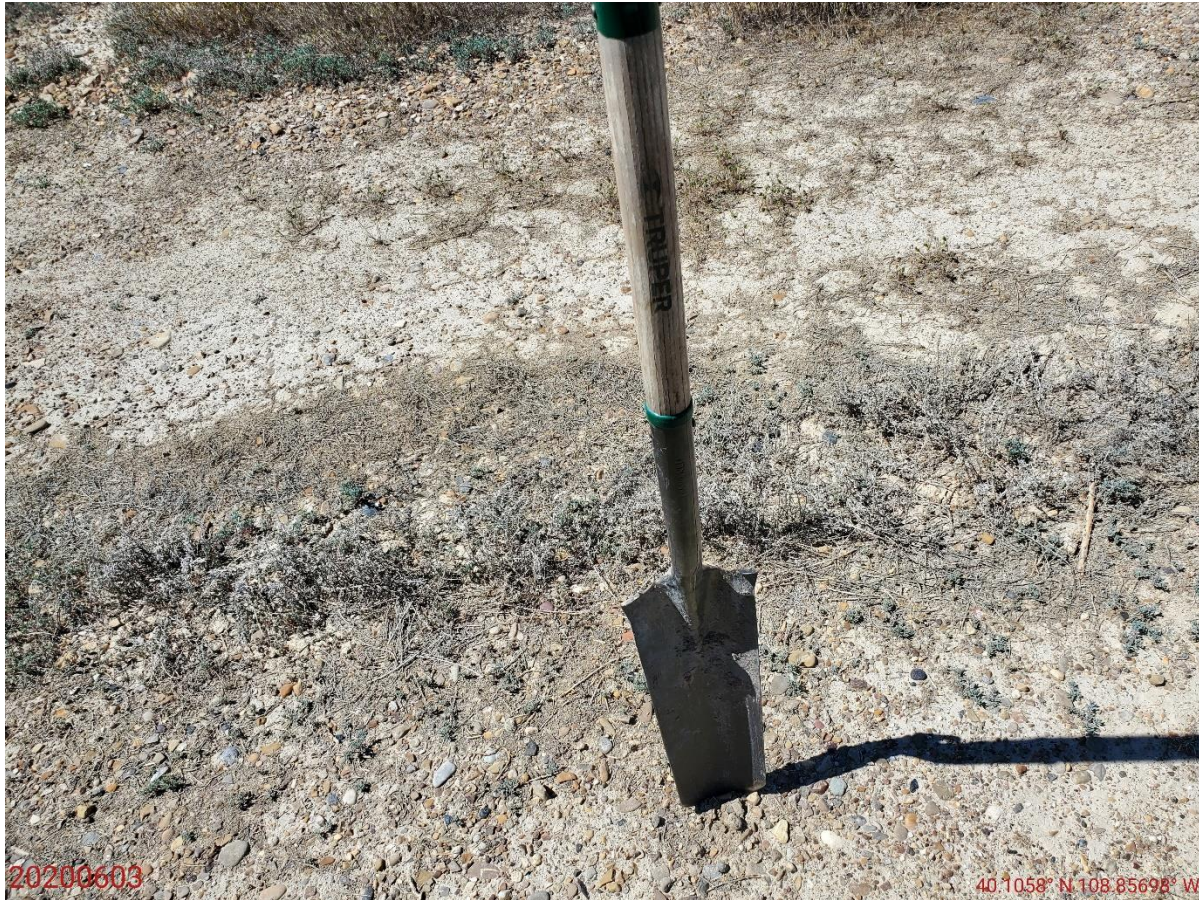
Photo 3: Photo taken from the northern section of the access road. Photo shows gravel remaining on access road. Photo also shows inspector tested for compaction along the access road with a 16 inch shovel; Inspector was unable to easily penetrate the soil surface of the access road; Compaction concerns remain.

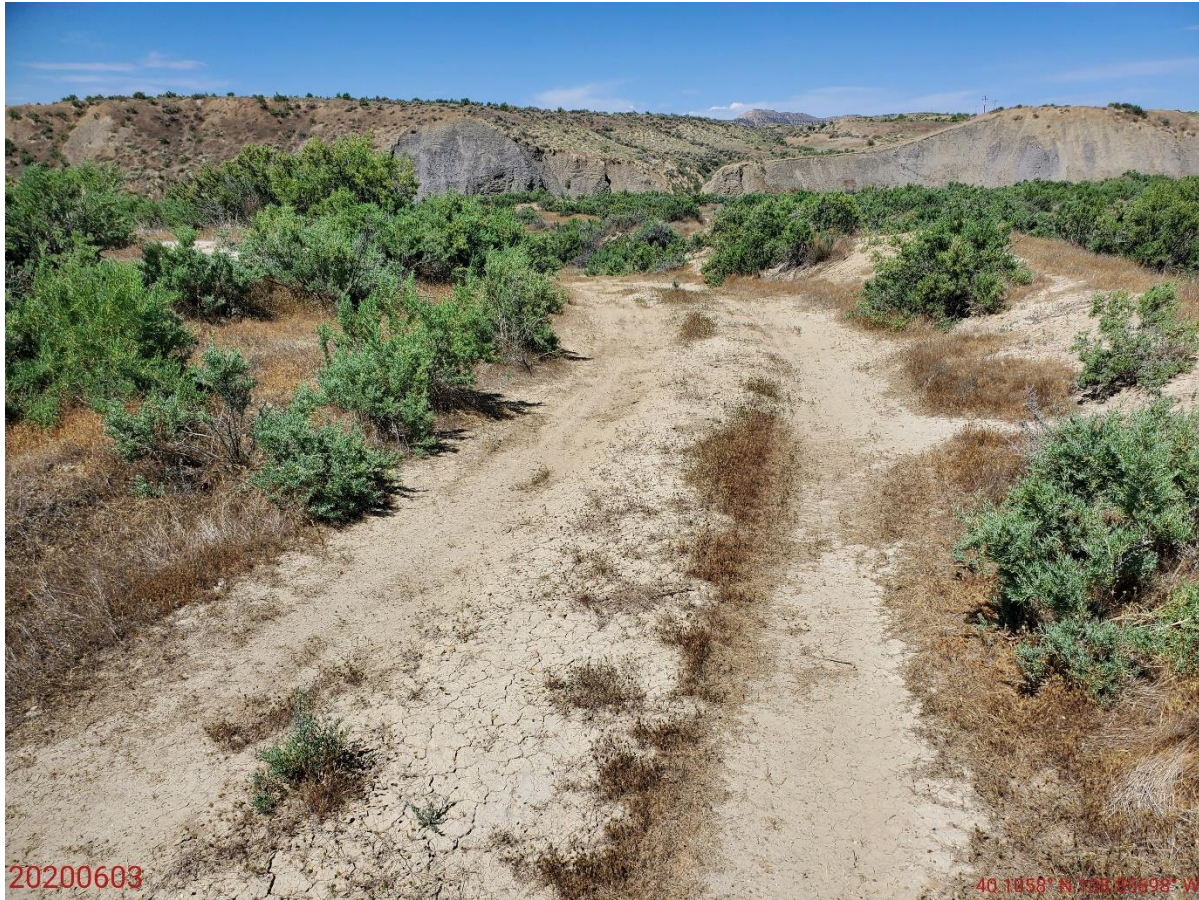
Photo 4: Photo taken from the northern access road, facing west. Photo shows access road has not been contoured or regraded.

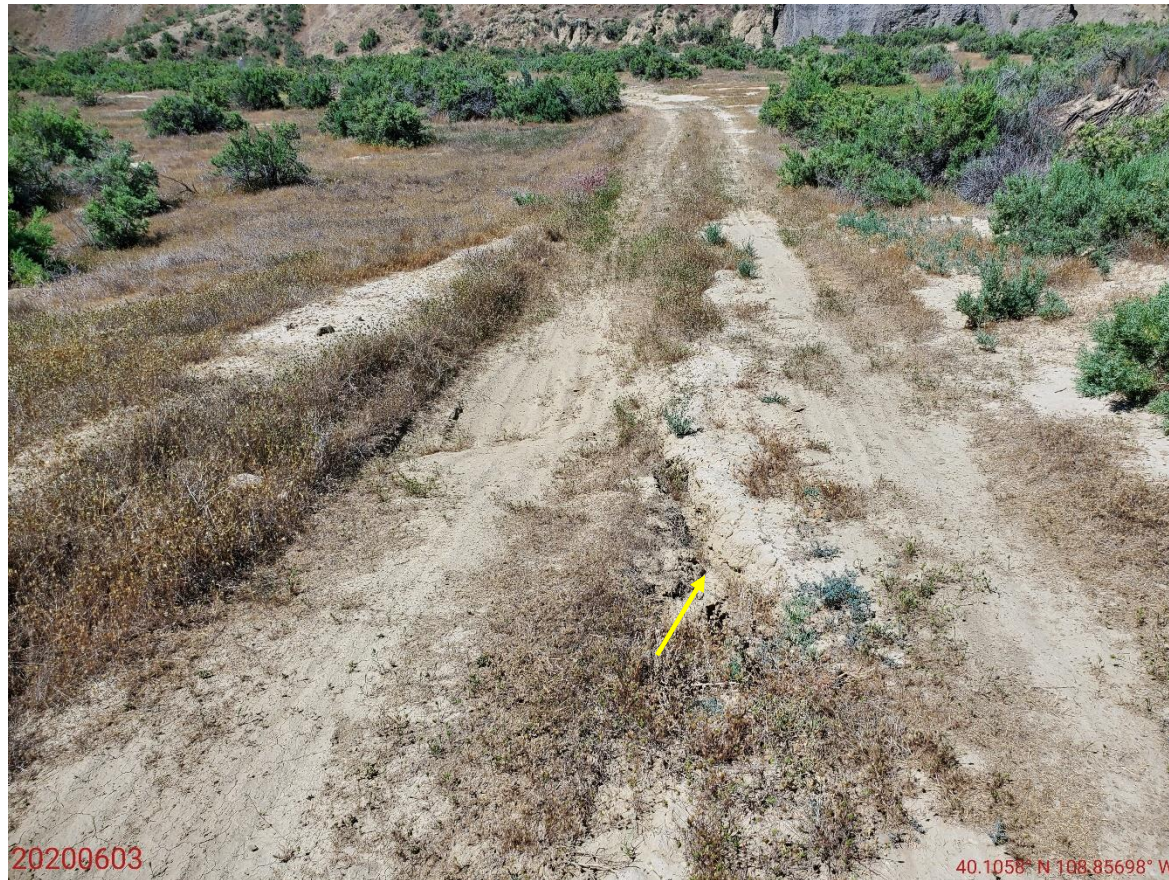
Photo 5: Photo taken from the northern access road, facing west. Photo shows stormwater erosion remains evident; No BMPs appear to have been installed.

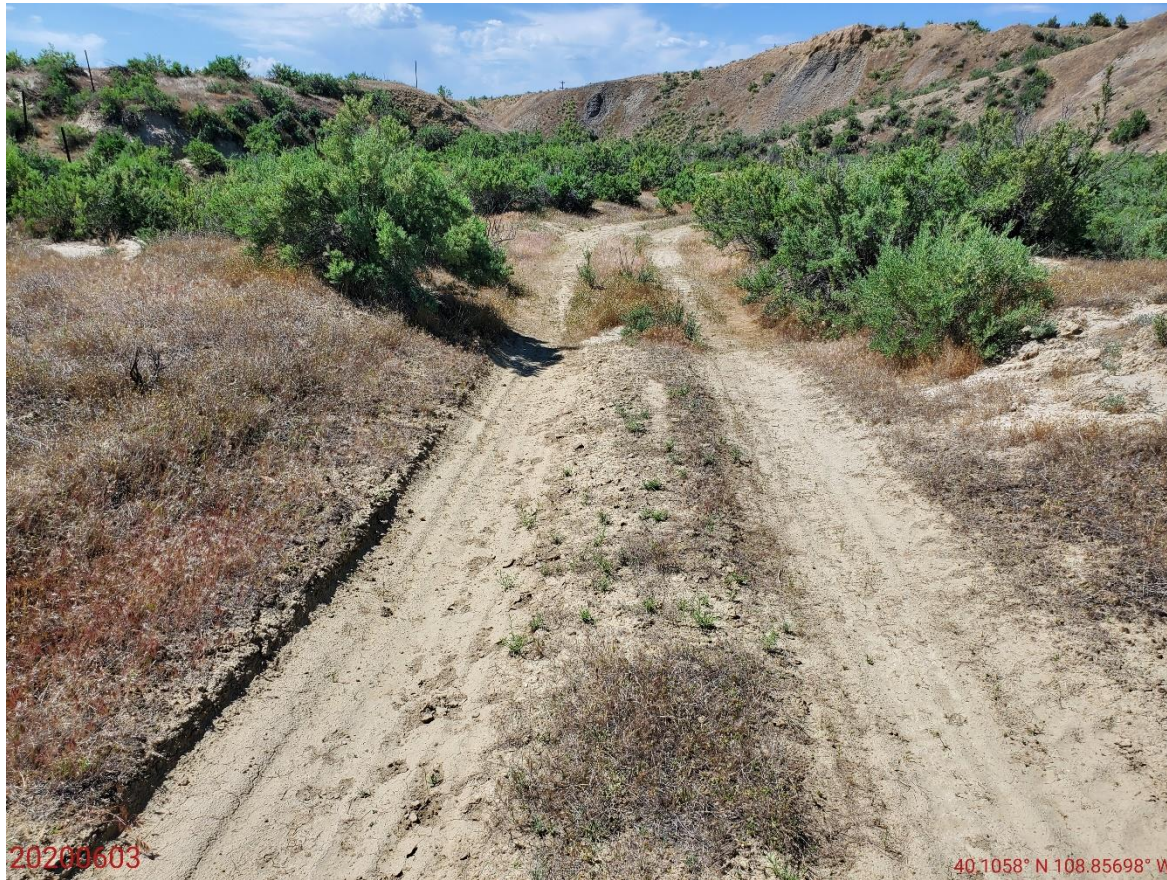
Photo 6: Photo taken from the northern access road, facing west. Photo shows access road has not been contoured or regraded.

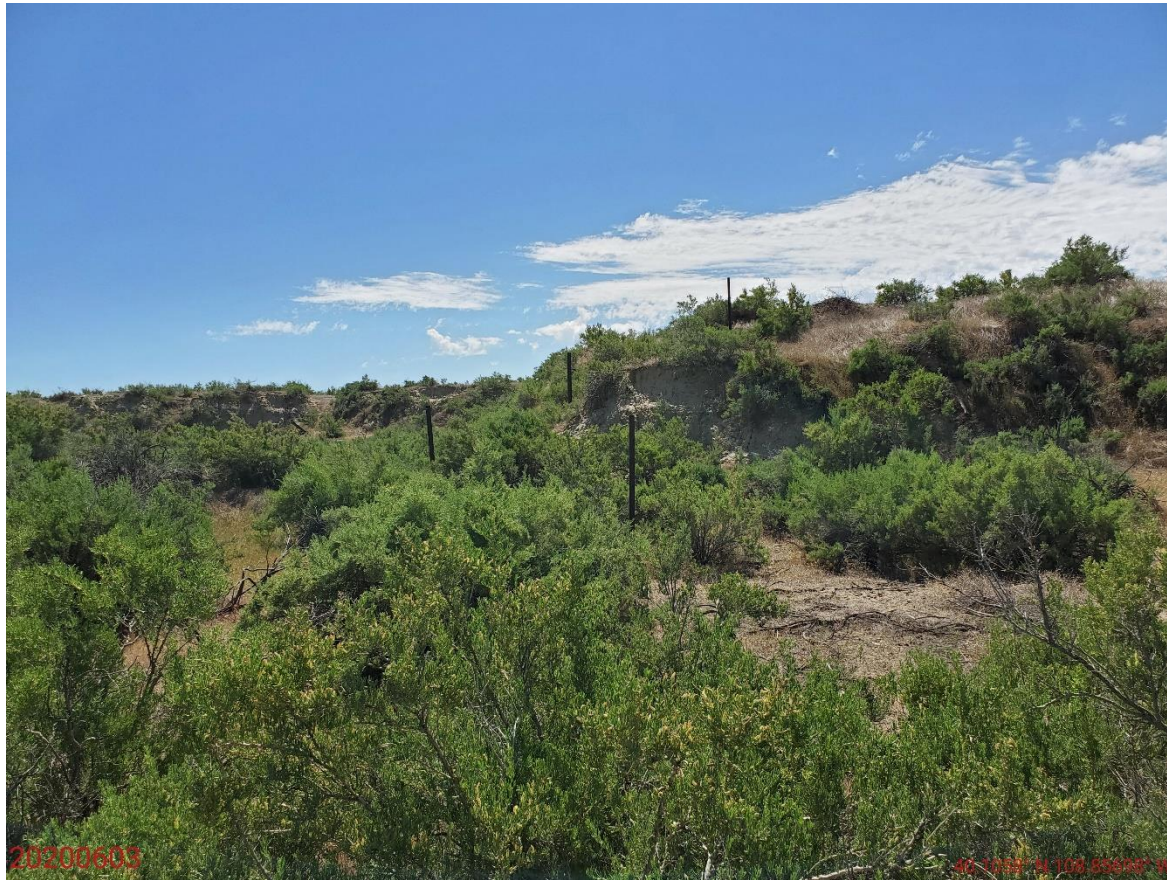
Photo 7: Photo taken from the Location, facing southeast. Photo shows metal poles previously documented have not been removed per corrective actions. Photo is example of Trash debris/poles/barrels/etc... that was previously documented that have not been removed. See photo document #696201072 for additional information.

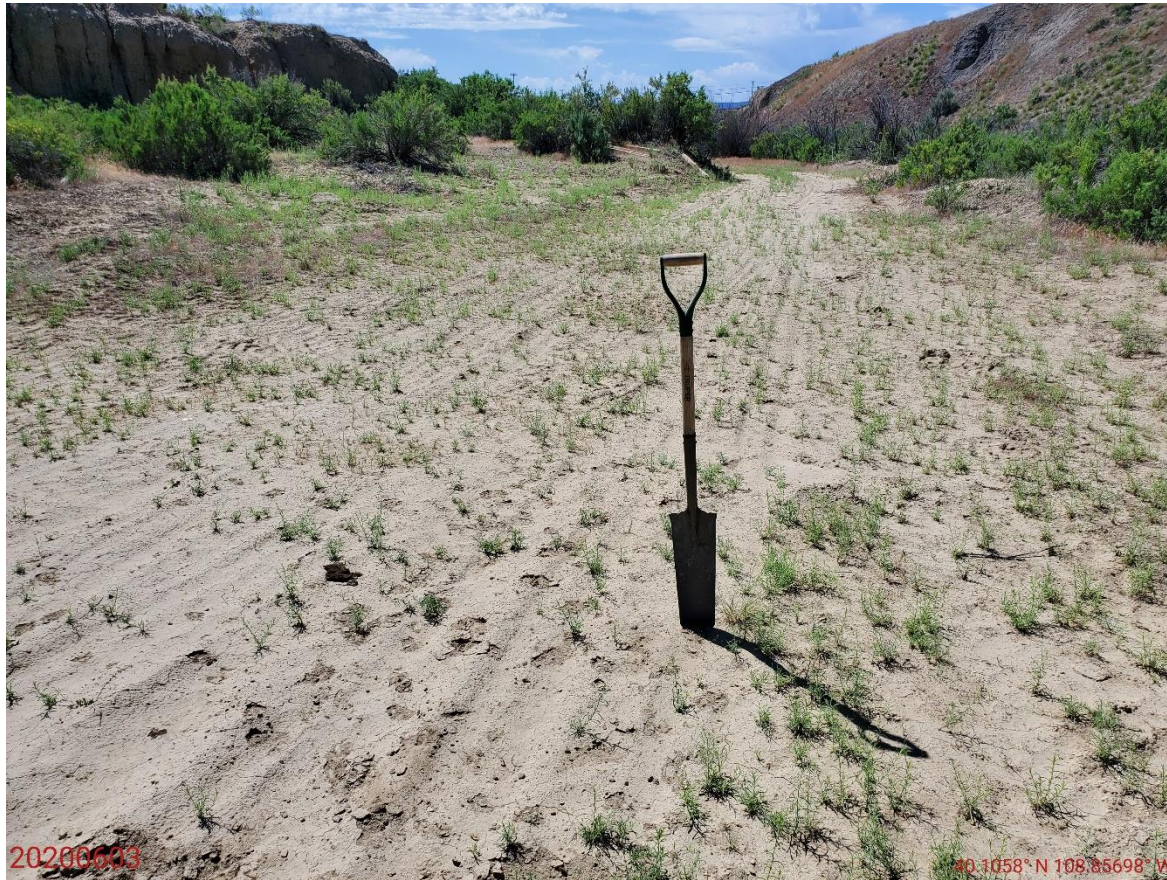
Photo 8: Photo taken from the Location facing west. Striations observed in the soil suggest additional revegetation activities appear to have been conducted. Top 4-6 inches of soil was unconsolidated, however, zones of compaction were observed below.

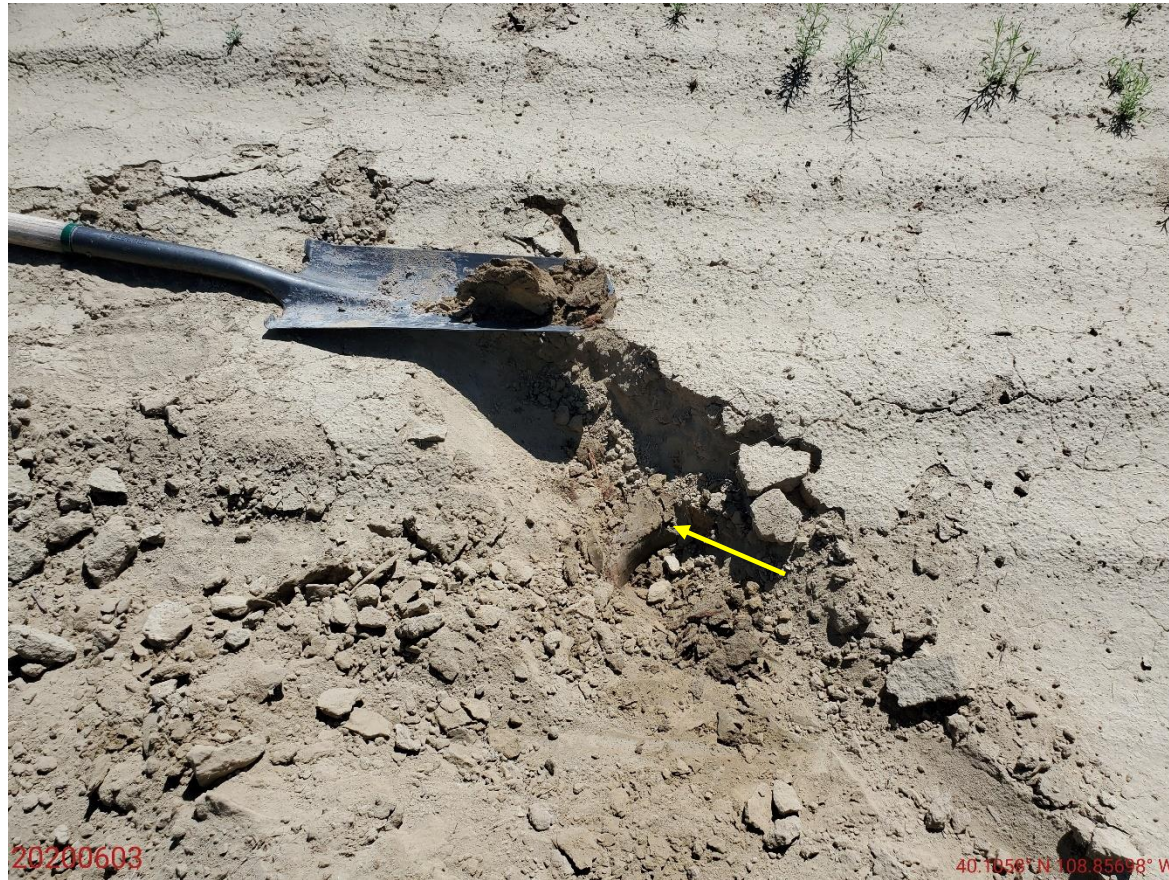
Photo 9: Photo taken from the Location. Photo shows inspector inspected the Location for compaction concerns; The top 4-6 inches of soil was unconsolidated, however, zones of compaction were observed below (yellow arrow).

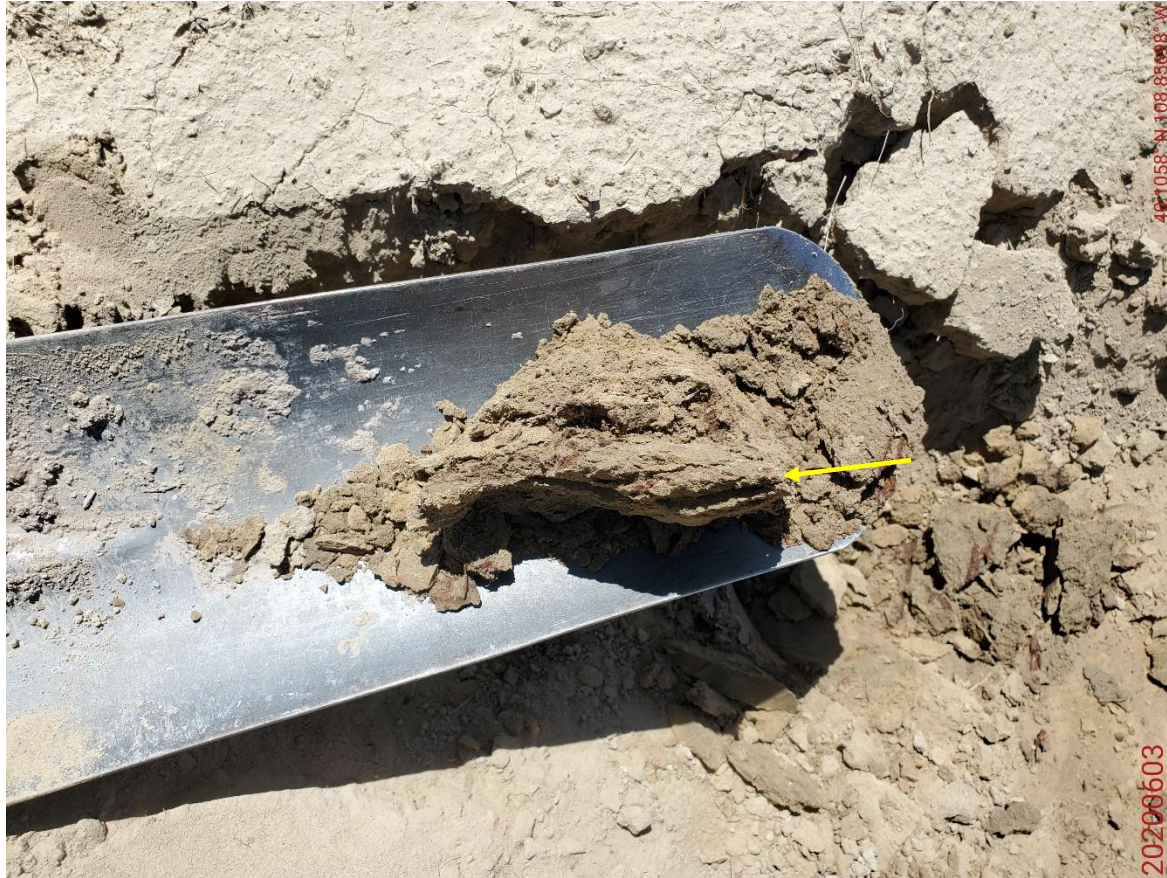
Photo 10: Continued from photo 9. Photo shows a soil sample taken from the observed compaction zone with “Platy” soil structures. These structures are thin, flat plates of soil that lie horizontally and are usually found in compacted soils.

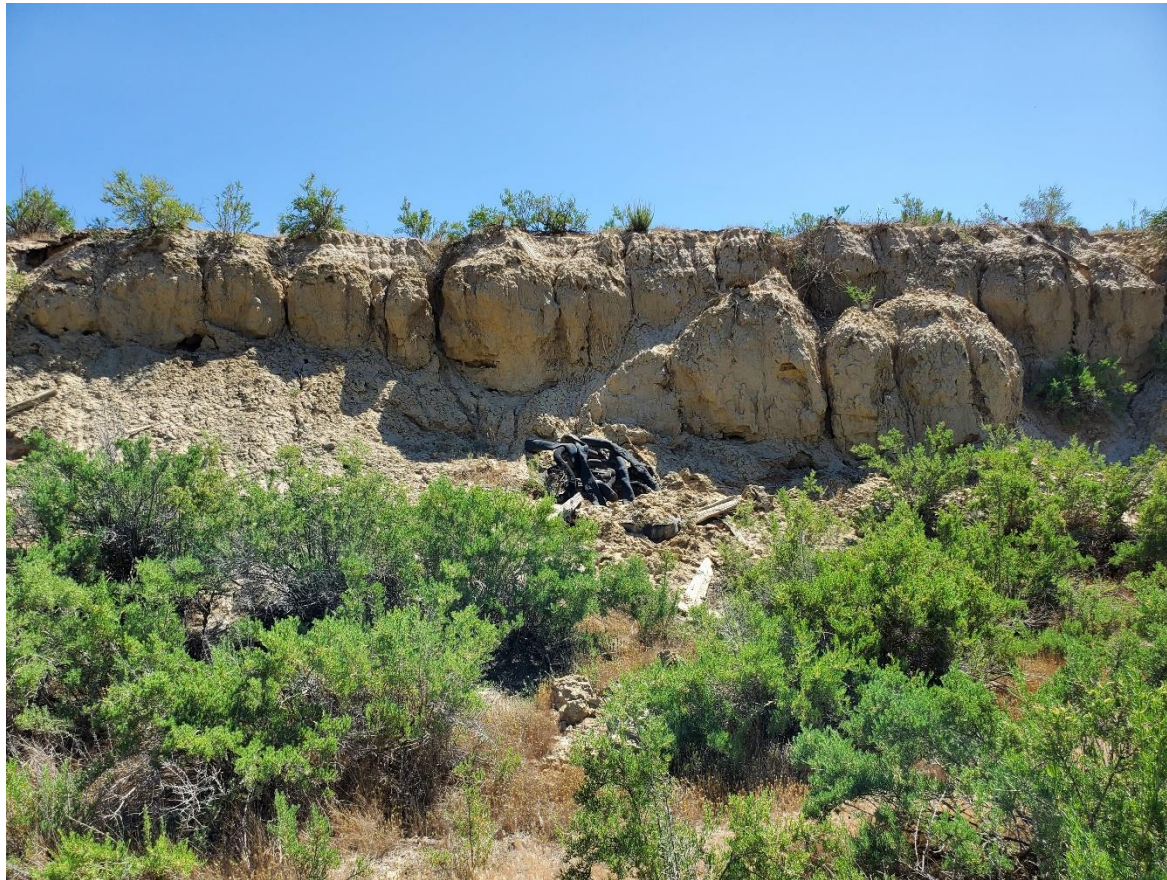
Photo 11: Photo taken from the Location facing east. Photo shows trash debris previously documented that has not been removed per corrective actions. Photo is example of Trash debris/poles/barrels/etc... that was previously documented that have not been removed. See photo document #696201072 for additional information.

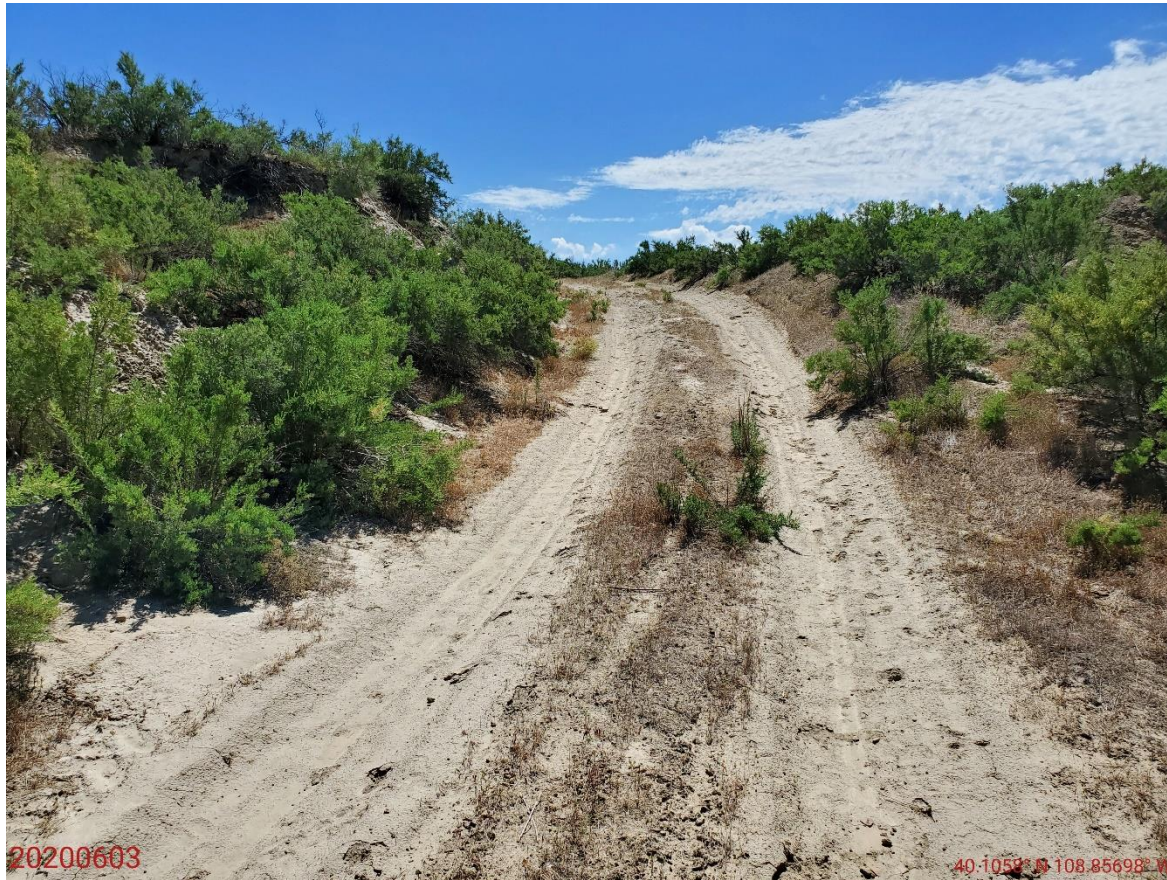
Photo 12: Photo taken from the southern access road, facing south. Photo shows access road has not been contoured or regraded.

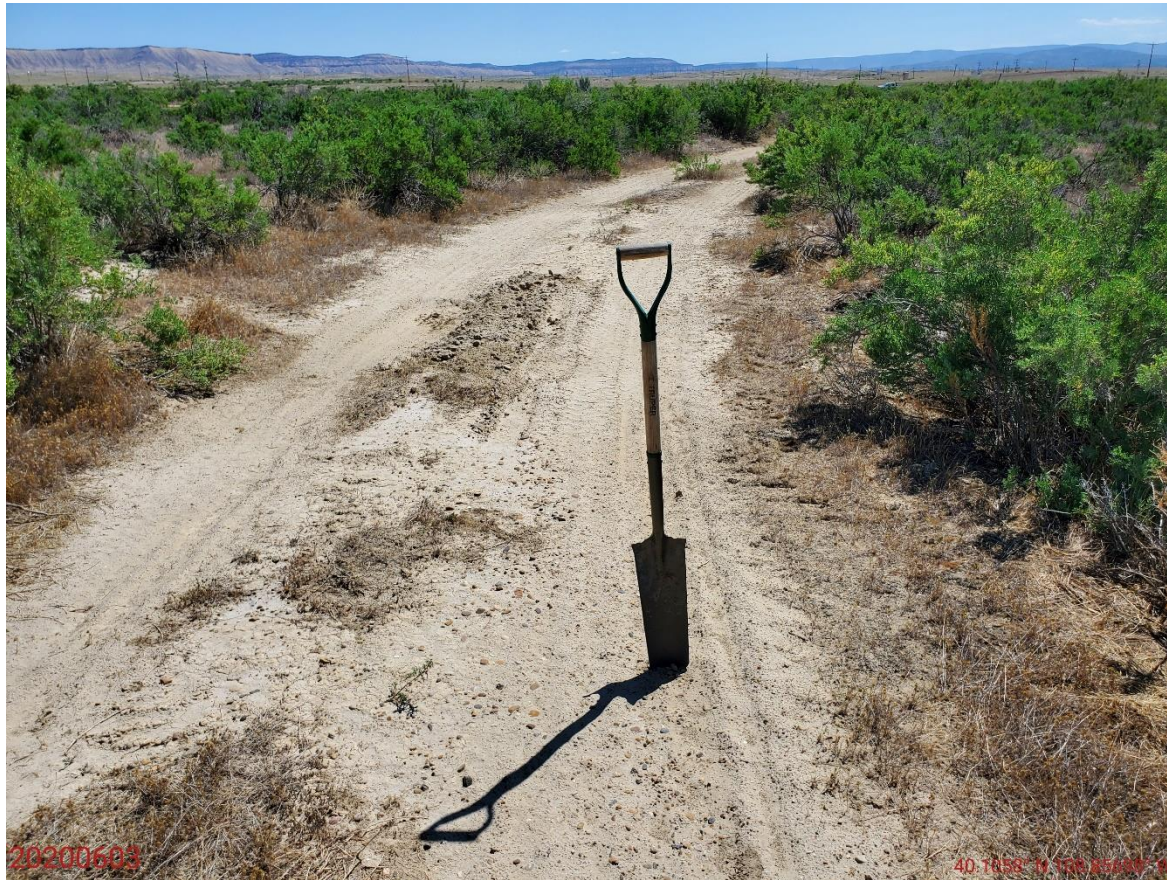
Photo 13: Photo taken from the southern section of the access road, facing east. Photo shows inspector tested for compaction along the access road with a 16 inch shovel; Inspector was unable to easily penetrate the soil surface of the access road; Compaction concerns remain.

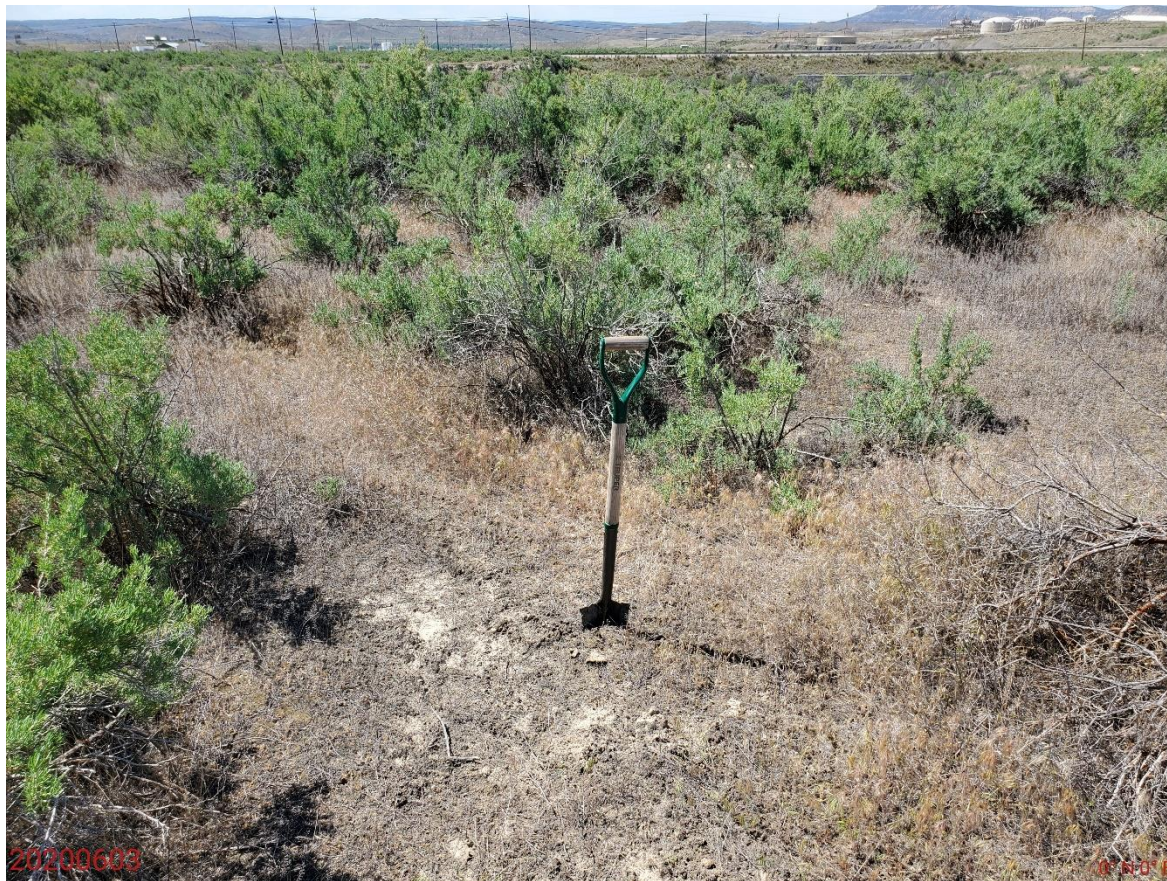
Photo 14: Photo taken from the adjacent reference area. Photo shows inspector was able to easily penetrate the top 14-16 inches of soil on the reference. Photo is to compare/contrast the compaction concerns observed on the Location and access road.
