Inspection Photos
Operator: Catamount Energy
API#: 067-08631
Date: 6/3/2020

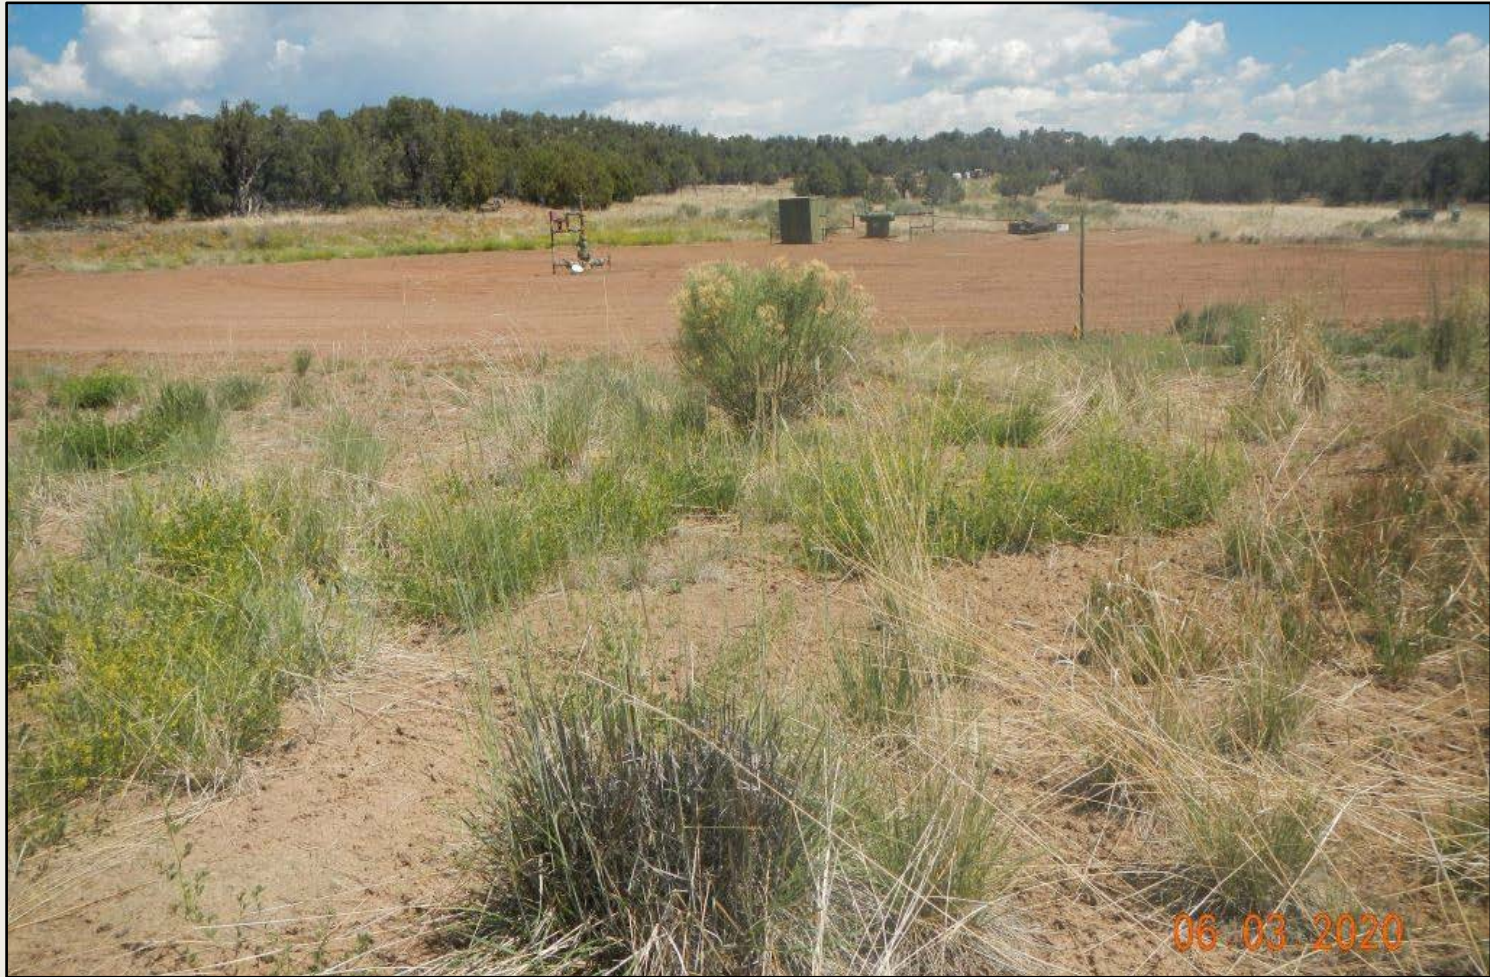
Photo 1. View of the project area from the southwestern corner facing center.

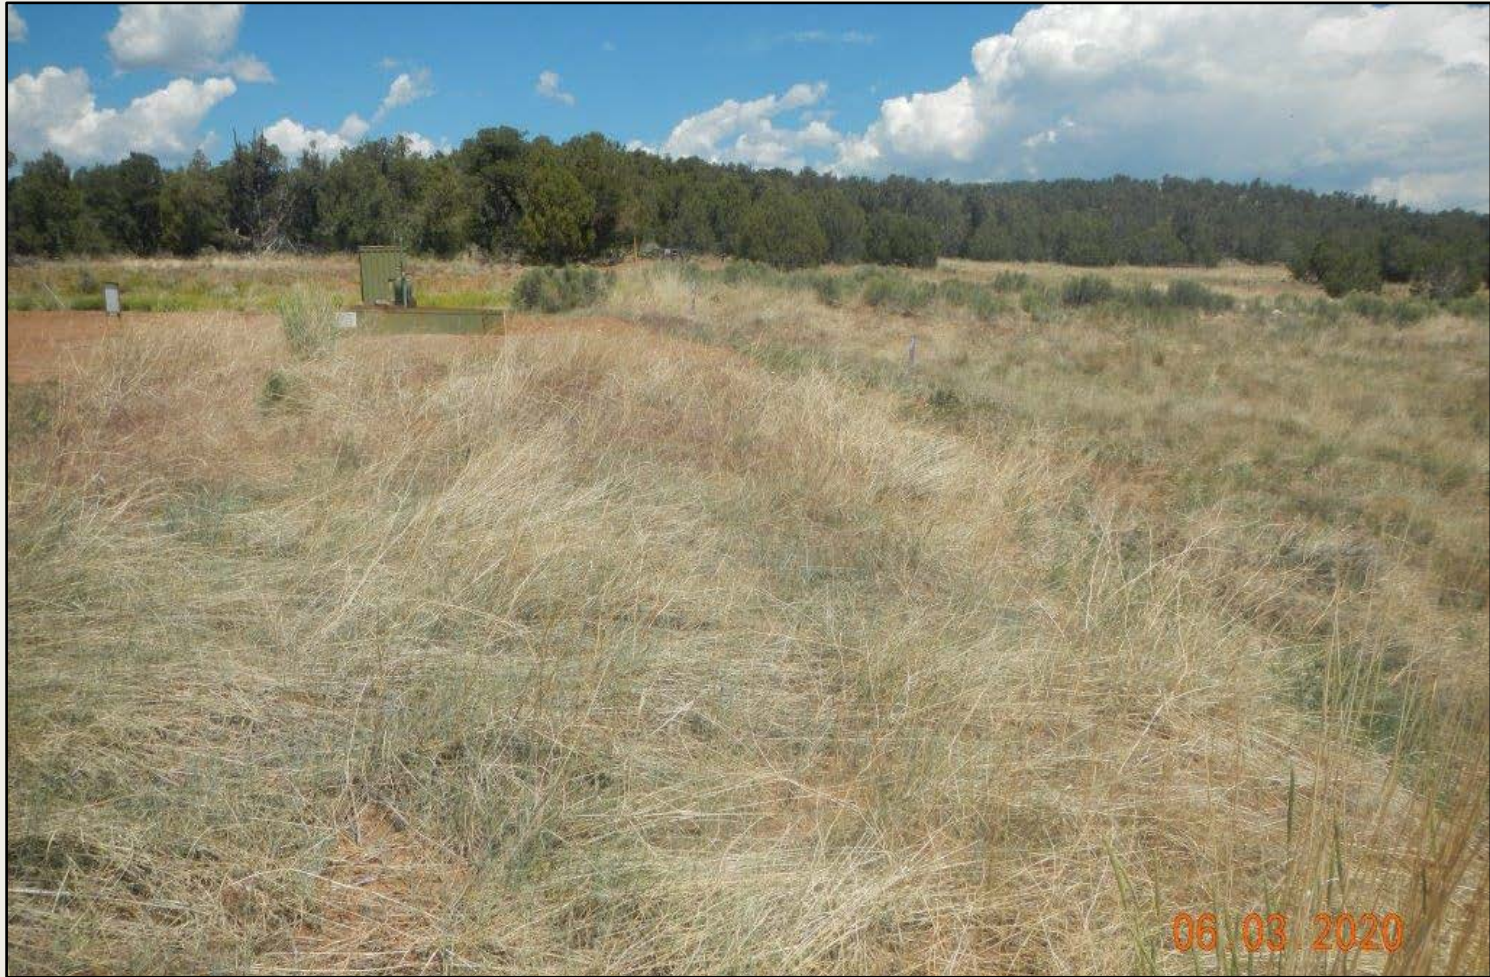
Photo 2. View of the eastern fill slope from the southeastern corner facing northward. Revegetation is progressing with crested wheatgrass, western wheatgrass, and intermediate wheatgrass.

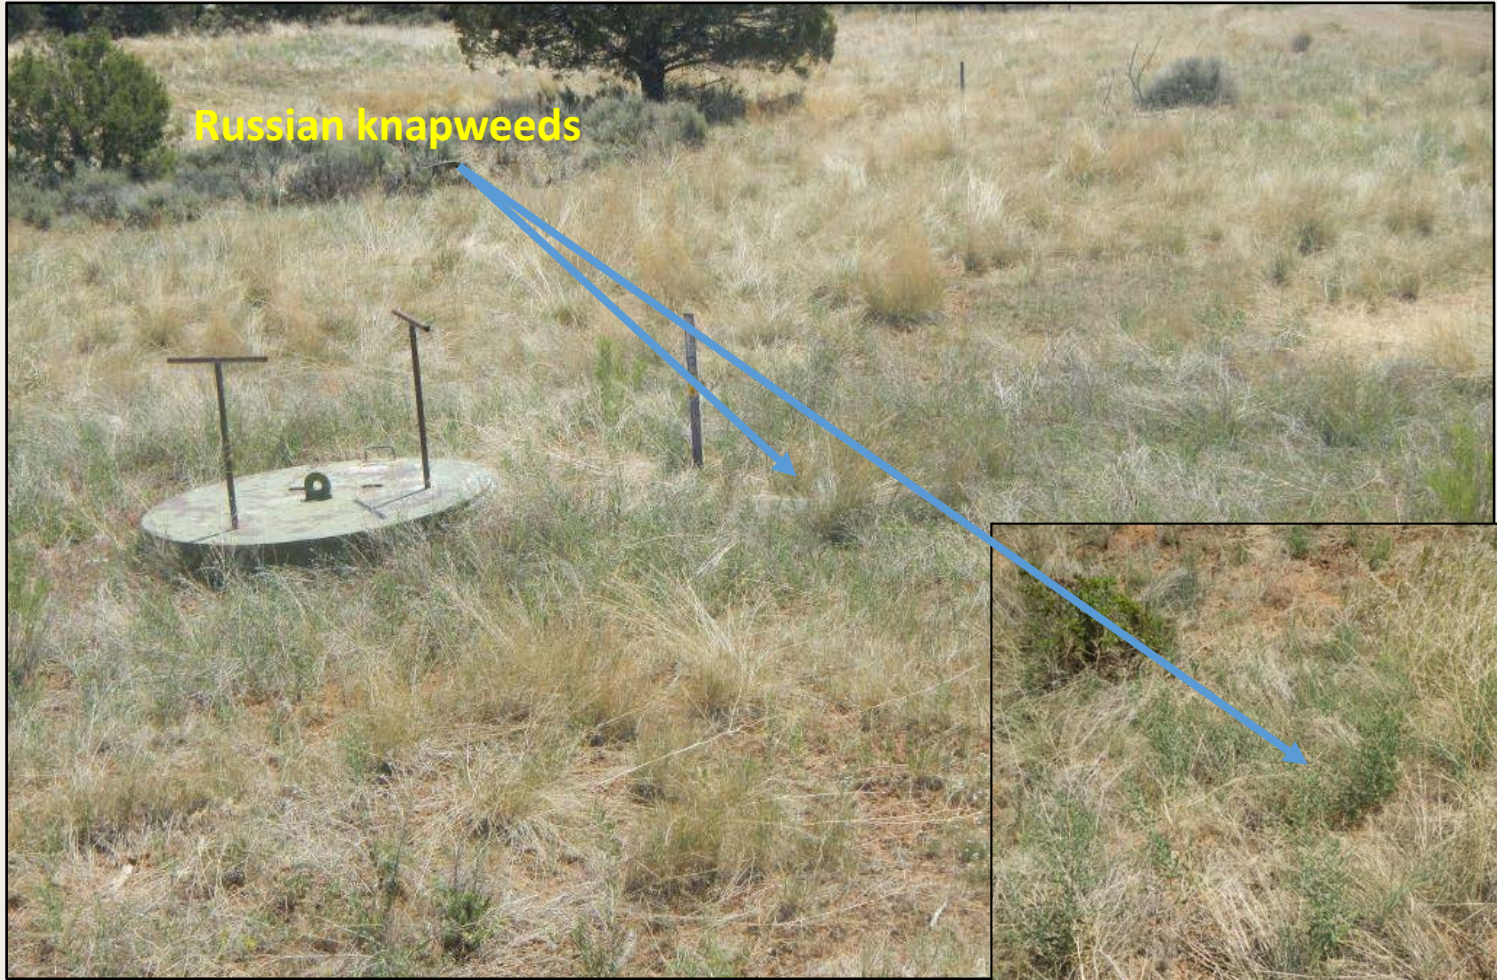
Photos 3/4. View of Russian knapweeds within the eastern project area. Approximately 2000 observed.

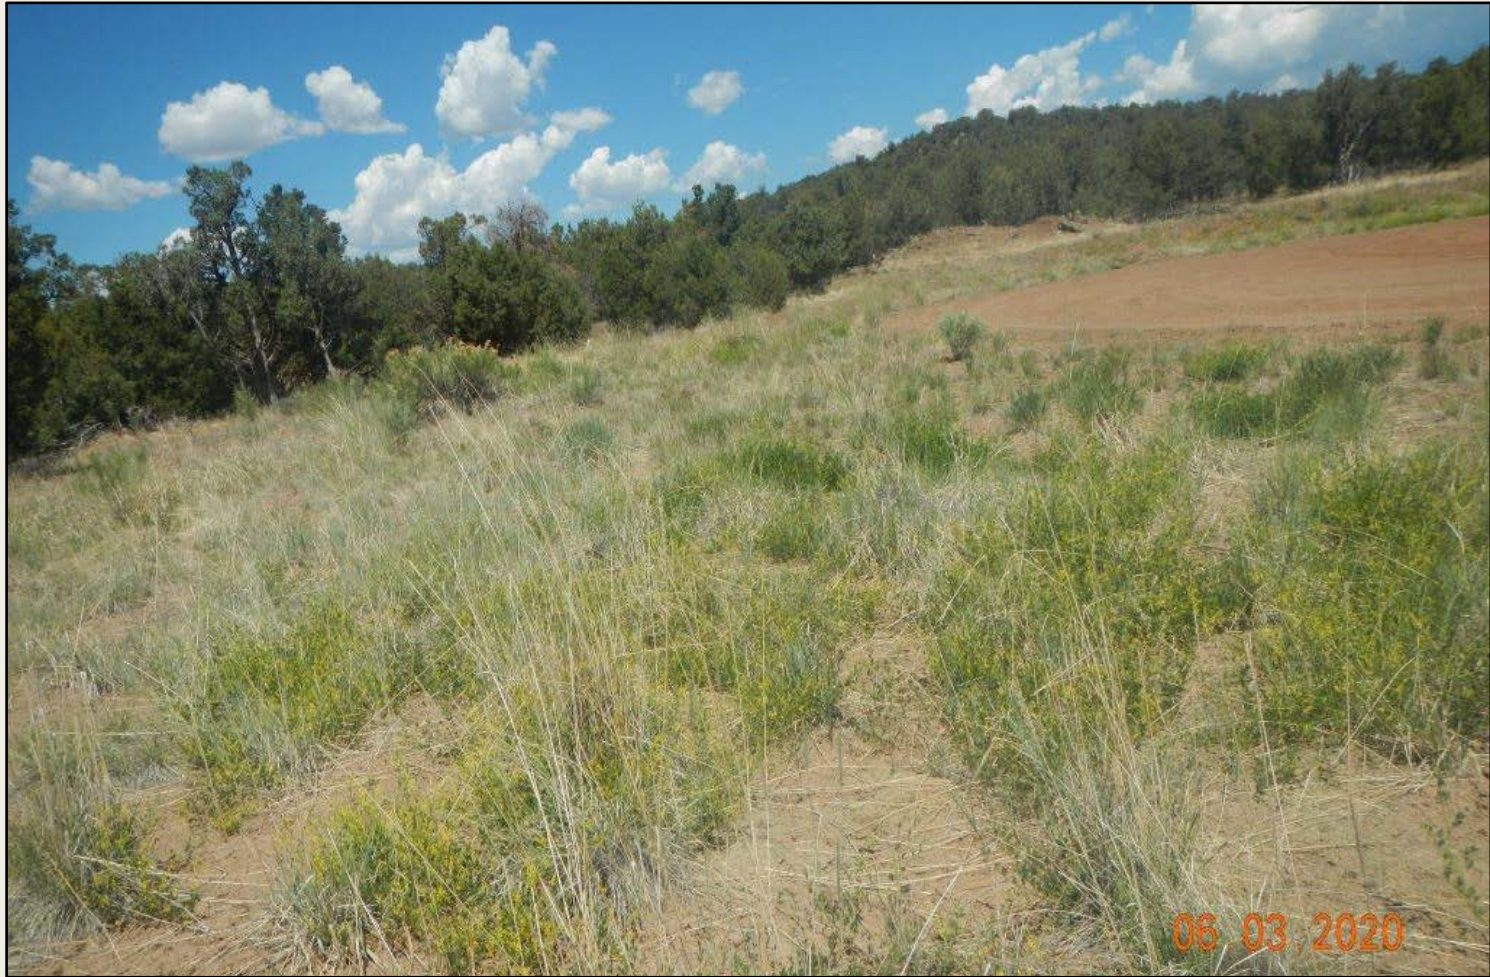
Photo 5. View of the western project area from the southwestern corner facing northward.

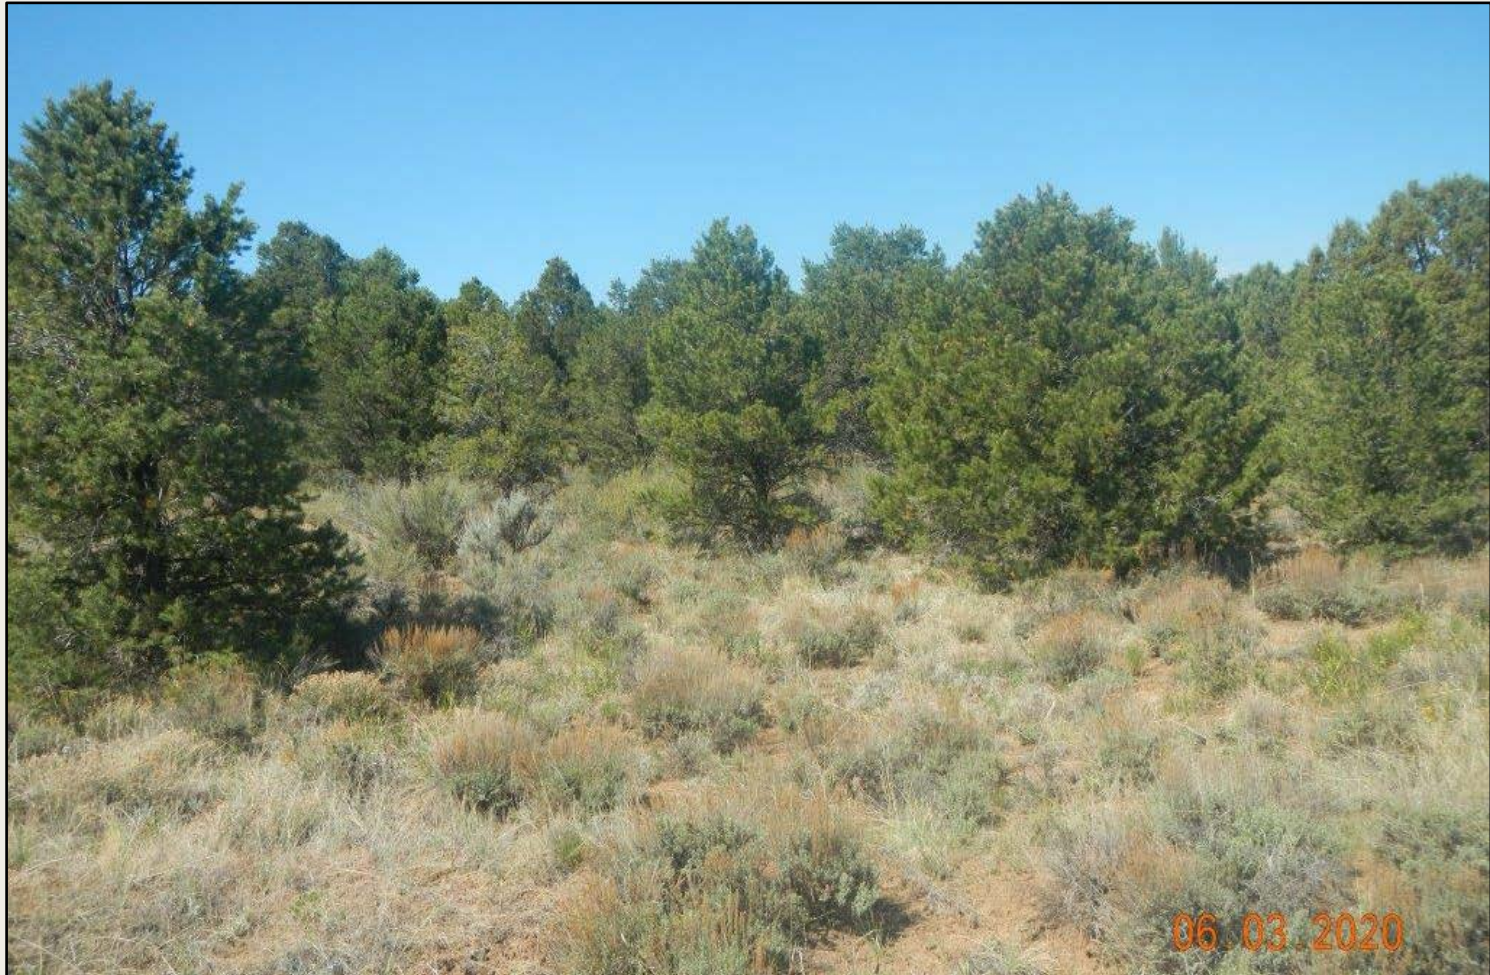
Photo 6. View of reference area comprised of pinyon and juniper woodland with understory of black sage, squirreltail, blue grama, and Navajo tea.
