Inspection Photos
Operator: Catamount Energy
API#: 067-08206
Date: 6/3/2020

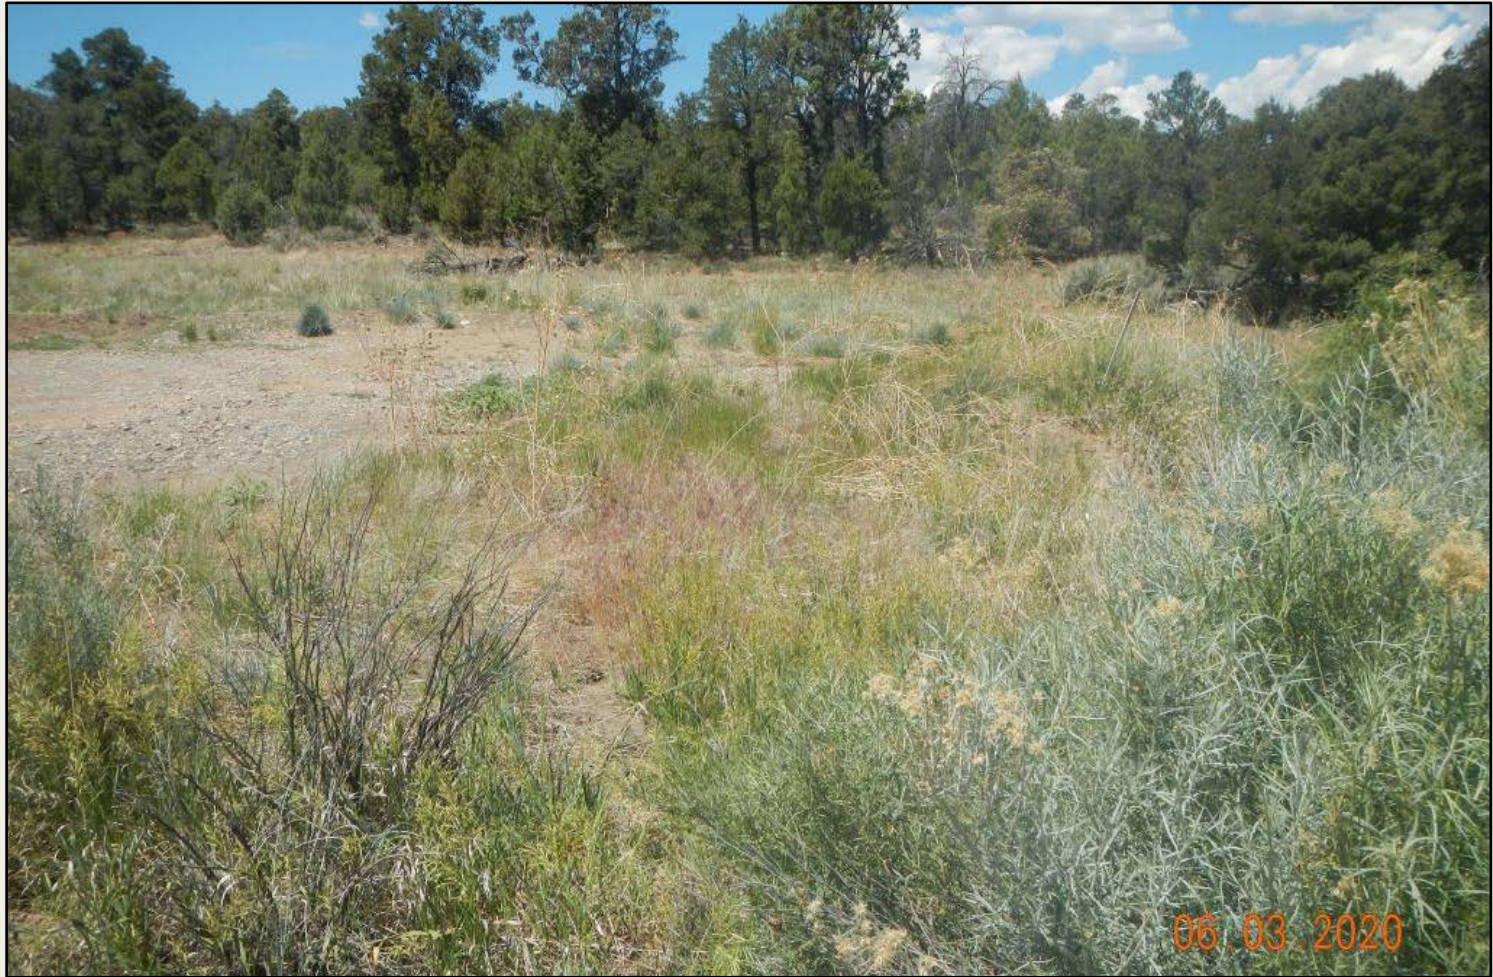
Photo 2. View of the northern fill slope from the northeastern corner facing westward. Revegetation is progressing in portions with western wheatgrass and smooth brome. However weed infestations (described below) are threatening successful revegetation.

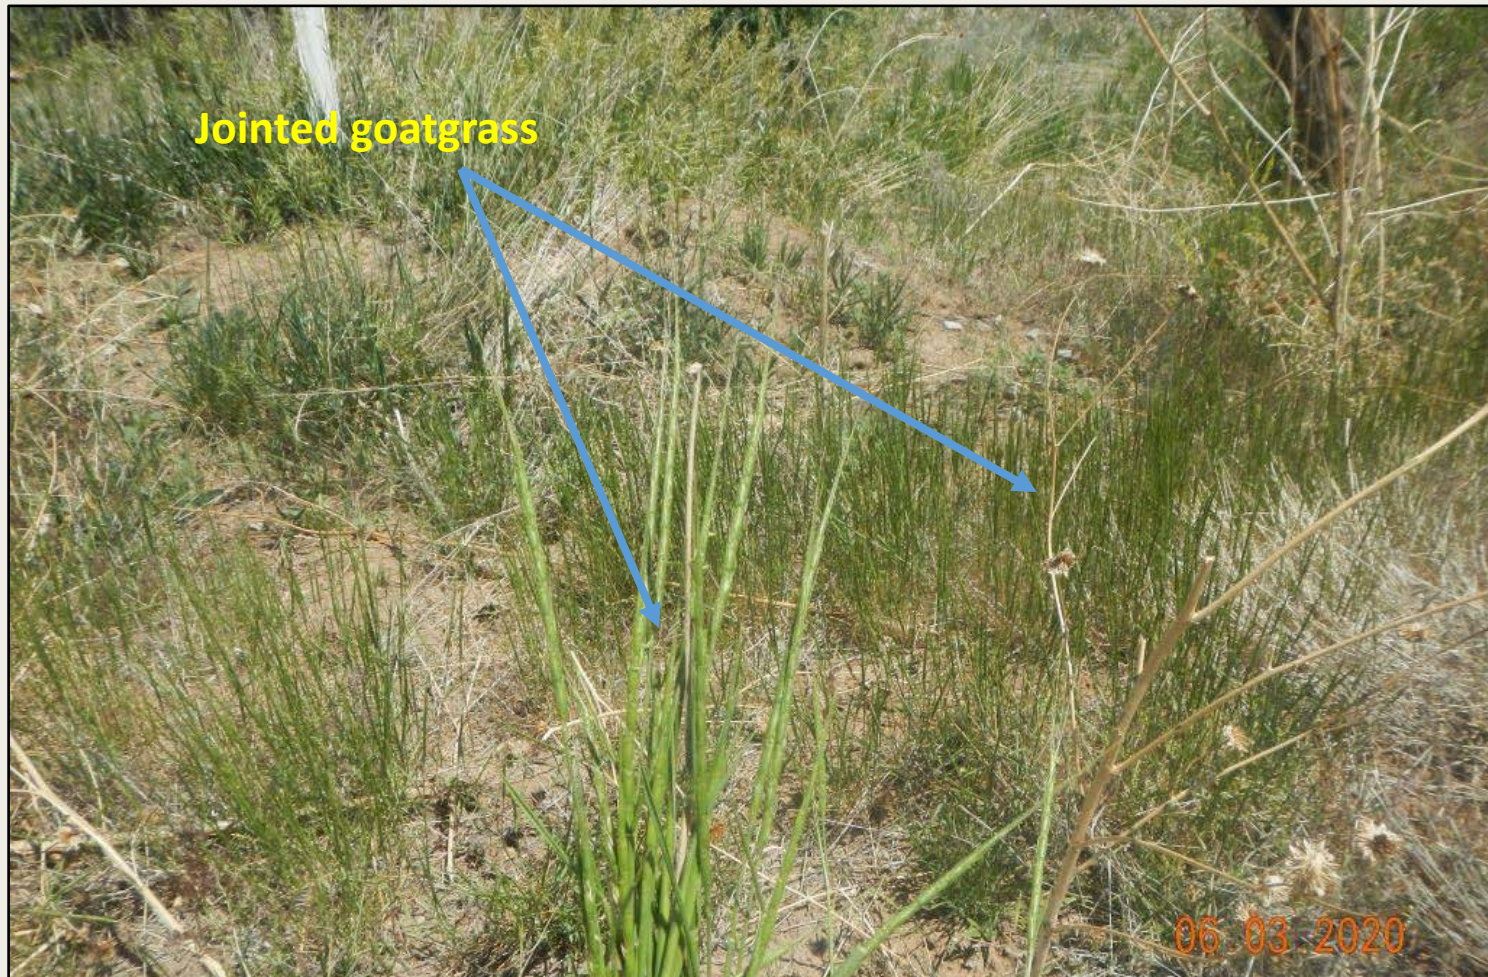
Photos 3. View of jointed goatgrass within the northern project area. Approximately 2000 individuals observed.

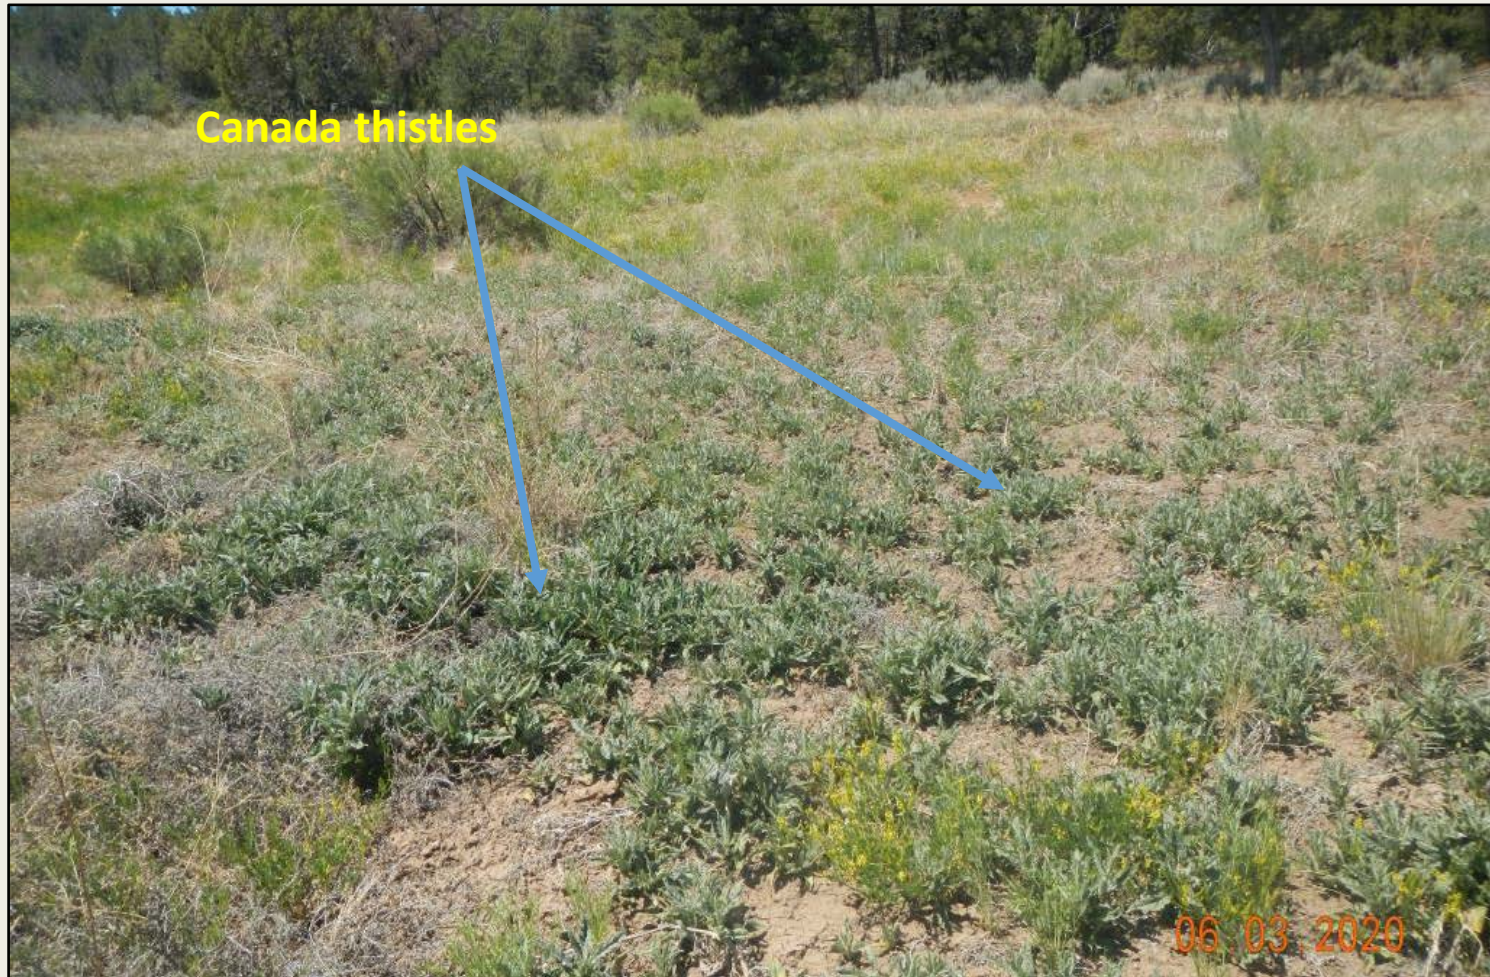
Photos 5. View of dense Canada thistles within the western interim reclamation area. Approximately 2000 individuals observed.
