Inspection Photos
Operator: Catamount Energy
API#: 067-06549
Date: 6/3/2020

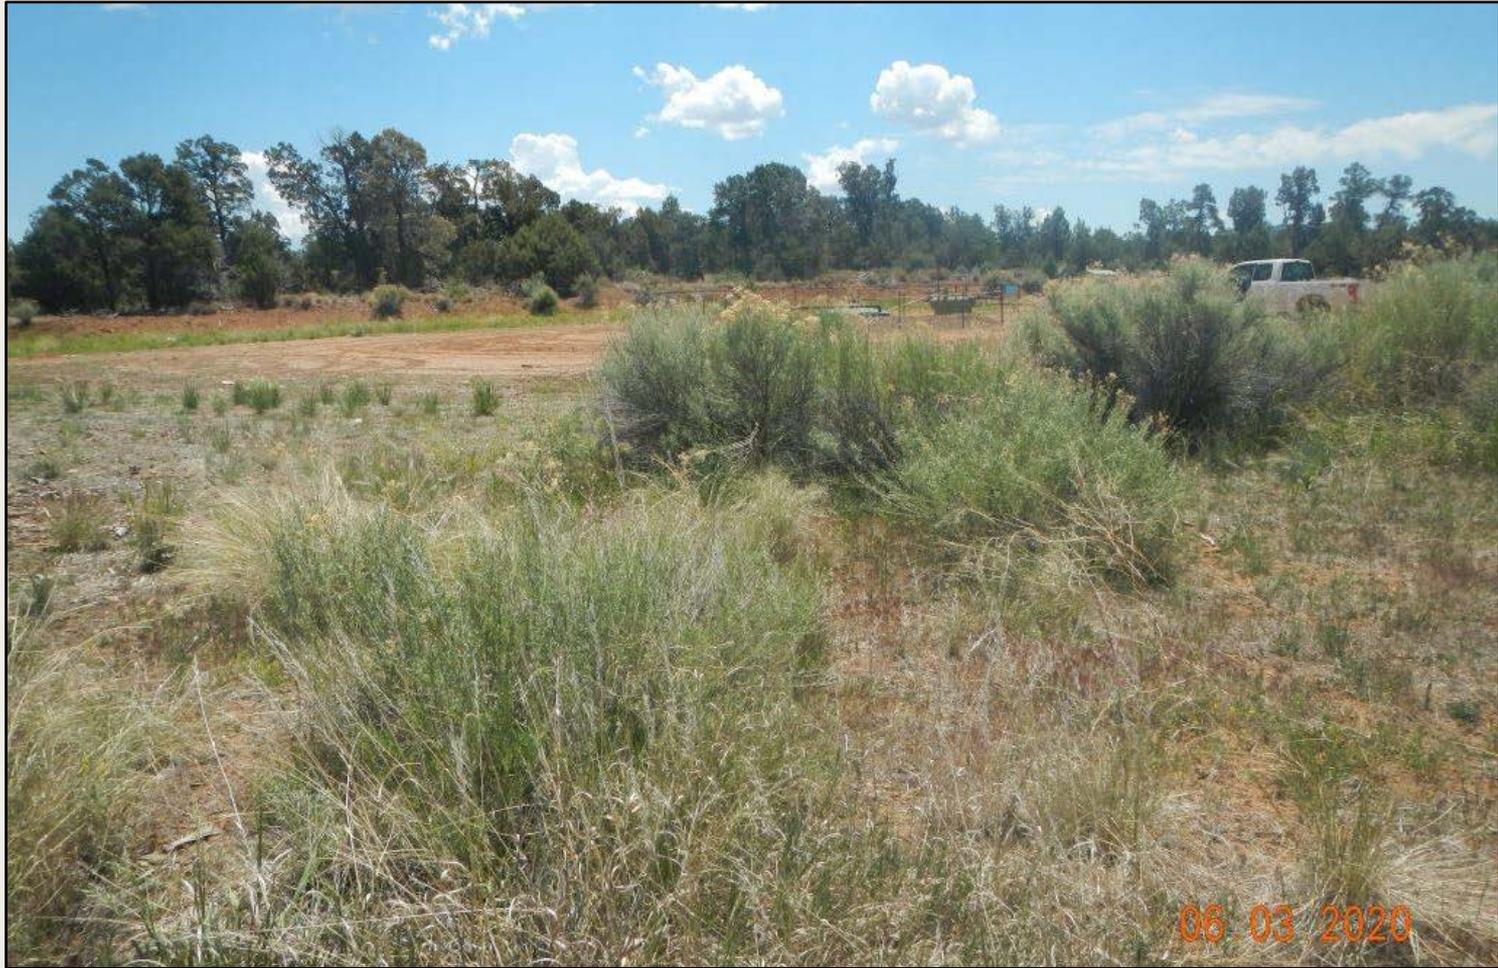
Photo 1. View of the project area from the northwestern corner facing center.

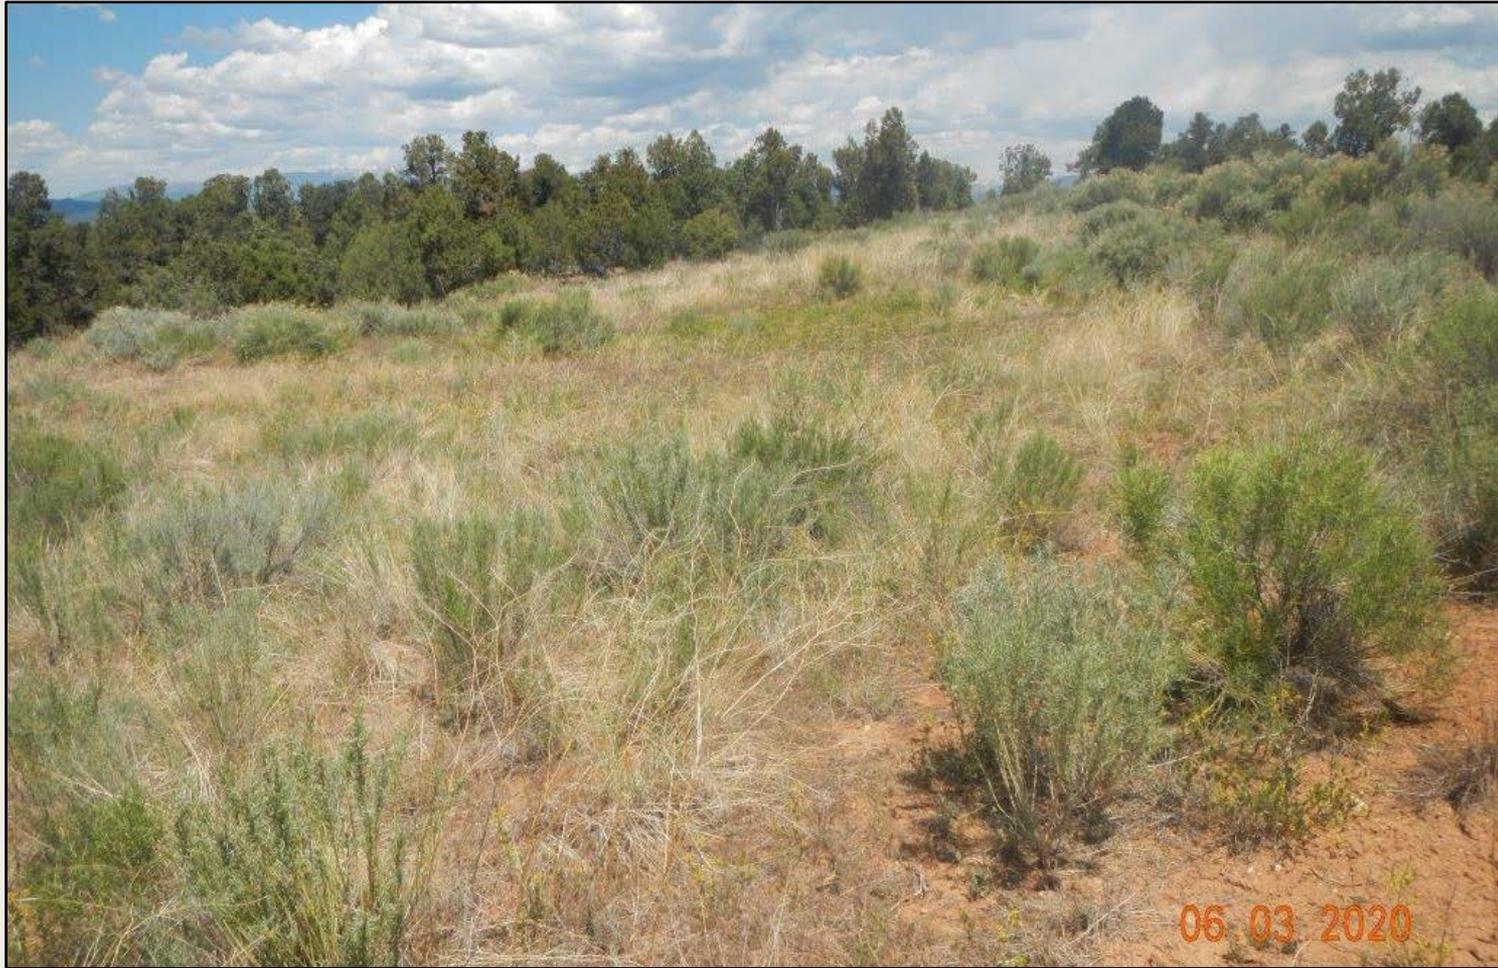
Photo 2. View of the western fill slope from the southwestern corner facing northward. Revegetation is progressing with sand dropseed, Indian ricegrass, and rubber rabbitbrush.

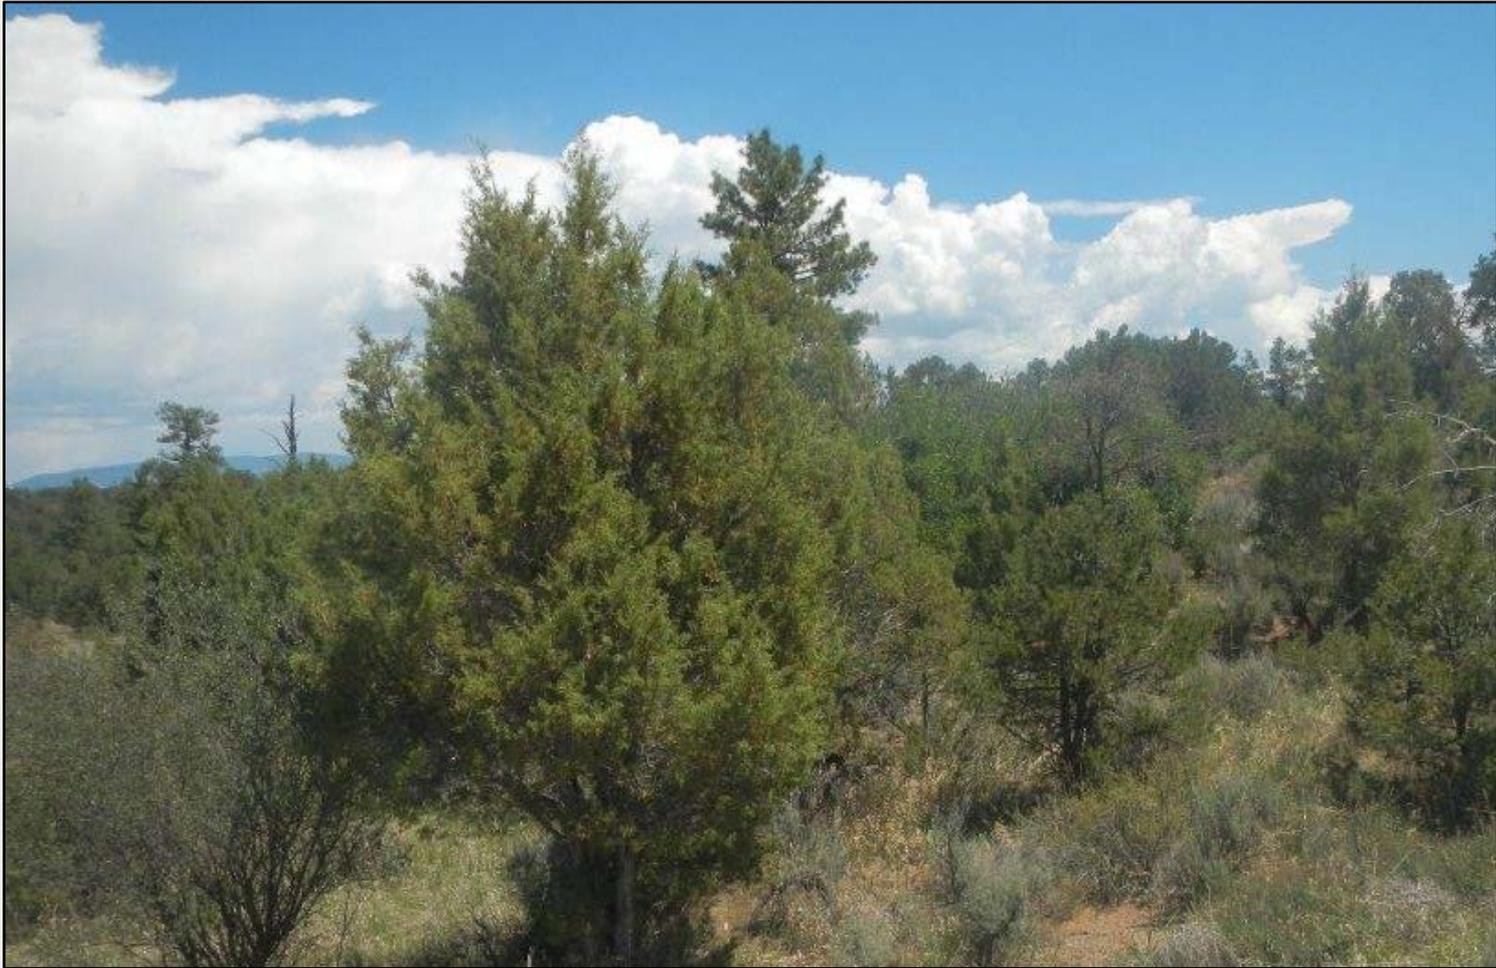
Photo 3. View of reference area comprised of pinyon and juniper woodland with understory of antelope bitterbrush, big sagebrush, James galleta, and penstemon.
