Inspection Photos

API: 05-071-60013

Operator: EP ENERGY

Inspection Date: 6/3/2020

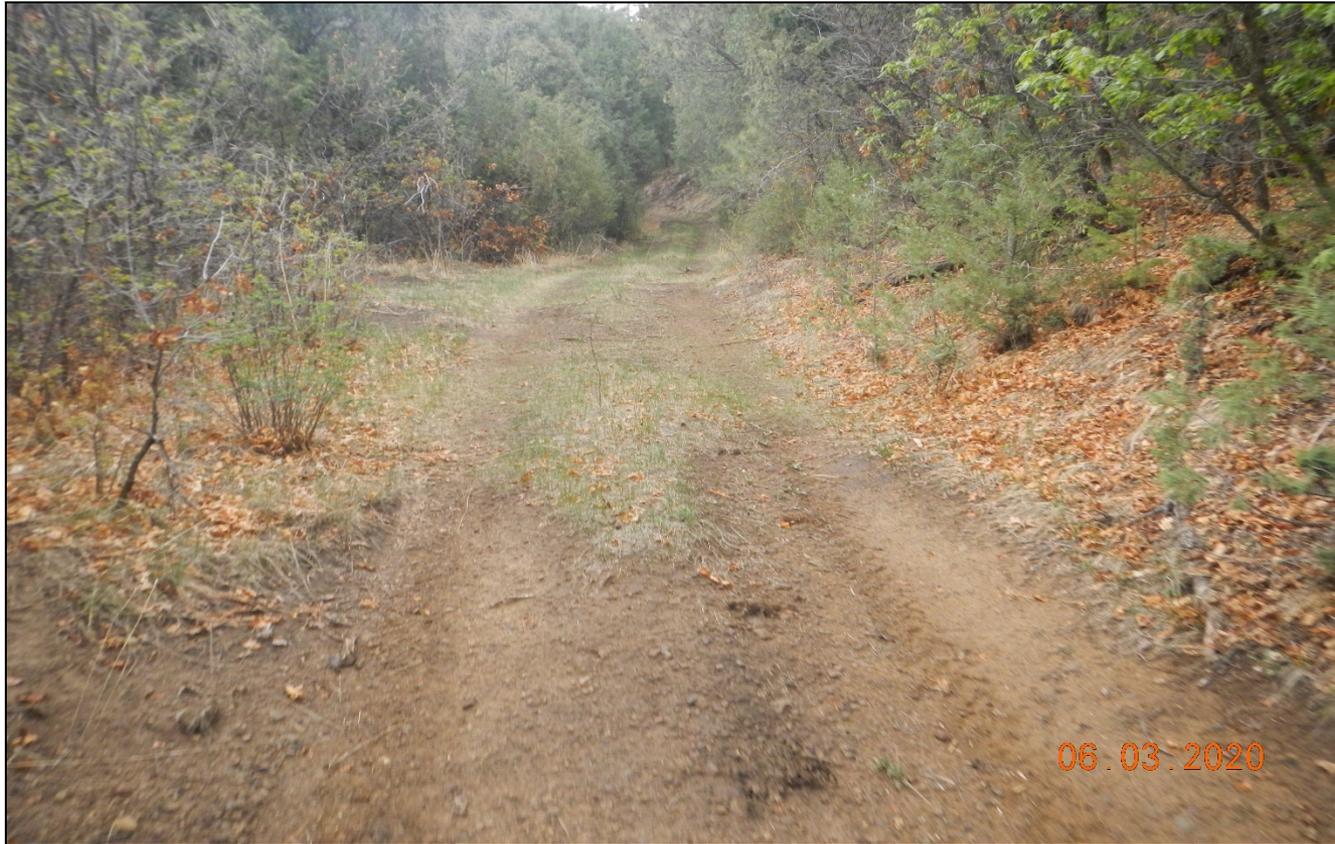
Photo 1. Facing northeast along the road toward the location.

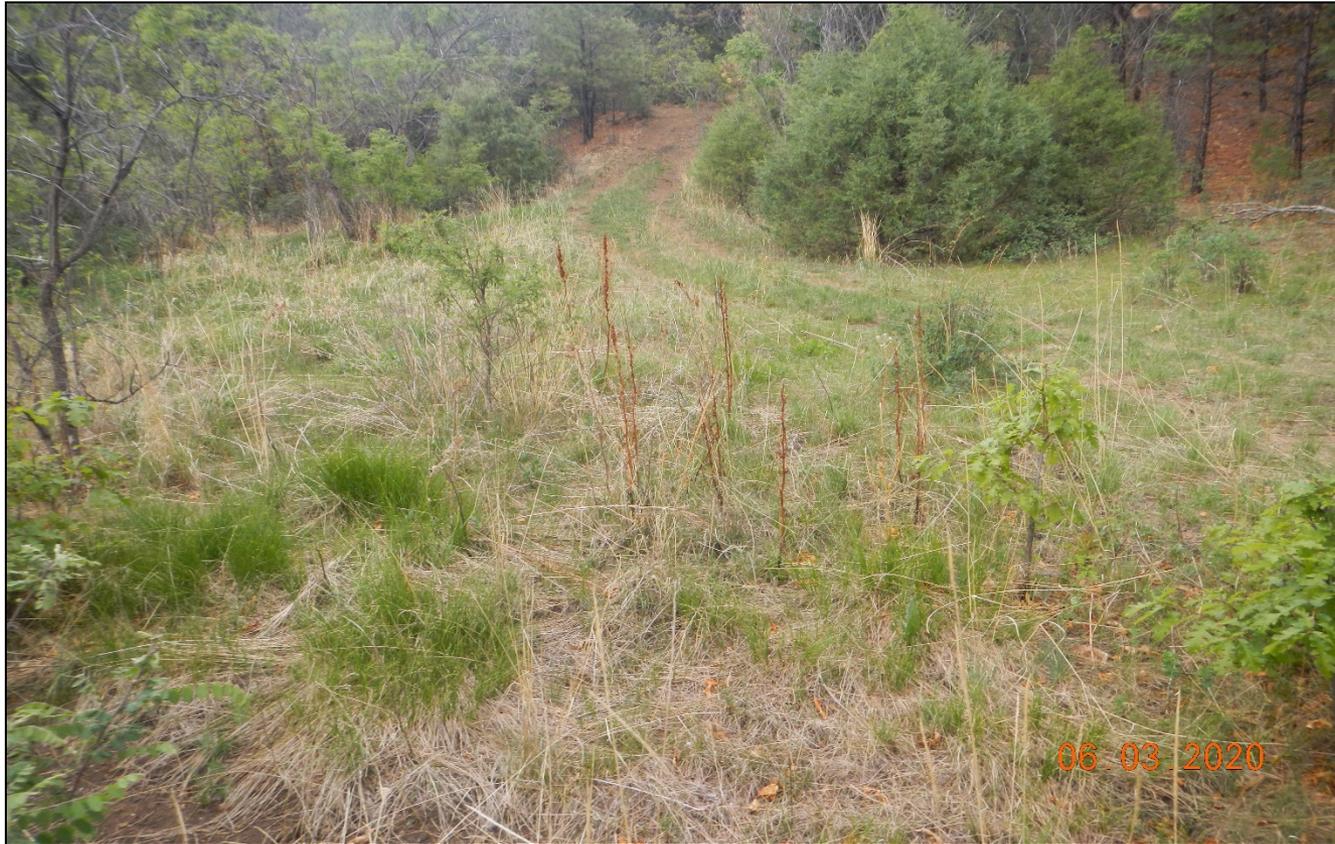
Photo 2. Facing east toward the location. The vegetation is well established at the location. The road continues past the location.

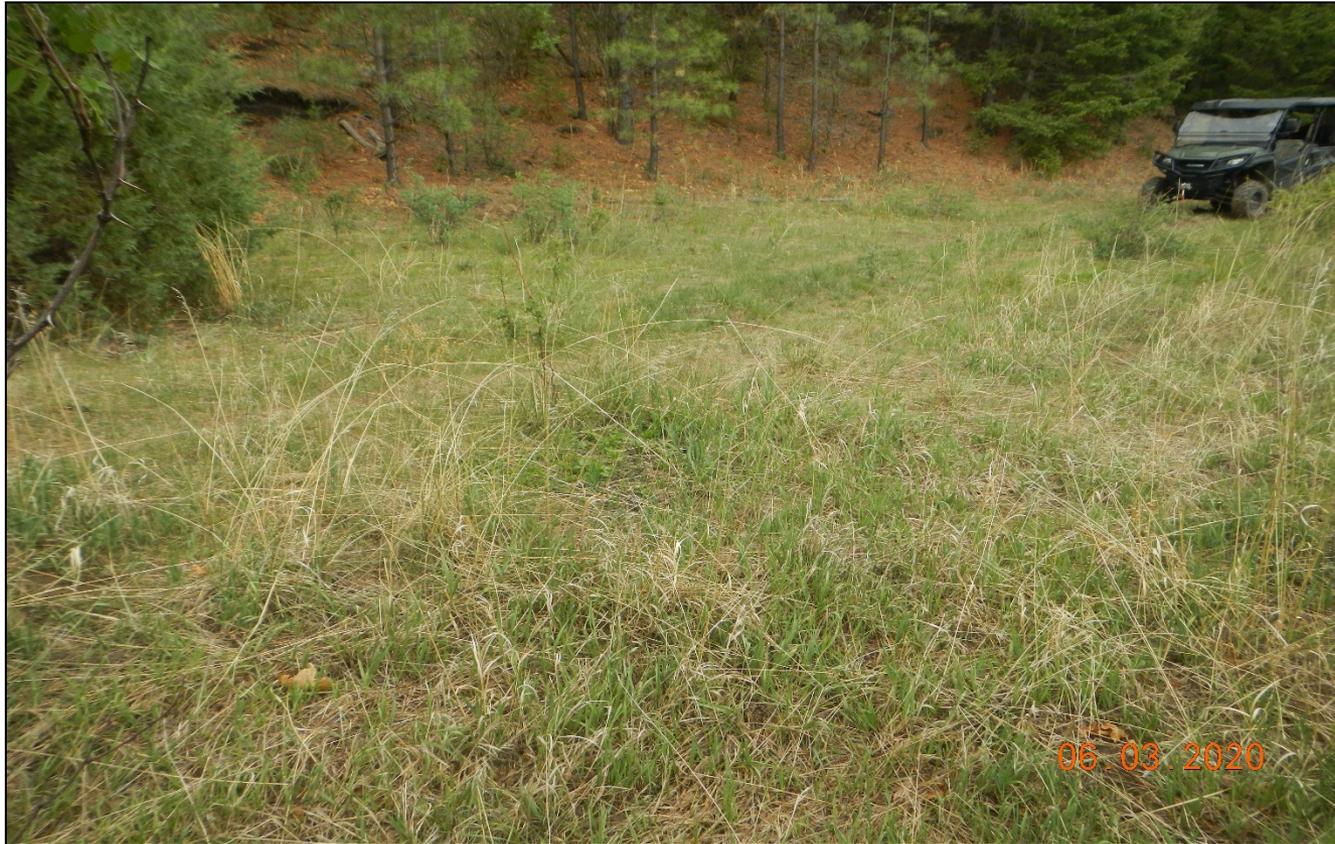
Photo 3. Facing south toward the location.

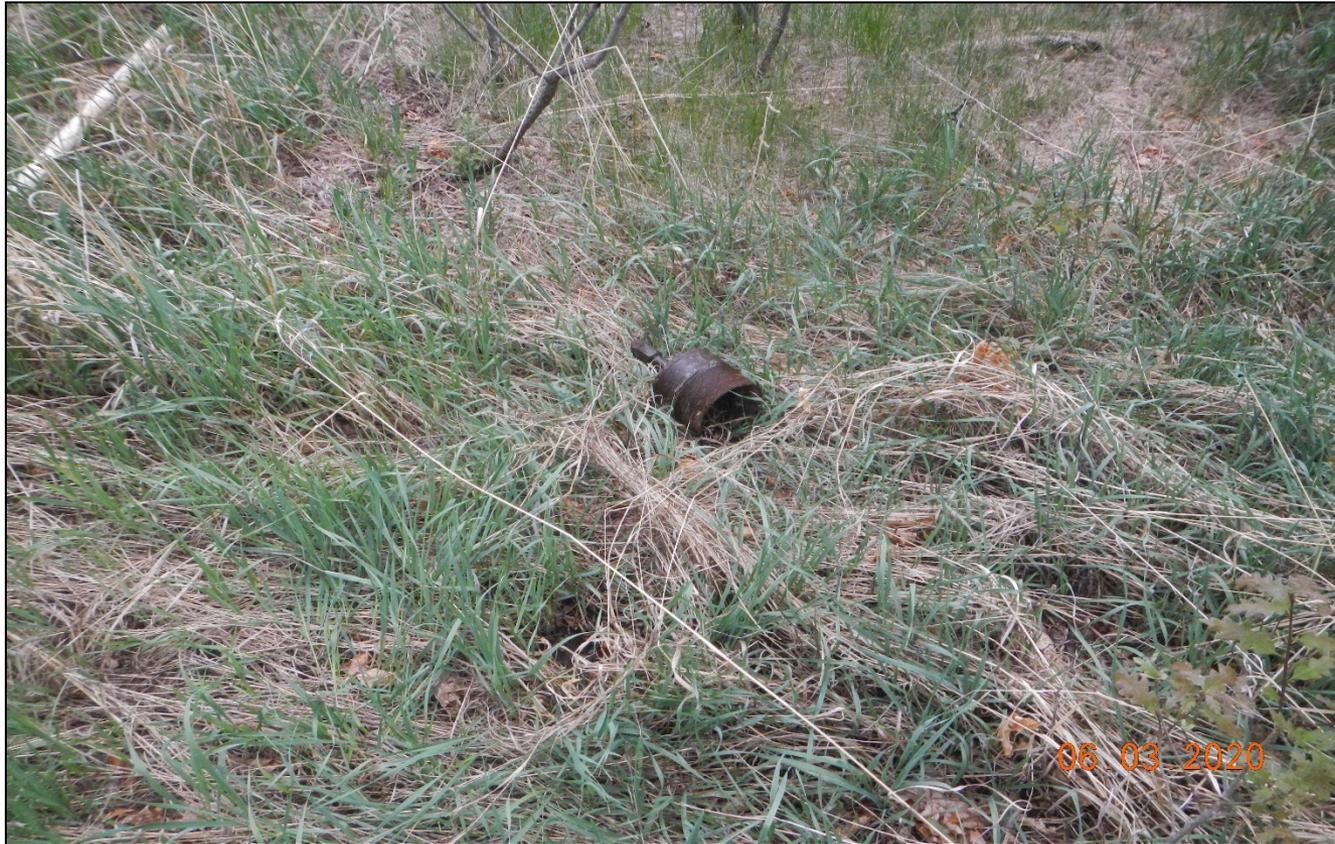
Photo 4. There were a few remnants of debris found at the location. It appears the unused pvc pipe previously observed has been removed.
