Inspection Photos

Location Name: LARAMIE ENERGY LLC Red Mountain Ranch /4-6 Pad

Location ID: 334512

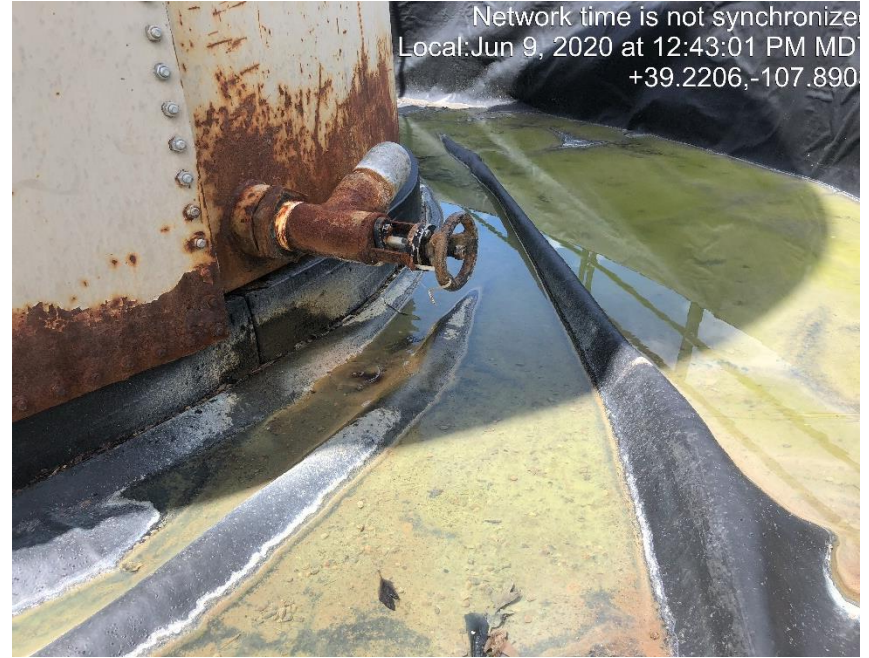
Photo #1331 Drain valve on tank #4-5 dripping condensate.

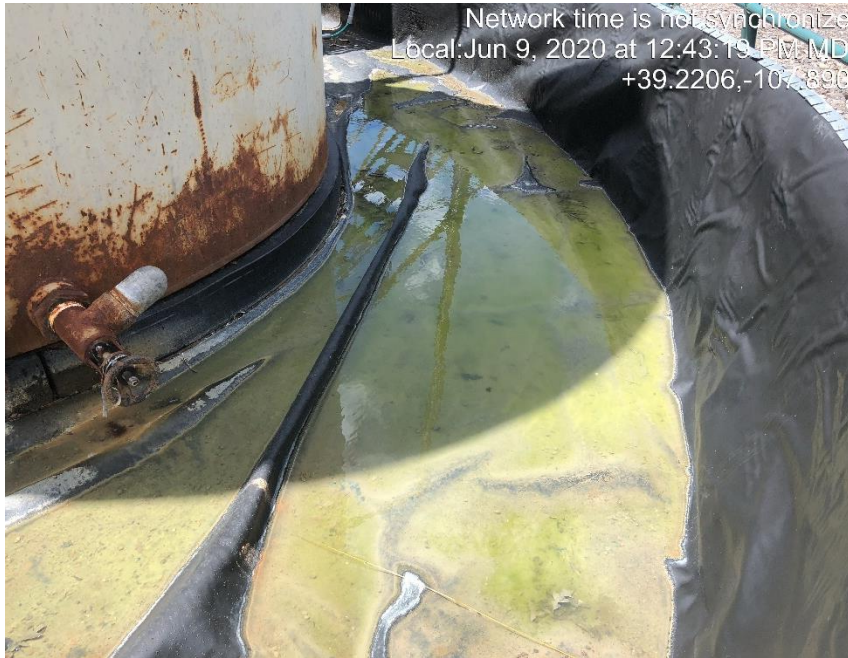
Photo #1332 Drain valve on tank #4-5 dripping condensate.
