Behrens Resources INC, State-Craig 3-16
005-06876

Inspection #688307987

6/8/2020

Tank Battery Inspection

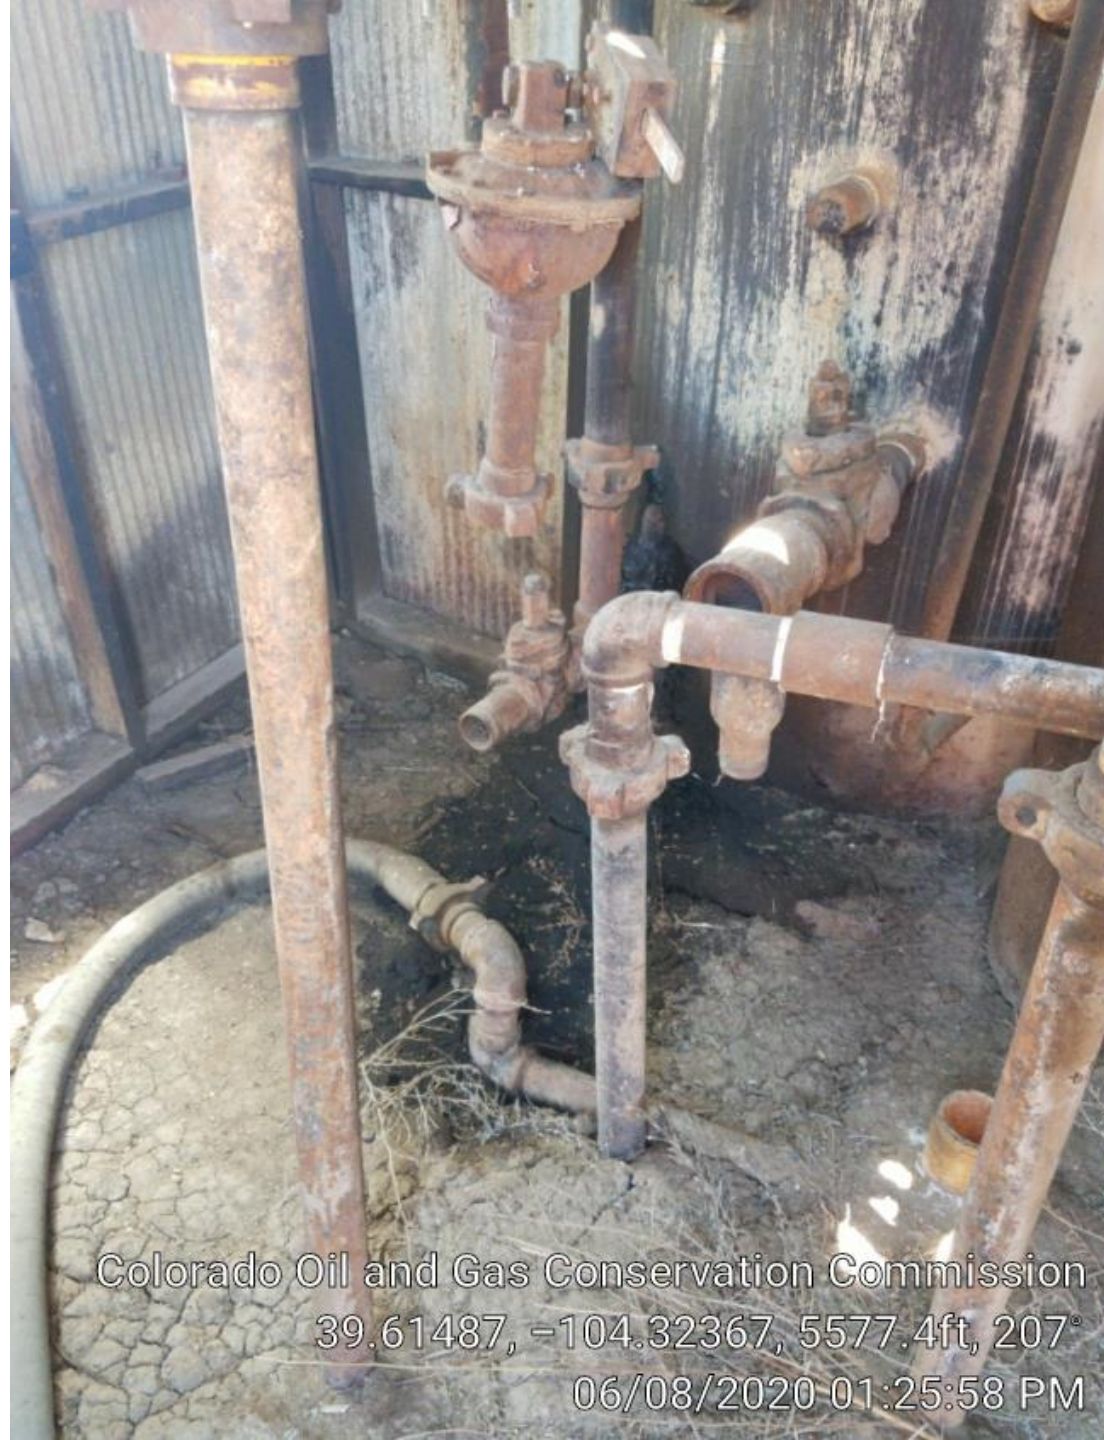
Stained soil in treater shed.
