Inspection Photos
Location Name: Stamp 31-2 Historical Release
Spill ID 476473; Rem 15517

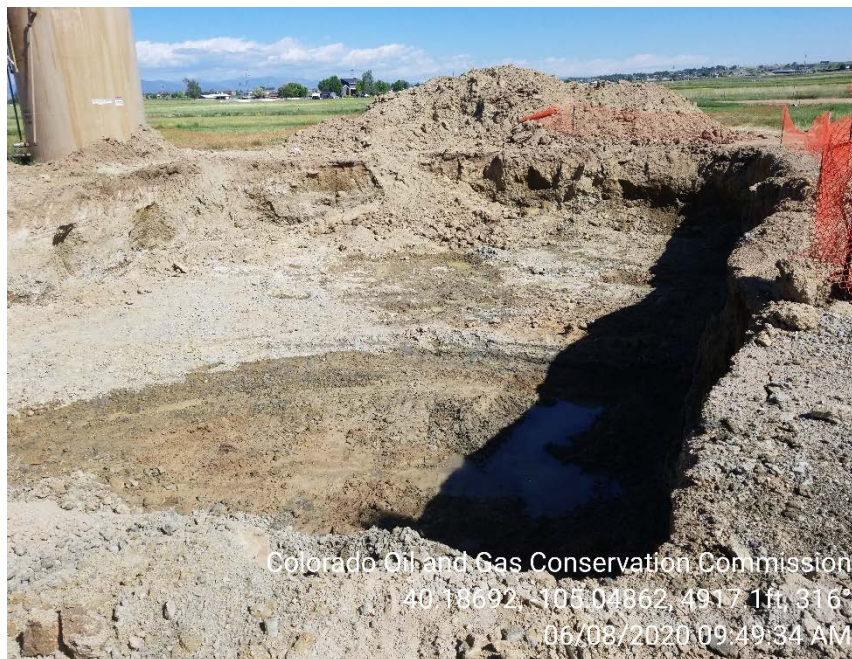
Photo 1 –Northern sidewall of excavation. Groundwater seeping in through deepest portions of the excavation

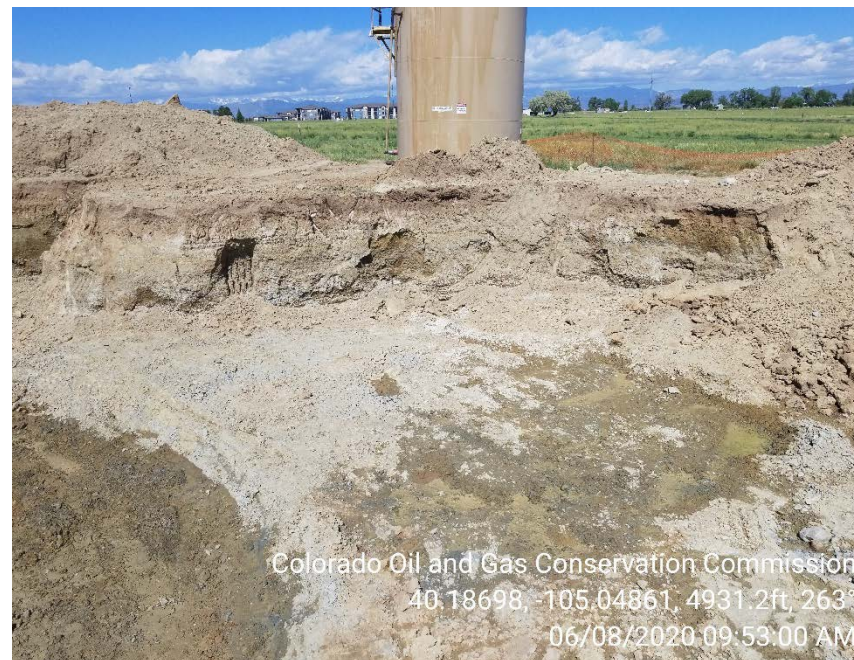
Photo 2 – Western sidewall of excavation. Groundwater seeping in through deepest portions of the excavation

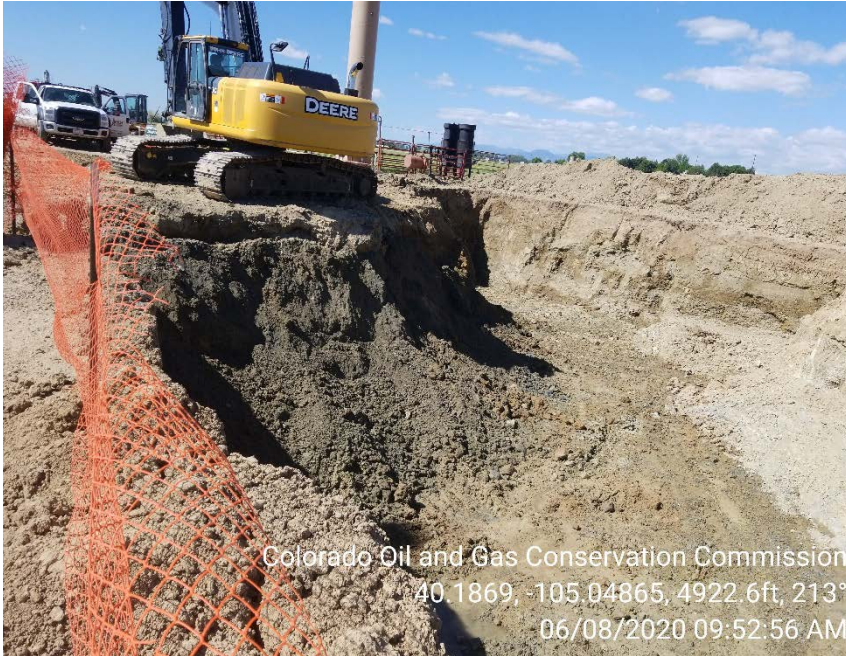
Photo 3 – Stained soil observed in southeast portion of the excavation.

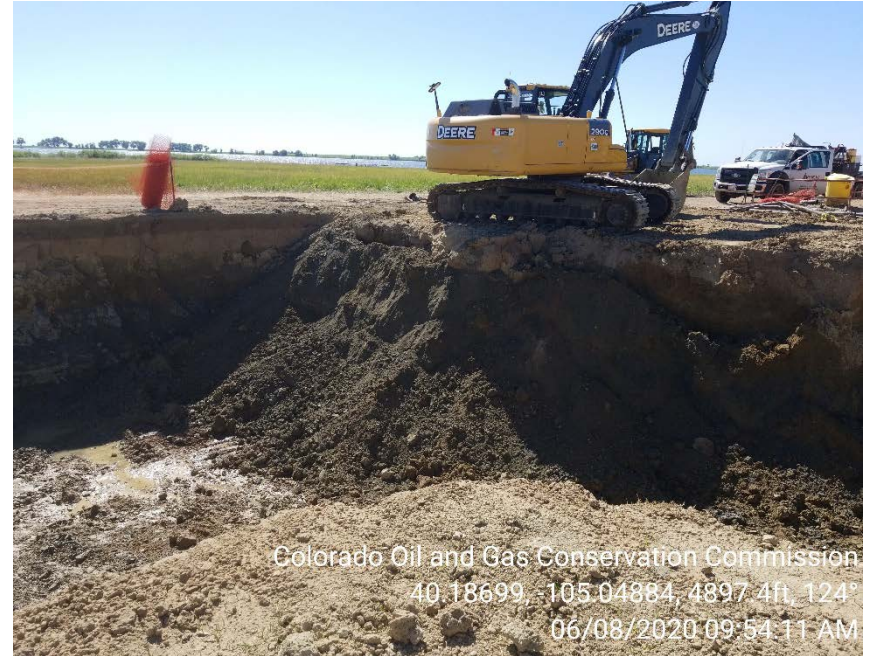
Photo 4 – Stained soil observed in sidewalls under excavator (southeast portion of the excavation).

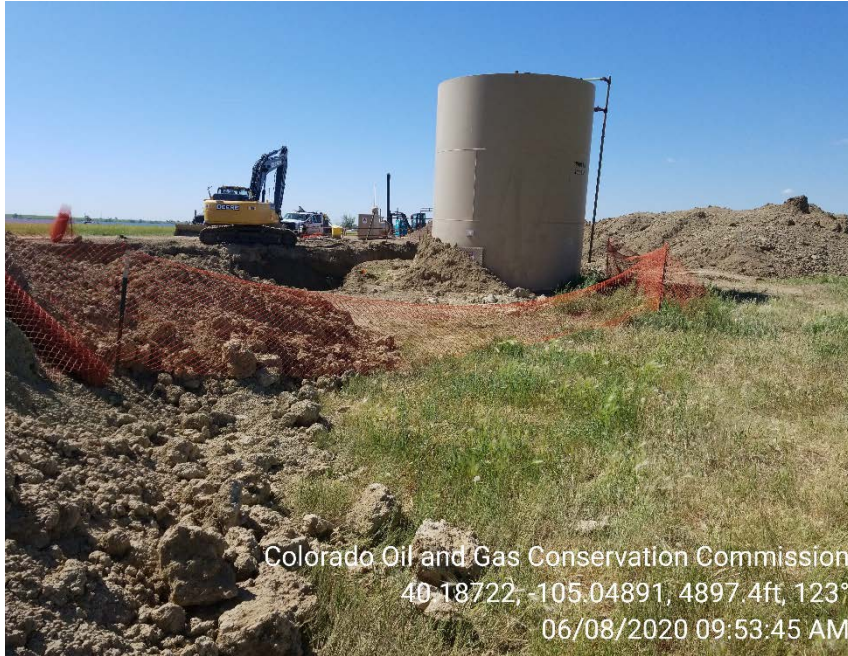
Photo 5 – Orange safety fencing around inactive parts of the excavation.

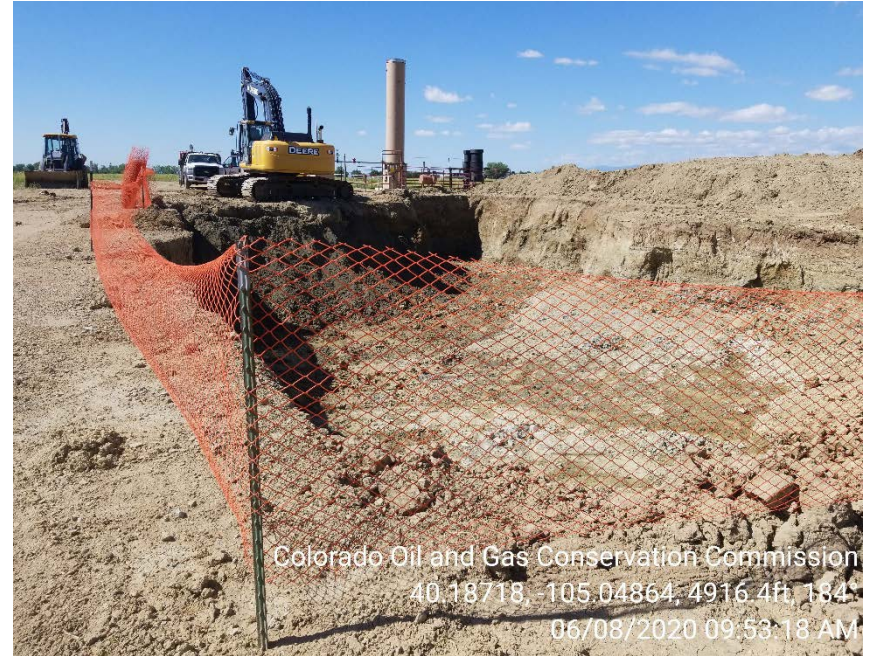
Photo 6 – Southern sidewall of excavation; stained soil observed in sidewalls under excavator. Orange safety fencing around inactive excavation extents.

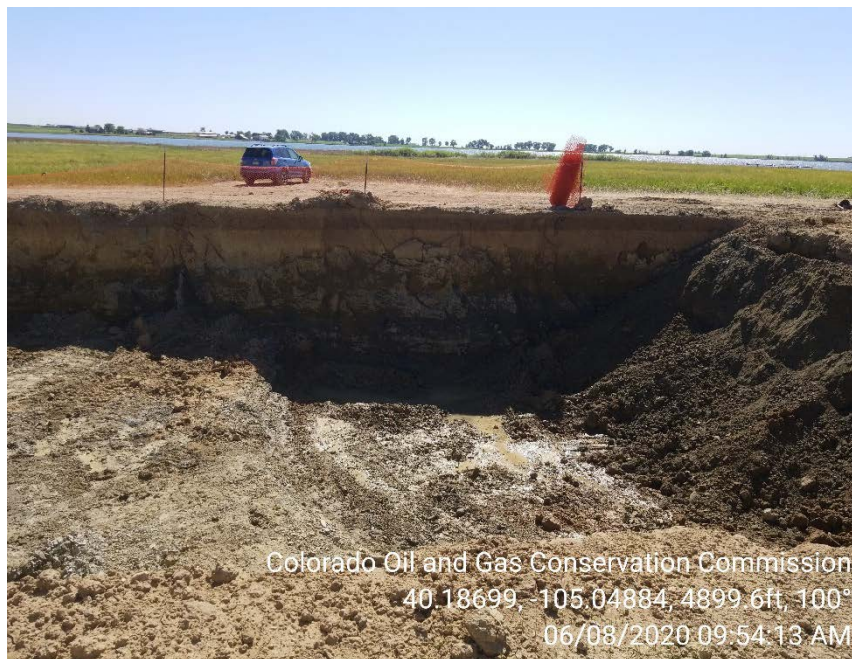
**Photo 7 – Eastern sidewall of excavation.
Goundwater seeping in through floor of excavation.**

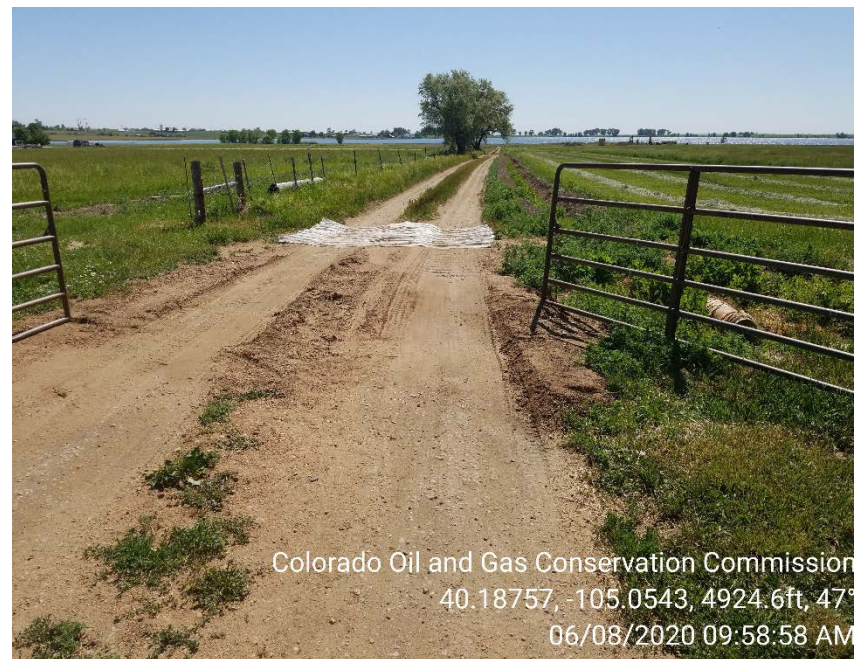
Photo 8 – Tracking pad at beginning of access road.
