Inspection Photos

6/5/2020, 6/9/2020

Operator: TEP ROCKY MOUNTAIN LLC #
96850

Location ID: 475753

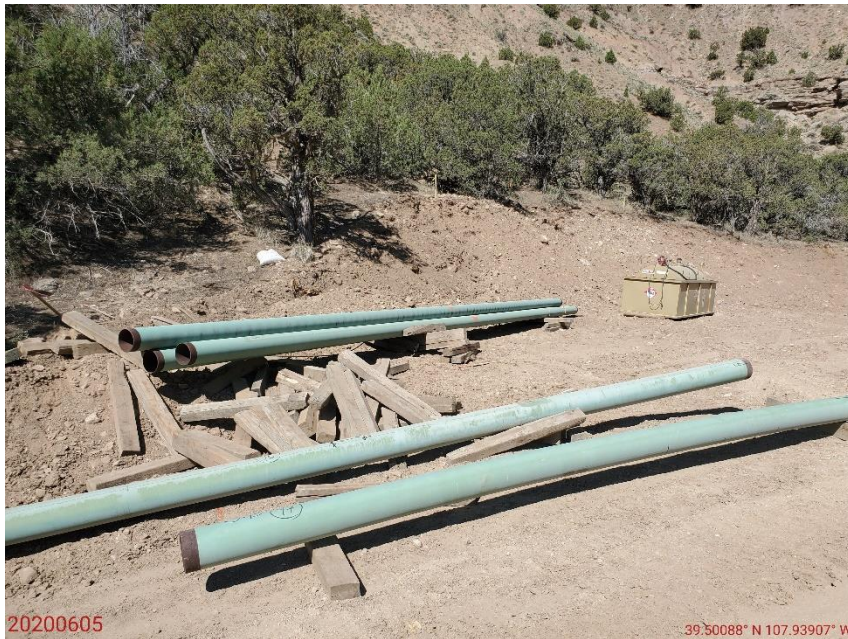
Photo 1: Photo taken from the south end of the Location facing northwest. Photos 1-4 provide an overview of the constructed pad from northwest, north, northeast, to east. Total area of disturbance ~3 acres. Pad area ~2.7 acres.

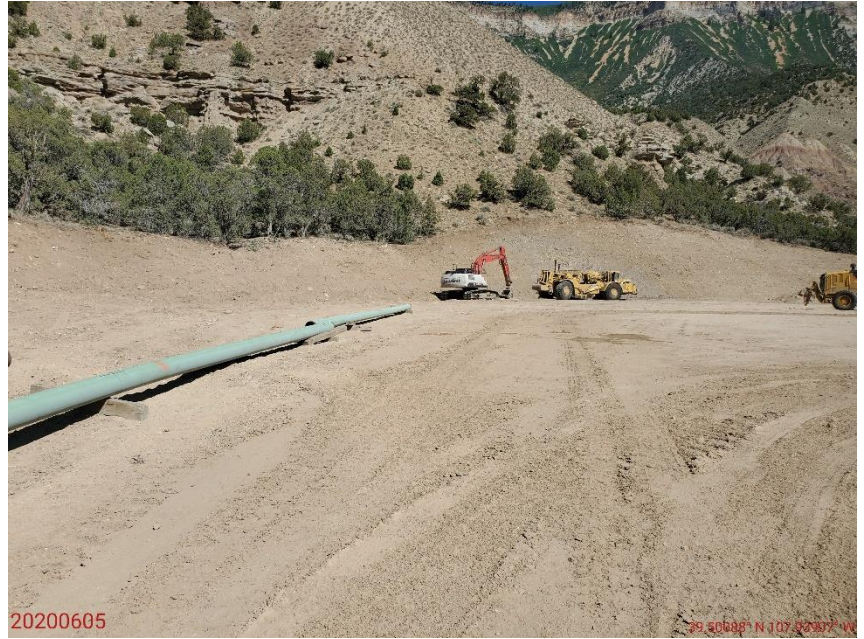
Photo 2: See comments under photo 1.

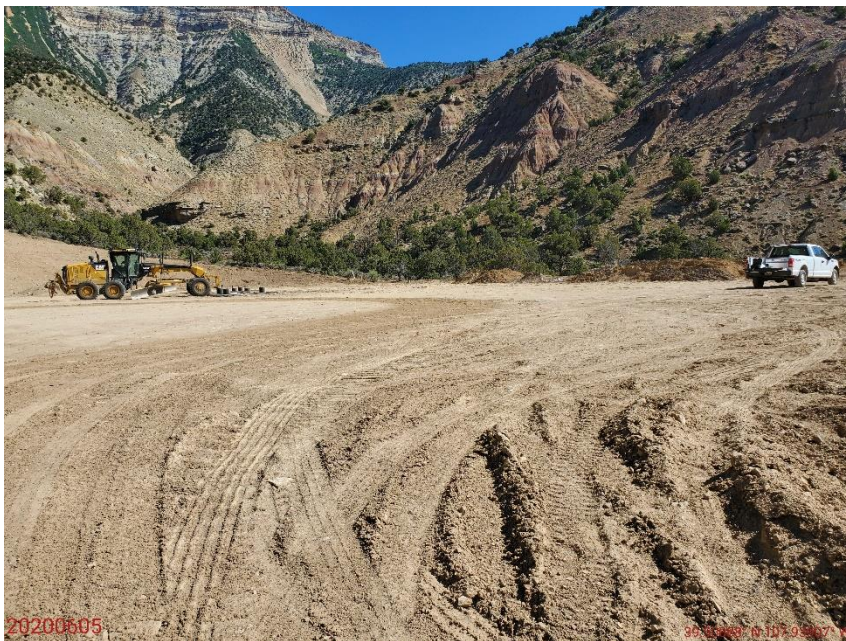
Photo 3: See comments under photo 1.

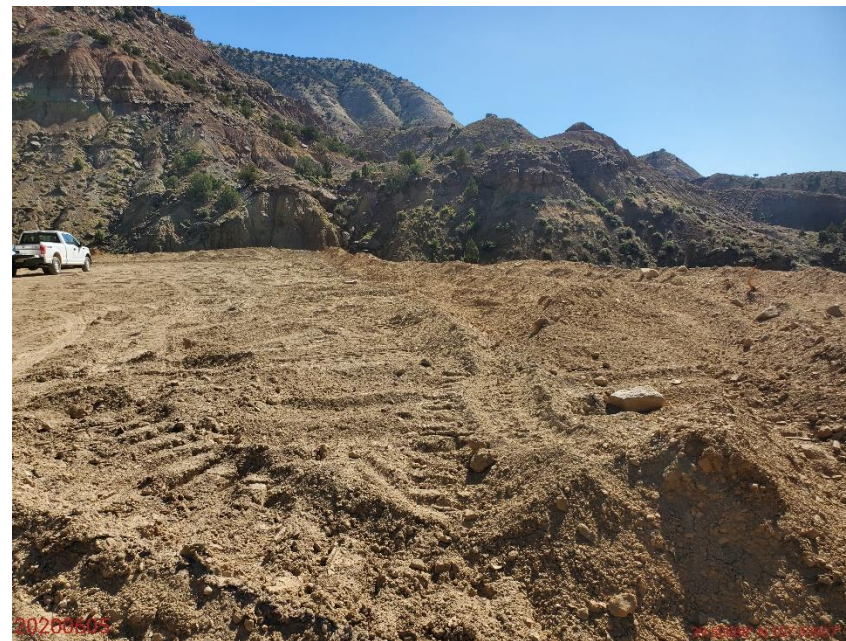
Photo 4: See comments under photo 1.

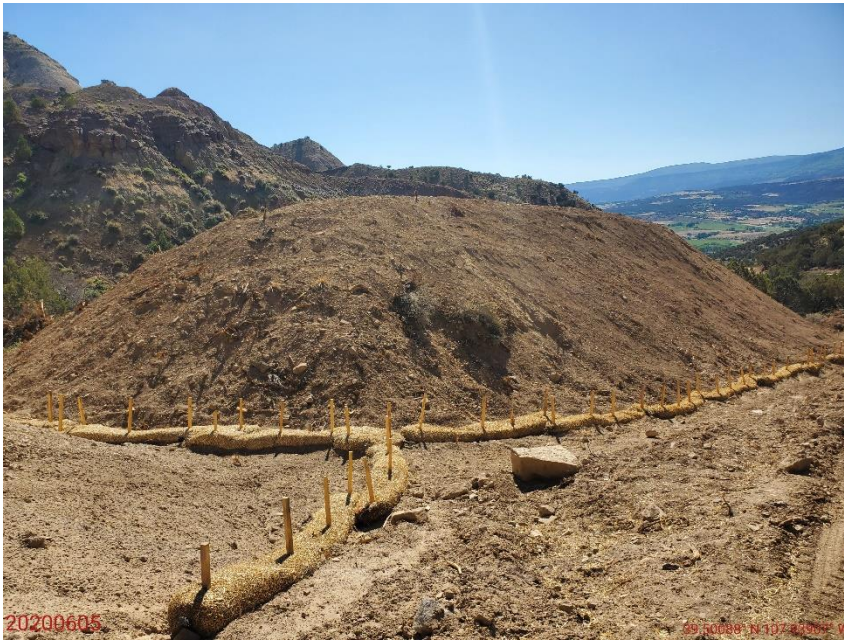
Photo 5: Photo taken from the south end of the Location, facing south. Photo shows soil stockpile on the Location; No other soil stockpiles appear to have been constructed. Photo also shows Operator has installed hay bale and wattle BMPs at the toe of the soil stockpile. Additional BMPs to stabilize the soils of the stockpile appear missing, or insufficient.

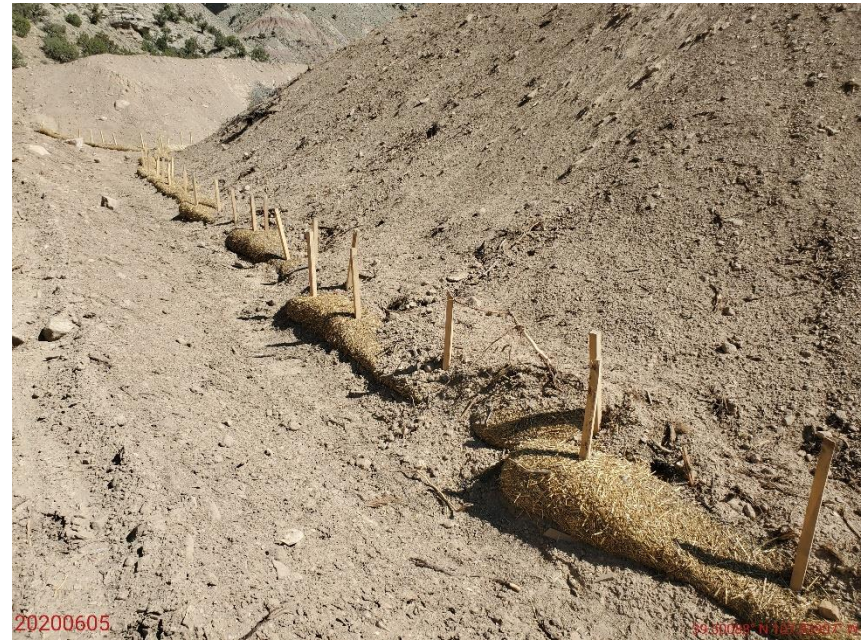
Photo 6: Photo taken from the soil stockpile. Photo shows Operator has installed hay bale and wattle BMPs at the toe of the soil stockpile. BMPs have filled with sediment and are no longer in proper functioning condition. BMPs used in conjunction with hay bale/wattles are missing, or insufficient to stabilize the soils of the stockpile.

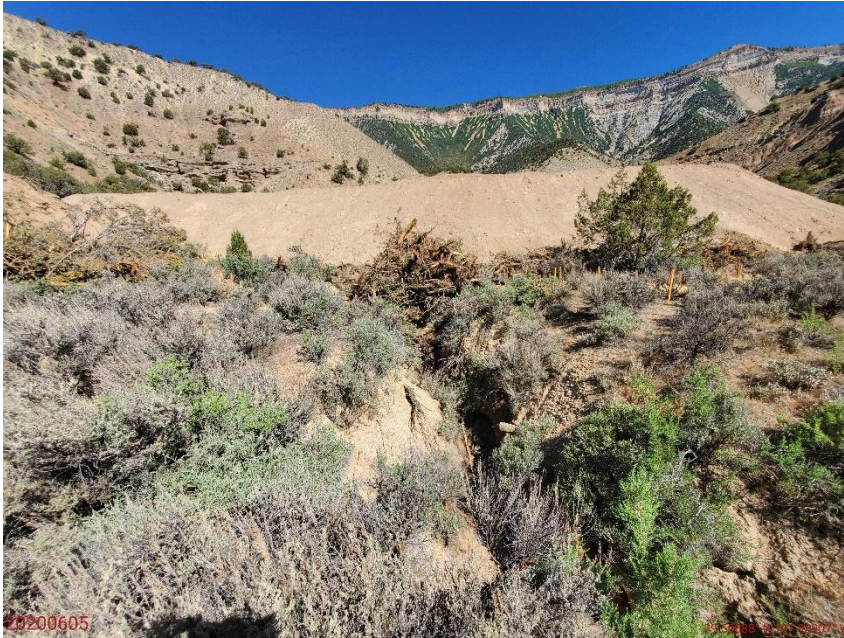
Photo 7: Photo taken from the south of the Location, facing north. Photo shows Operator appears to have placed/piled woody vegetation on the south end of the pad, and next to the soil stockpile. This is considered debris and needs to be properly removed/disposed.

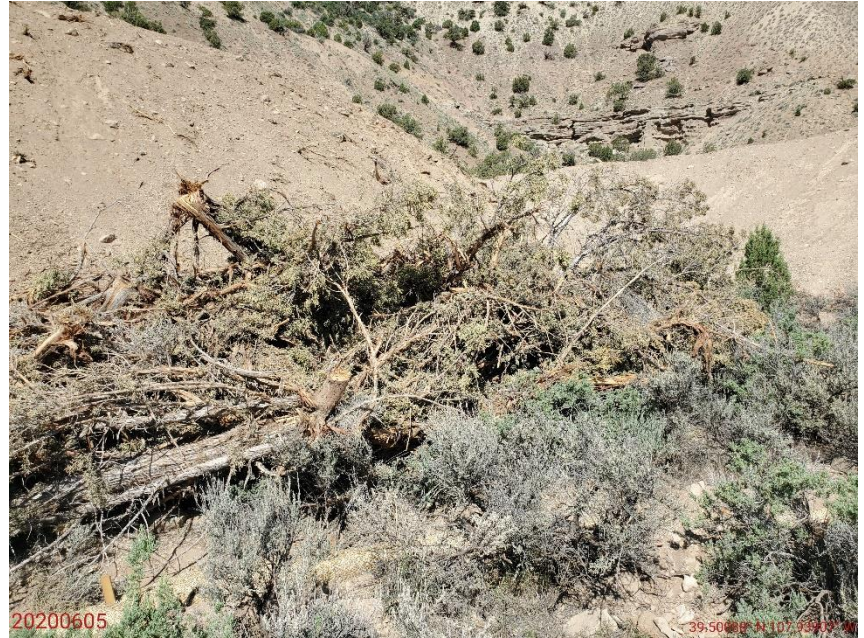
Photo 8: See comments under photo 7.

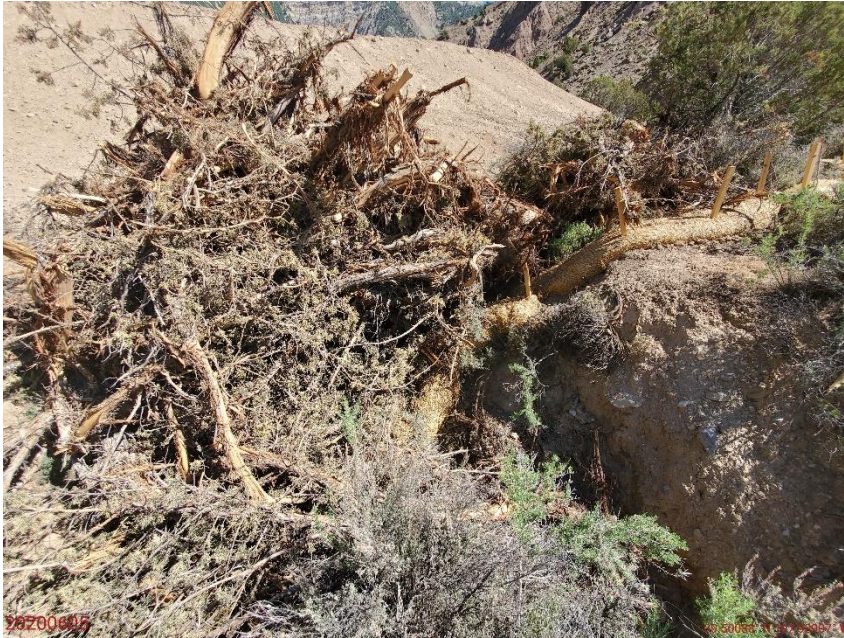
Photo 9: See comments under photo 7.

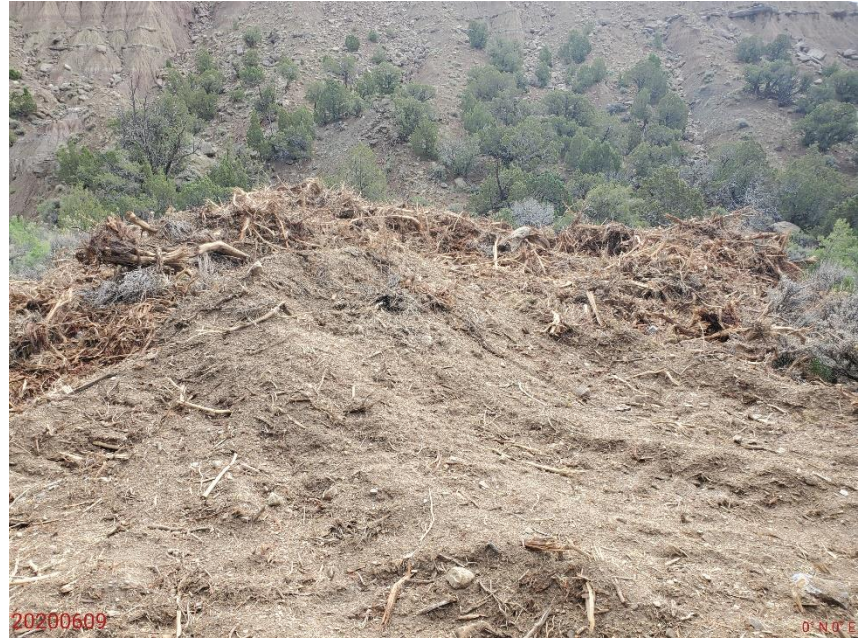
Photo 10: Photo taken from the north of the Location, facing east. shows Operator appears to have placed/piled woody vegetation north the pad. This is considered debris and needs to be properly removed/disposed. Photo also shows disturbance due to Operator's activities. Areas will require reclamation.

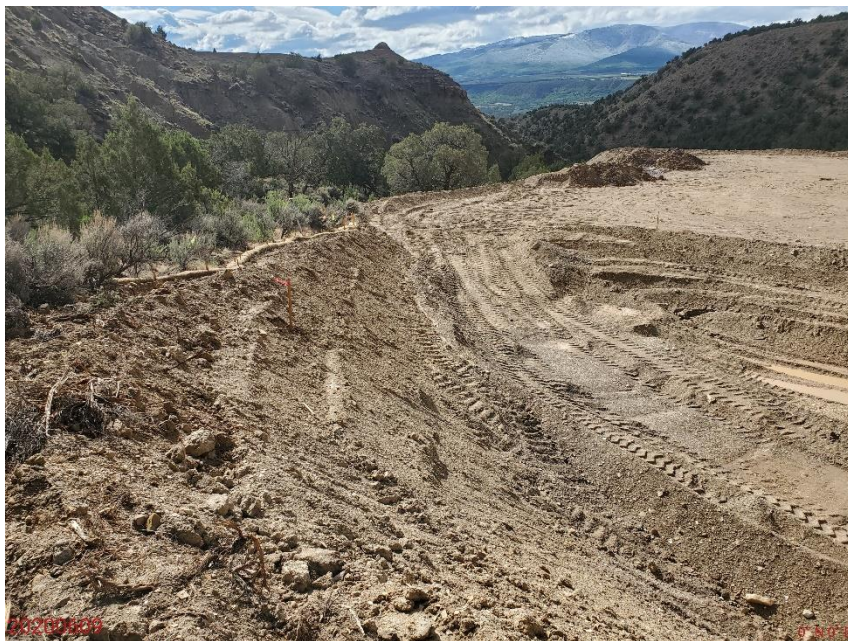
Photo 11: Photo taken from the northeast end of the Location, facing south. Photos 11-13 provide an overview of the Location from south, southwest to west.

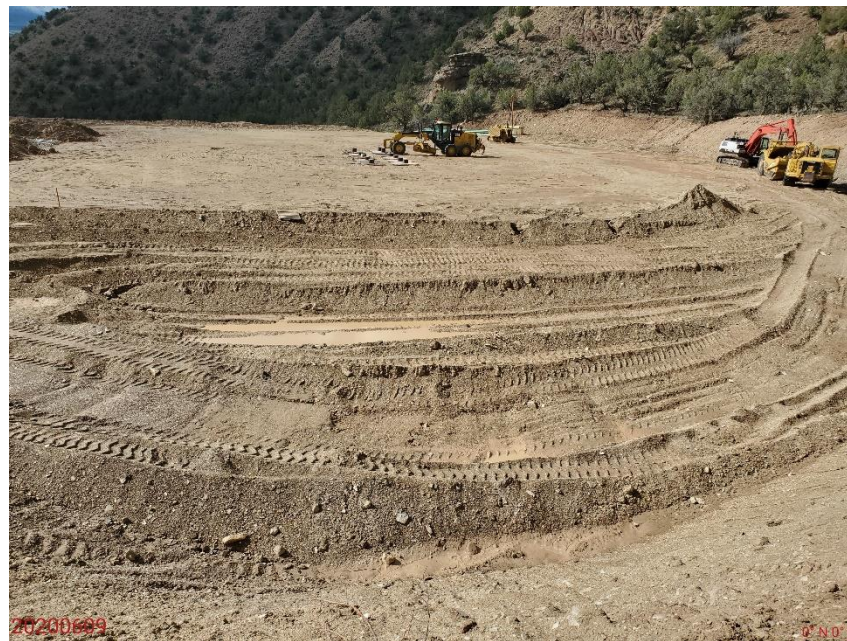
Photo 12: See comments under photo 11.

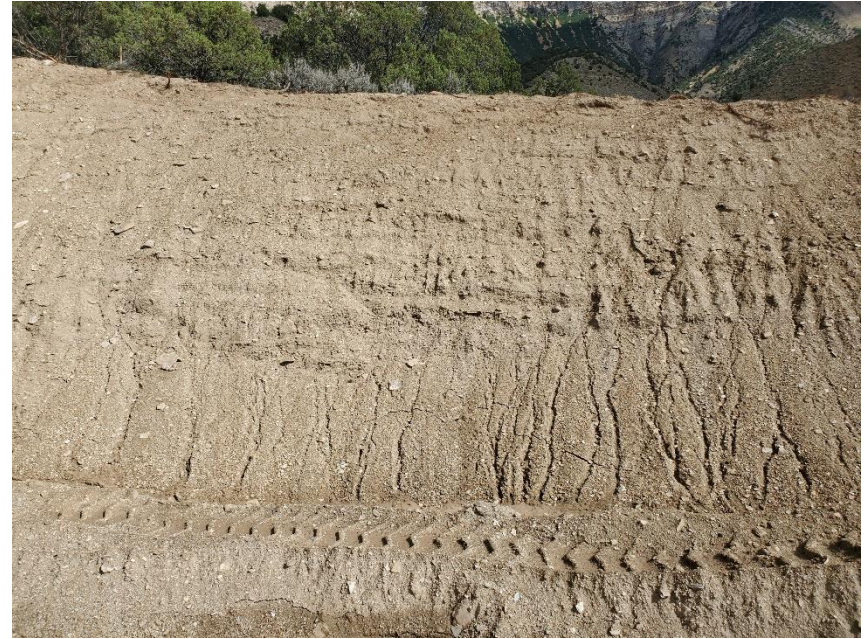
Photo 14: Photo taken from the north end of the Location, facing north. Photo shows soils on cut slopes. BMPs to stabilize and protect slopes appear insufficient or missing; Erosion degradation evident.

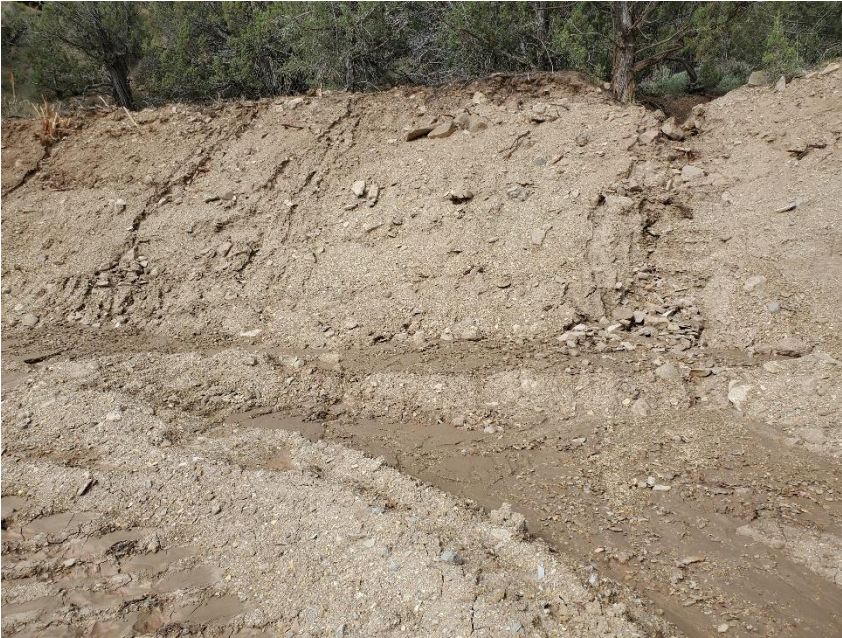
Photo 15: Photo taken from the west end o the Location, facing west. Photo shows soils on cut slopes. BMPs to stabilize and protect slopes appear insufficient or missing; Erosion degradation evident.

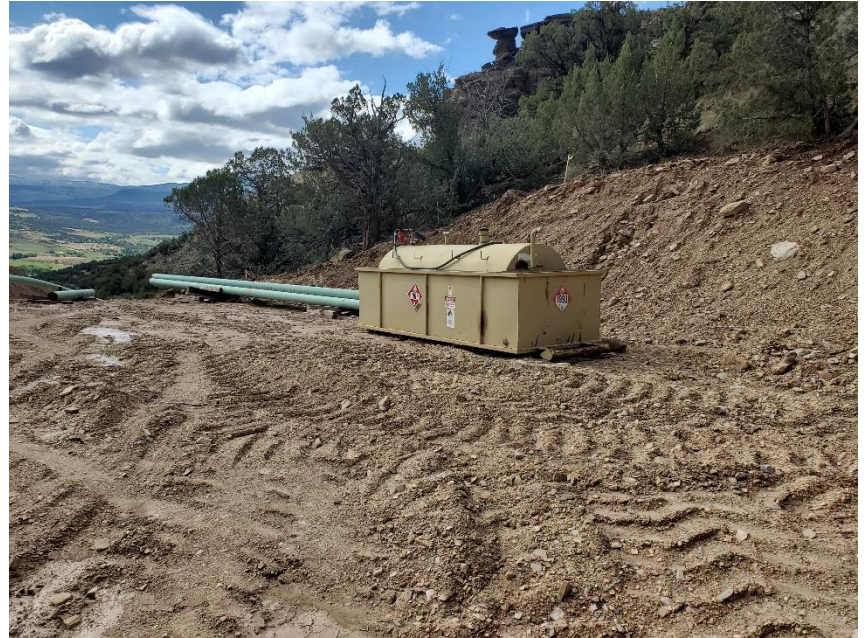
Photo 16: Photo shows fuel container in proper containment.

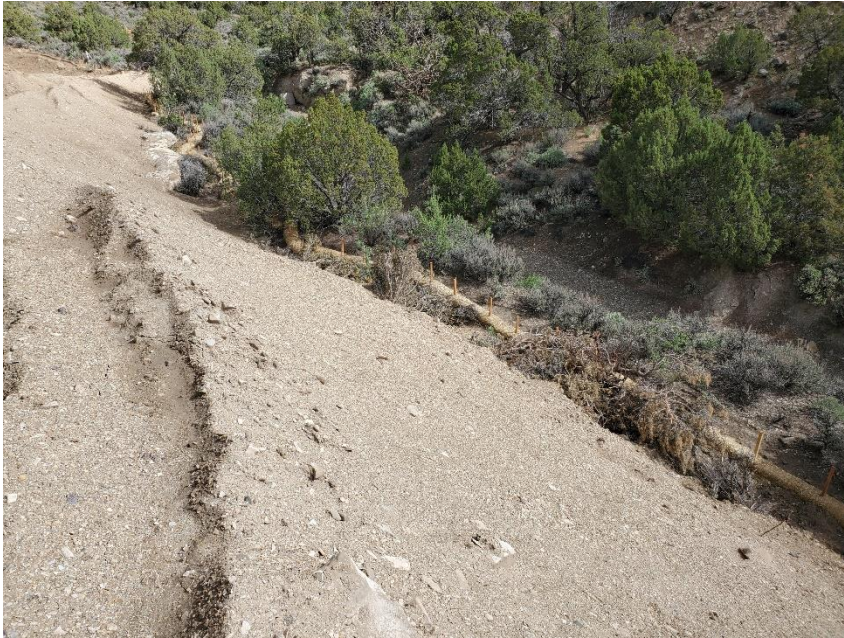
Photo 17: Photo taken from the east end of the Location, facing north. Photo shows soils on the fill slopes. BMPs to stabilize and protect slopes appear insufficient or missing

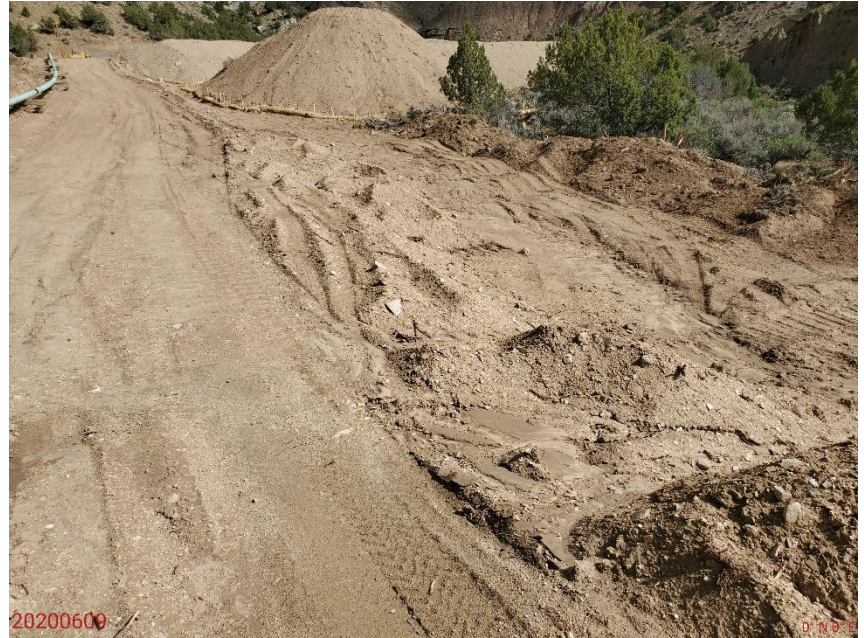
Photo 18: Photo taken from the access road, south of the Location. Photo shows area where stormwater runoff from the pad and access road concentrates and discharges.

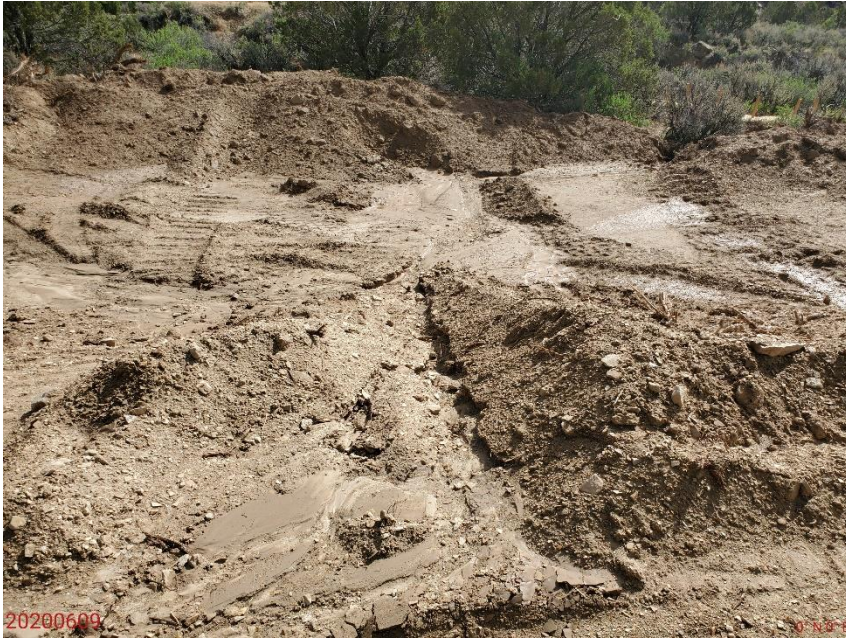
Photo 19: Continued from photo 18. Photo shows erosion degradation and sediment deposition.

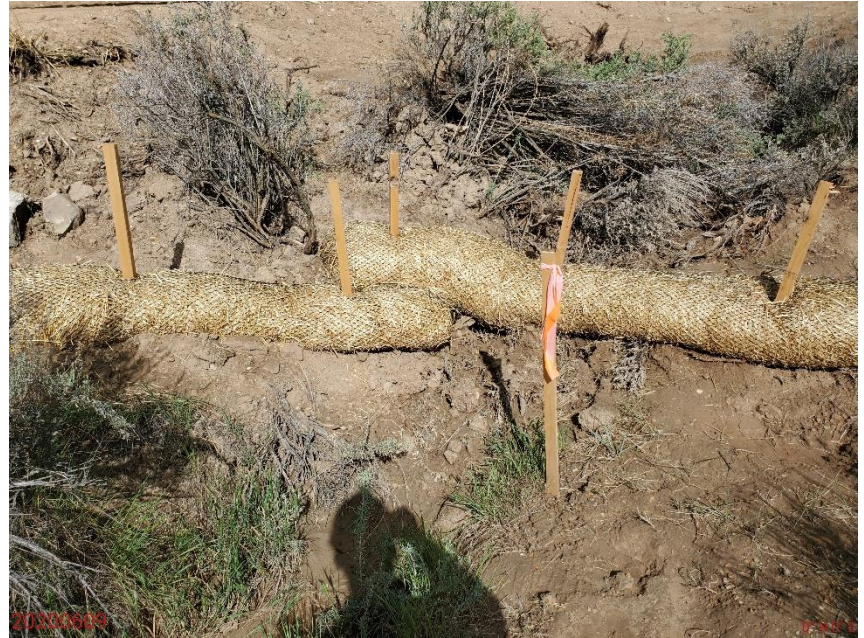
Photo 20: Continued from photo 18. Photo shows point where stormwater discharges. Photo shows that the Wattle BMP is not in proper functioning condition; Stormwater appears to have cut under the wattle resulting and erosion degradation and off-site sediment discharge.

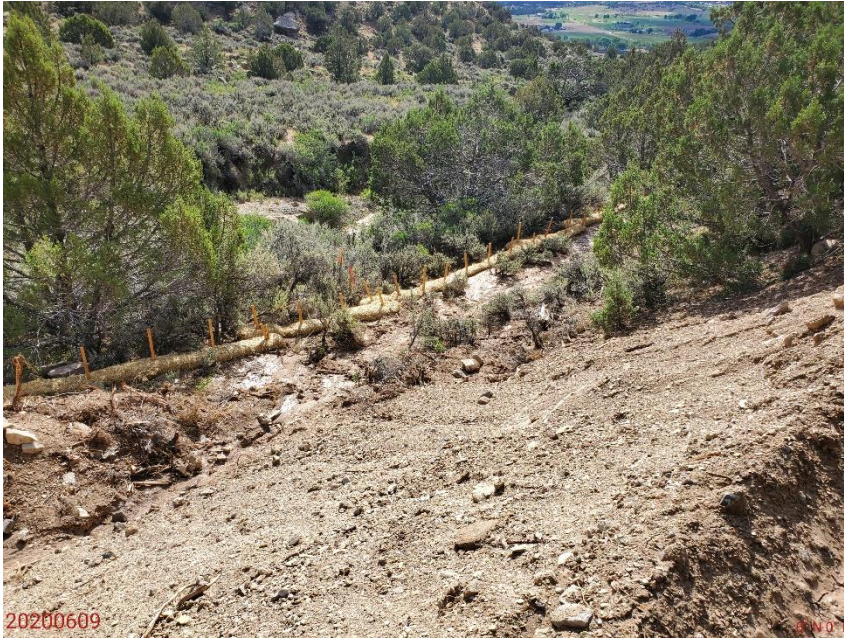
Photo 21: Photo taken from the access road, facing southwest. Photo shows areas where sediment deposition has begun filling the wattle BMPs. Advised maintenance prior to BMP failure.

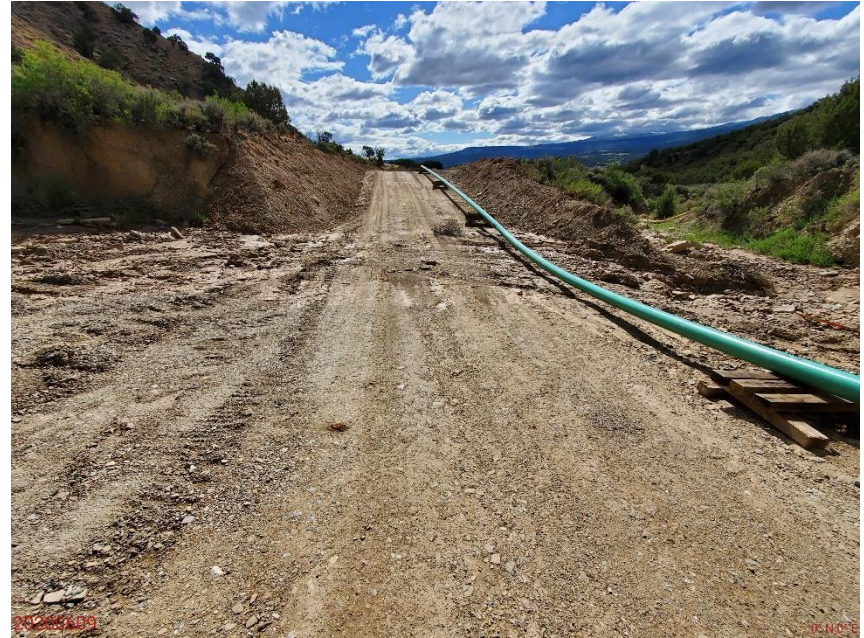
Photo 22: Photo taken from where access road crosses drainage. Photo shows BMPs to stabilize access road appear missing or insufficient.
