**Inspection Photos**  
**Location Name: Sack #1**  
**Location ID:319867**

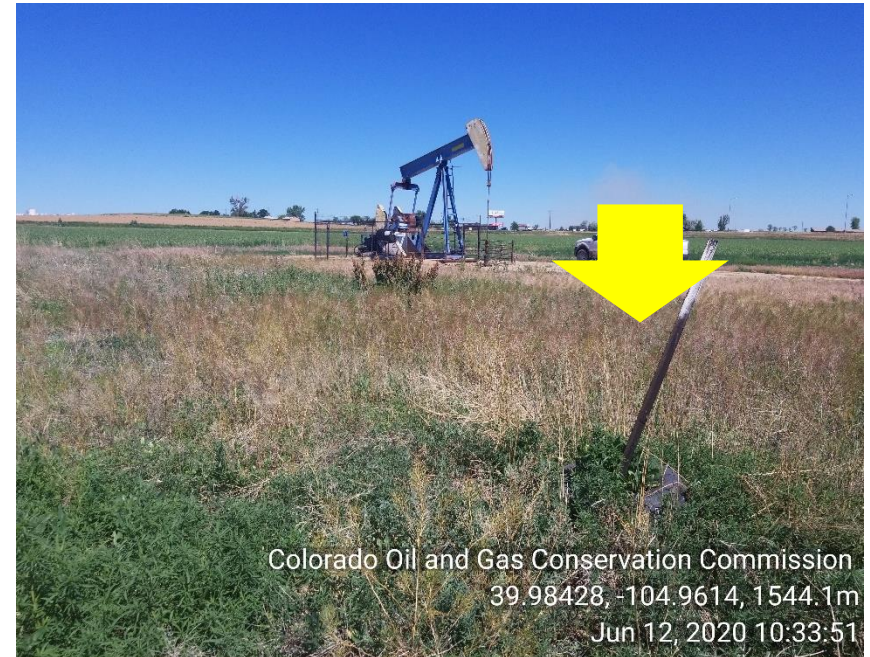
**Photo 2 Weeds on location and gut line anchor not properly marked**

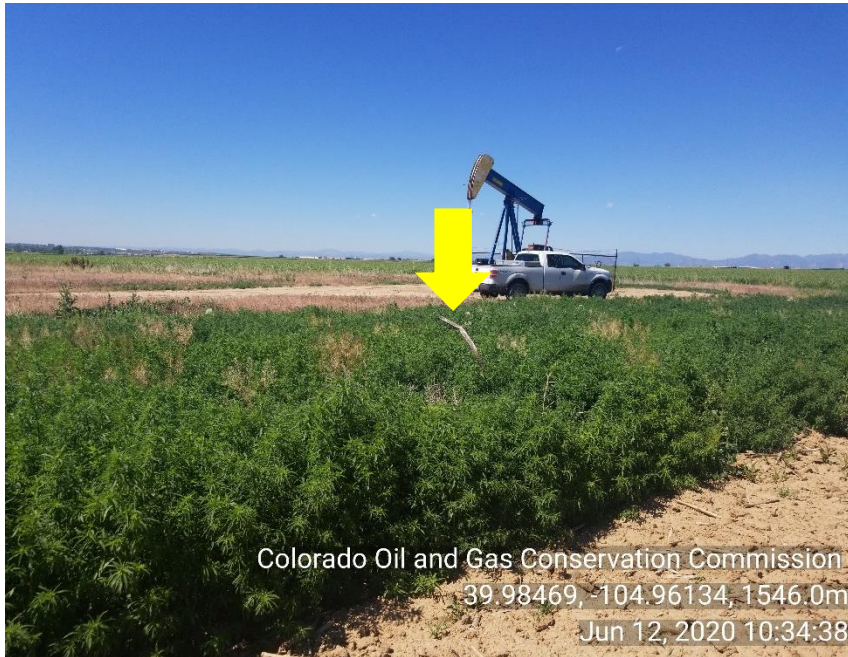
**Photo 3 Weeds on location and gut line anchor not properly marked**

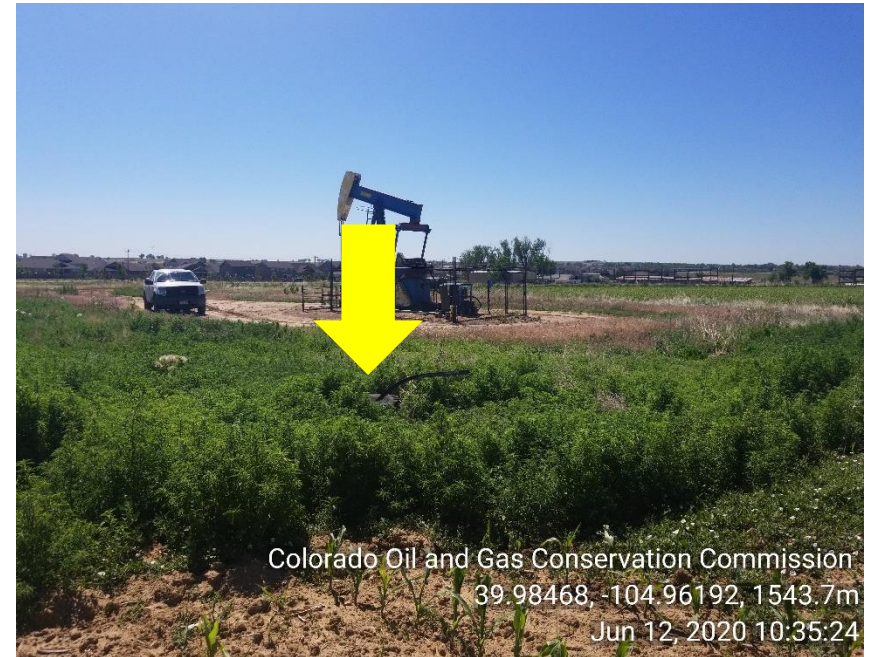
**Photo 4 Weeds on location and gut line anchor not properly marked**

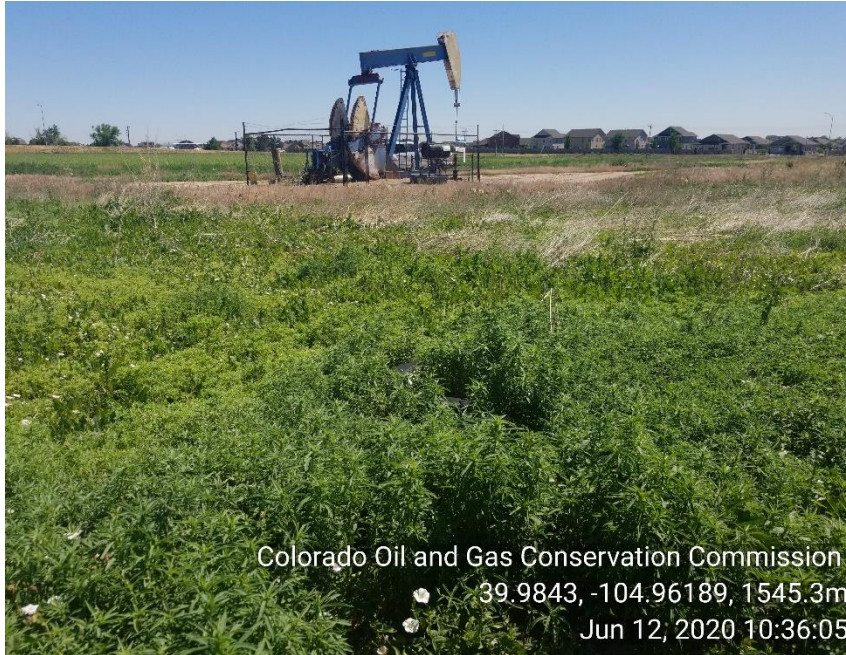
**Photo 5 Weeds on location and gut line anchor not properly marked**

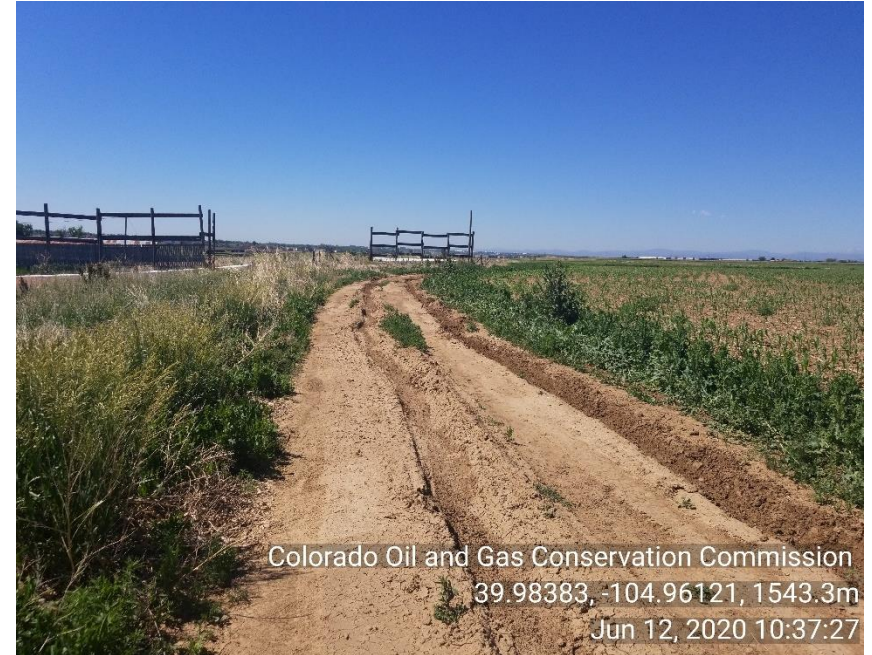
**Photo 6 Weeds along road access and deep ruts in road no proper BMP's**

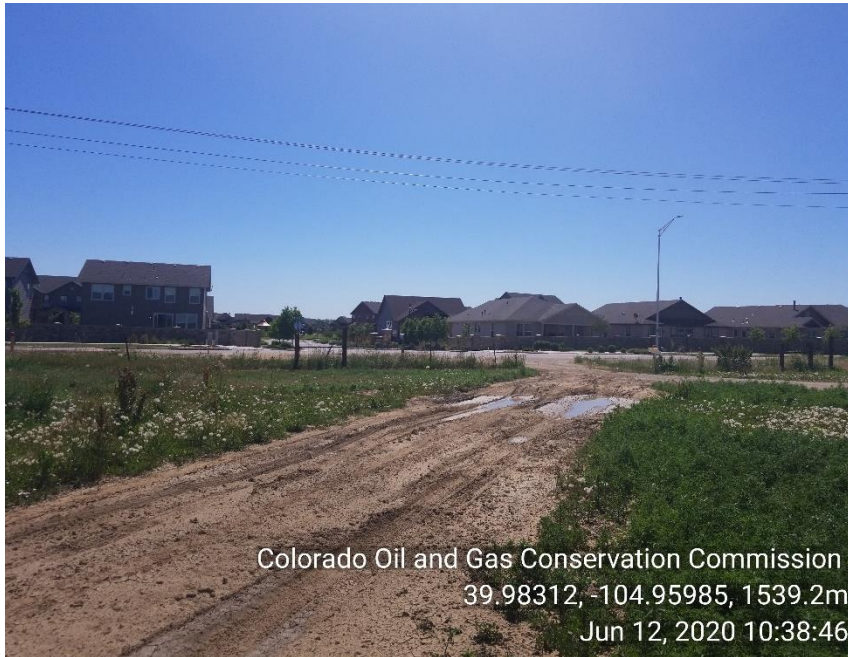
**Photo 7 no tracking pad on lease road entrance . Deep ruts on access road no proper BMP's**

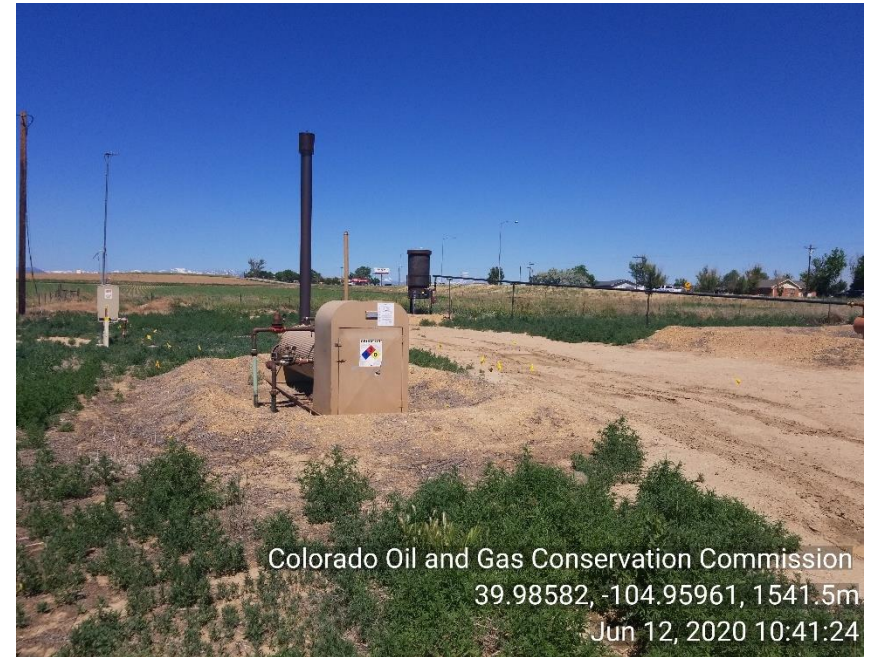
**Photo 8 Weeds on location.**

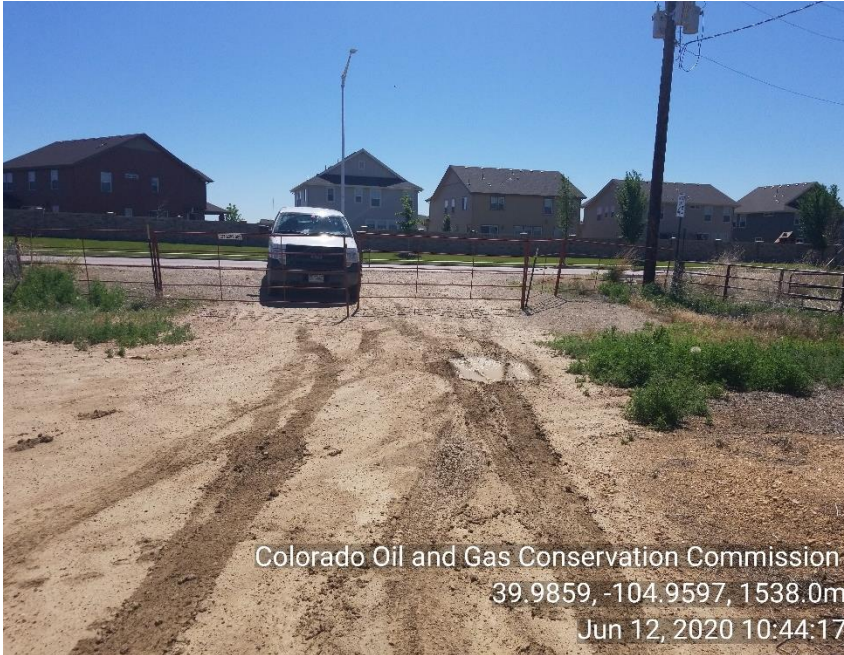
**Photo 11 no tracking pad to entrance to production facility from York street.**

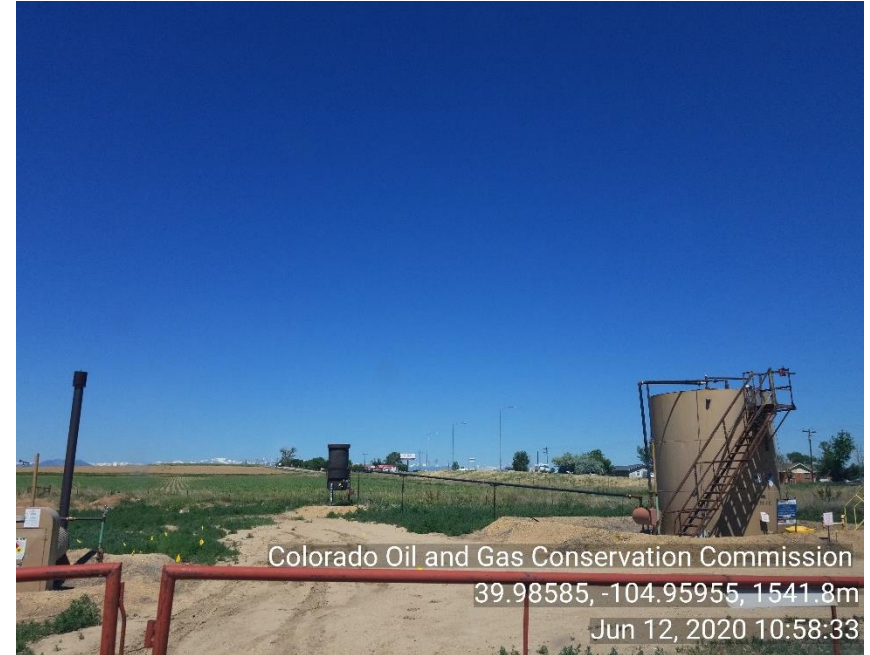
**Photo 12 New 3in line ran from production tank to ECD**
