**Inspection Photos**  
**Operator: Catamount Energy**  
**API#: 067-07336**  
**Date: 6/11/2020**

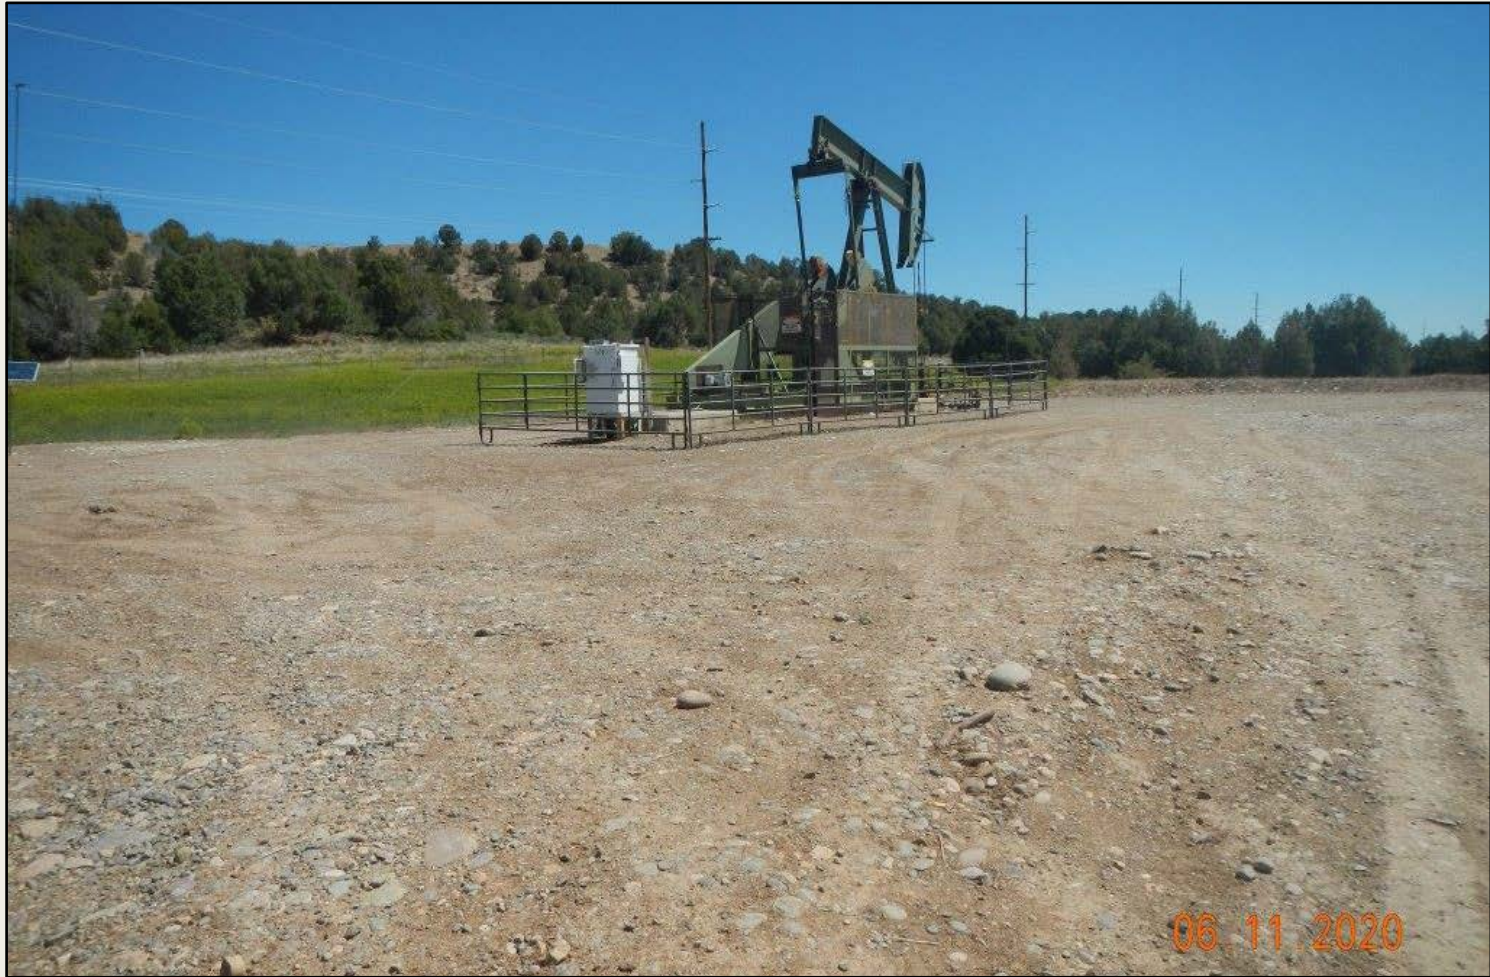
Photo 1. View of the project area from the well pad entrance facing center.

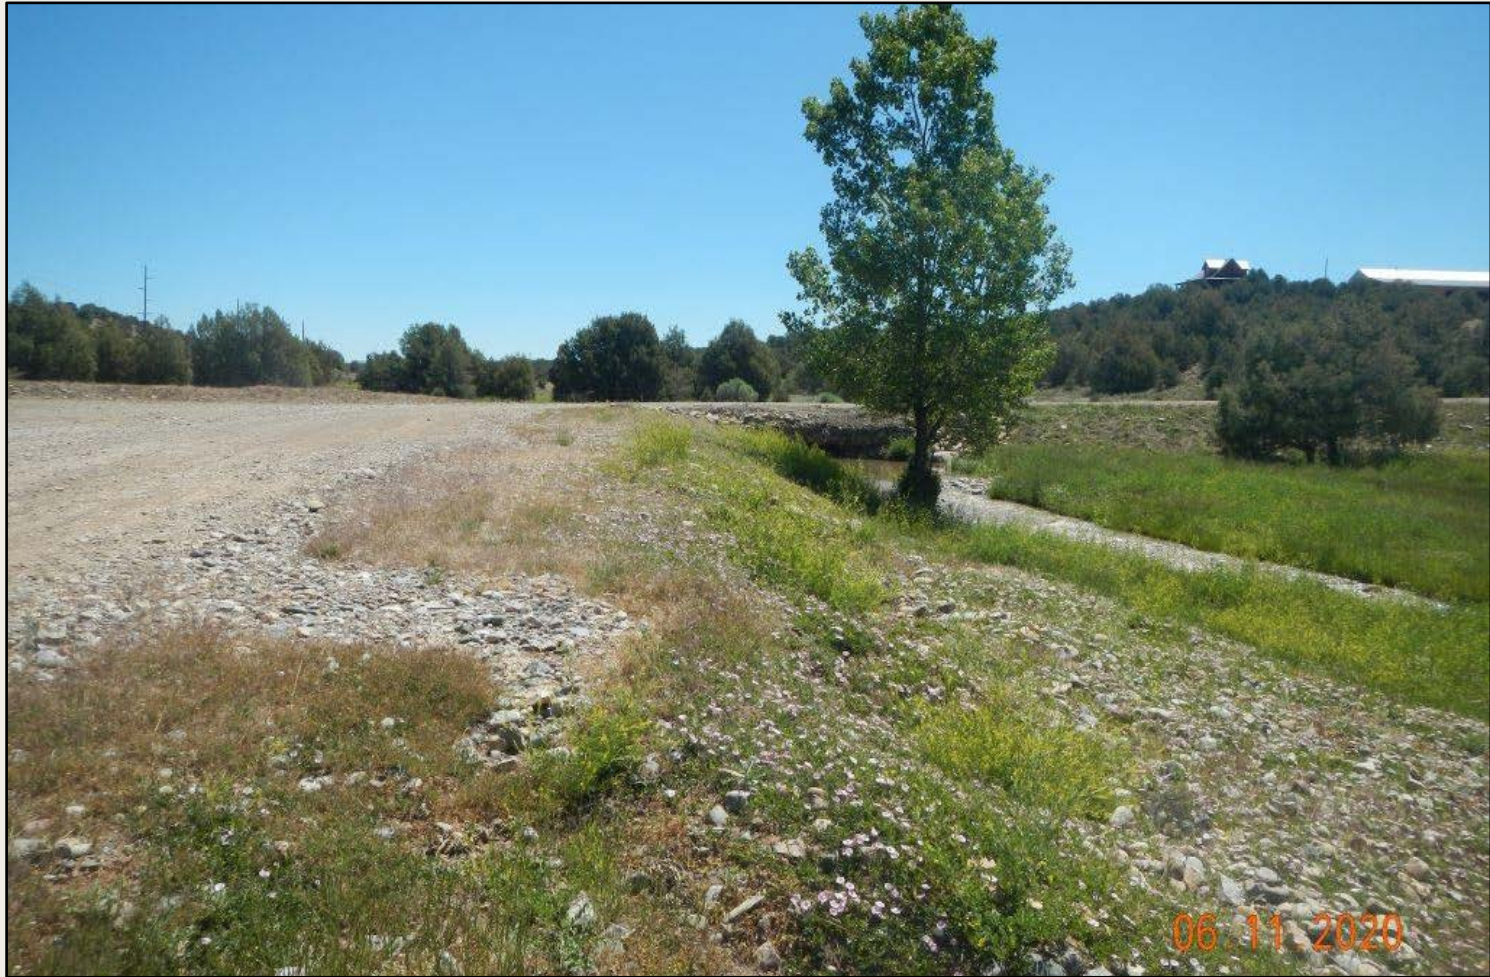
Photo 2. View of the southern project area from the southwestern corner facing eastward. Revegetation is progressing on cobbles, although weedy, with irrigated pasture grasses and yellow sweetclover.

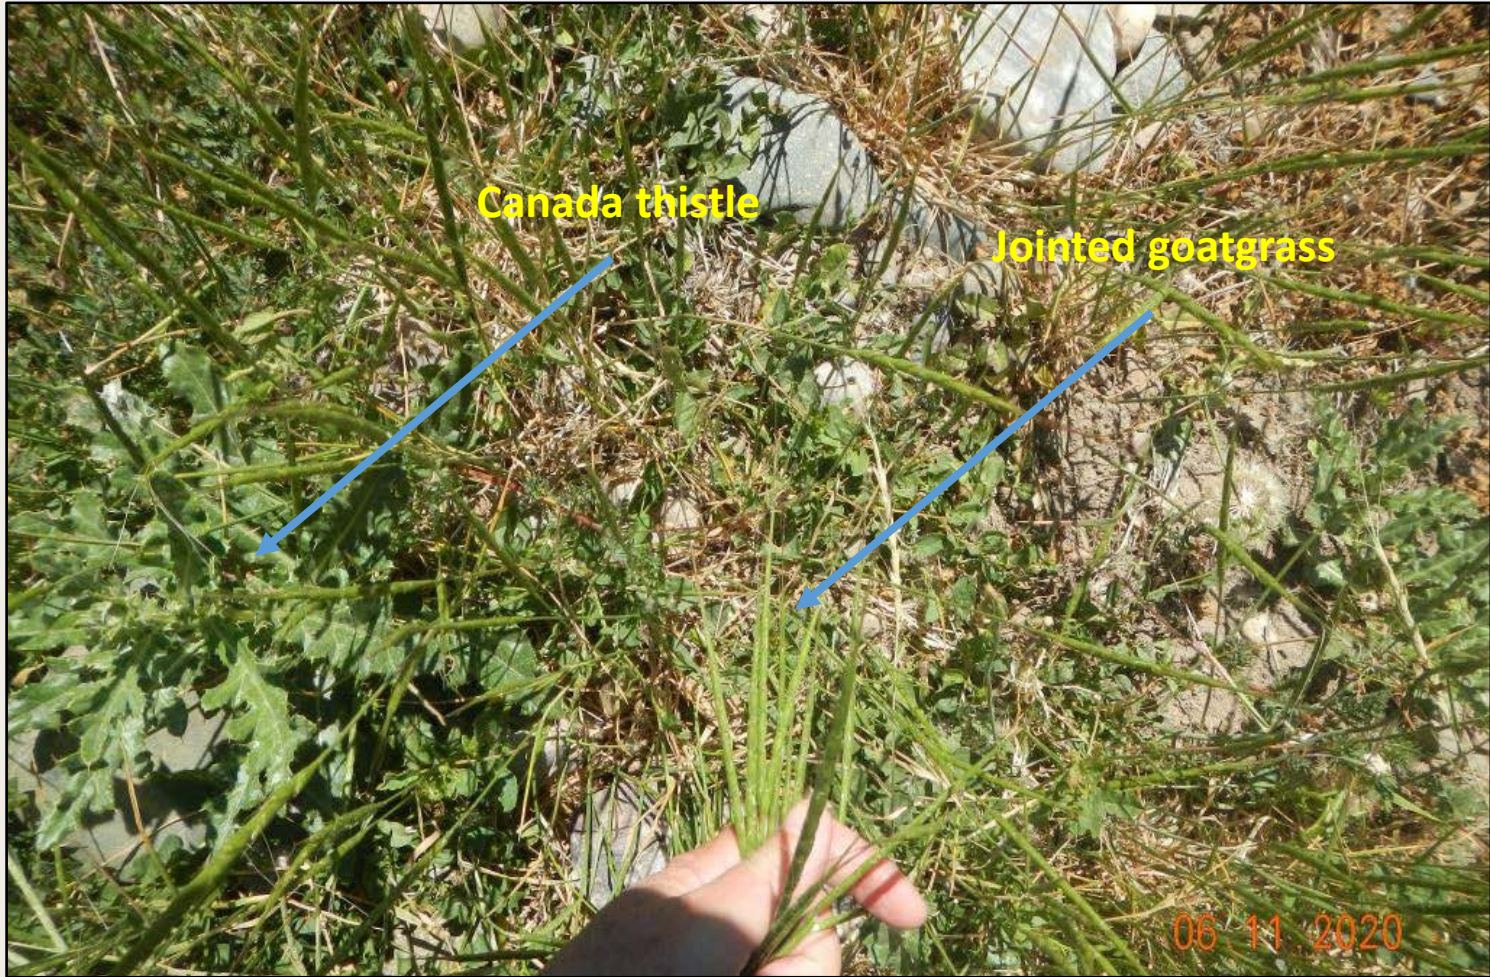
Photo 3. View of jointed goatgrass (approx. 300) and Canada thistles (approx. 75), two noxious weeds that need to be treated within the southern project area.

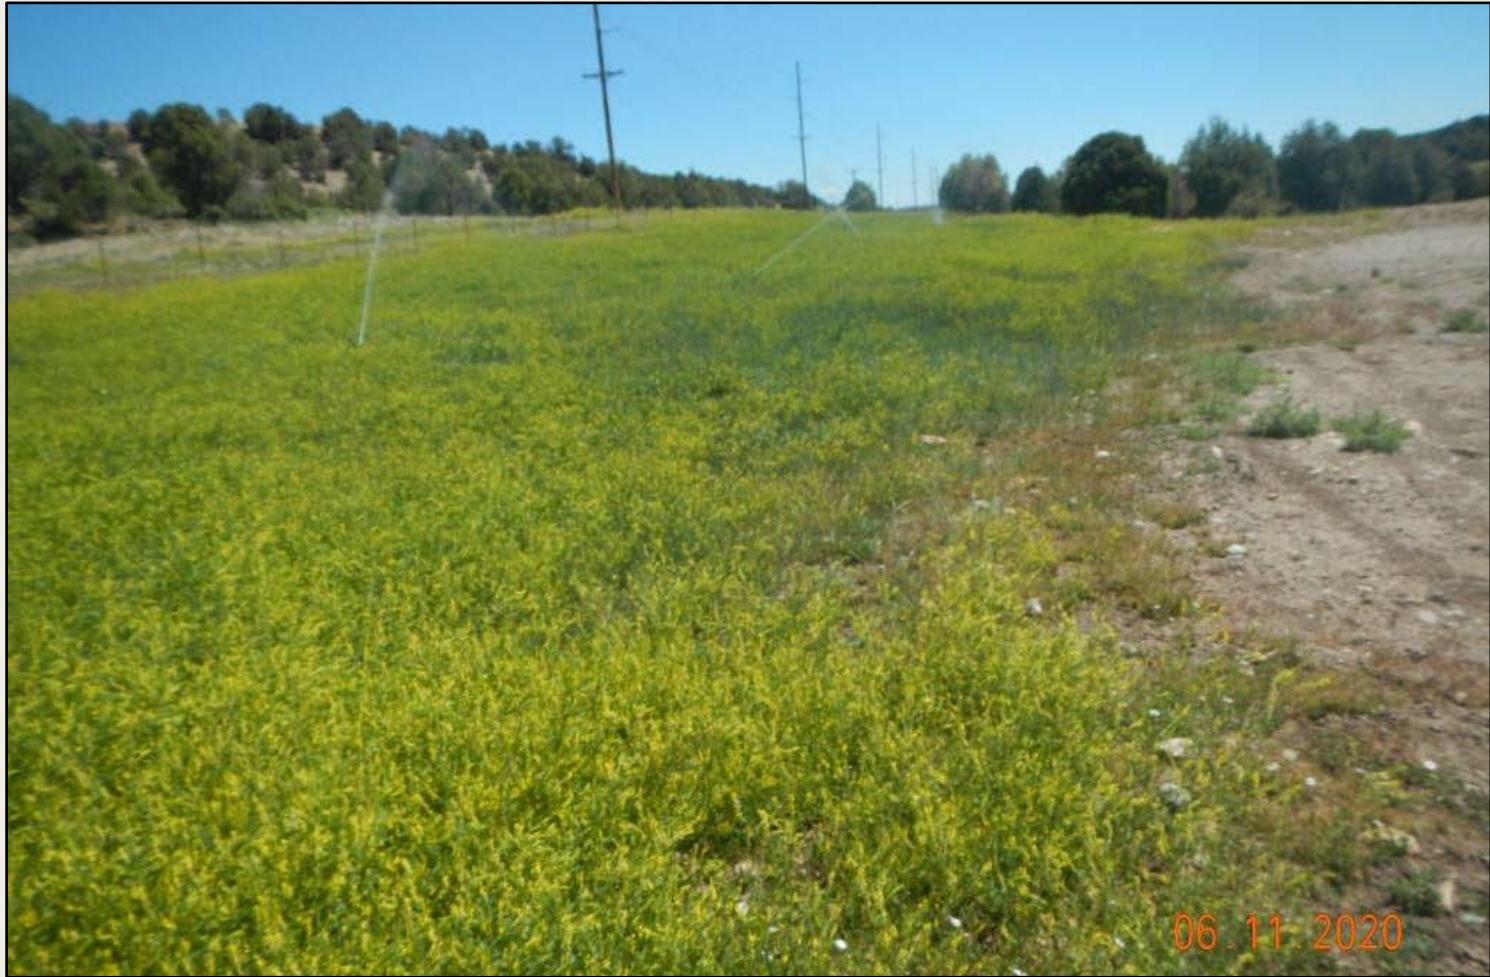
Photo 4. View of the northern project area from the northwestern corner facing eastward. Revegetation is irrigated and appears to be progressing similar to the reference area.

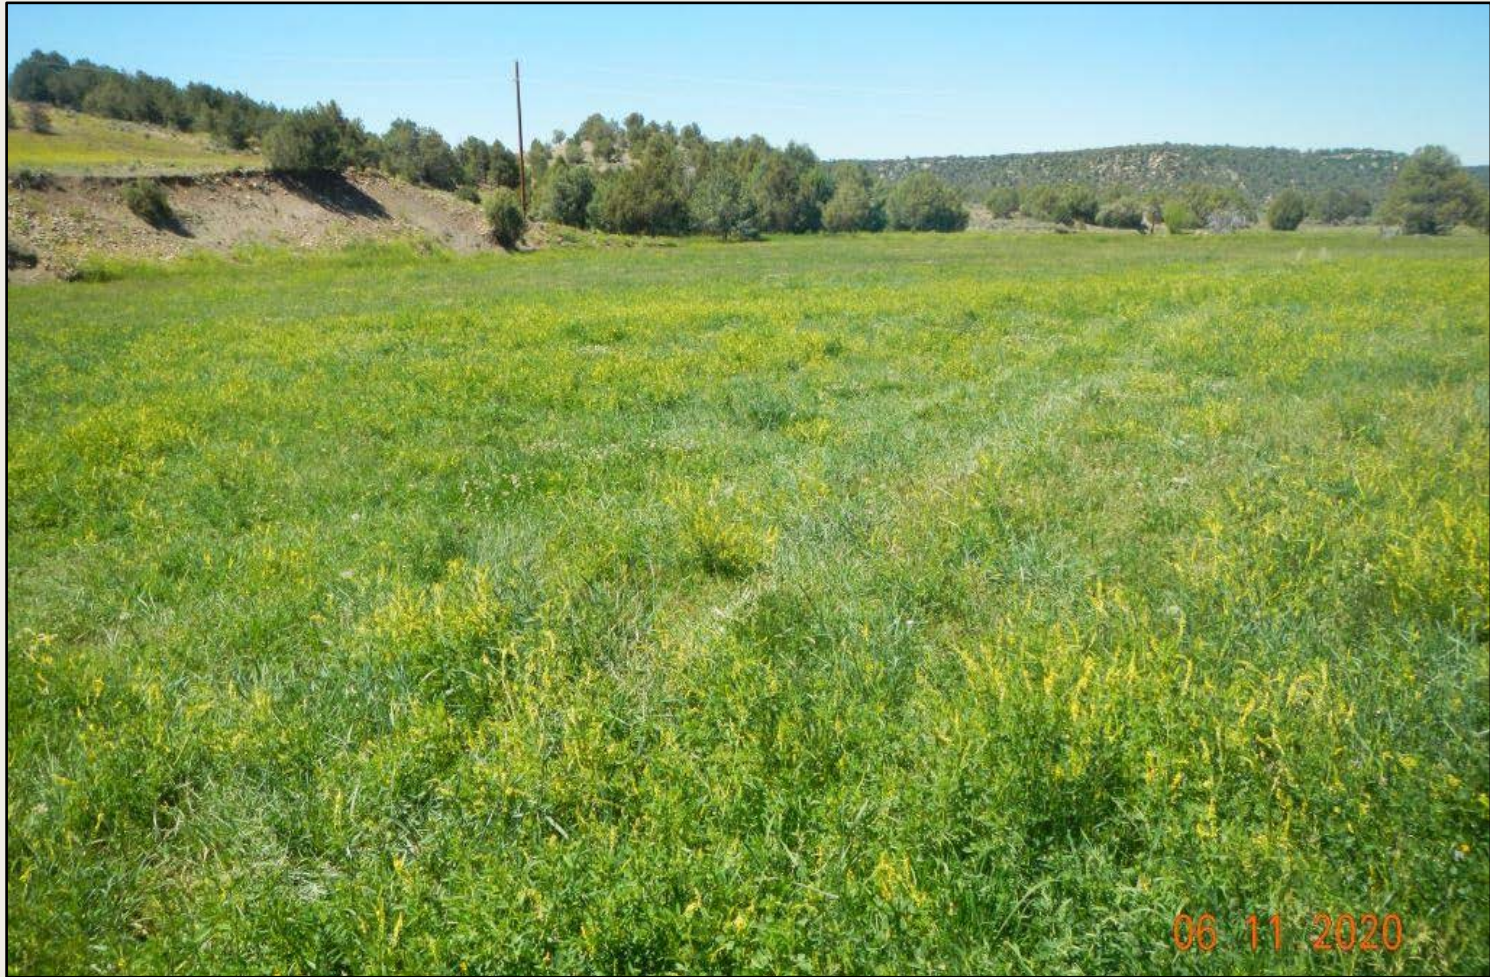
Photo 5. View of reference area comprised of irrigated field, with grasses such as orchard grass, tall fescue, and forbs such as yellow sweetclover.
