Inspection Photos

Operator: Merrion Oil and Gas
API: 067-06119
Date: 6/11/2020

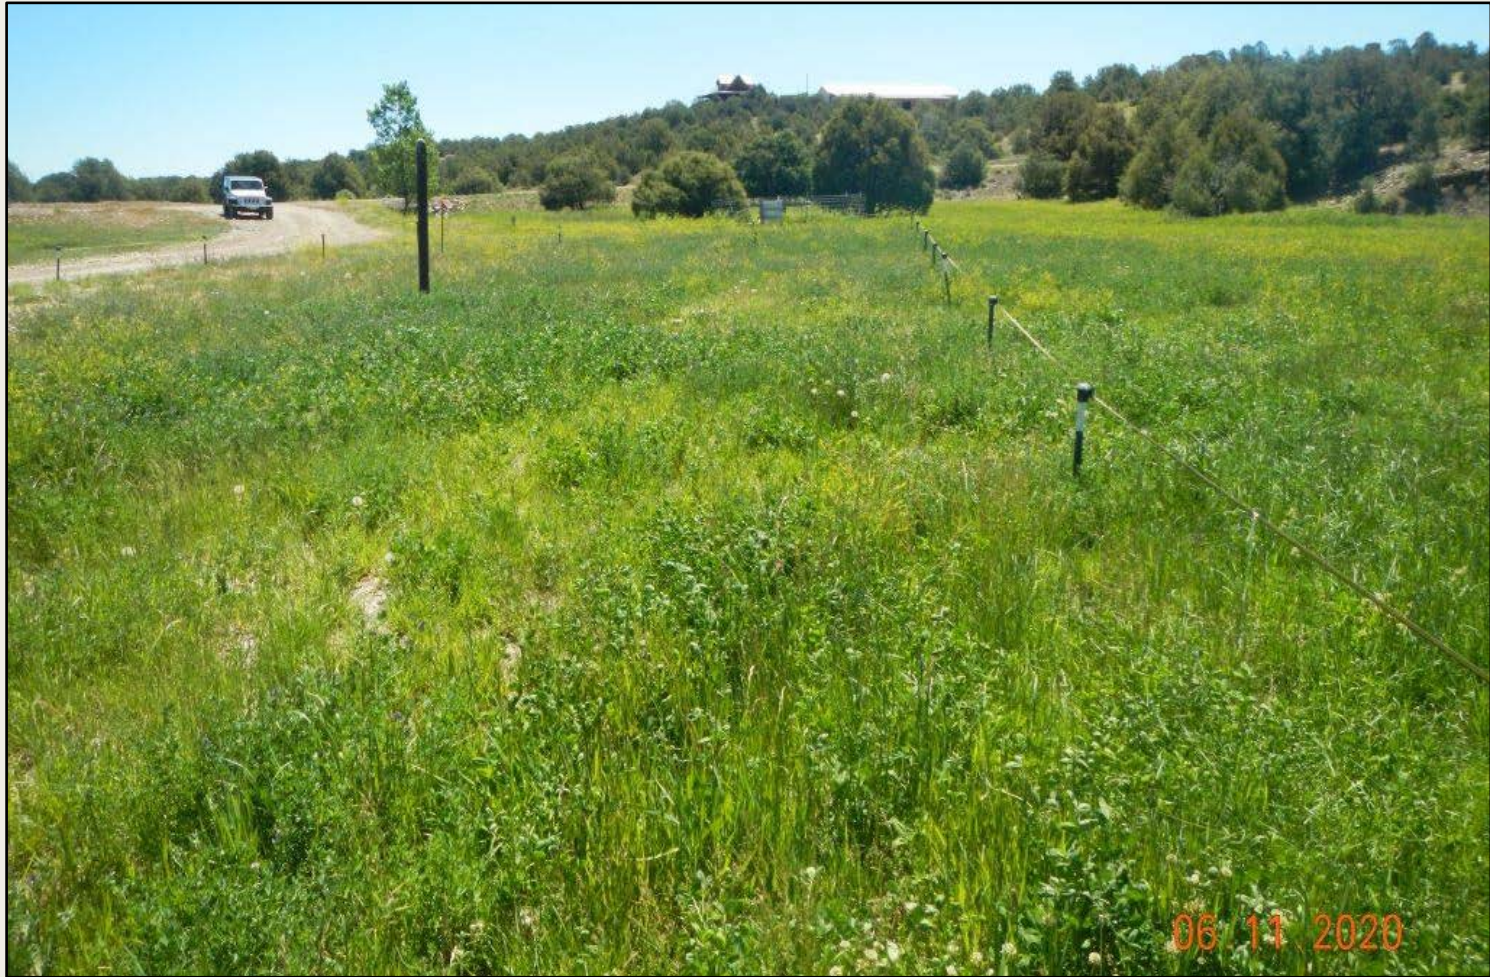
Photo 1. View of the project area from the northwestern corner facing southeastward. Revegetation within the western project area is approximately the same as surrounding reference area.

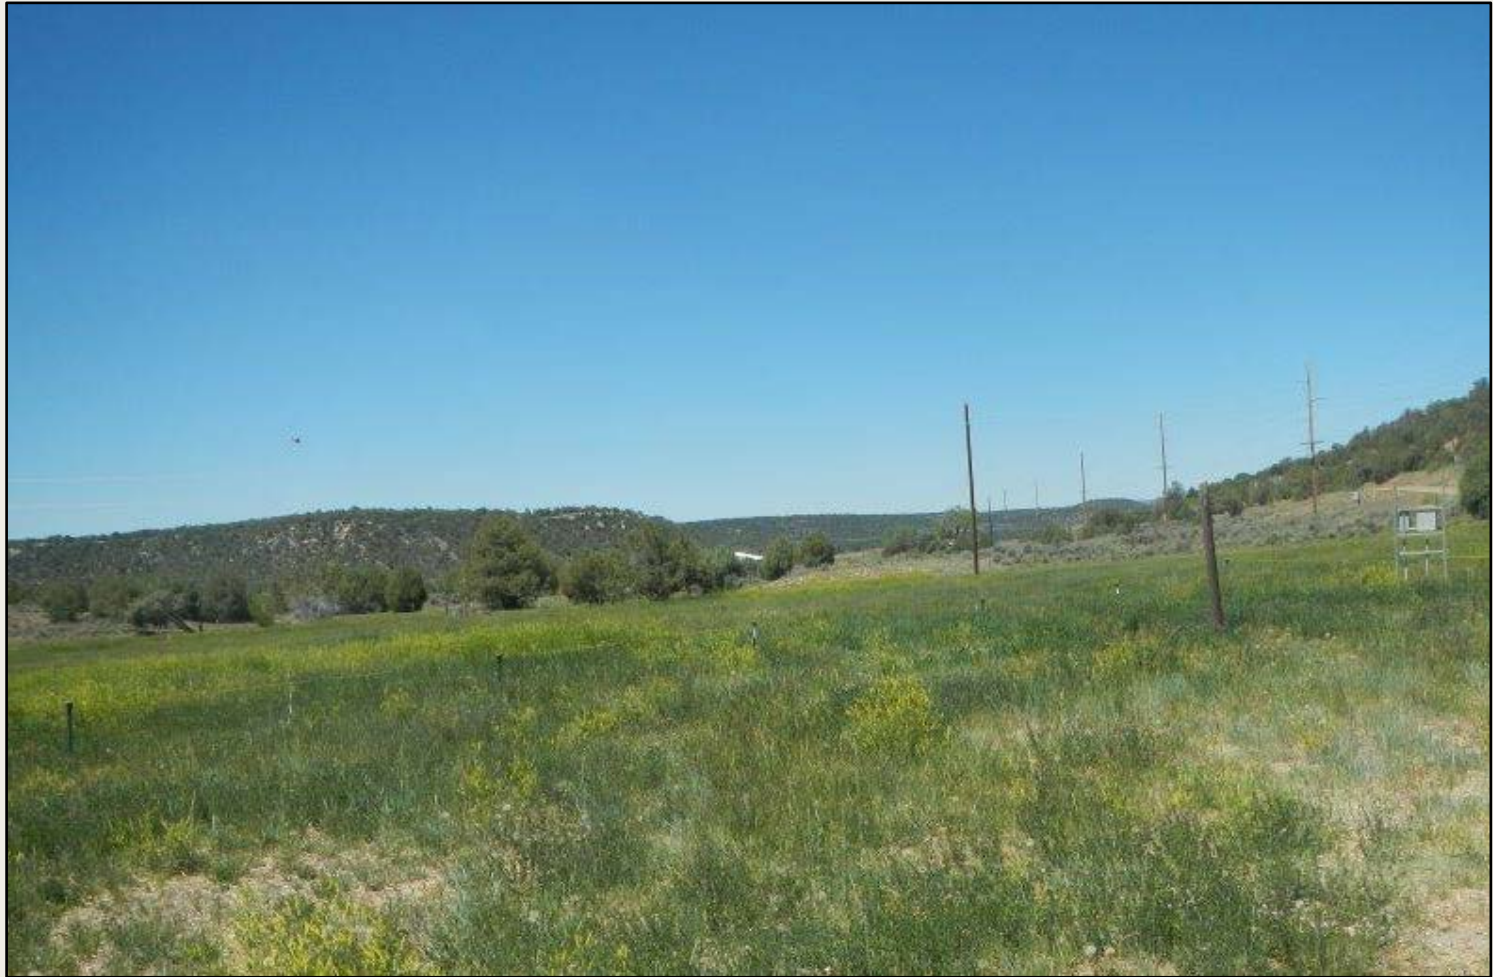
Photo 2. View of the project area from the southeastern corner facing northwestward. Revegetation in the eastern portion is more sparse than western project area, but appears to be approaching reclamation 80 percent of reference area standard.

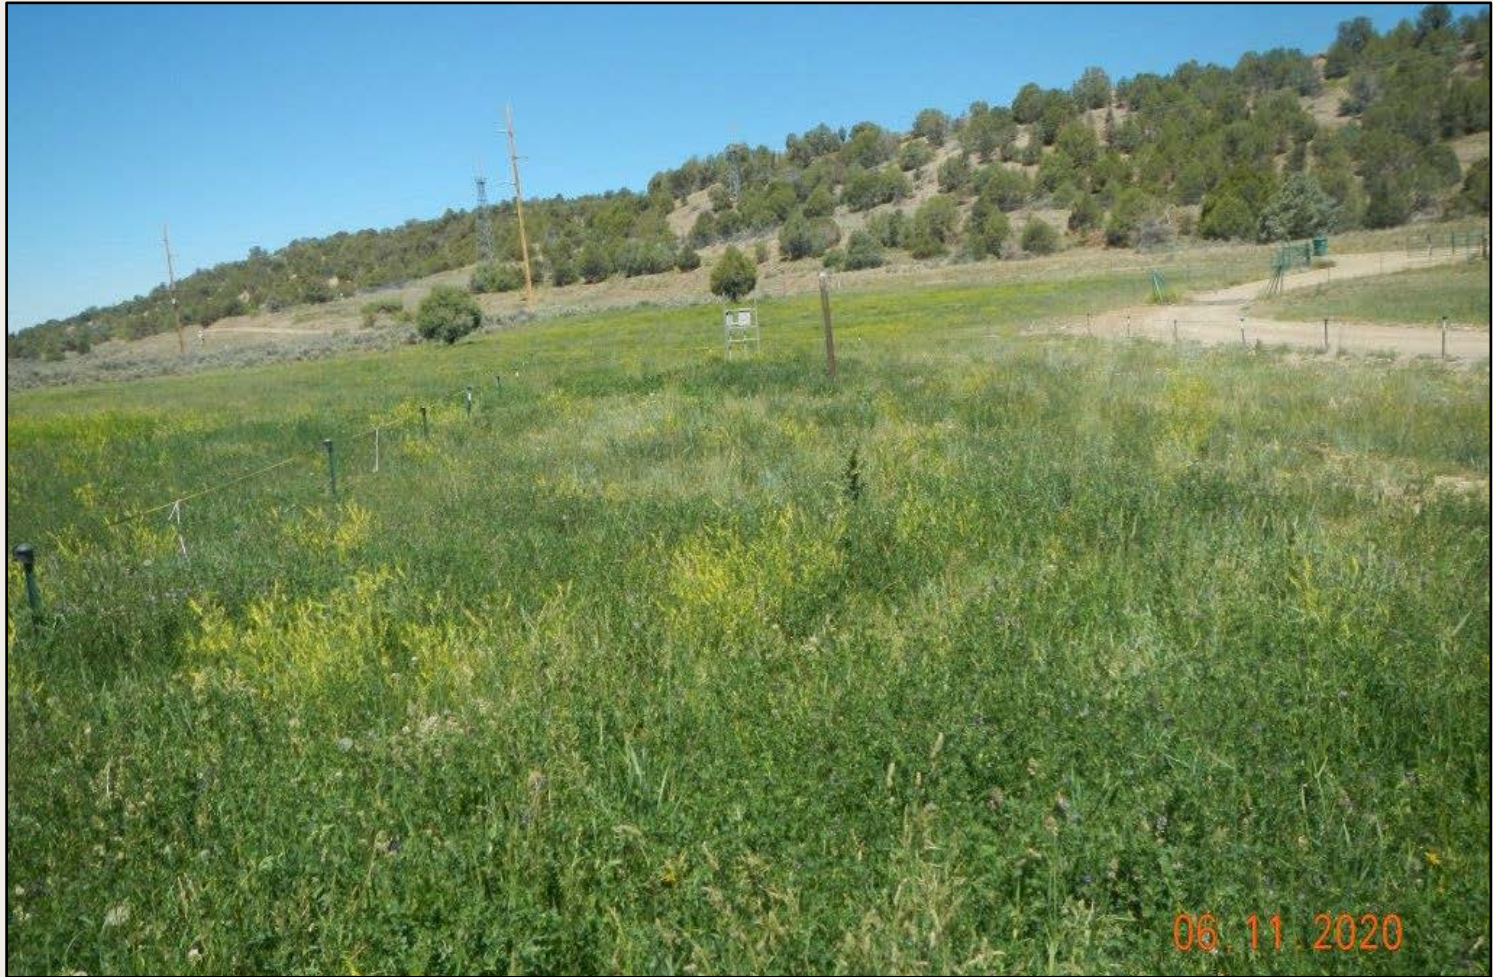
Photo 3. View of the project area from the southern edge facing northward. Revegetation is progressing with grasses and forbs similar to the reference area, irrigated field, with orchard grass, alfalfa, and yellow sweetclover.
