# Inspection Photos

API: 05-055-06037

Operator: OXY USA INC

Inspection Date: 6/9/2020

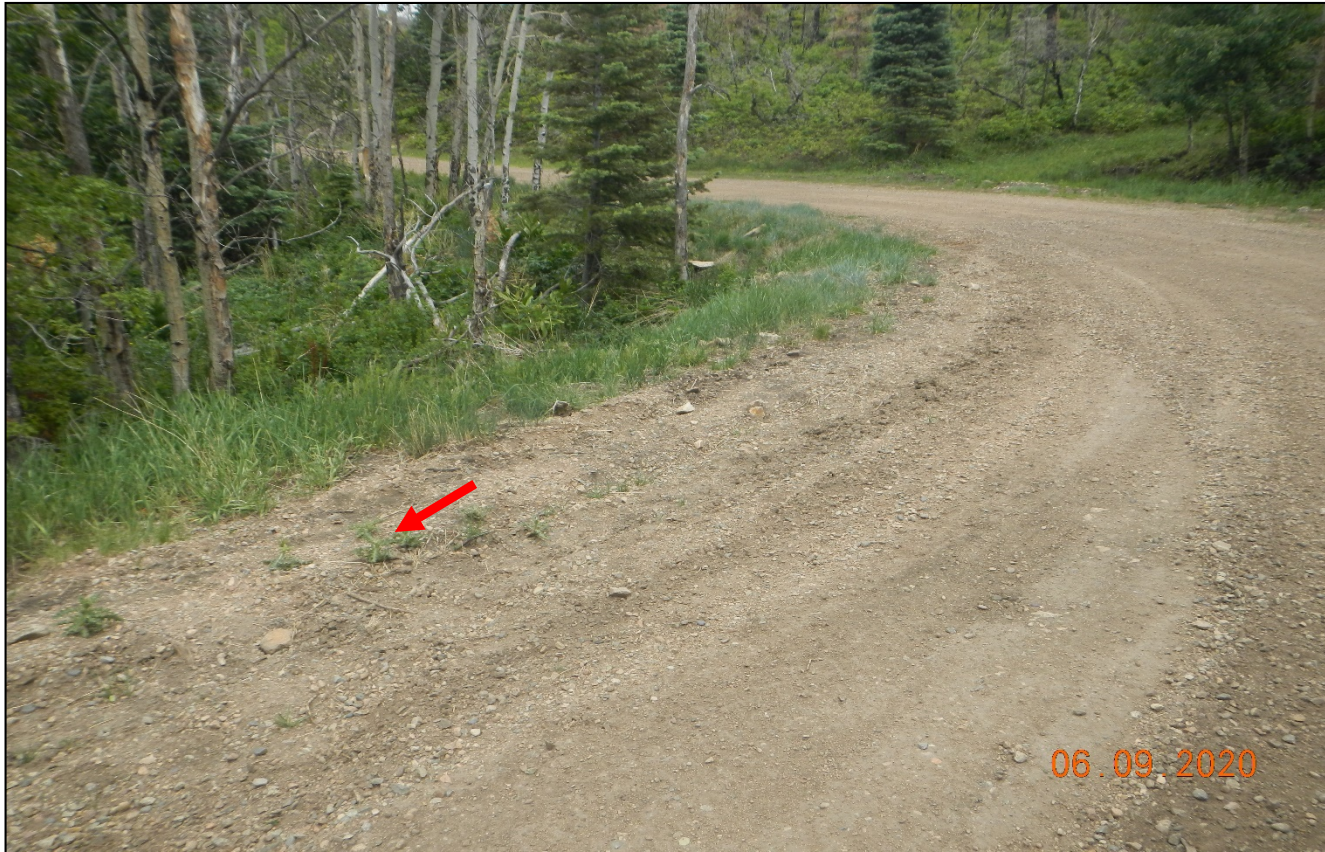
**Photo 1.** Facing toward the sharp turn in the road near the location. Noxious weeds were controlled in this area and are much less present. There are a few noxious weeds beginning to emerge so a follow up weed control should be performed.

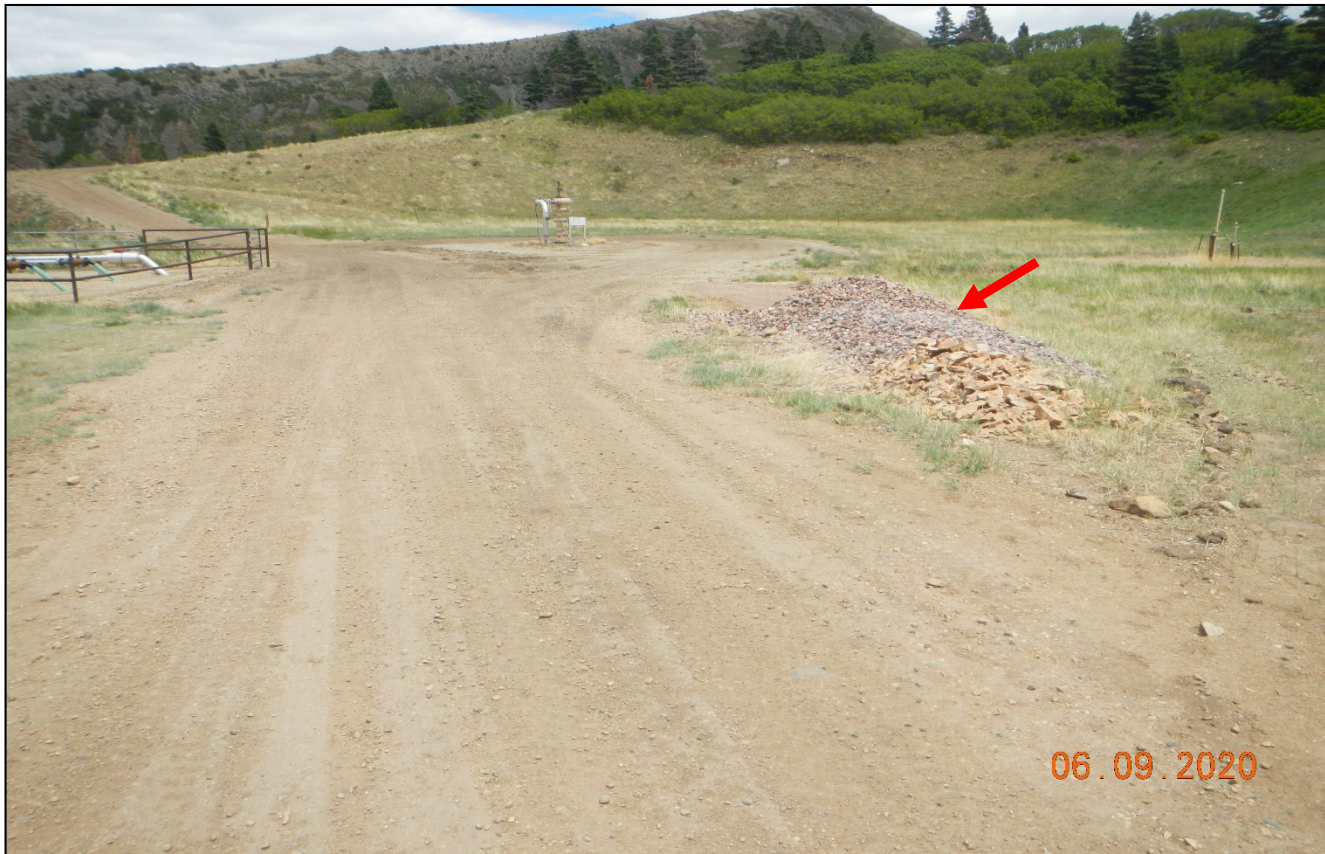
**Photo 2.** Facing east toward the location. A pile of rock debris is stored at the location and will need to be removed.

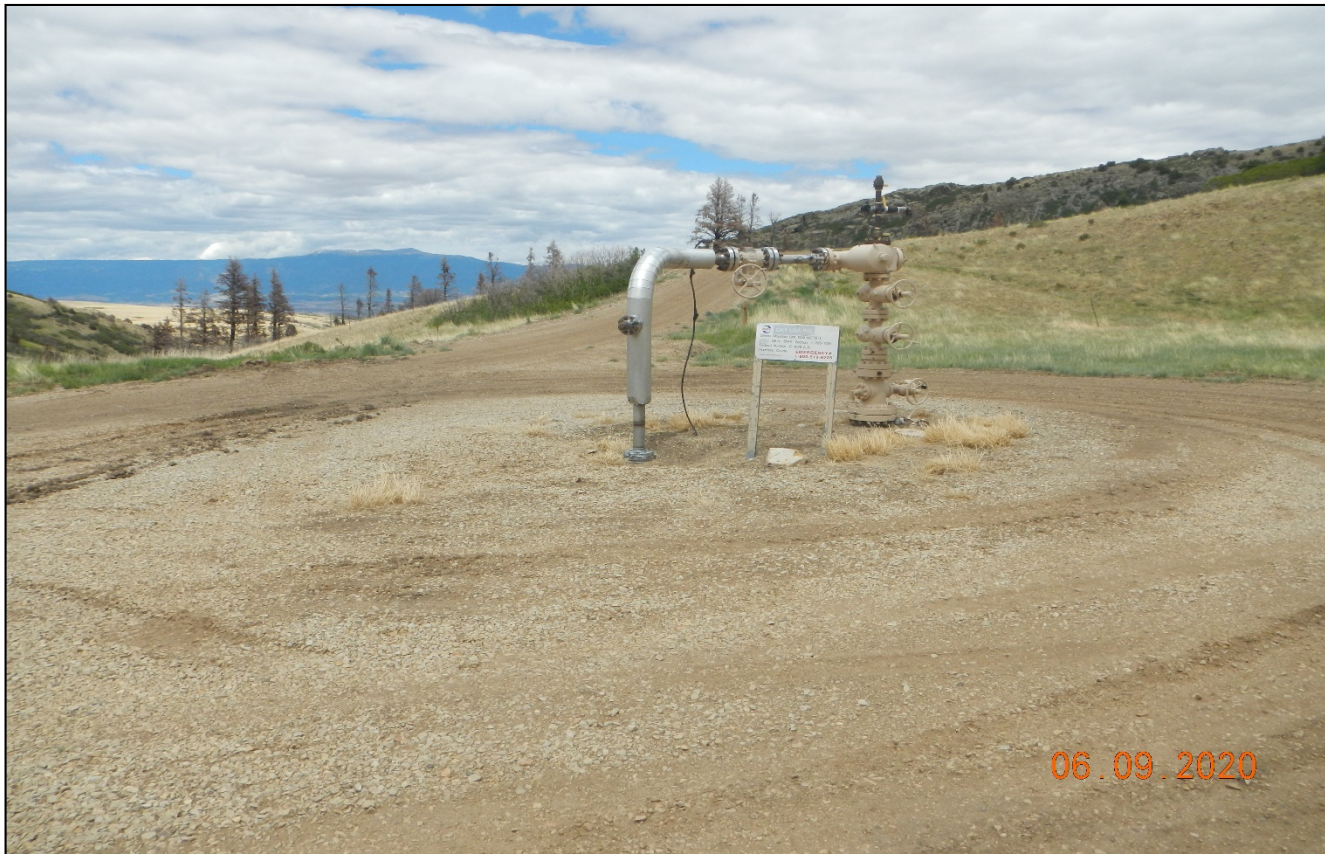
**Photo 3.** Well sign has been updated to reflect the current operator.

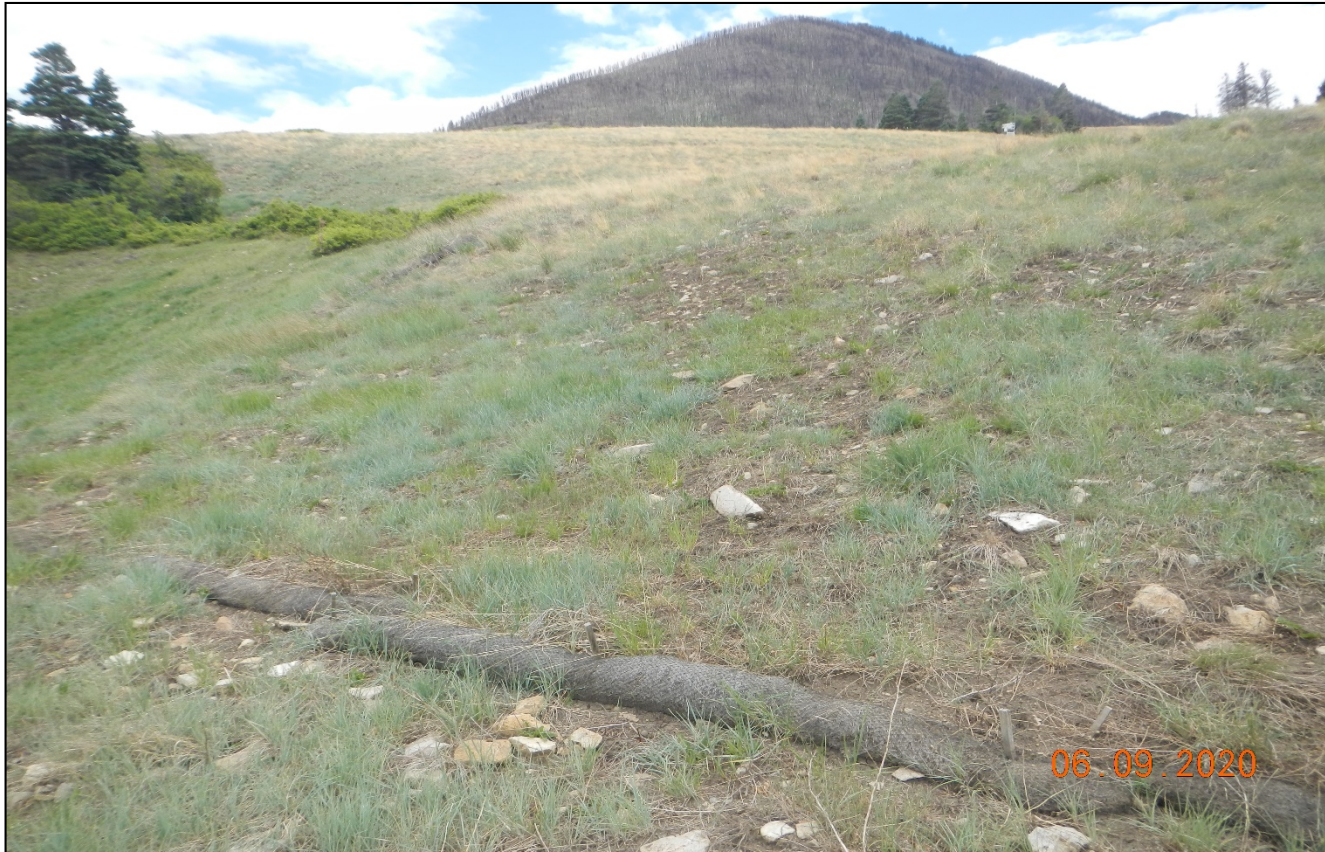
**Photo 4.** Noxious weed control was performed in this area last fall which appears to have been effective.

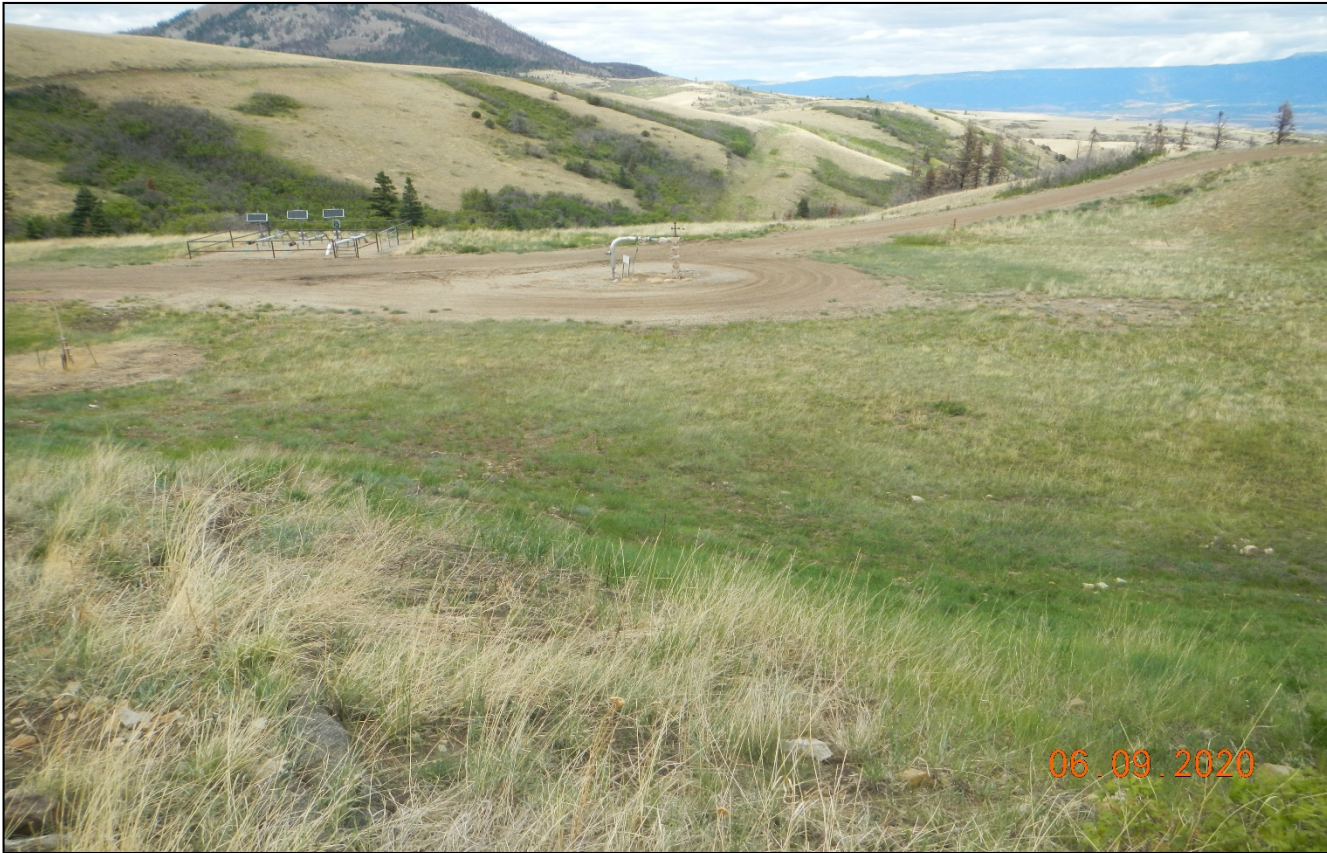
**Photo 5.** Facing north toward the location.
