Inspection Photos

API: 05-055-06316

Operator: OXY USA INC

Inspection Date: 6/9/2020

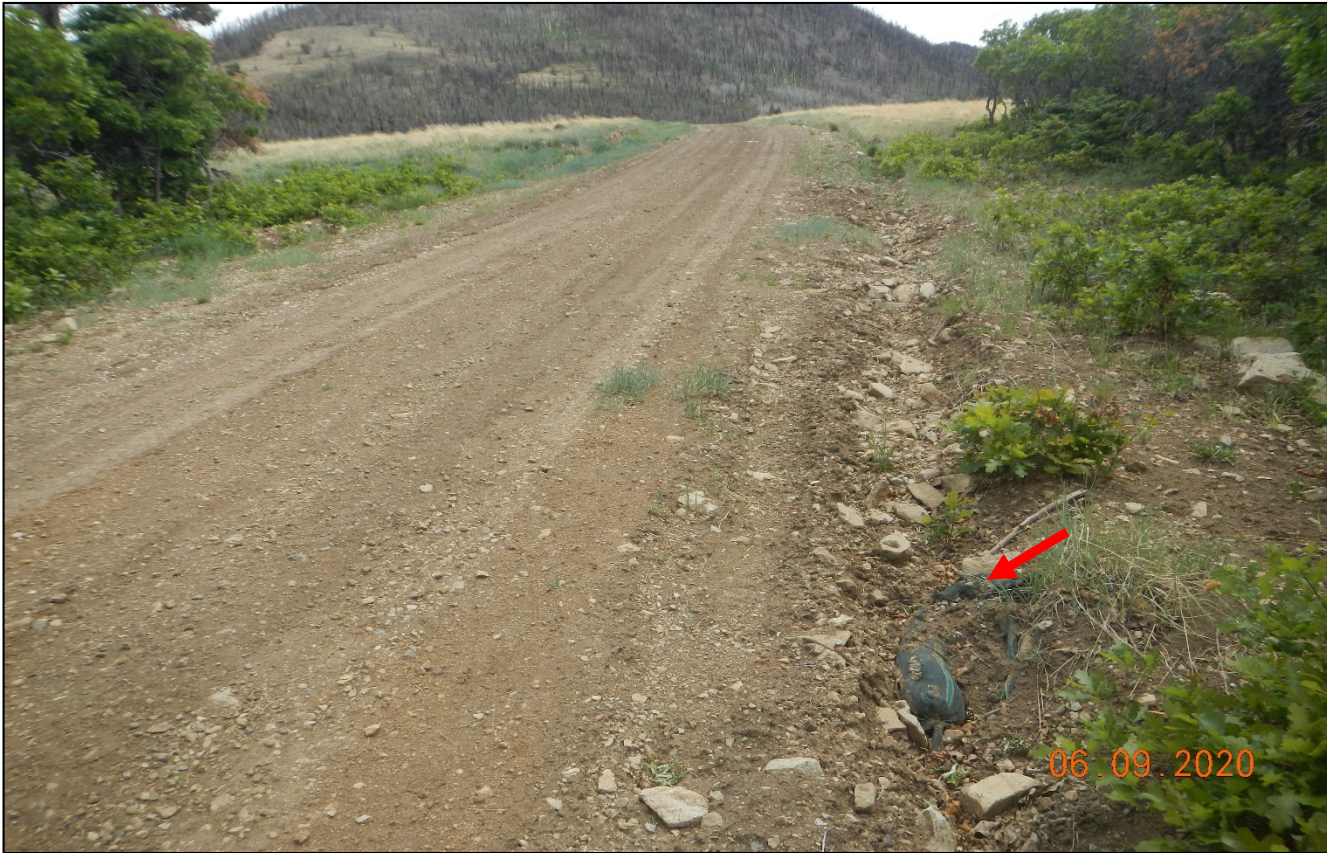
Photo 1. Facing south ascending the hill toward the location. The BMP's along the side of the road are not maintained. Red arrow points to rock wattle.

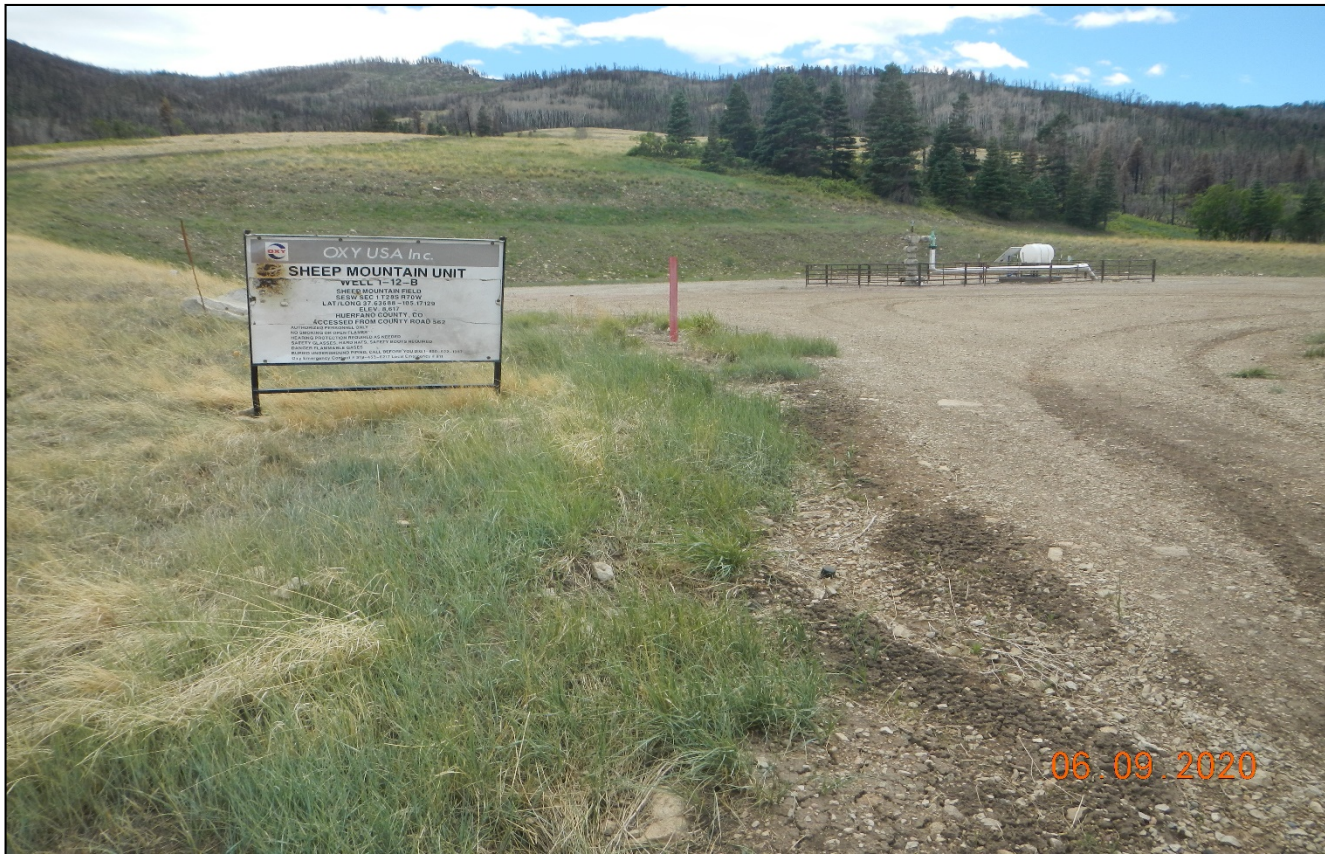
Photo 2. Facing southwest toward the location. Operator sign has been repaired.

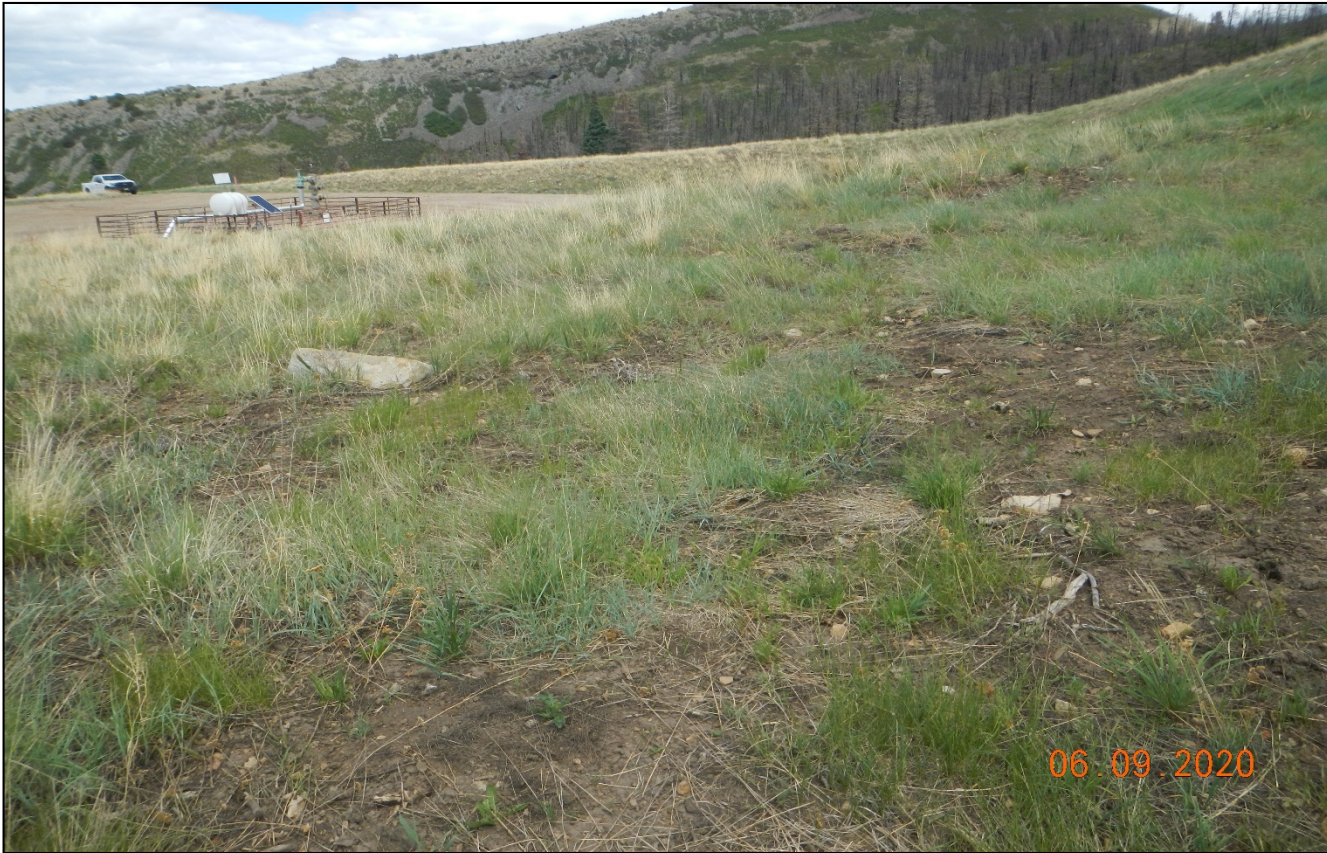
Photo 3. Facing northeast along the hill side at the location. Noxious weed control was performed in this area last fall which appears to have been effective.

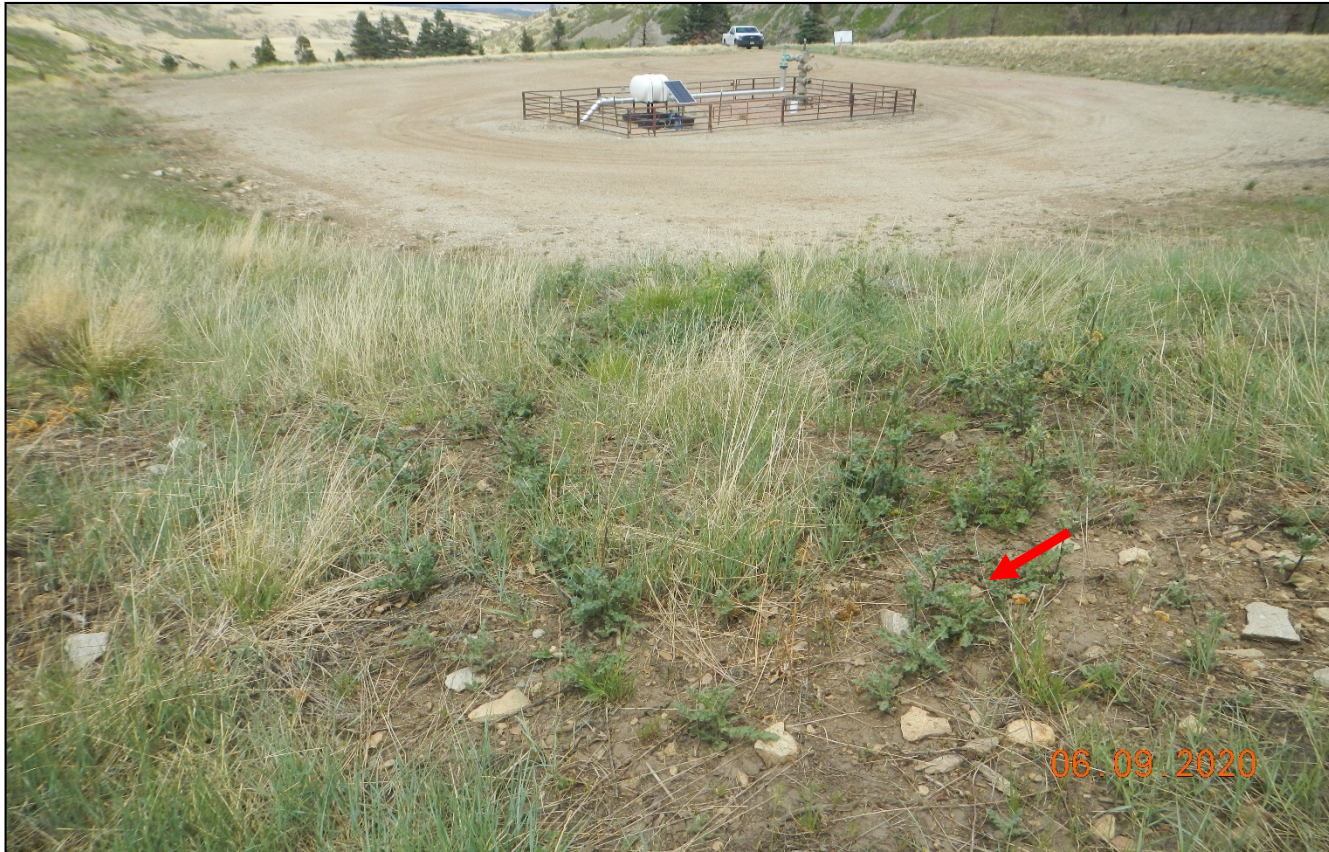
Photo 4. Facing northeast toward the location from at the top cut slope. There is some noxious weeds present in this area which needs to be controlled to prevent spreading.

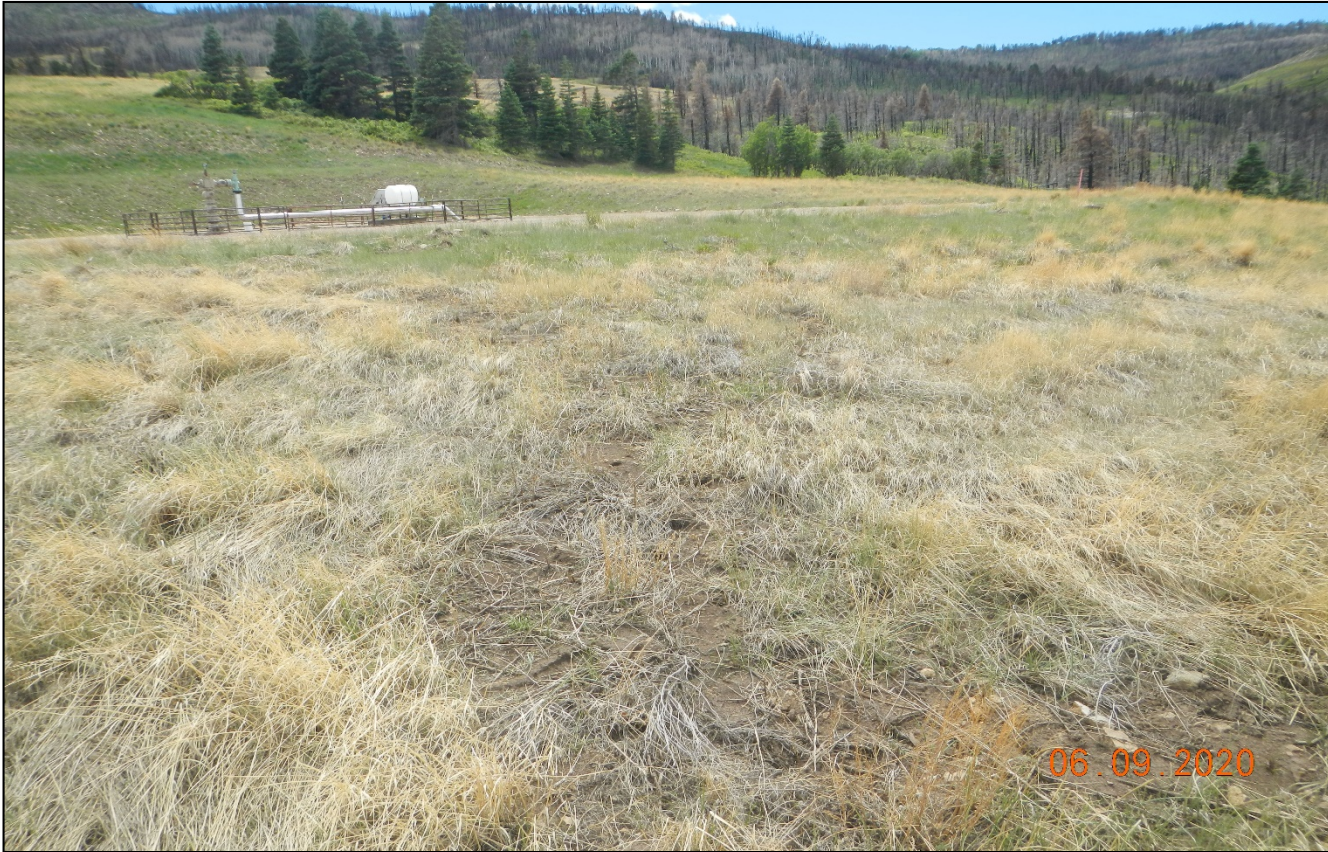
Photo 5. Facing southwest toward the location. Vegetation is well established in the interim reclamation area.
