Inspection Photos
Operator: BP America
API: 067-07632
Date: 6/16/2020

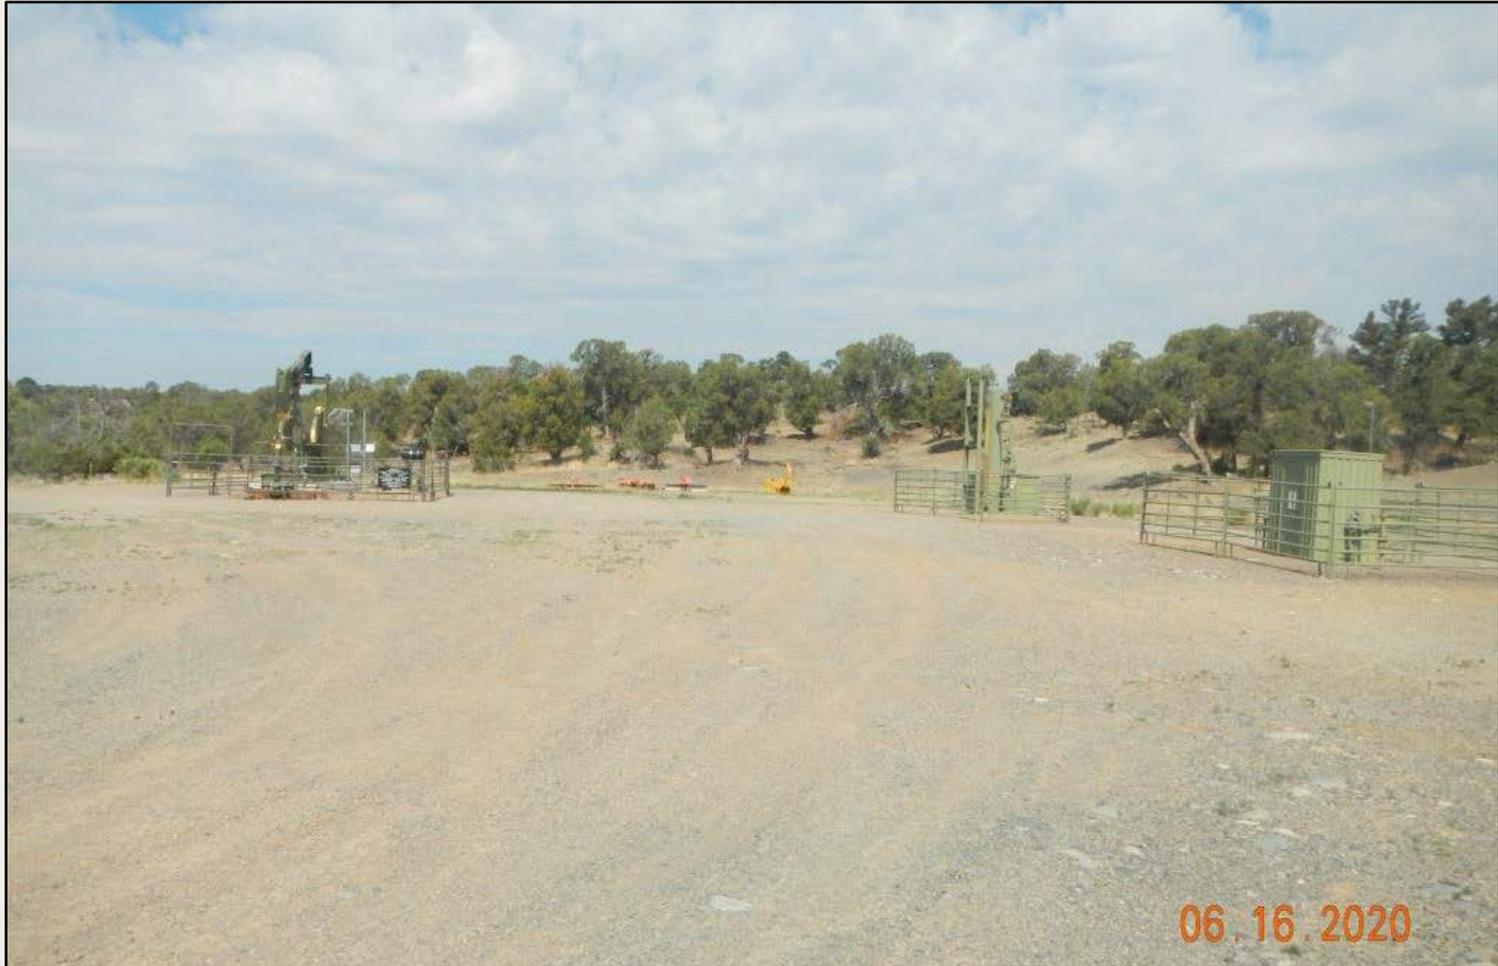
Photo 1. View of the project area from the well pad entrance facing center.

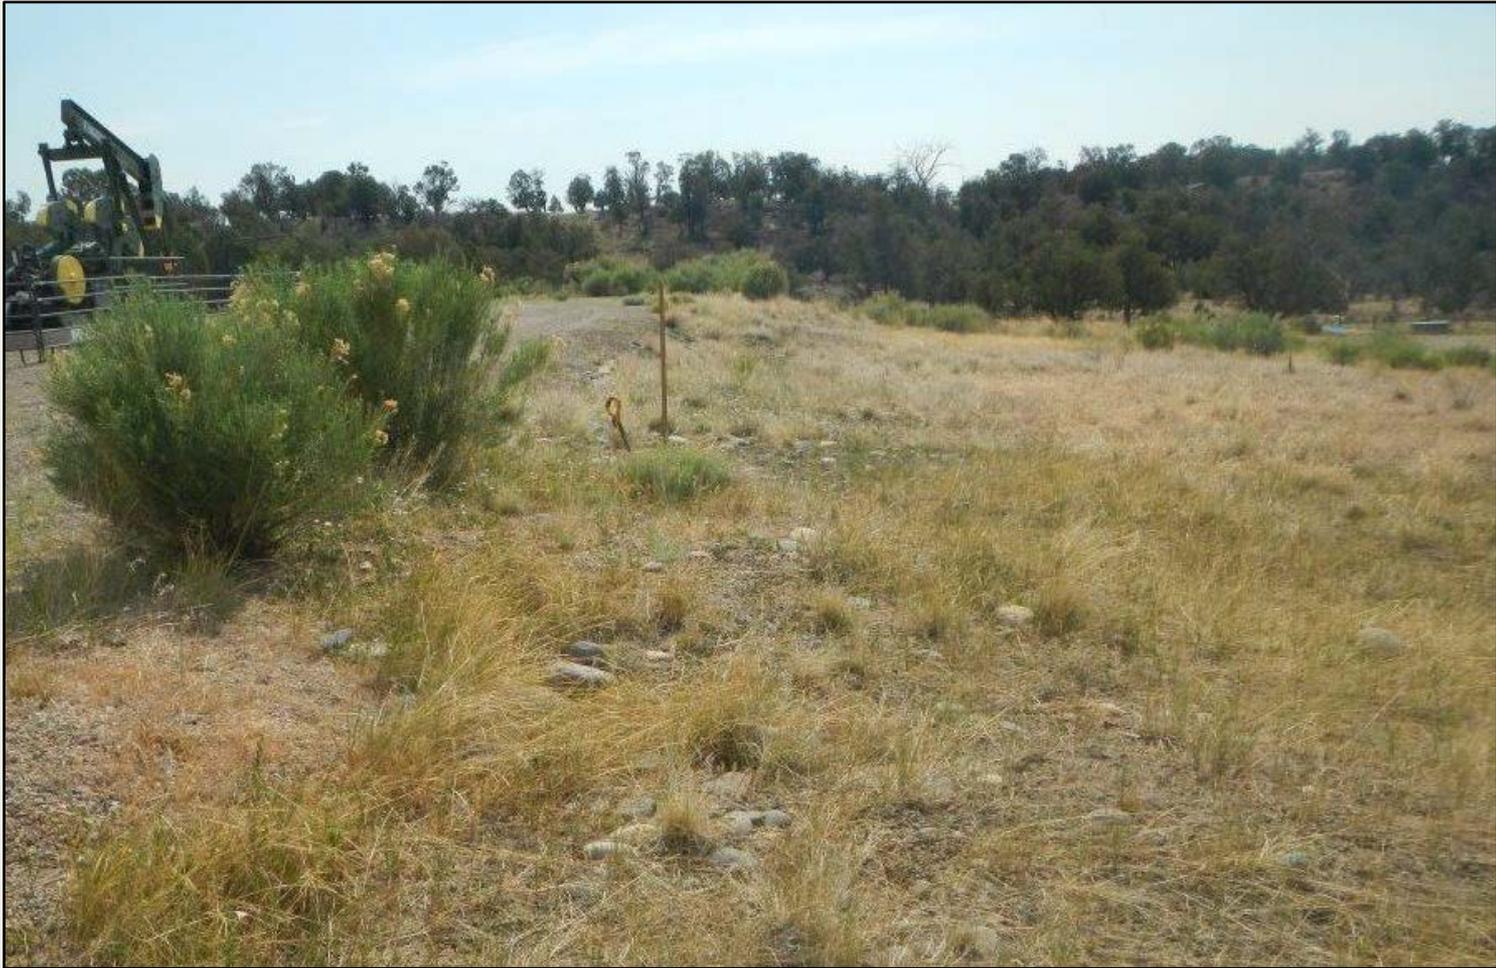
Photo 2. View of the southern project area from the southwestern corner facing eastward. Revegetation is progressing here with western wheatgrass, sand dropseed, and rubber rabbitbrush.

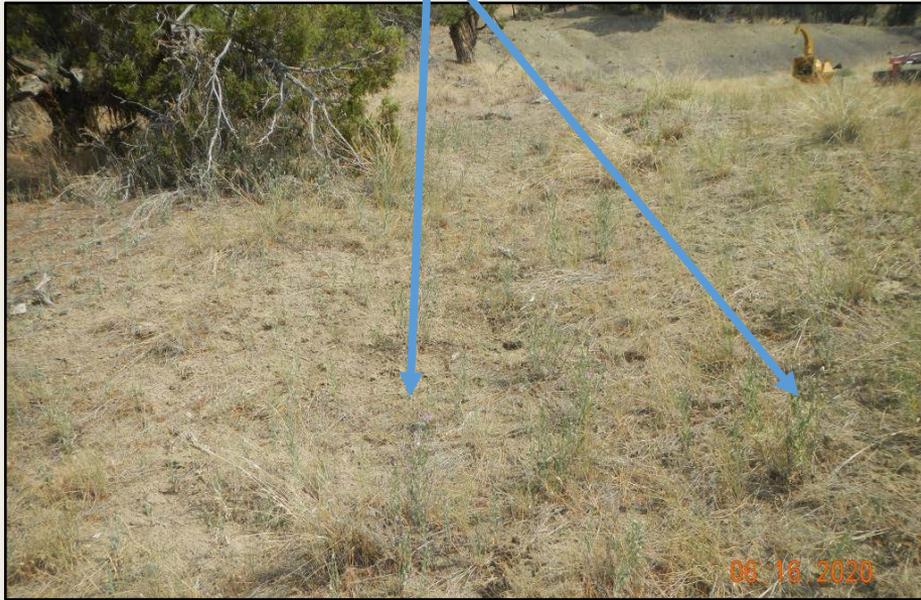
Photos 3/4. View of the weeds within the project area. Russian knapweeds on the left are not treated. Musk thistles on the right appear to be treated.

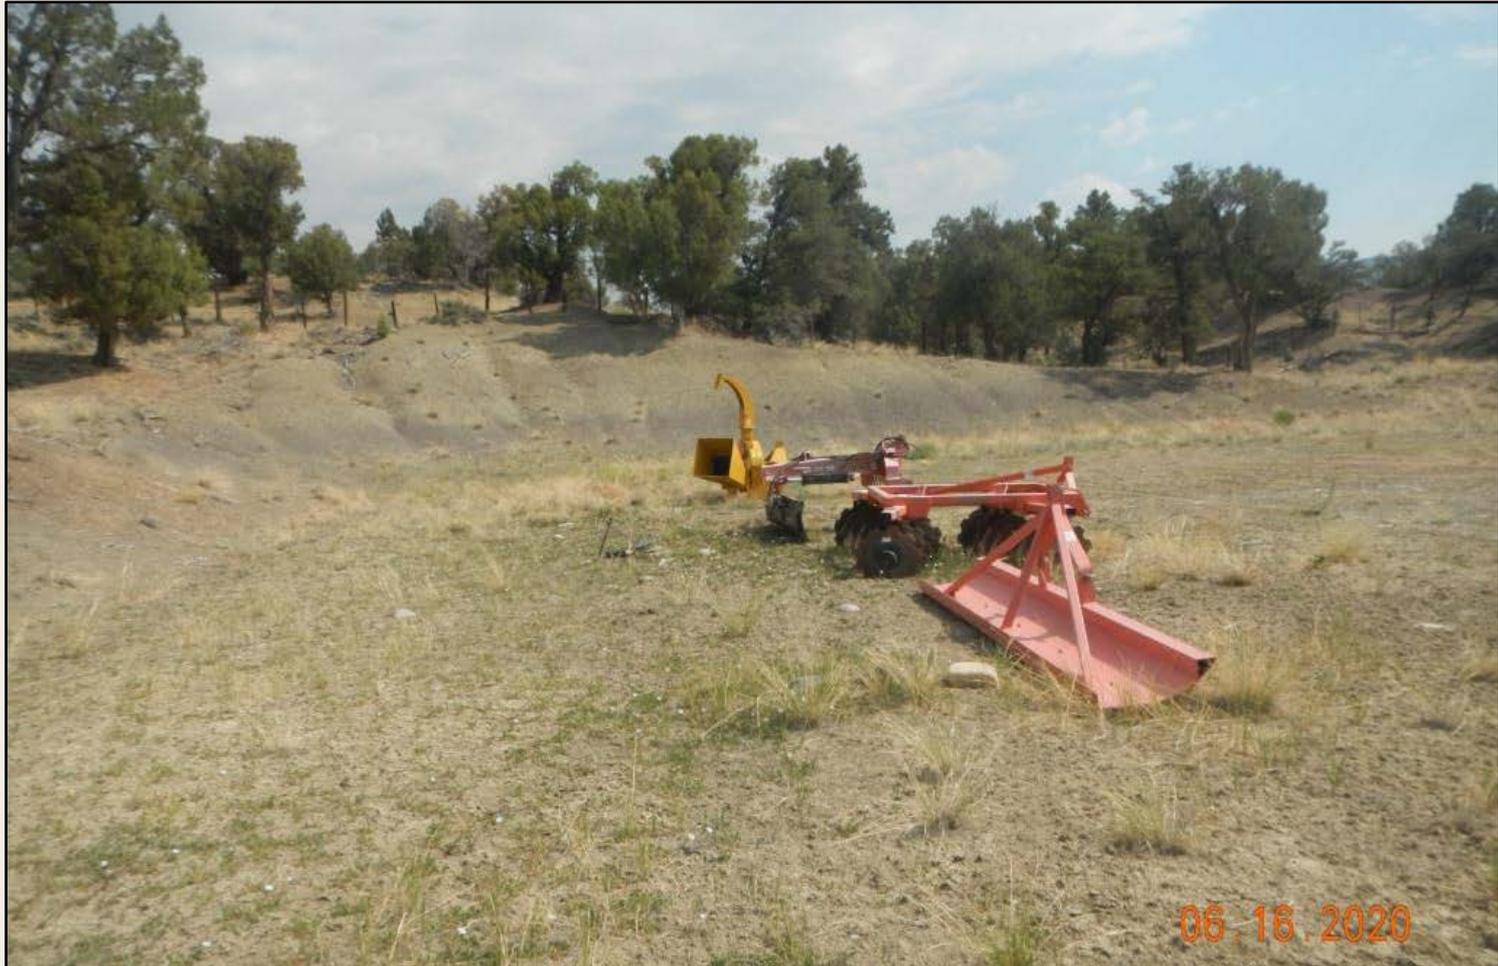
Photo 5. View of the western project area, facing northward. Equipment stored in this portion of the project area.

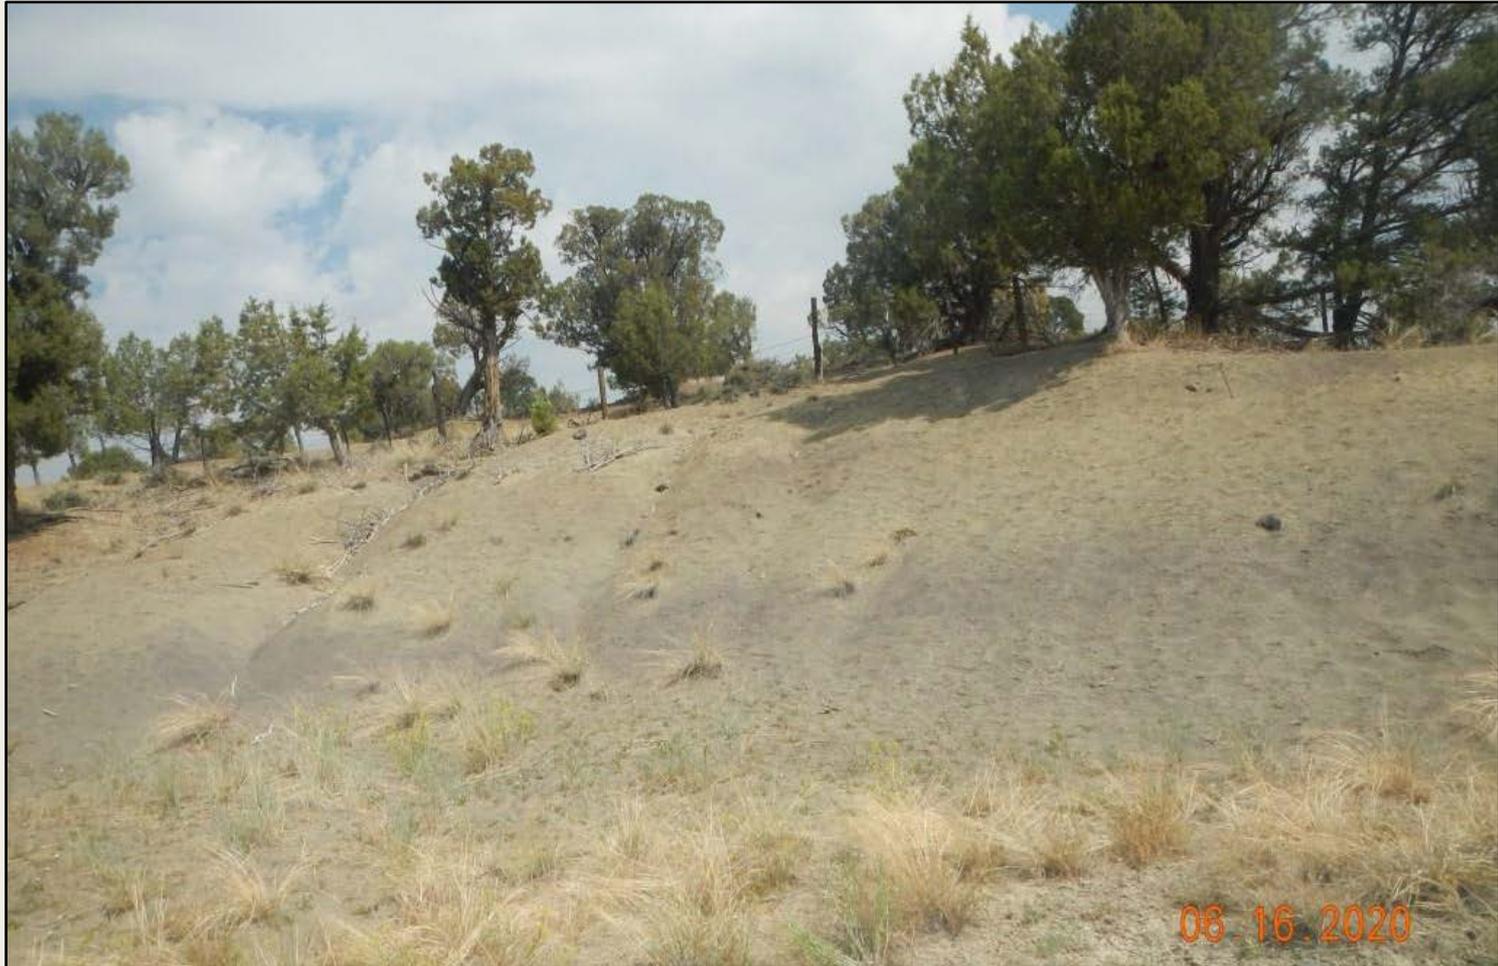
Photo 6. View of the northwestern cut-slope , needs further stabilization.

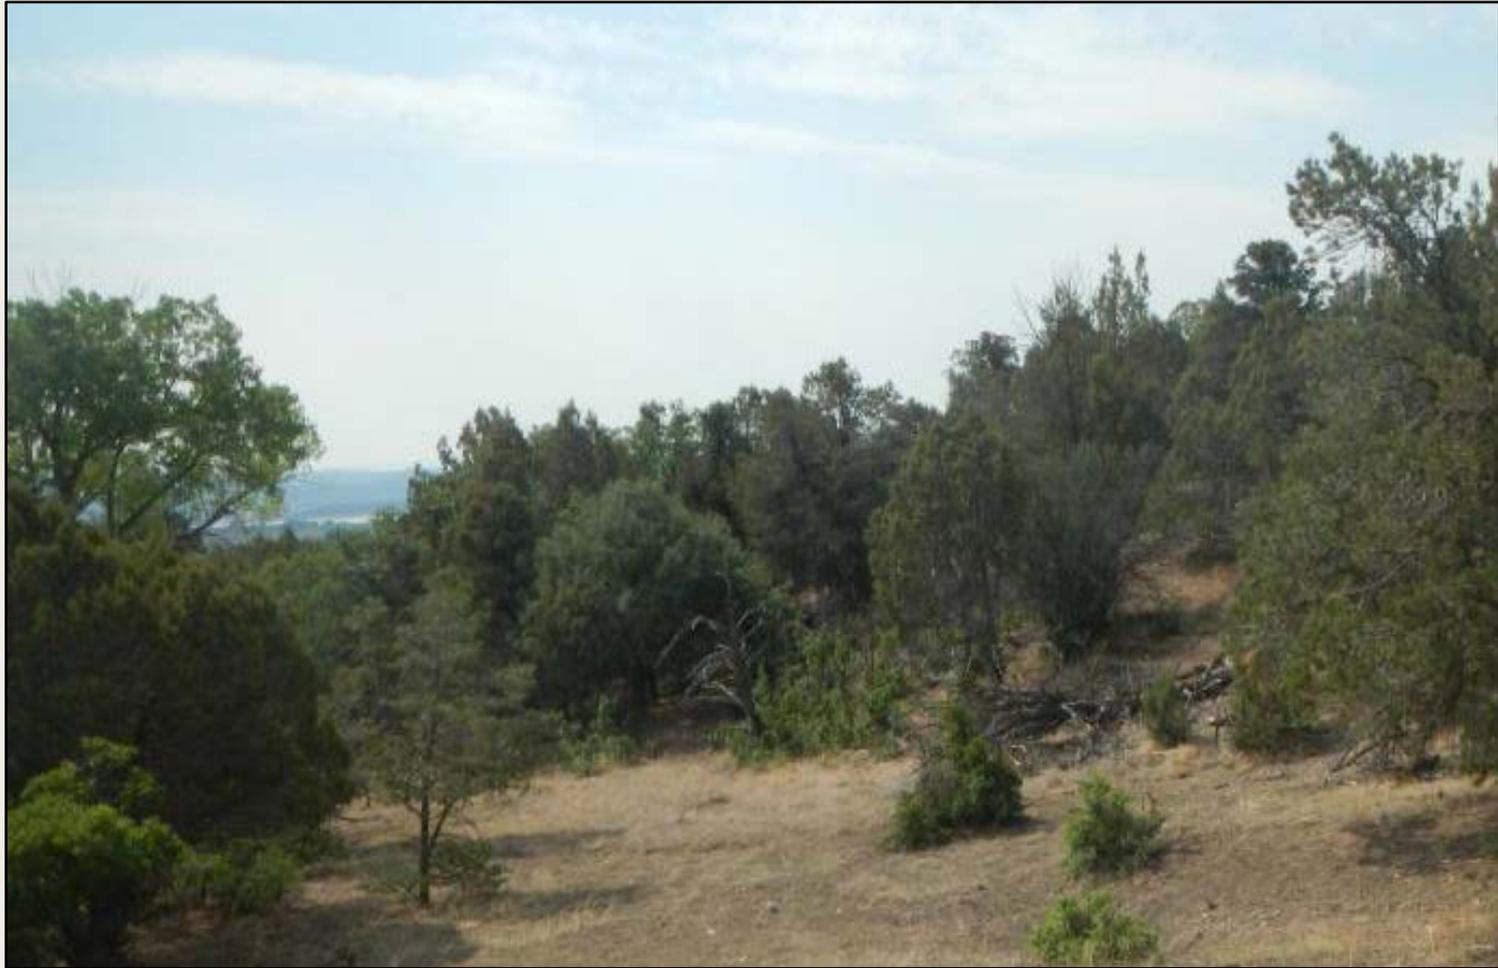
Photo 6. View of the reference area, comprised of pinyon and juniper woodland with understory of grasses and forbs such as western wheatgrass, blue grama, prickly pear, as well as shrubby gambel oak.
