Inspection Photos
Operator: BP America
API: 067-07620
Date: 6/16/2020

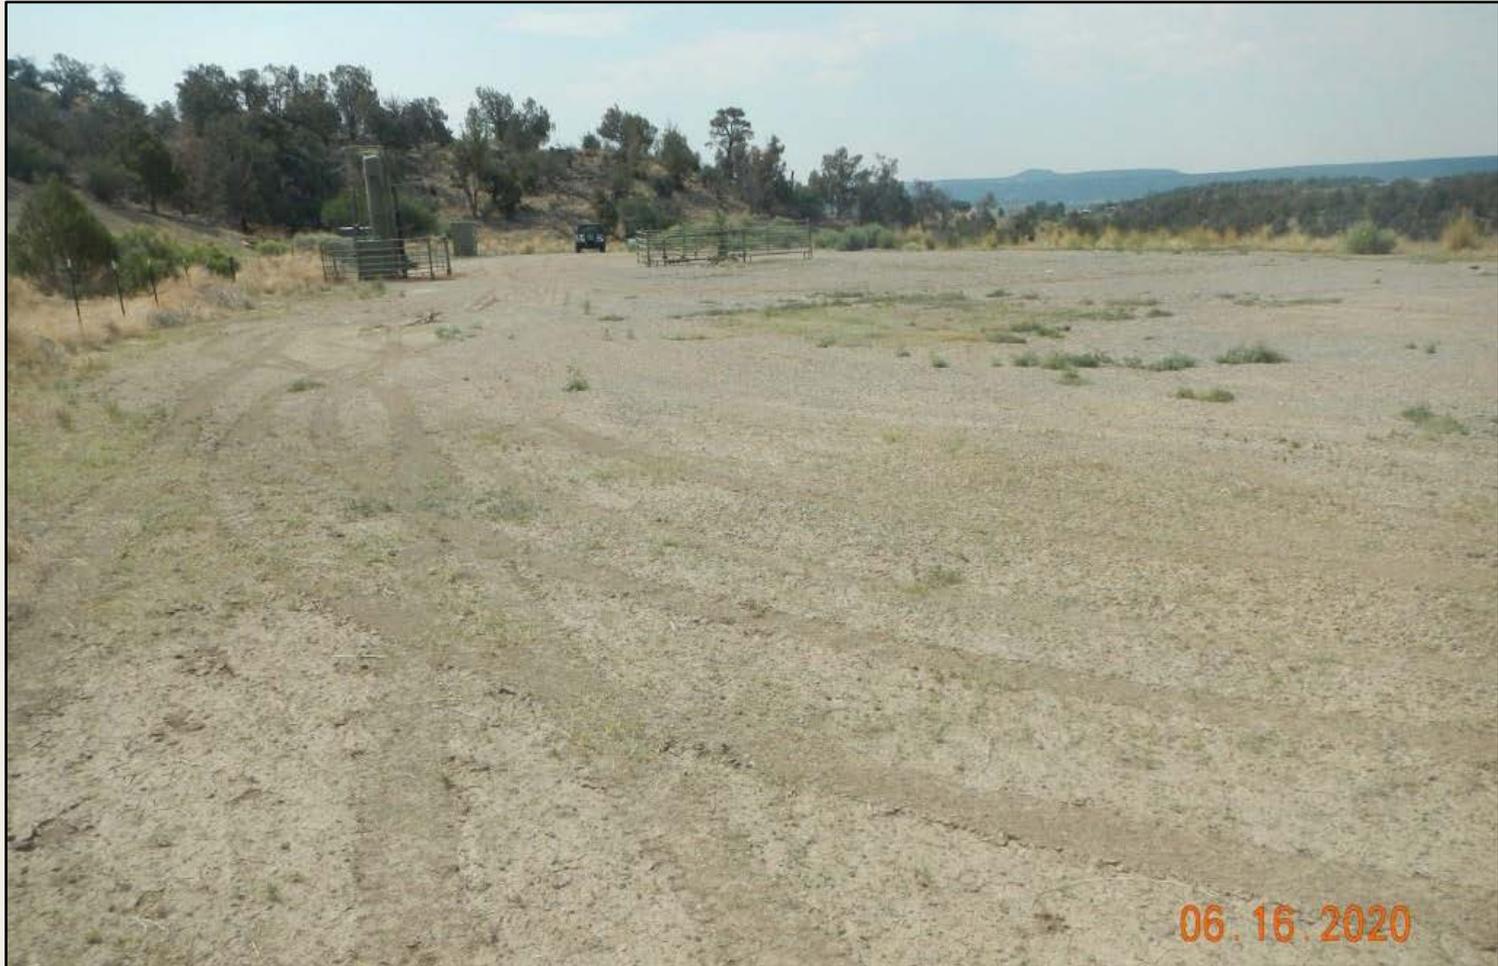
Photo 1. View of the project area from the northeastern corner facing center.

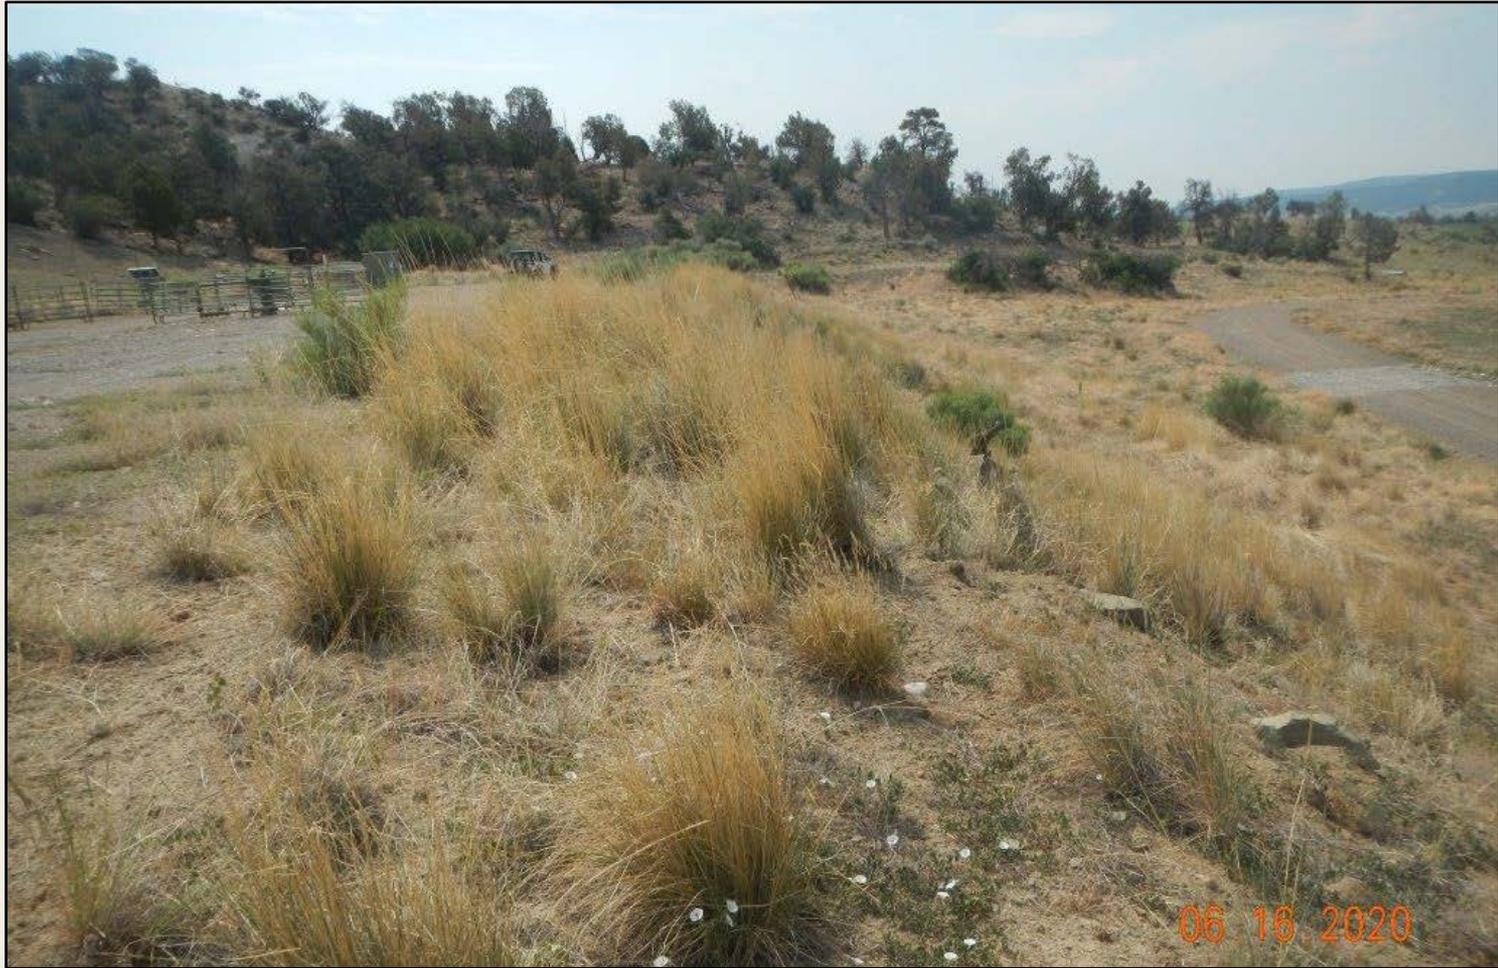
Photo 2. View of the western project area from the northwestern corner facing southward. Revegetation is progressing, although sparse, with western wheatgrass, crested wheatgrass, and sand dropseed.

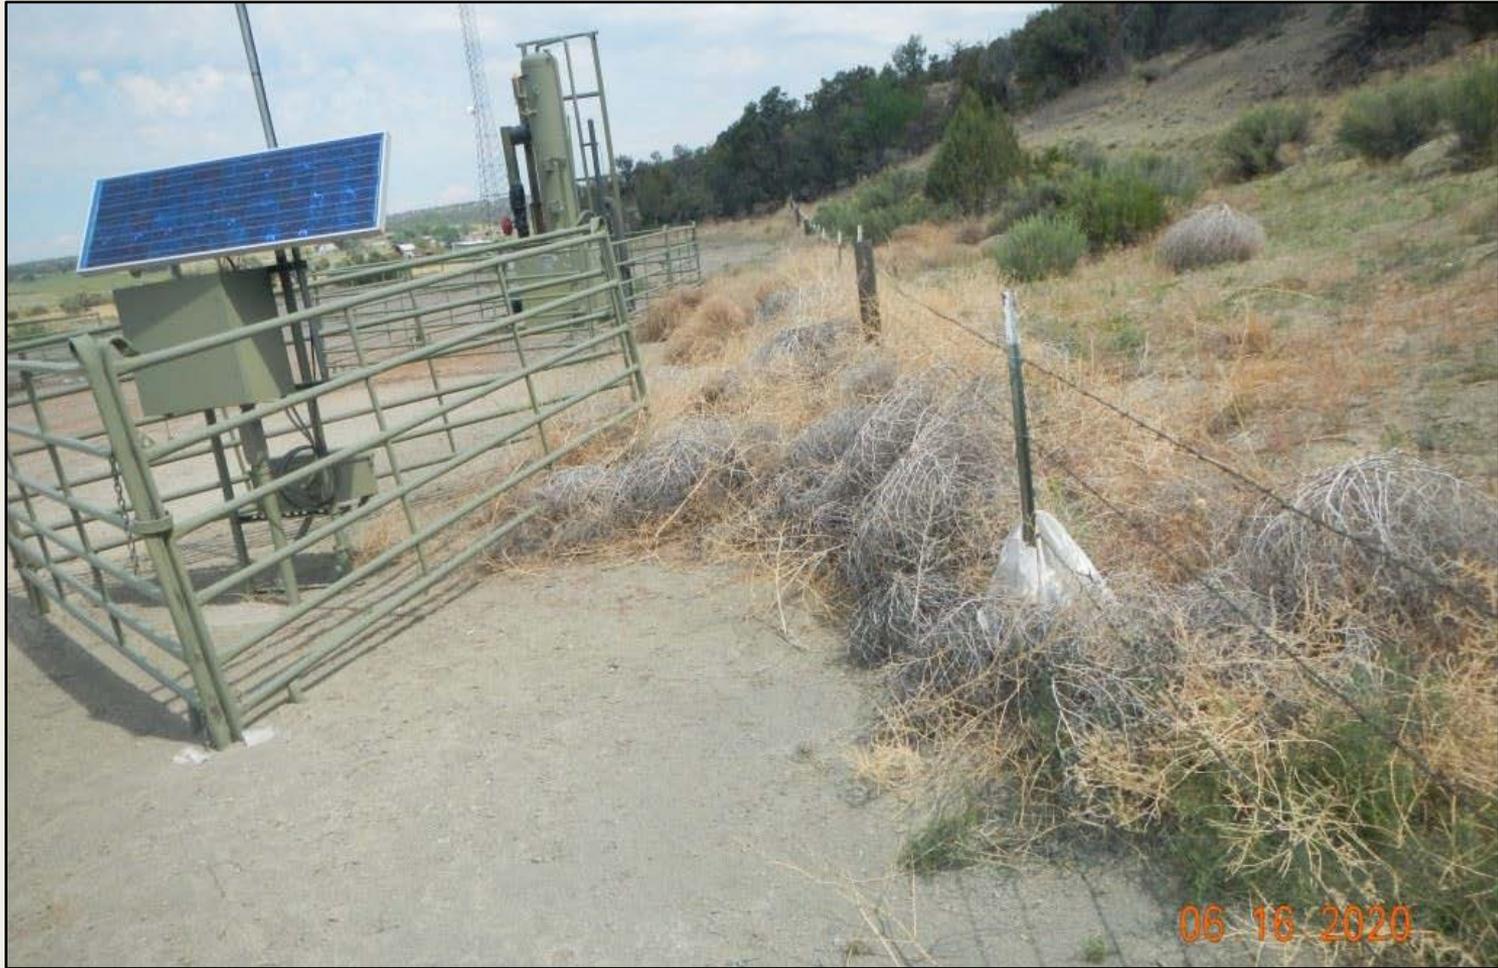
Photo 3. View of Russian thistle debris and plastic debris on fence and near fired equipment.

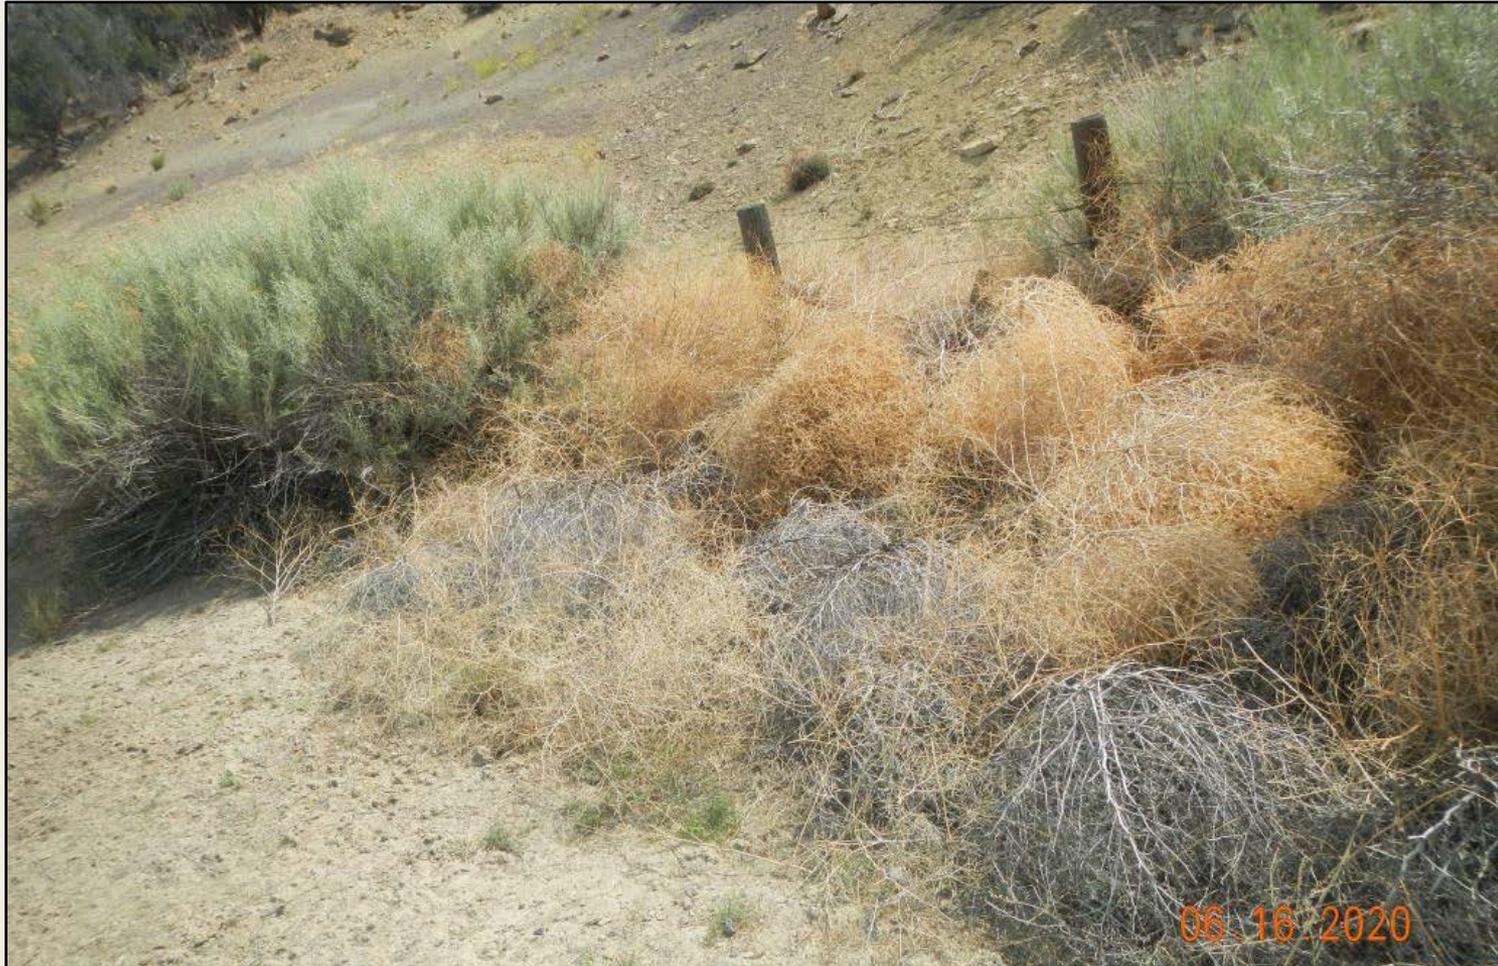
Photo 4. View of more Russian thistle debris at fenceline, needs to be removed and properly disposed of.

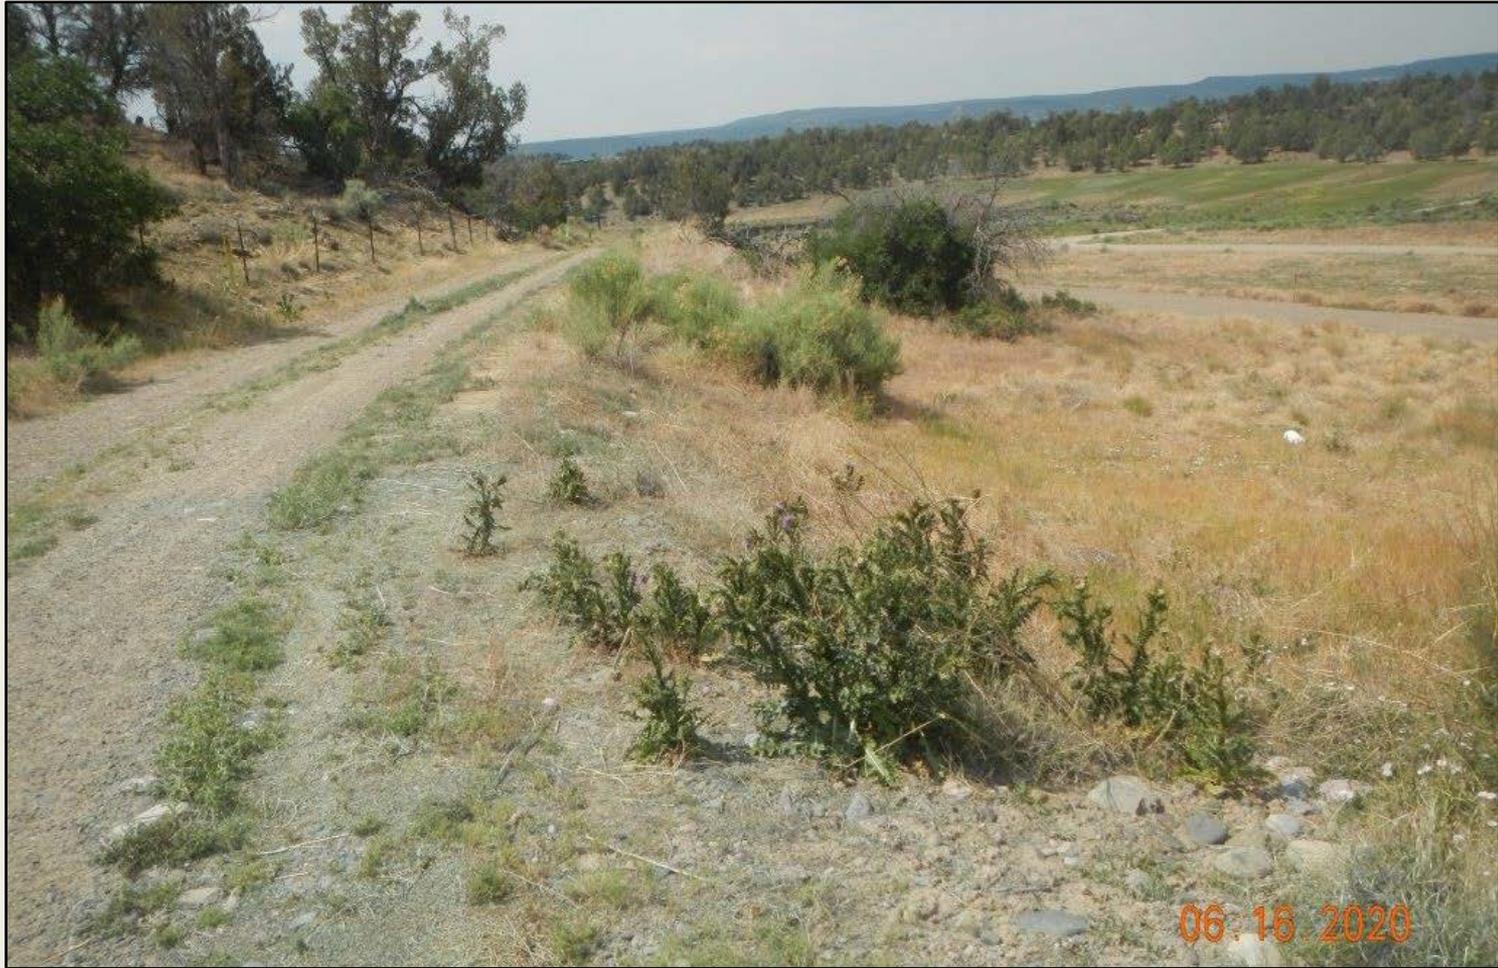
Photo 5. View of musk thistles along the access road that appear to be treated with herbicide recently.

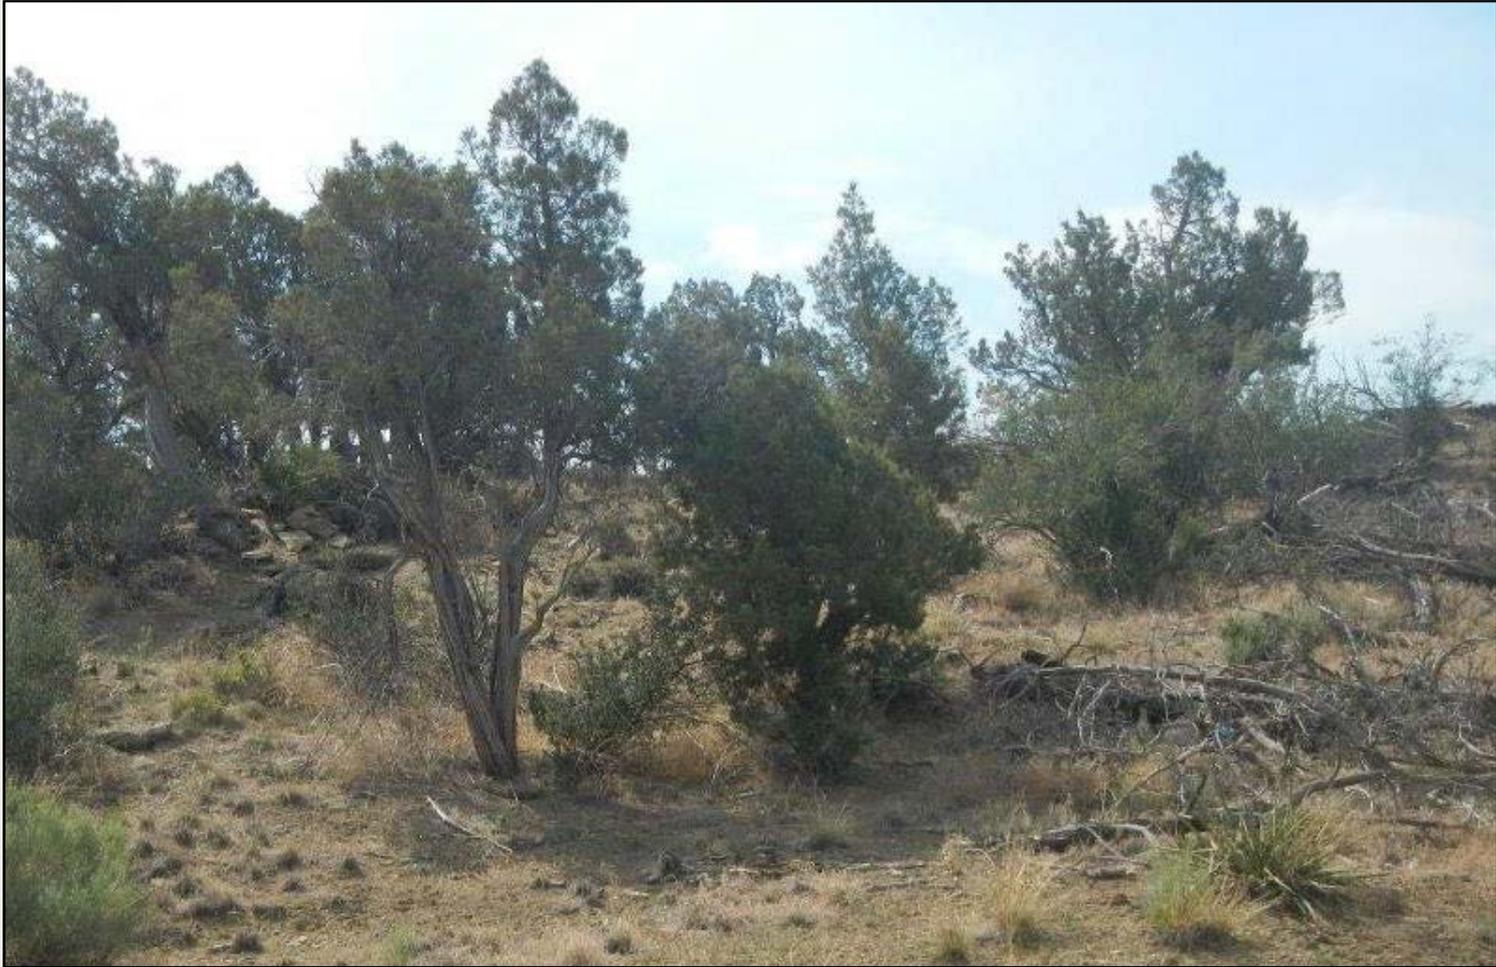
Photo 6. View of the reference area, comprised of pinyon and juniper woodland with understory of grasses and forbs such as western wheatgrass, blue grama, prickly pear, as well as shrubby gambel oak.
