**Inspection Photos**  
**Operator: Southland Royalty**  
**API: 067-08654**  
**Date: 6/16/2020**

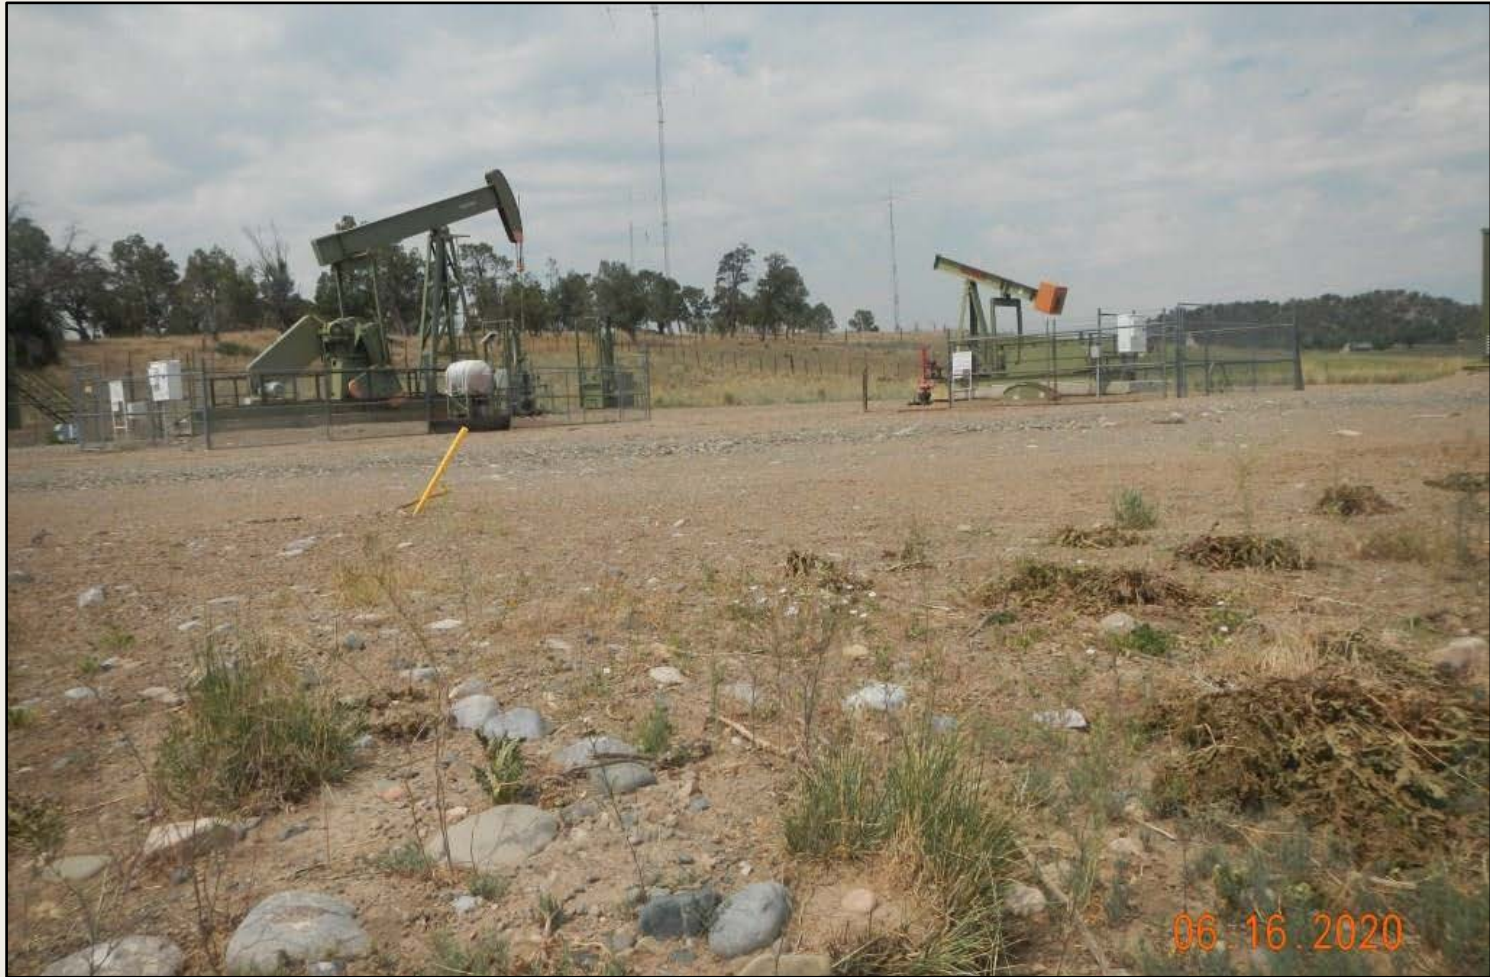
Photo 1. View of the project area from the northeastern corner facing center.

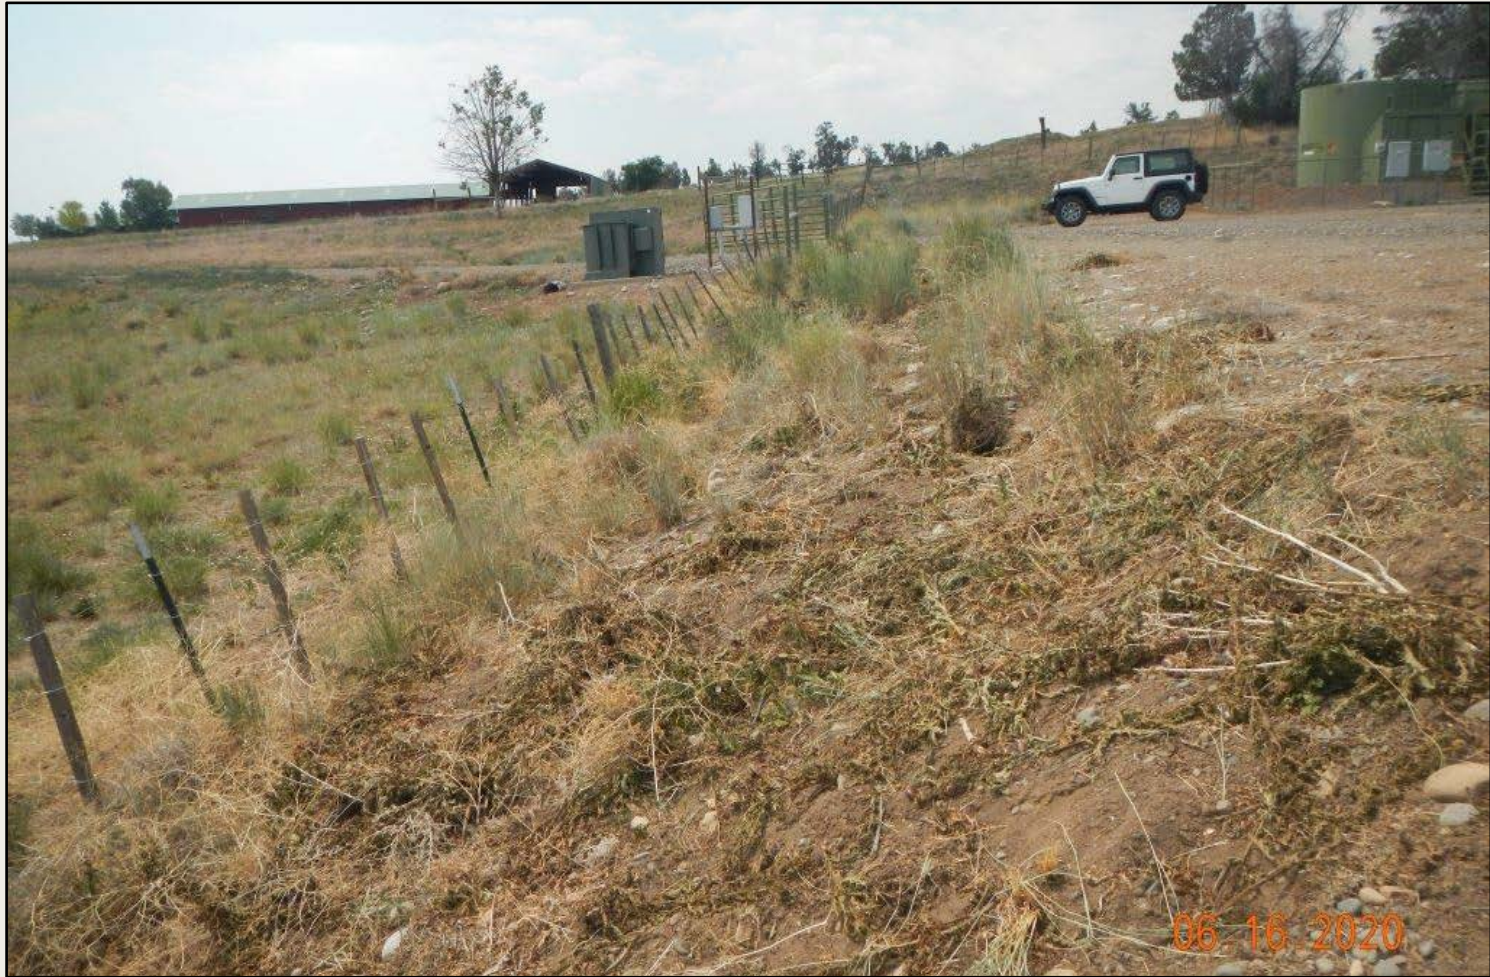
Photo 2. View of the eastern project area from the northeastern corner facing southward. Aggressive musk thistle removal was recently conducted. Thousands of individuals appear treated. Revegetation is needed to stabilize treatment areas and promote desirable vegetation.

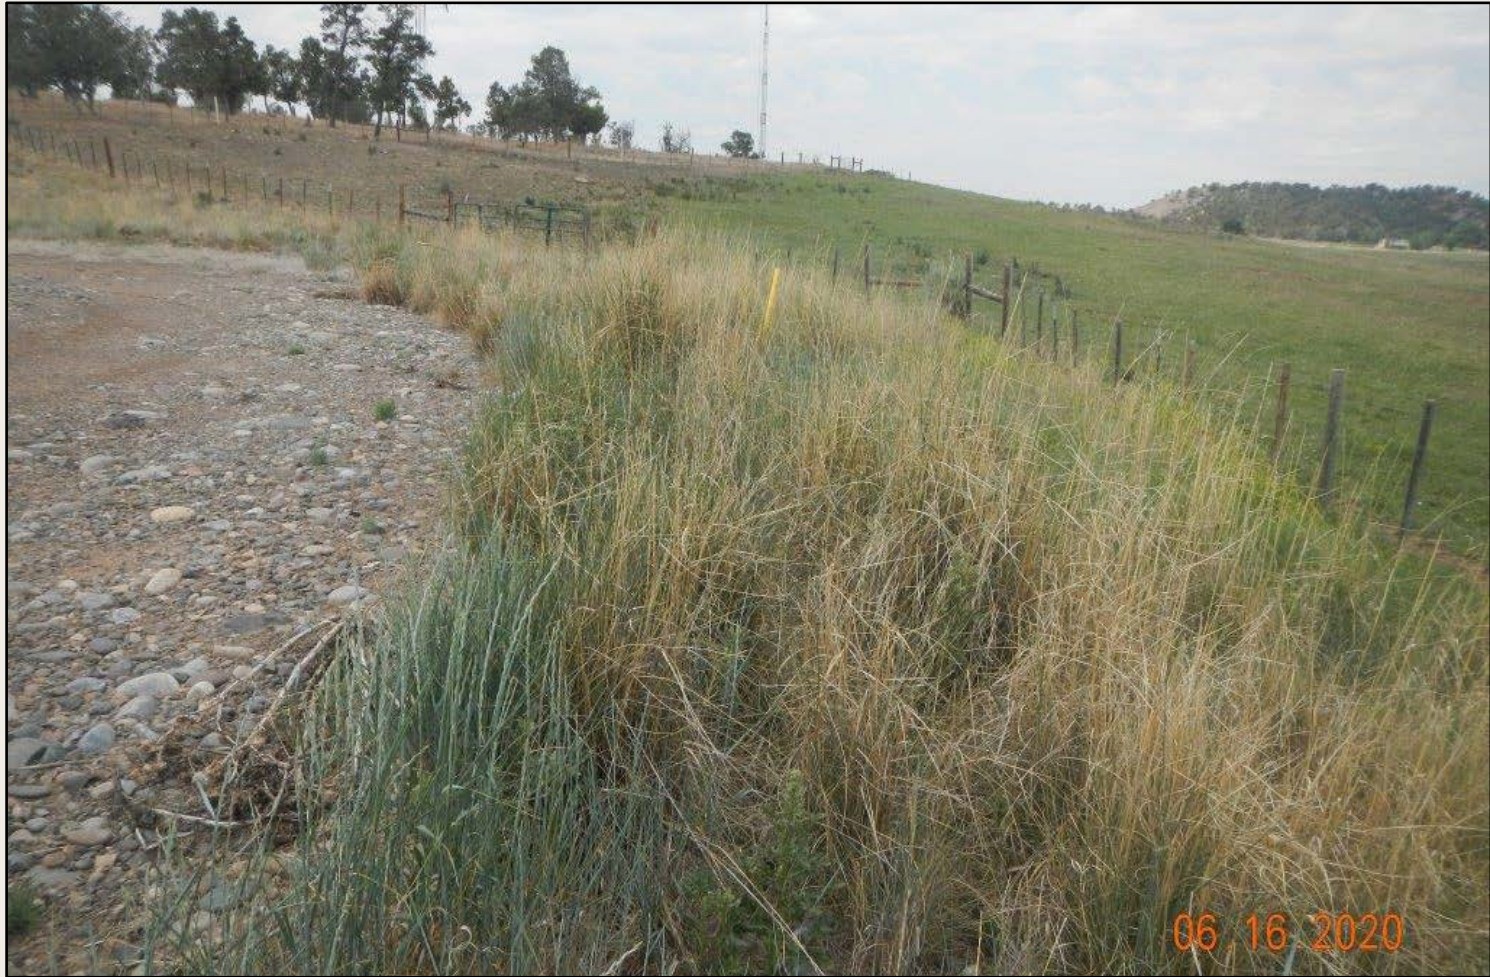
Photo 3. View of the western project area from the northwestern corner facing southward. Revegetation is progressing here with western wheatgrass, crested wheatgrass, and smooth brome.

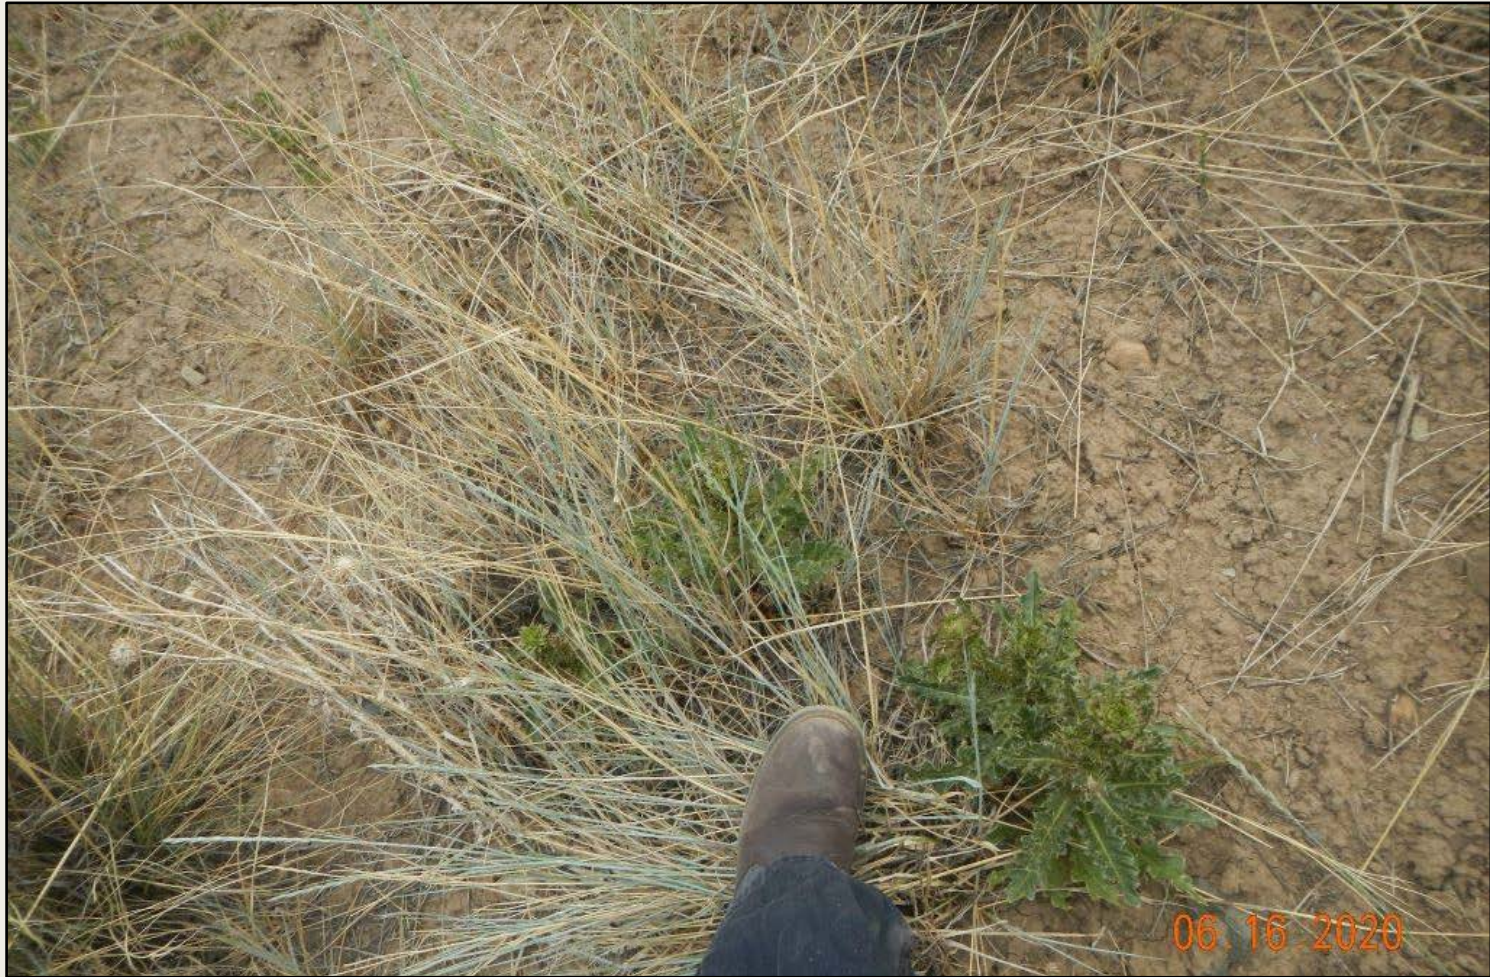
Photo 4. View of musk thistle rosettes within the project area.

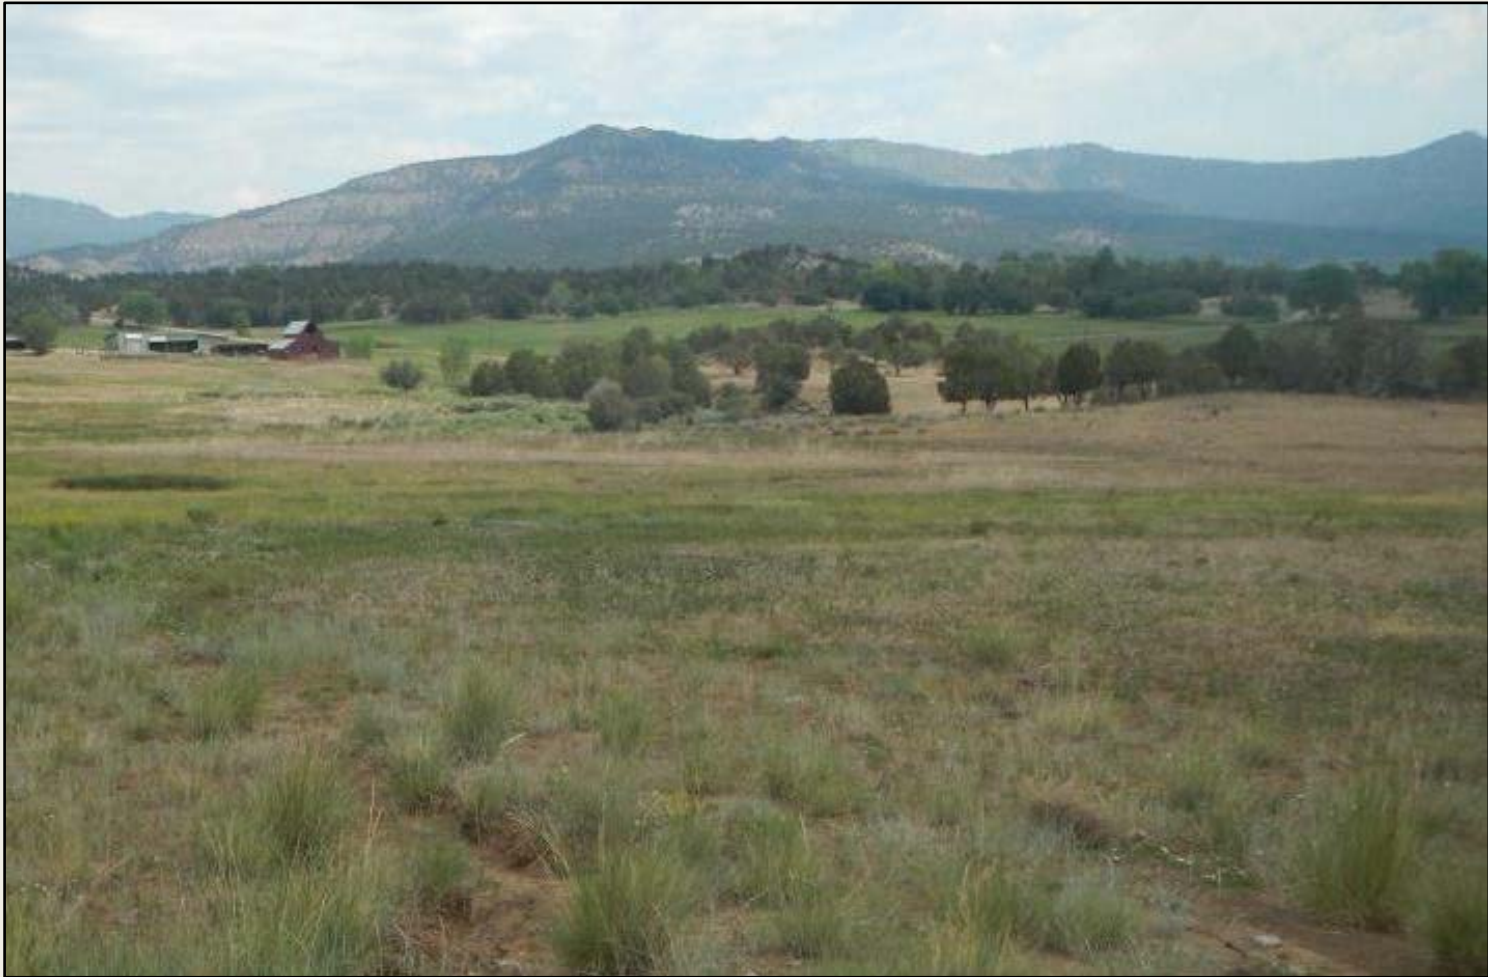
Photo 5. View of the reference area, comprised of open grass field with grasses such as western wheatgrass, Indian ricegrass, and smooth brome.
