# Final Reclamation Inspection

June 16, 2020

Operator: EXTRACTION OIL & GAS INC - #10459

Location ID: 319865

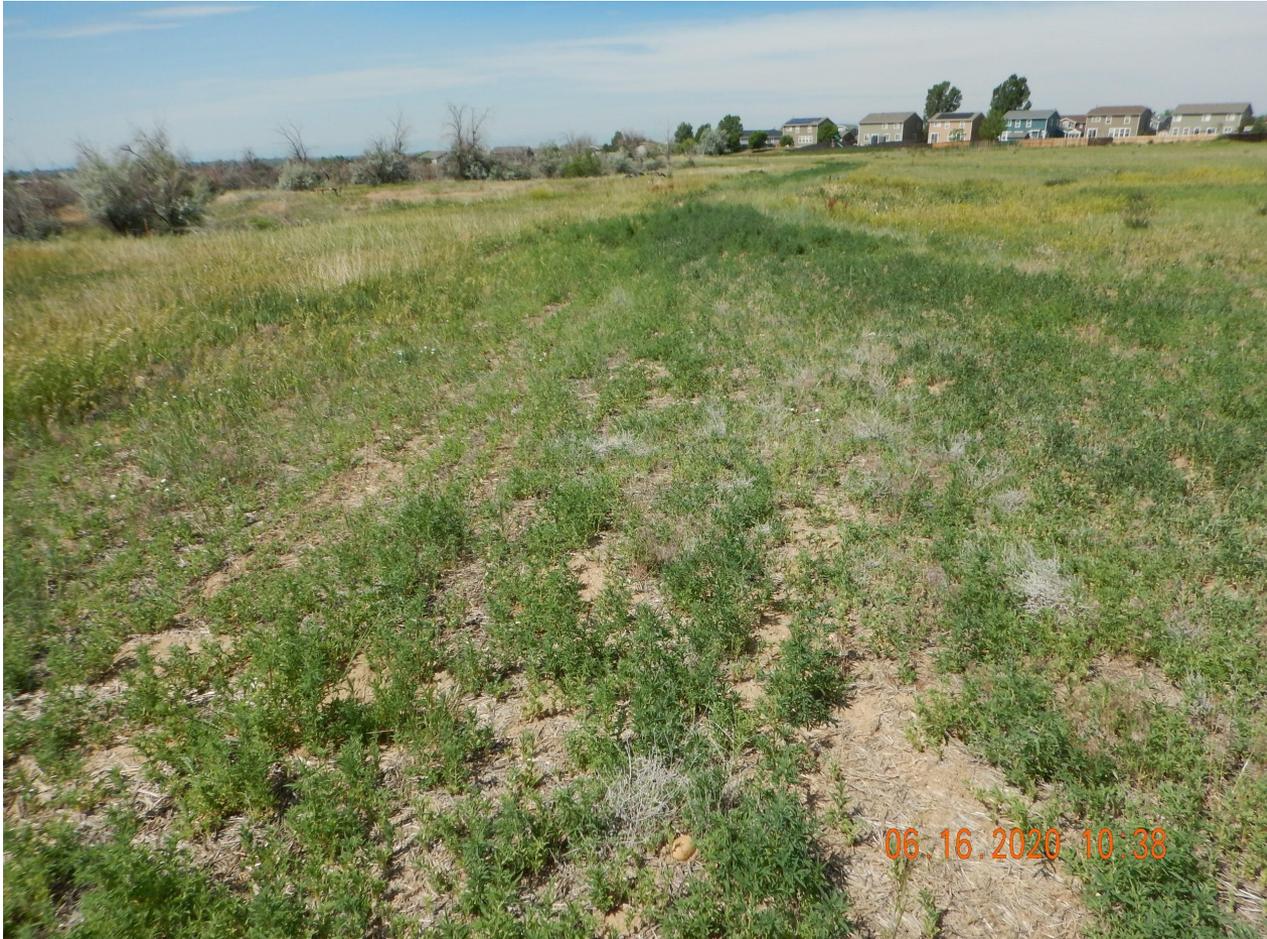
**Photo 1.** Photo taken from the northern access road, facing West. Photo illustrates the Operator attempted to conduct final reclamation activities; however, the establishment of desirable plant species was not uniform throughout. Patches of weedy, undesirable annuals (mostly Kochia) were observed along the access road and well location.

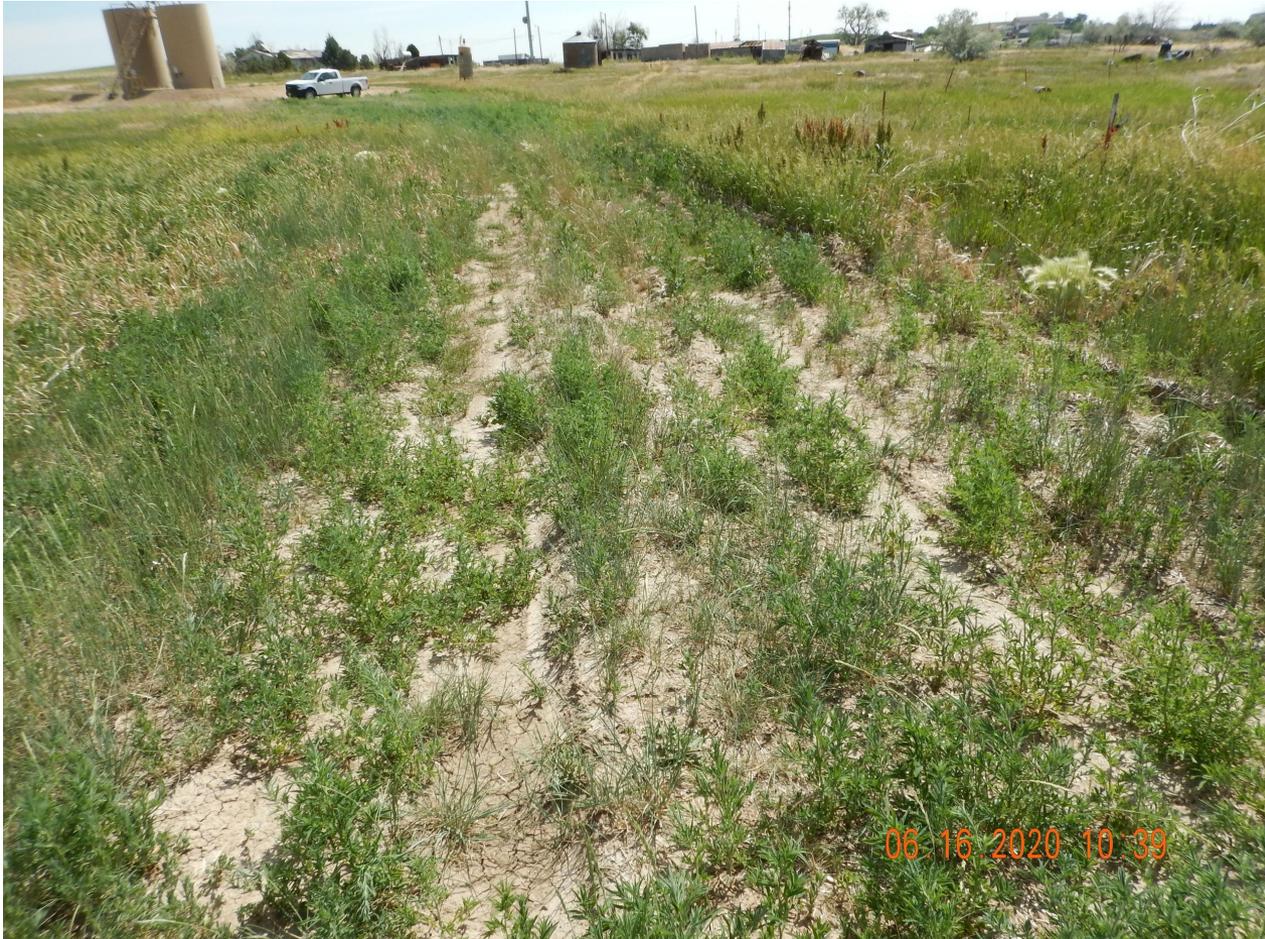
**Photo 2.** Photo taken from the northern access road, facing East. See comments under Photo 1.

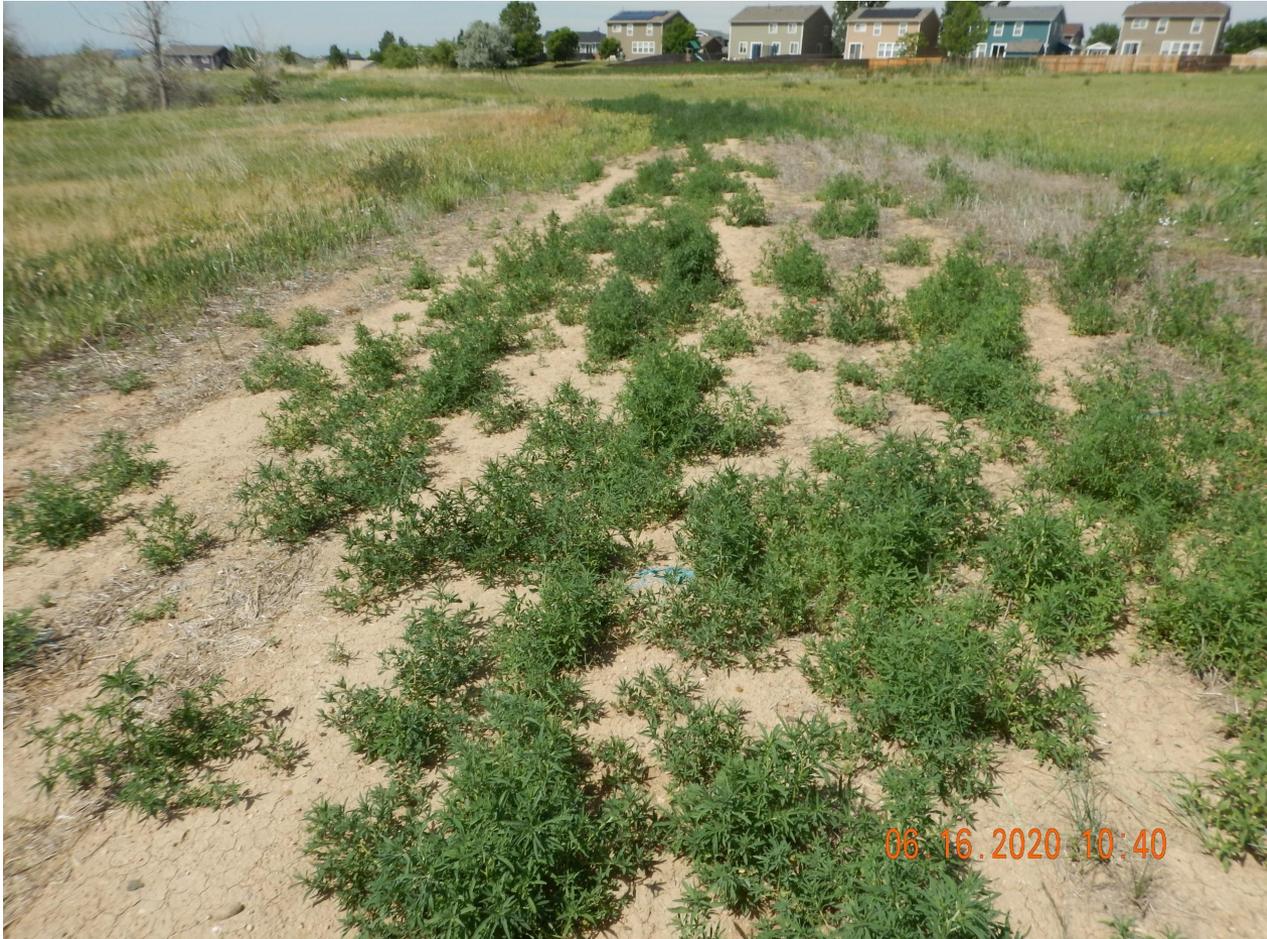
**Photo 3.** Photo taken along a portion of the access road, facing West. Photo illustrates little germination of desirable plant species with the establishment of Kochia.

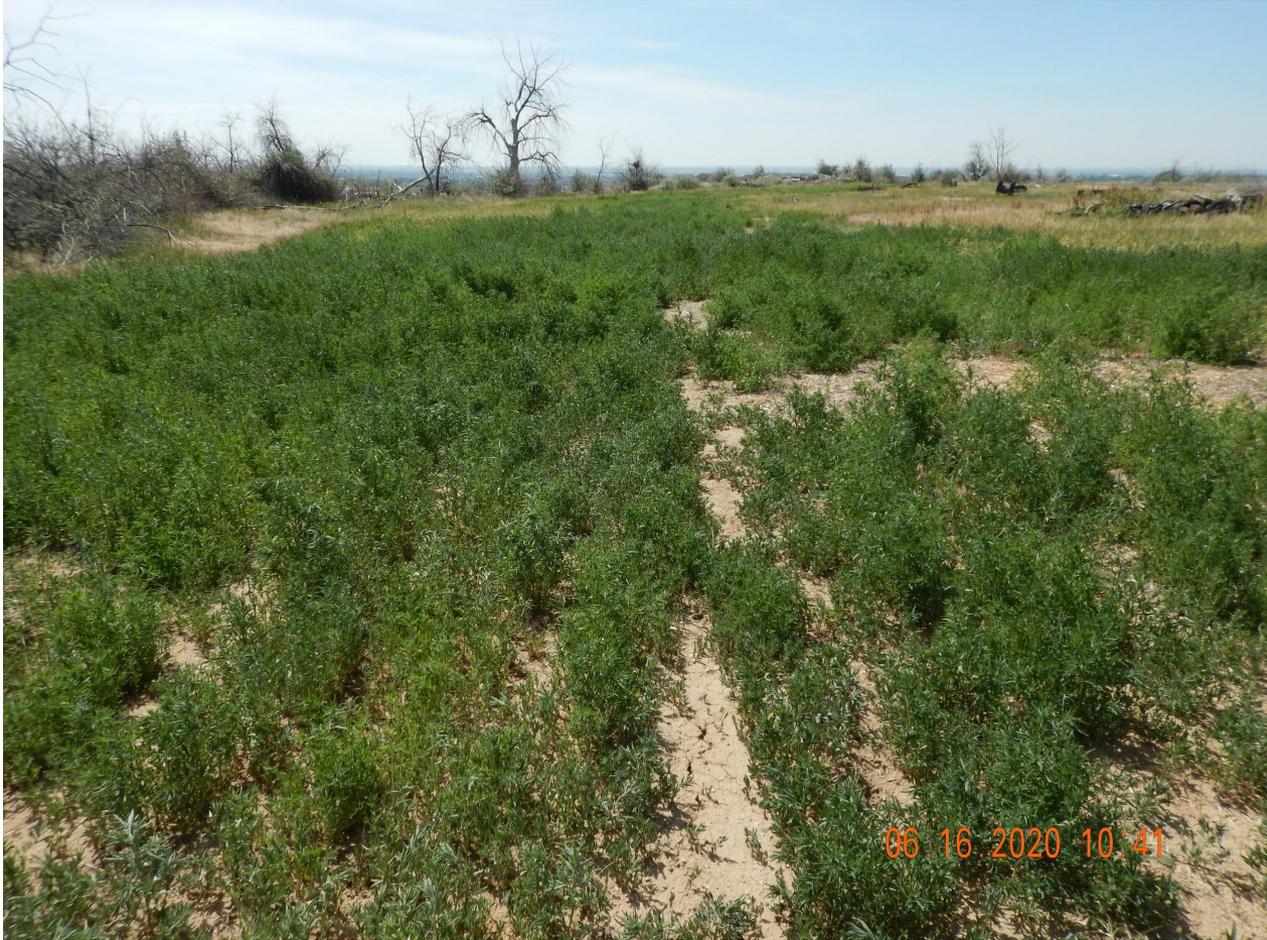
**Photo 4.** Photo taken along a portion of the access road, facing South. See comments under Photo 3.

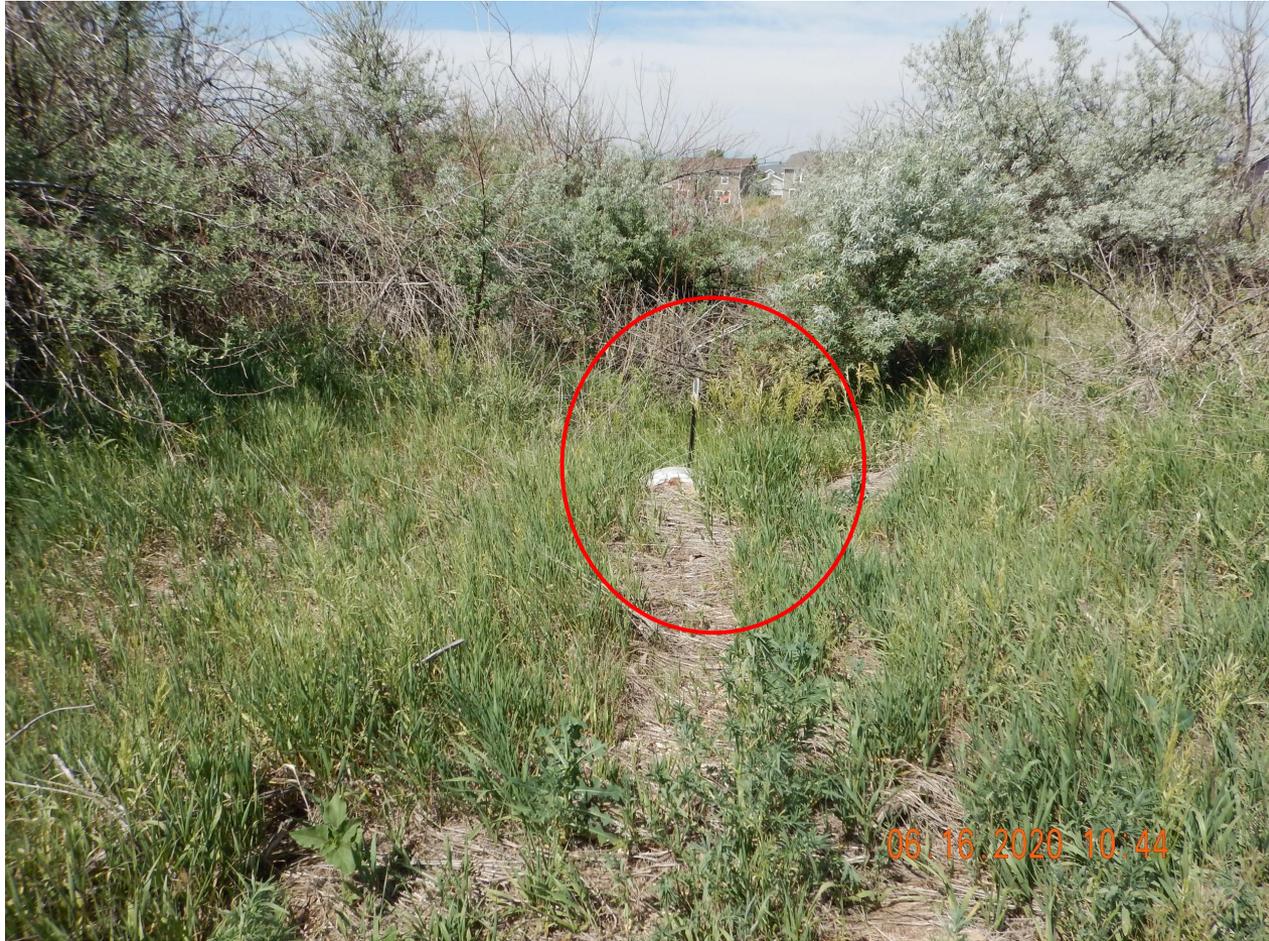
**Photo 5.** Photo taken along a portion of the access road, facing West. Photo illustrates a culvert has not been removed. There appears to be an old irrigation ditch.

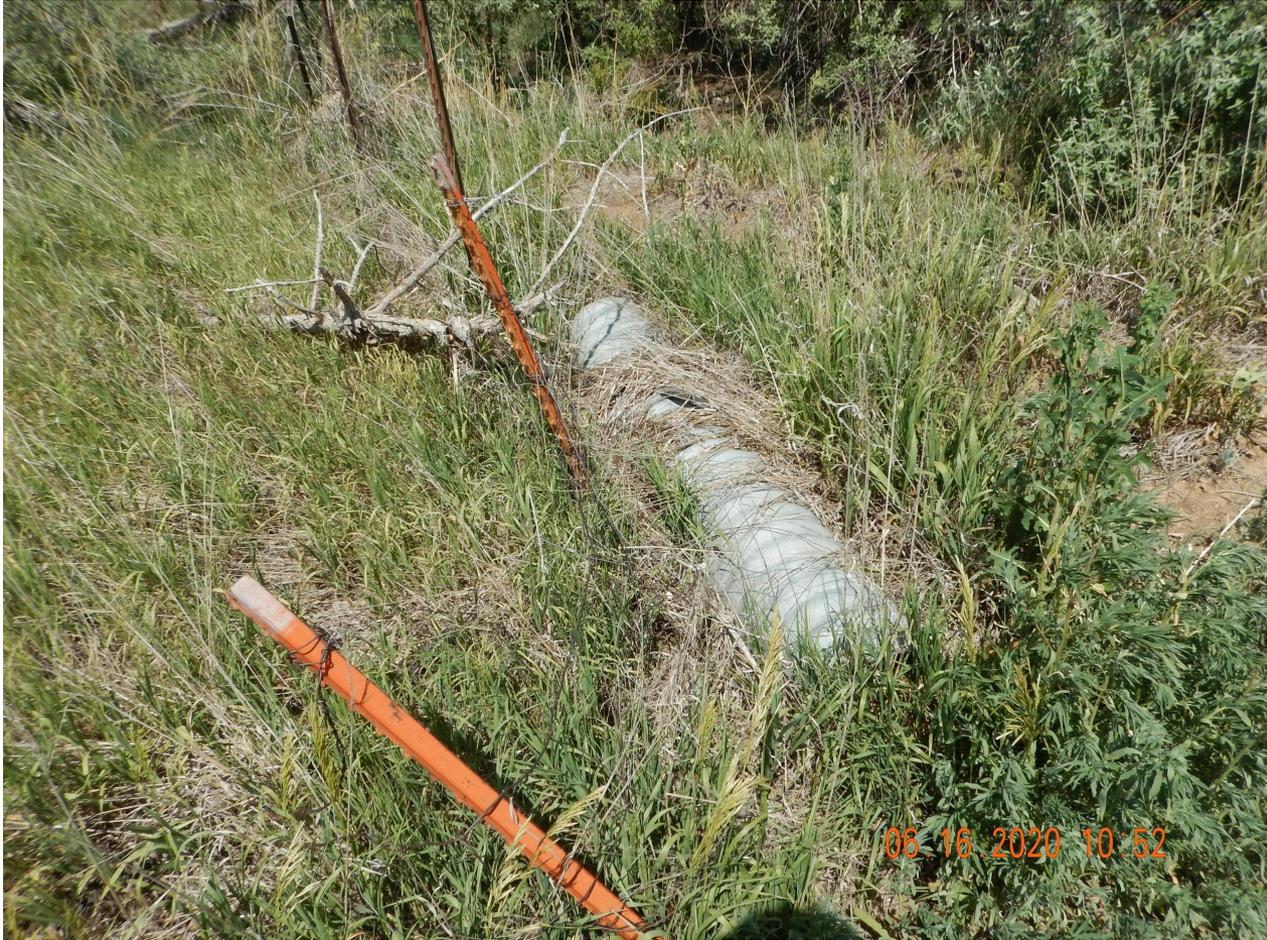
**Photo 6.** Photo taken along a portion of the access road, facing West. This is a second culvert left just south of the previous.

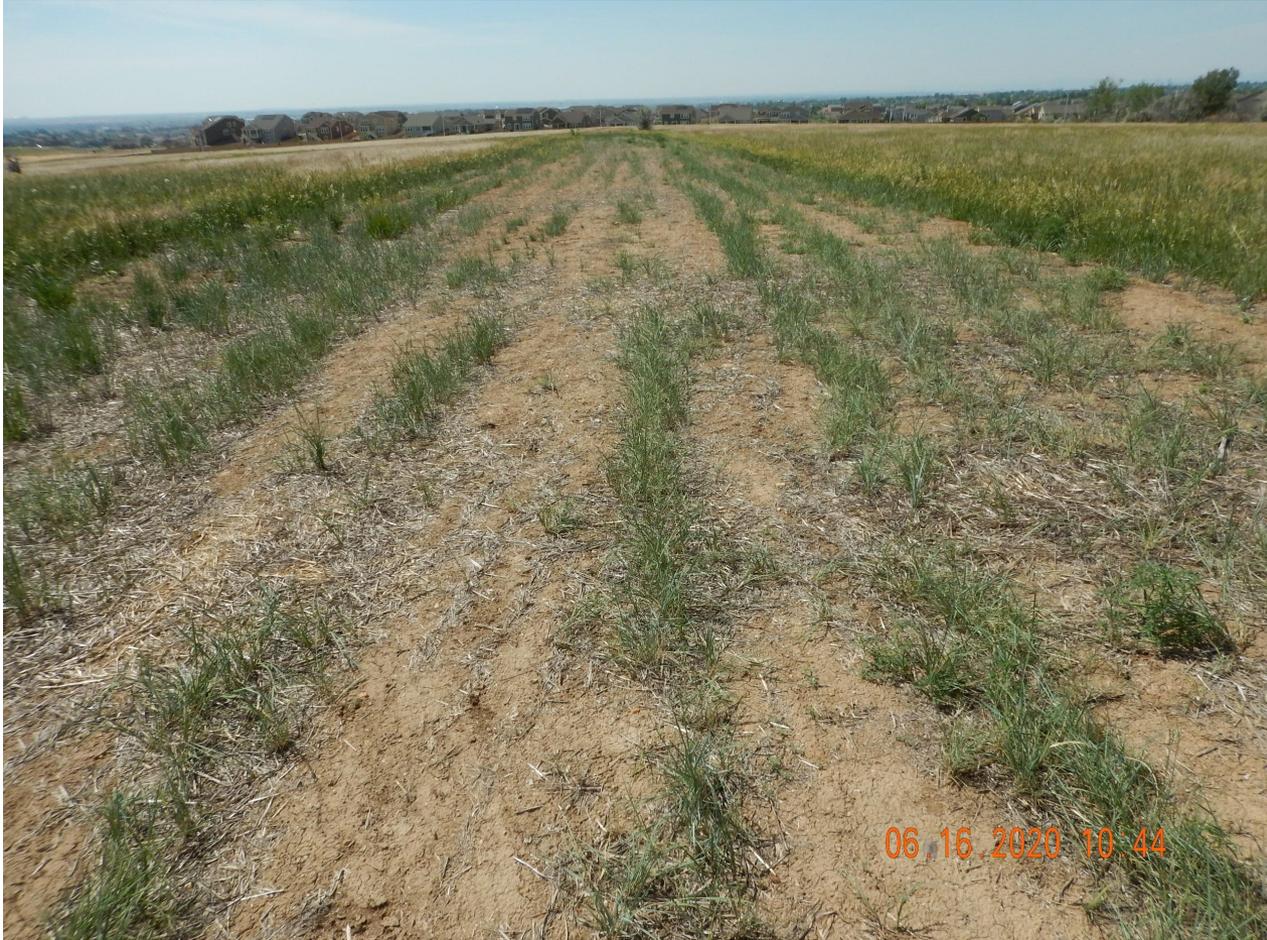
**Photo 7.** Photo taken from the southern access road, facing South. Photo illustrates the establishment of desirable species but lacks uniform establishment with bare patches.

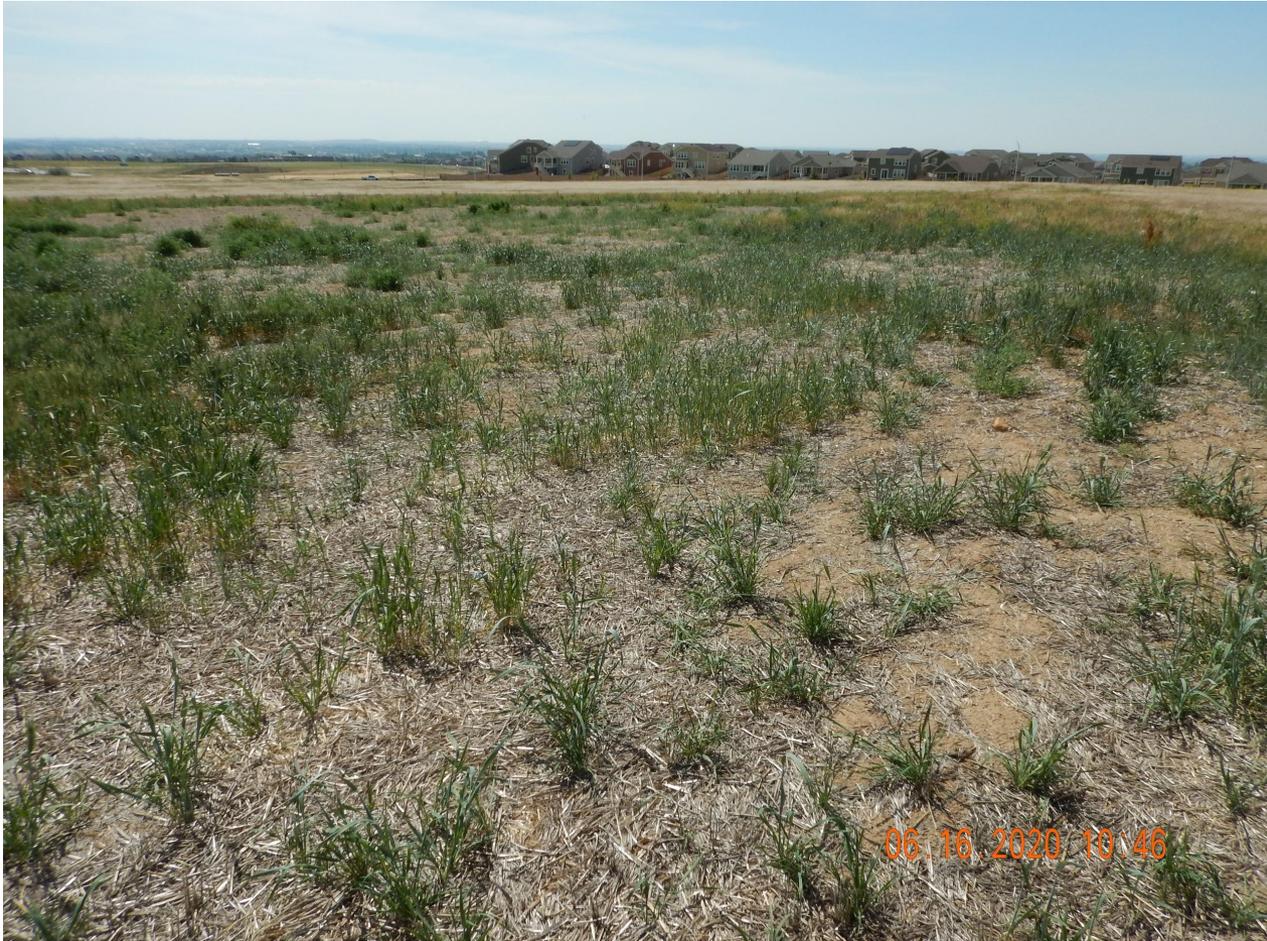
**Photo 8.** Photo taken from the northern well location, facing South. Photo illustrates vegetative growth of wheat that appears to have established from the mulch. There was some desirable plant species establishment but not uniform.

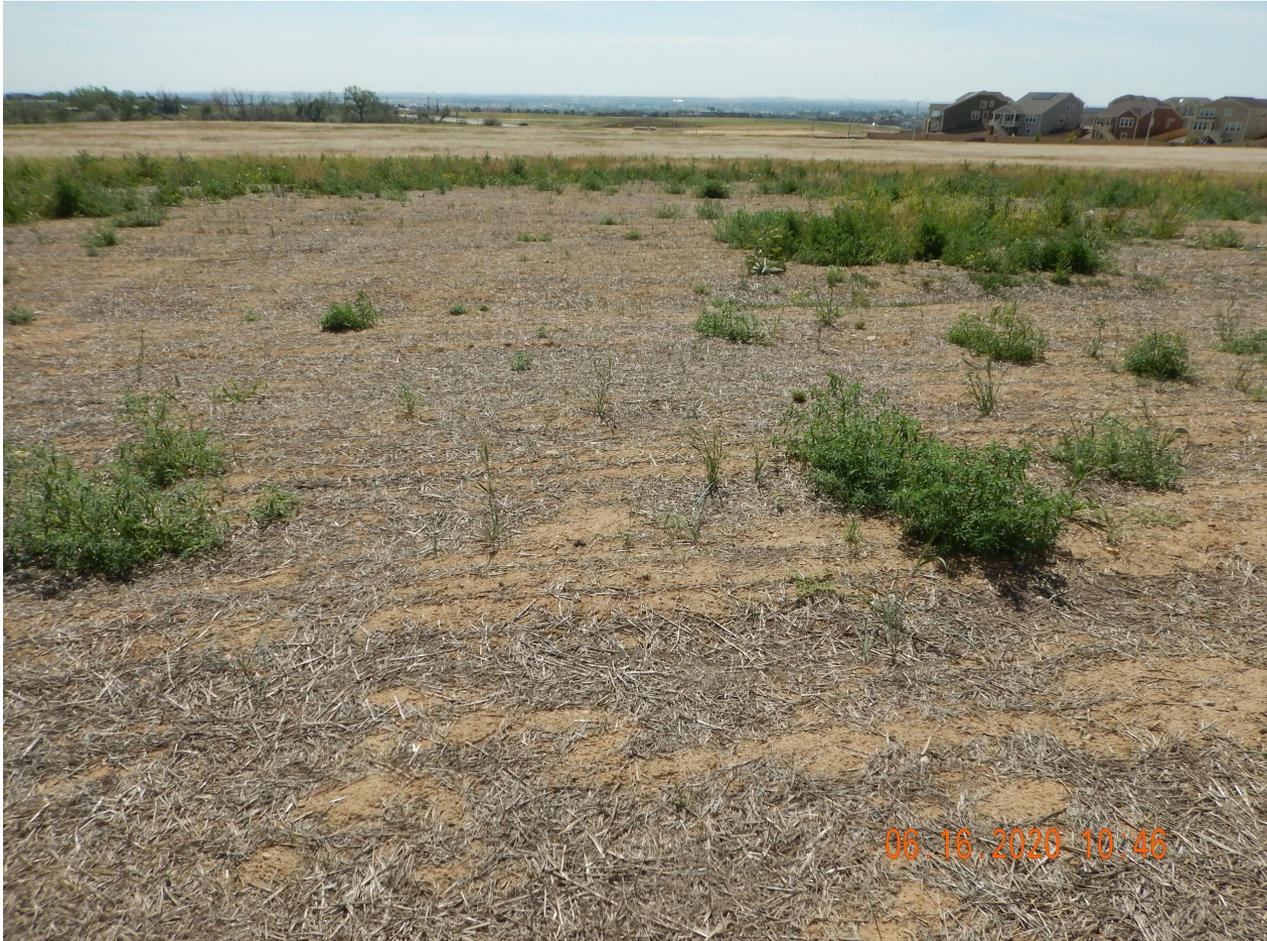
**Photo 9.** Photo taken from the northwestern well location, facing Southeast. See comments under Photo 8.

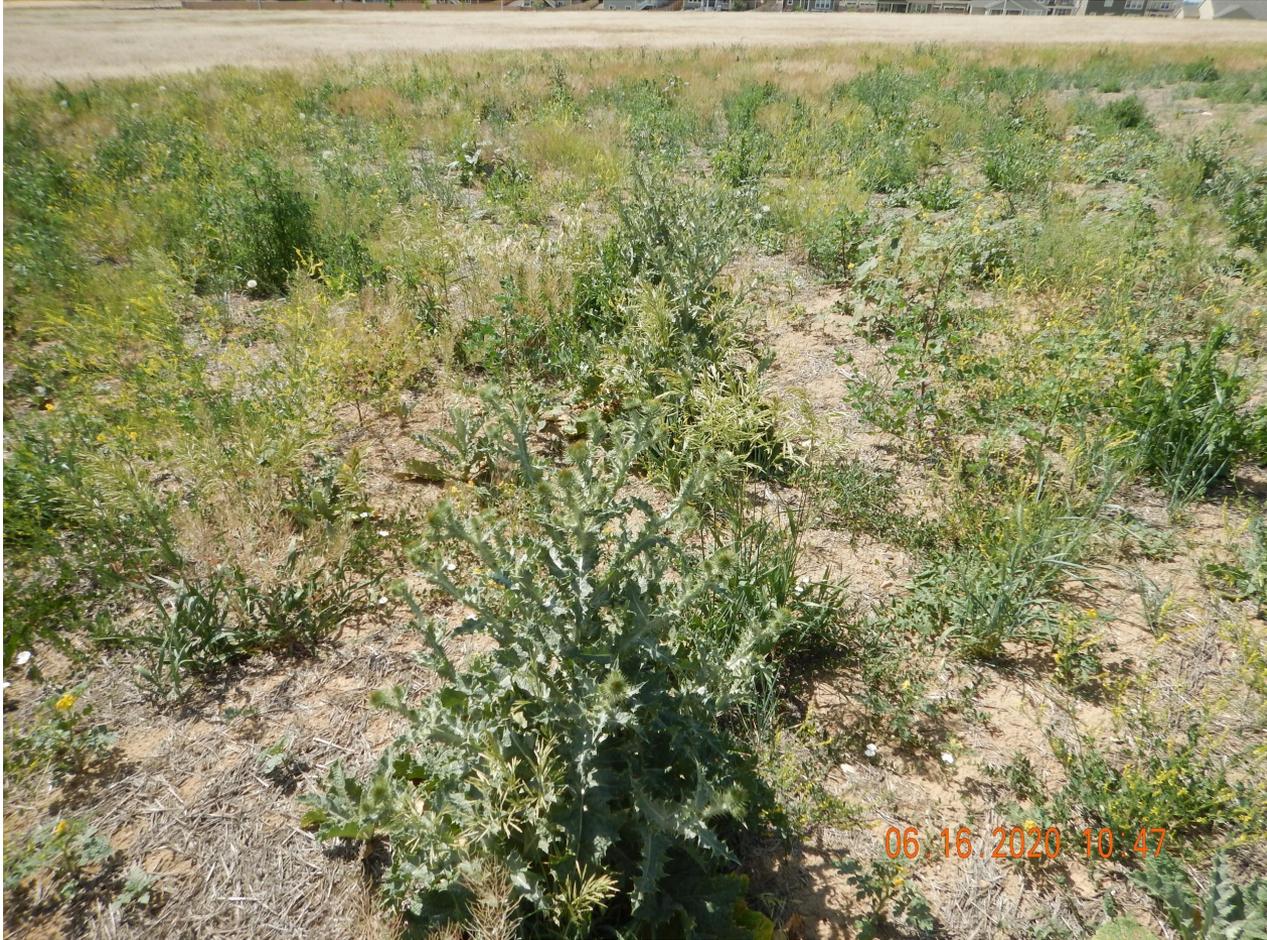
**Photo 10.** Photo taken from a portion of the well location. Photo illustrates the establishment of Scotch thistle, a List B CO Noxious weed. No Scotch thistle was observed flowering, only some Musk.

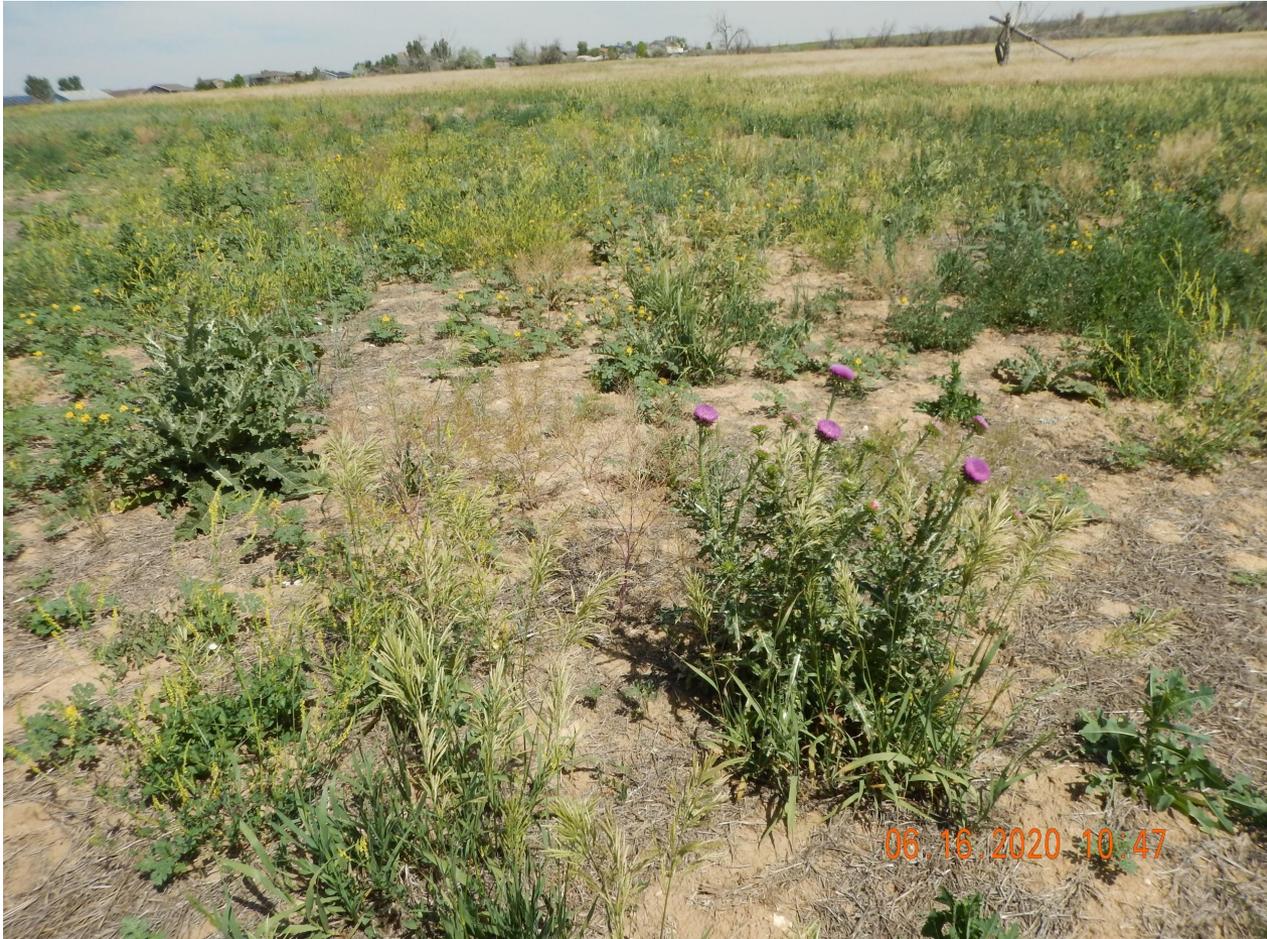
**Photo 11.** Photo taken from a portion of the well location. Photo illustrates the establishment of Musk thistle, a List B CO Noxious weed. Musk thistle has appeared to just start flowering.
