COLORADO
Oil & Gas Conservation
Commission
Department of Natural Resources

Taiga Fed 7F-21-4-102

API: 05-103-08086

Inspection: 700402056

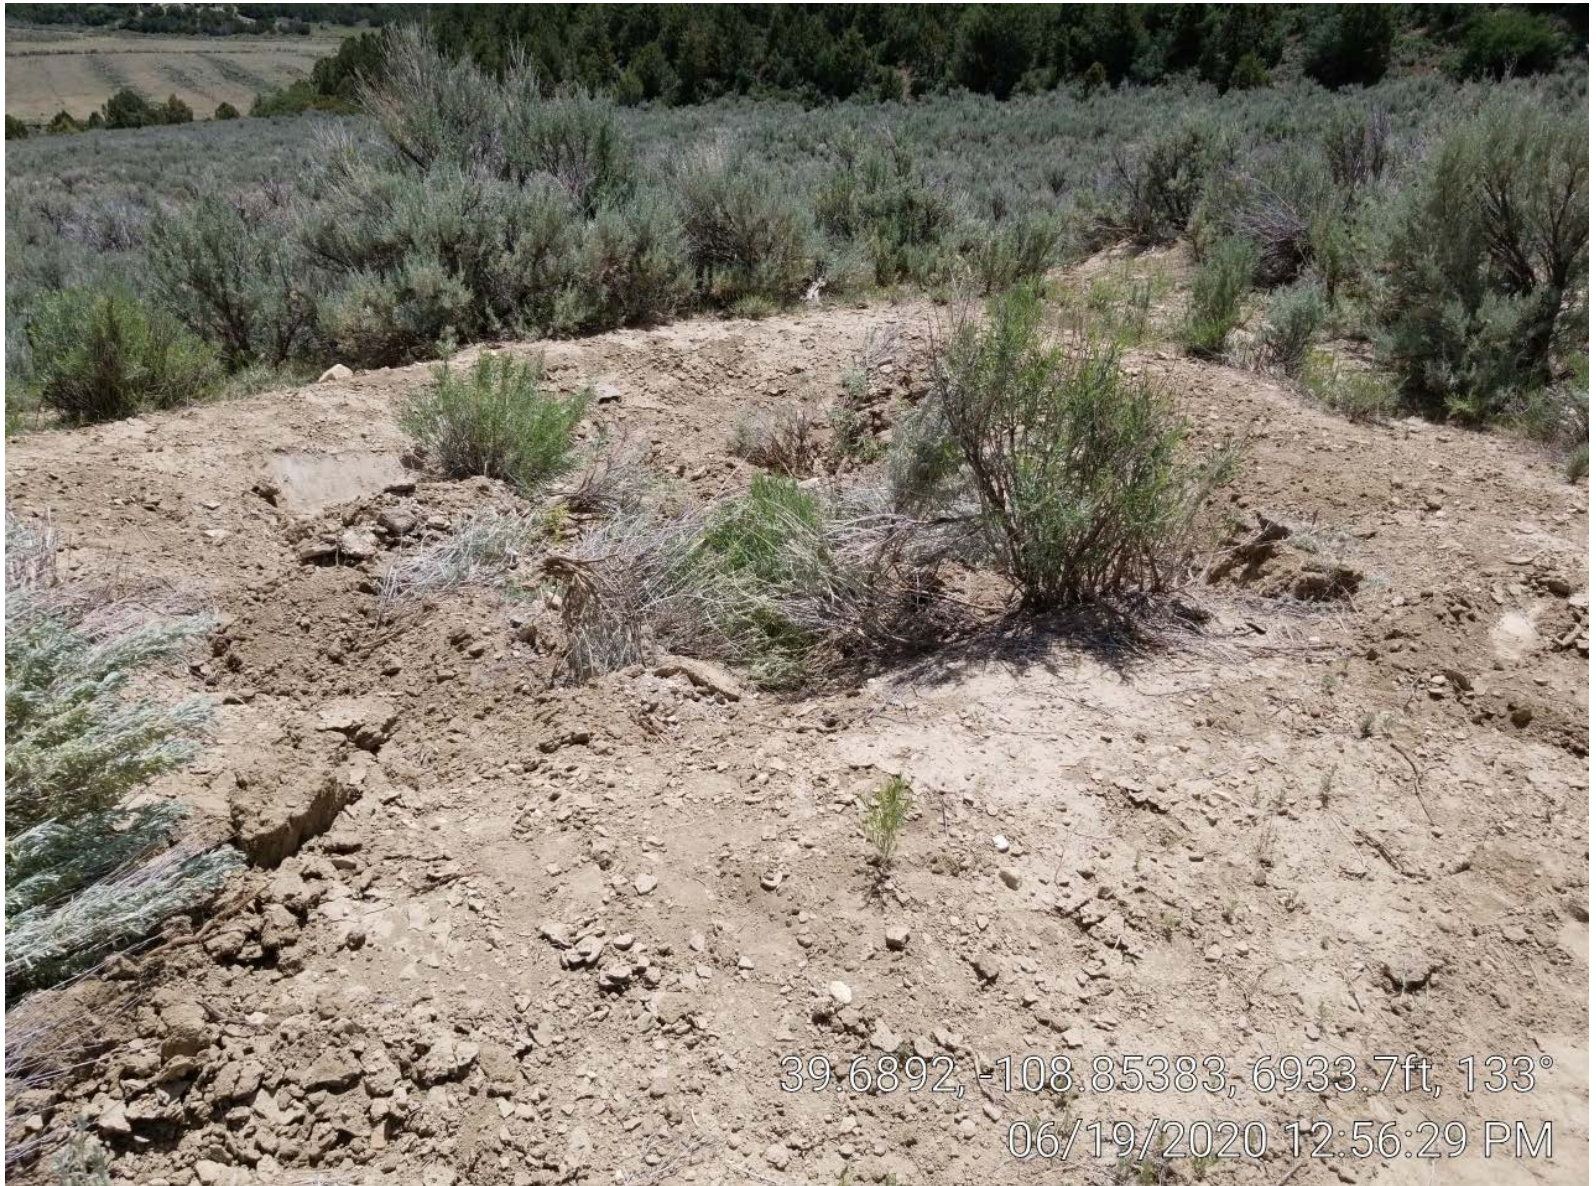
Photo 3. Flow line valve.

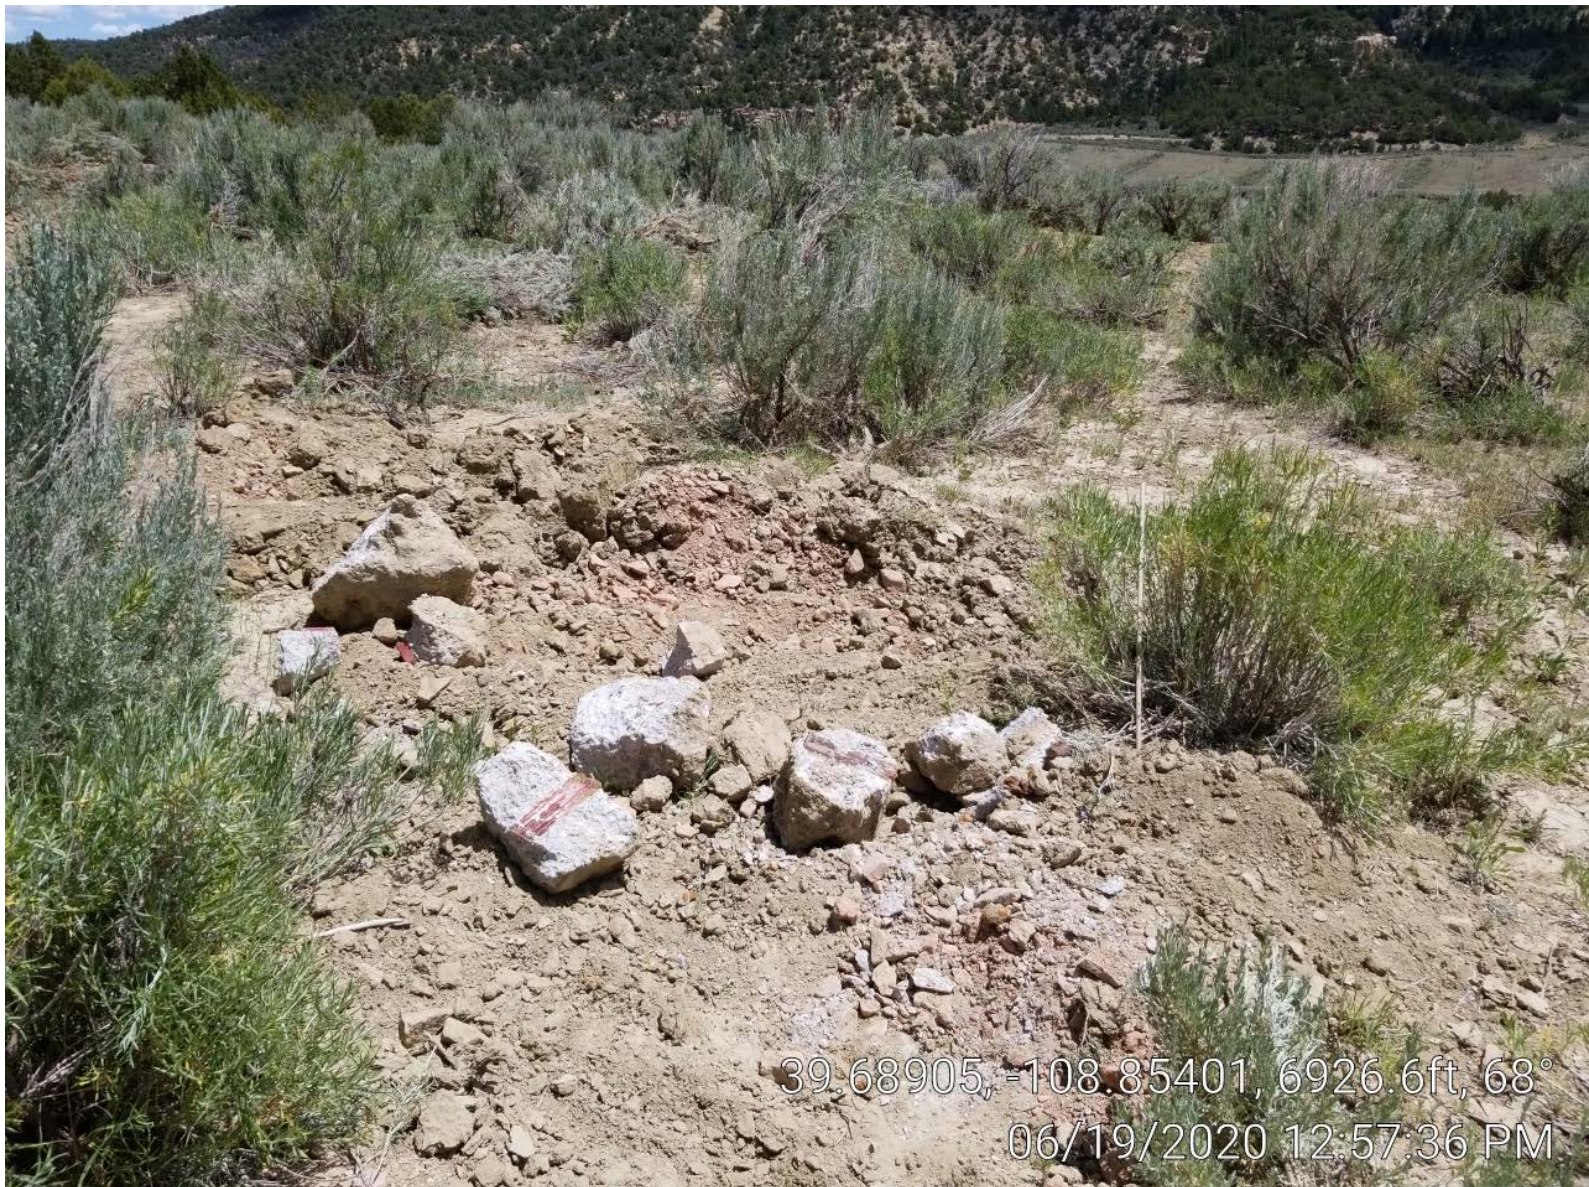
Photo 4. Bermed area.

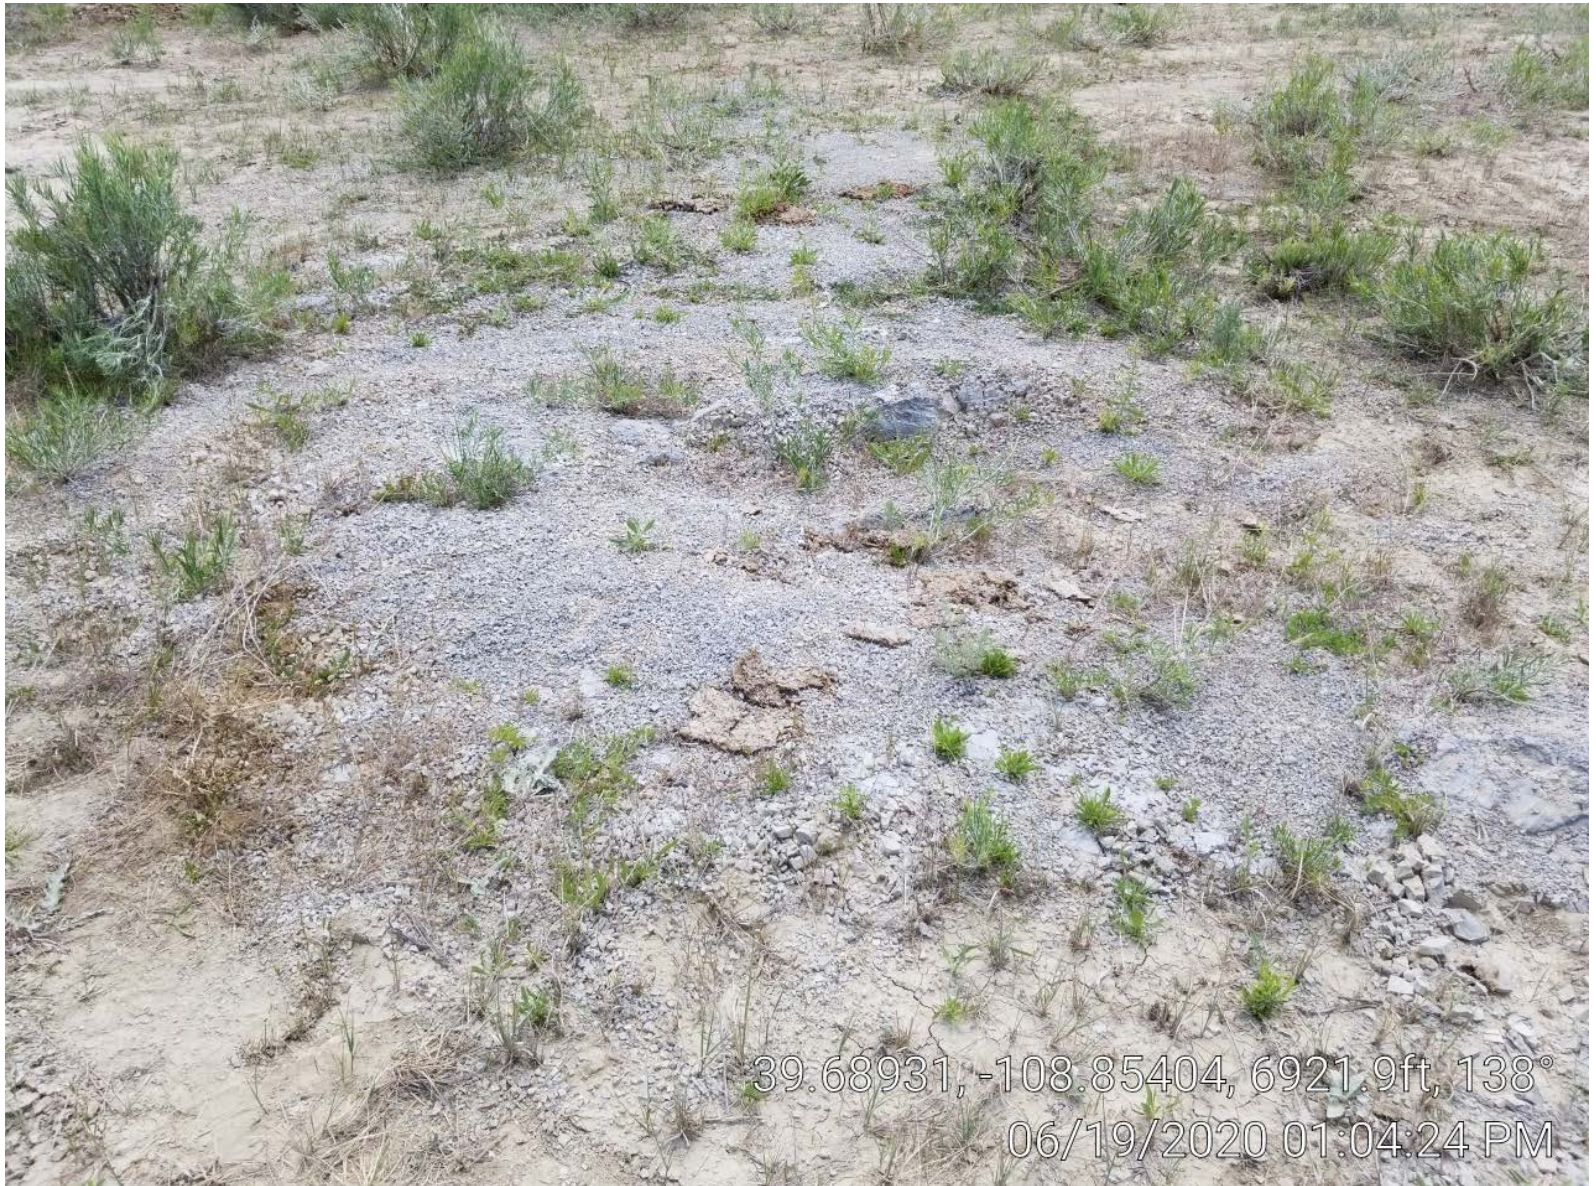
Photo 5. Concrete chunks.
