Inspection Photos
Operator: BP America
API: 067-08991
Date: 6/19/2020

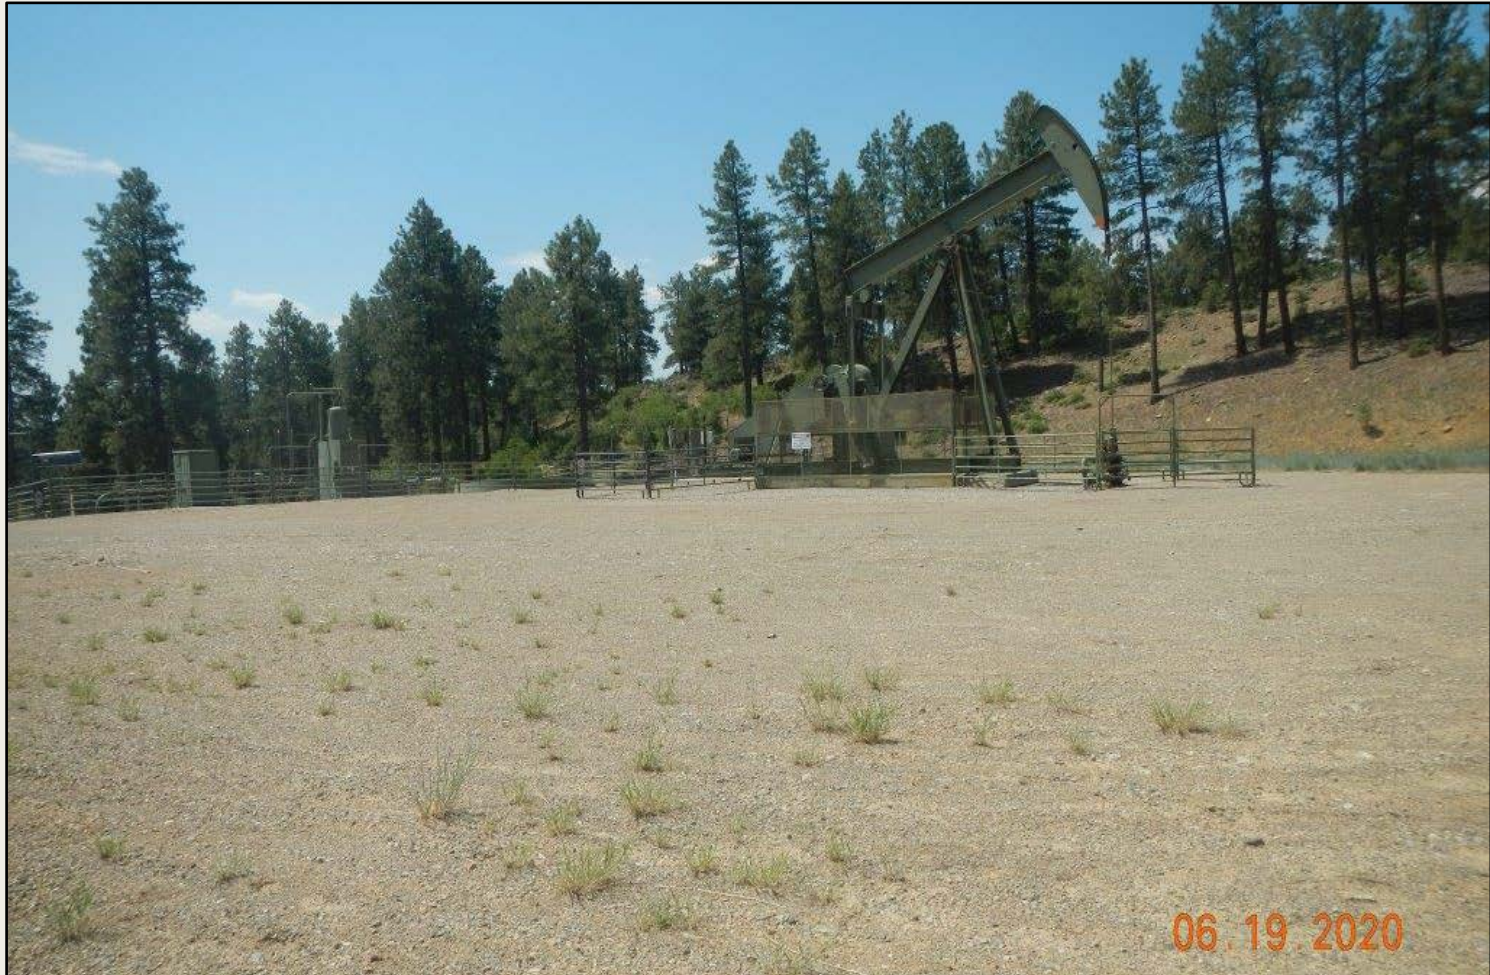
Photo 1. View of the project area from the northeastern corner facing center.

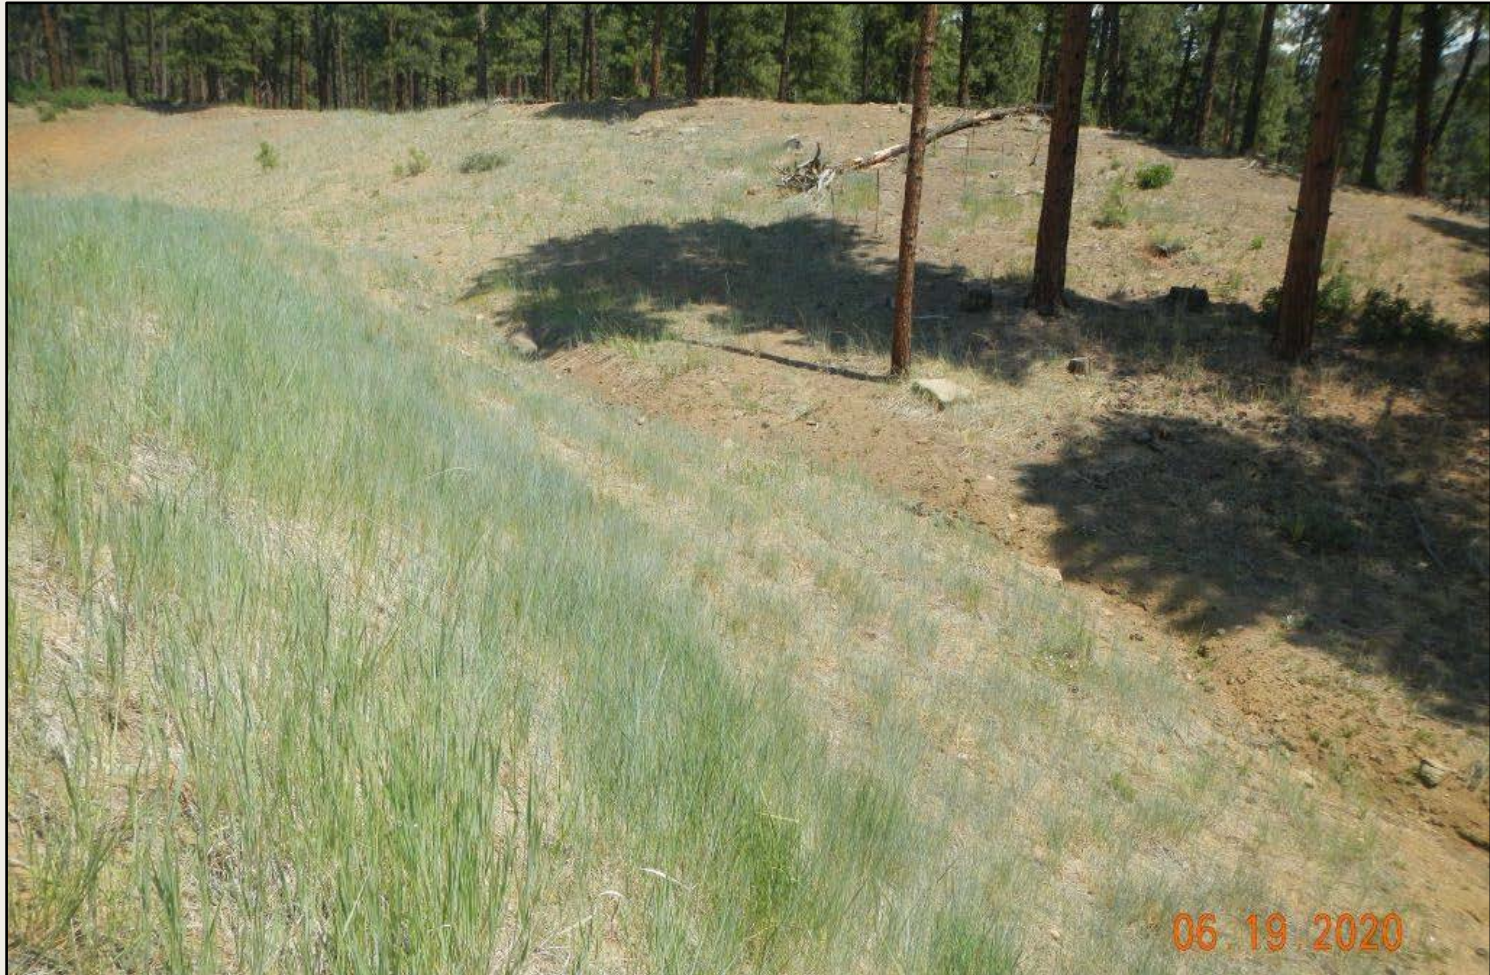
Photo 2. View of the eastern fill slope from the southeastern corner facing westward. Revegetation is progressing, largely with smooth brome and western wheatgrass.

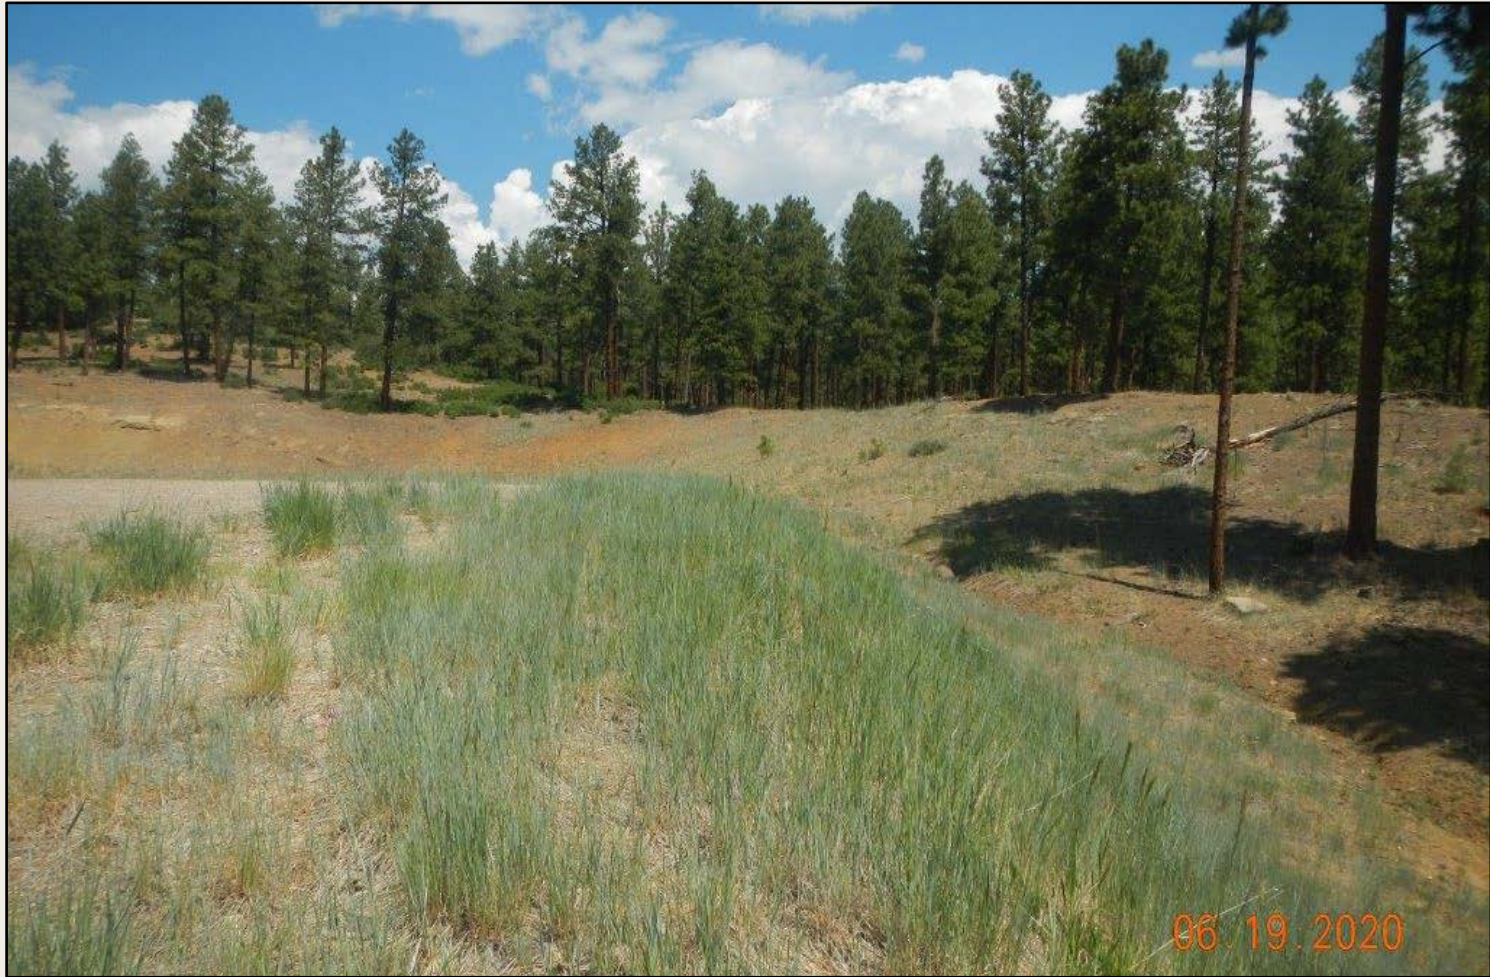
Photo 3. View of the northeastern fill slope from the northeastern corner facing westward.

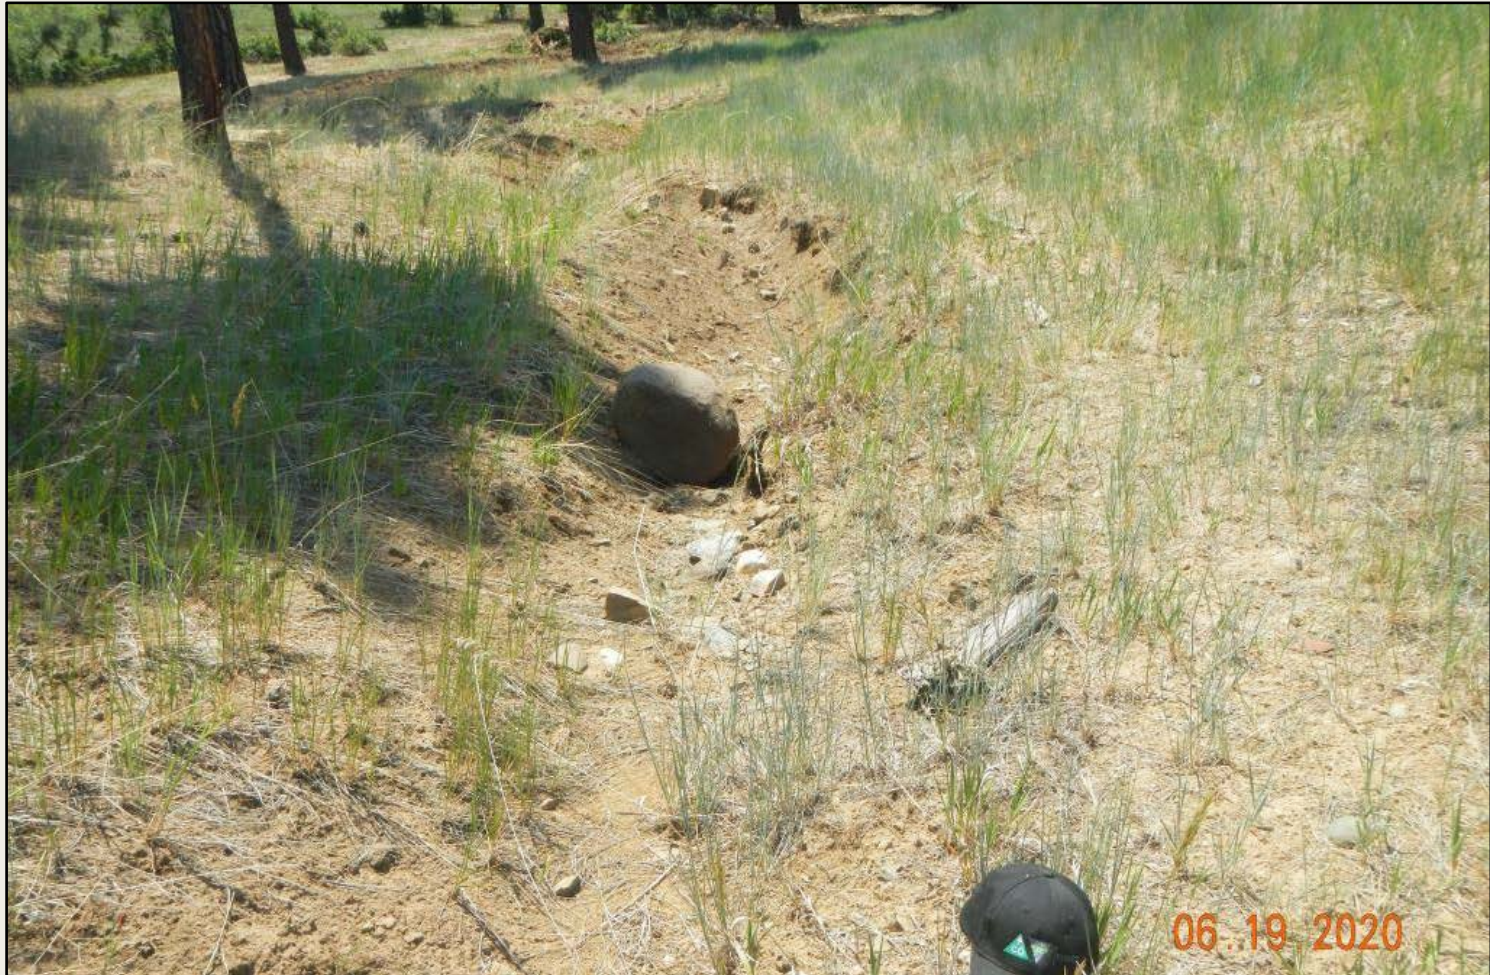
Photo 4. View of erosional channel forming downstream of northeastern diversion, approximately 2 feet wide and 1 foot deep.

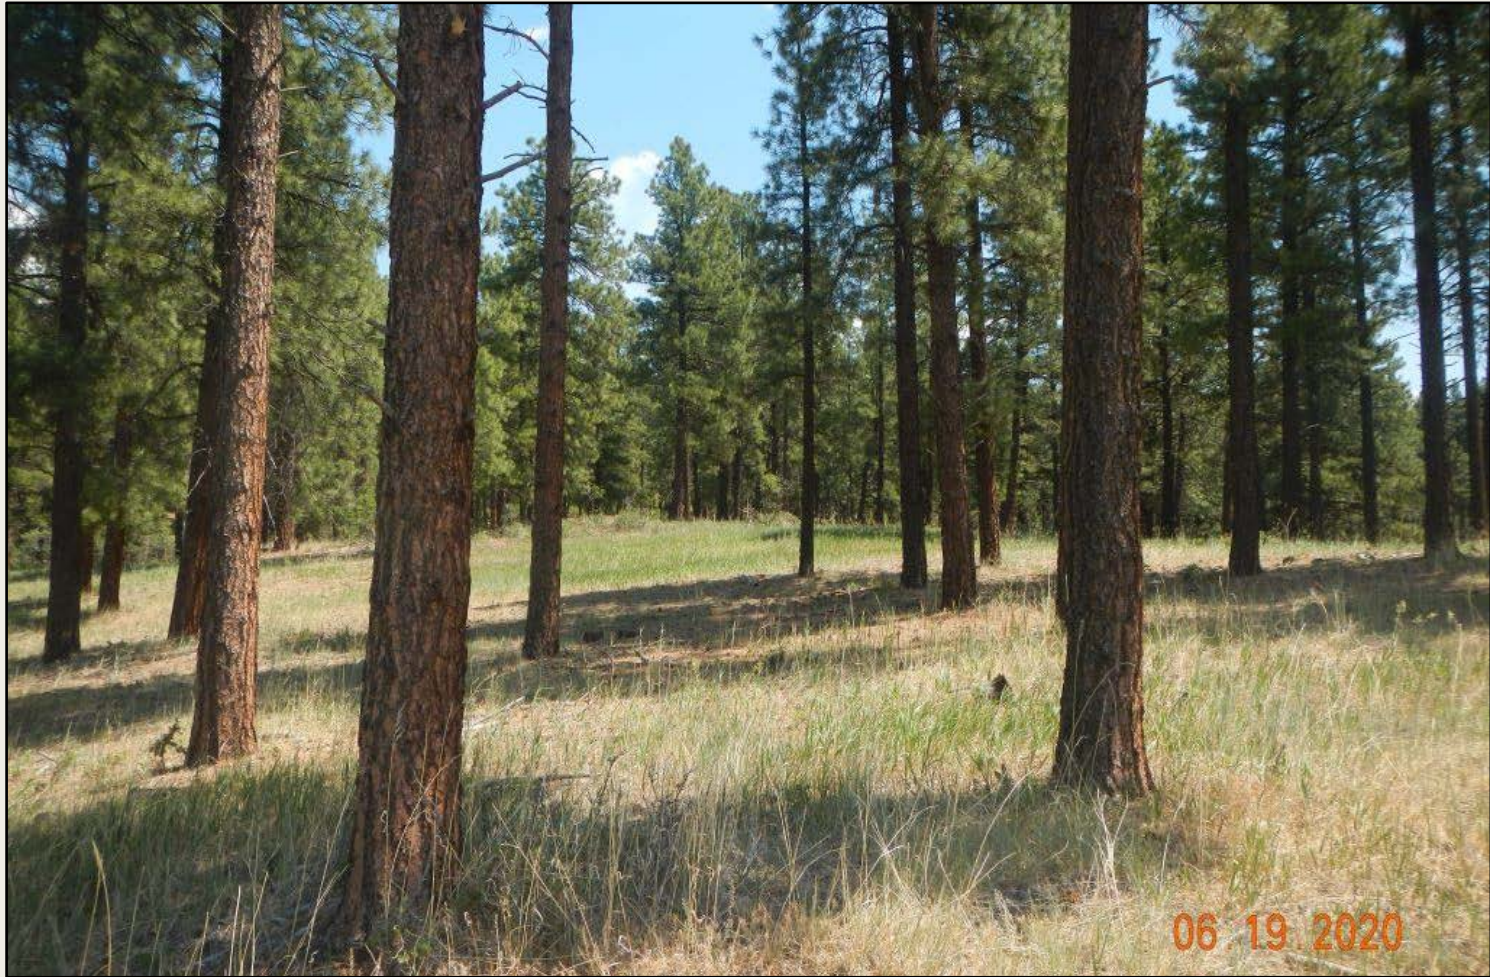
Photo 5. View of the reference area, comprised of ponderosa pine woodland with a grassy understory of smooth brome and western wheatgrass, as well as gambel oaks.
