Interim Reclamation and Stormwater Inspection

June 11, 2020

Operator: PDC ENERGY INC - 69175

Location ID: 433548

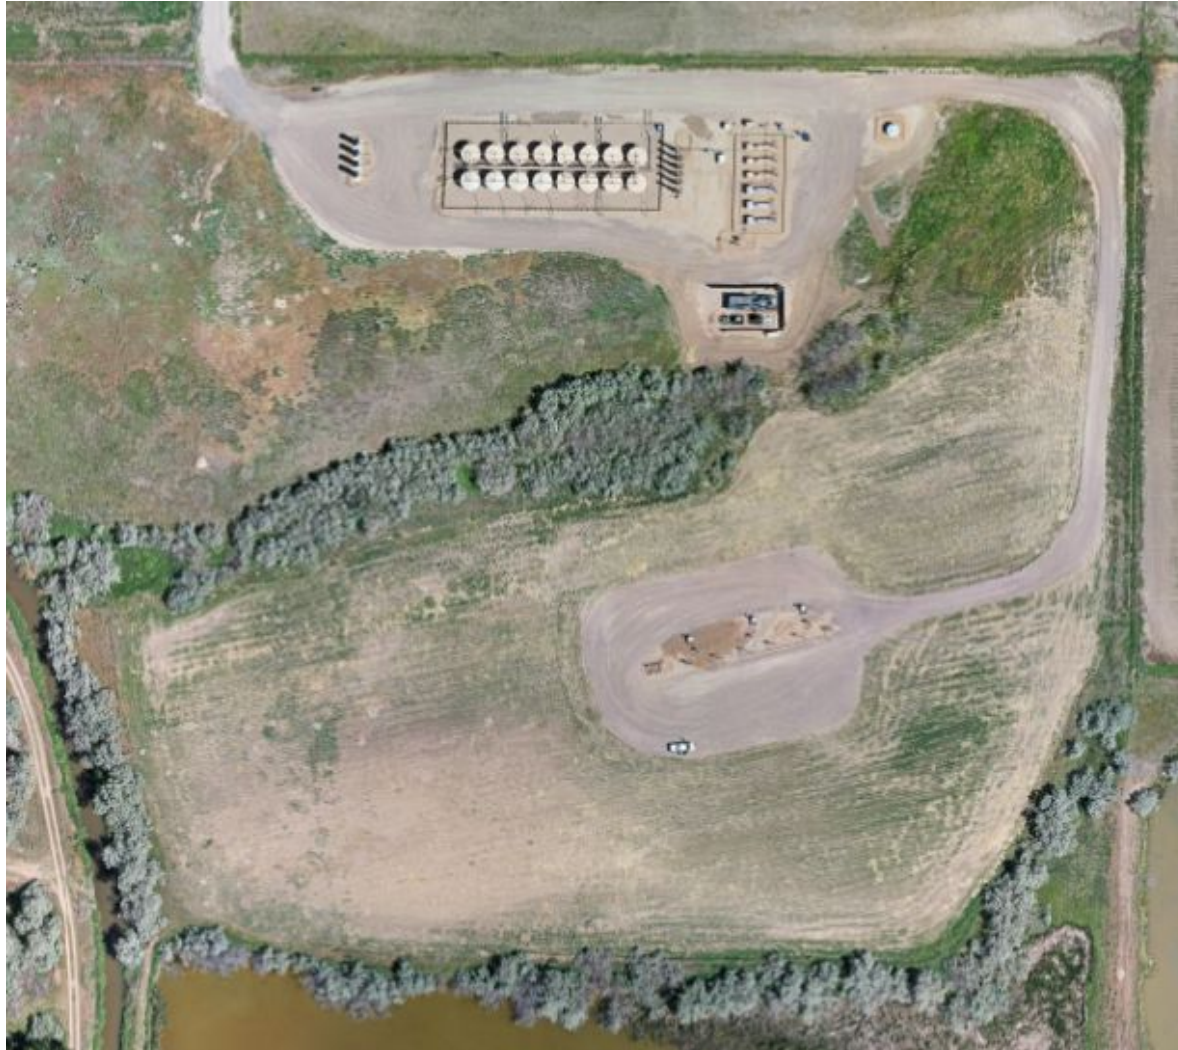
Photo 1. Drone aerial imagery from June 11, 2020 illustrates the Phelps location.

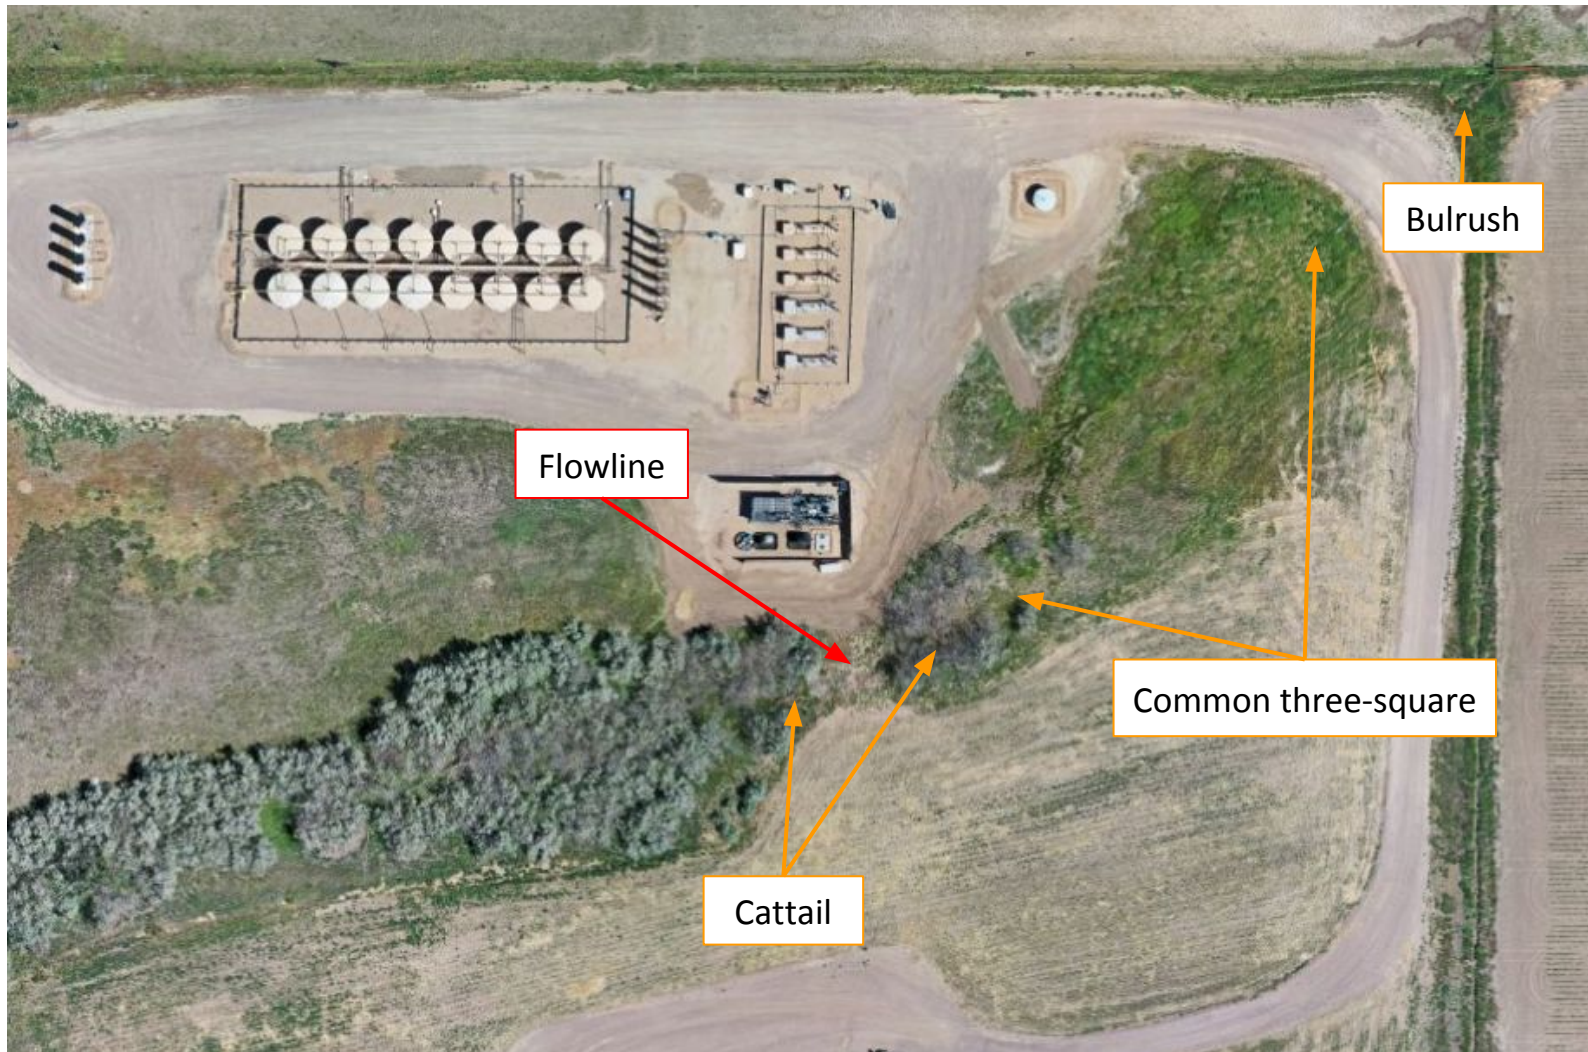
Photo 2. Drone aerial imagery from June 11, 2020. Imagery illustrates some of the obligate wetland vegetation observed in relation to the Phelps disturbance areas. Refer to Photos 3-5 for wetland vegetation.

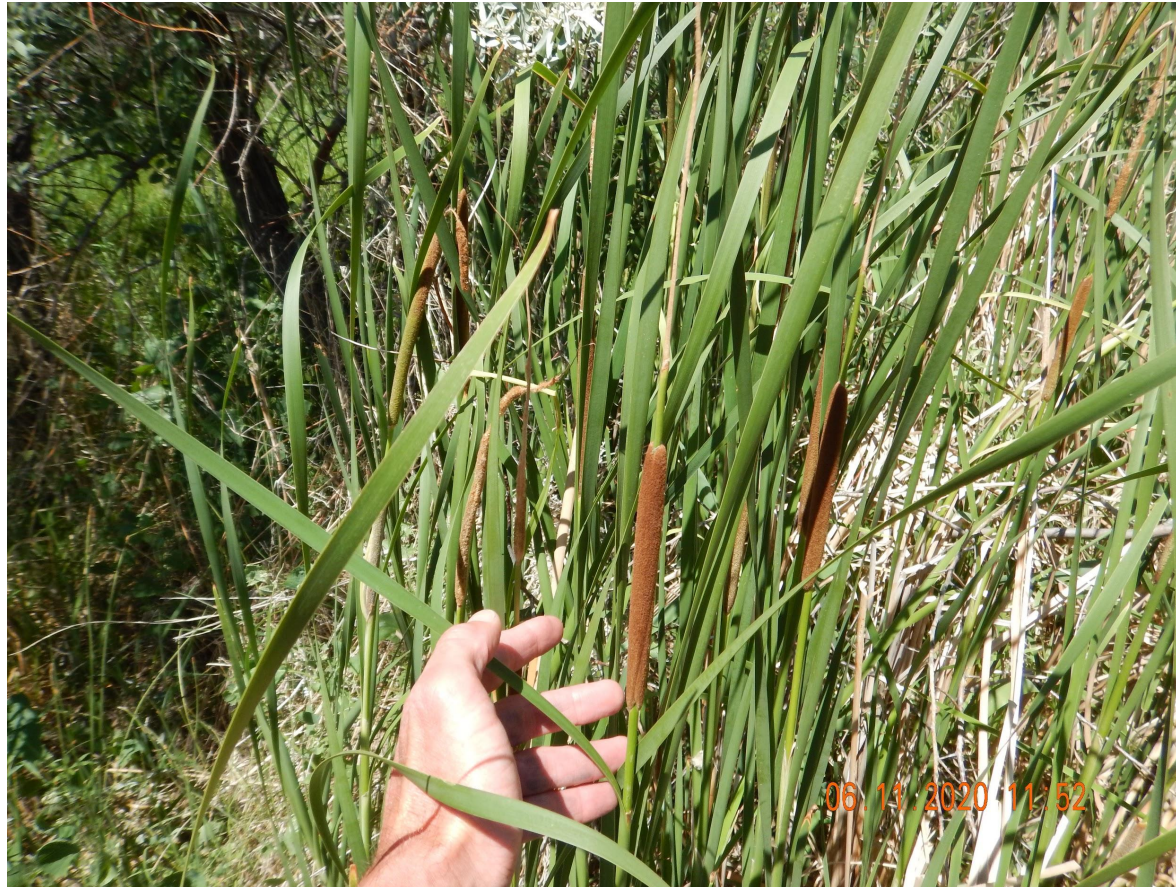
Photo 3. Photo taken west of the flowline area. Photo illustrates Narrowleaf cattail, an obligate wetland plant species.

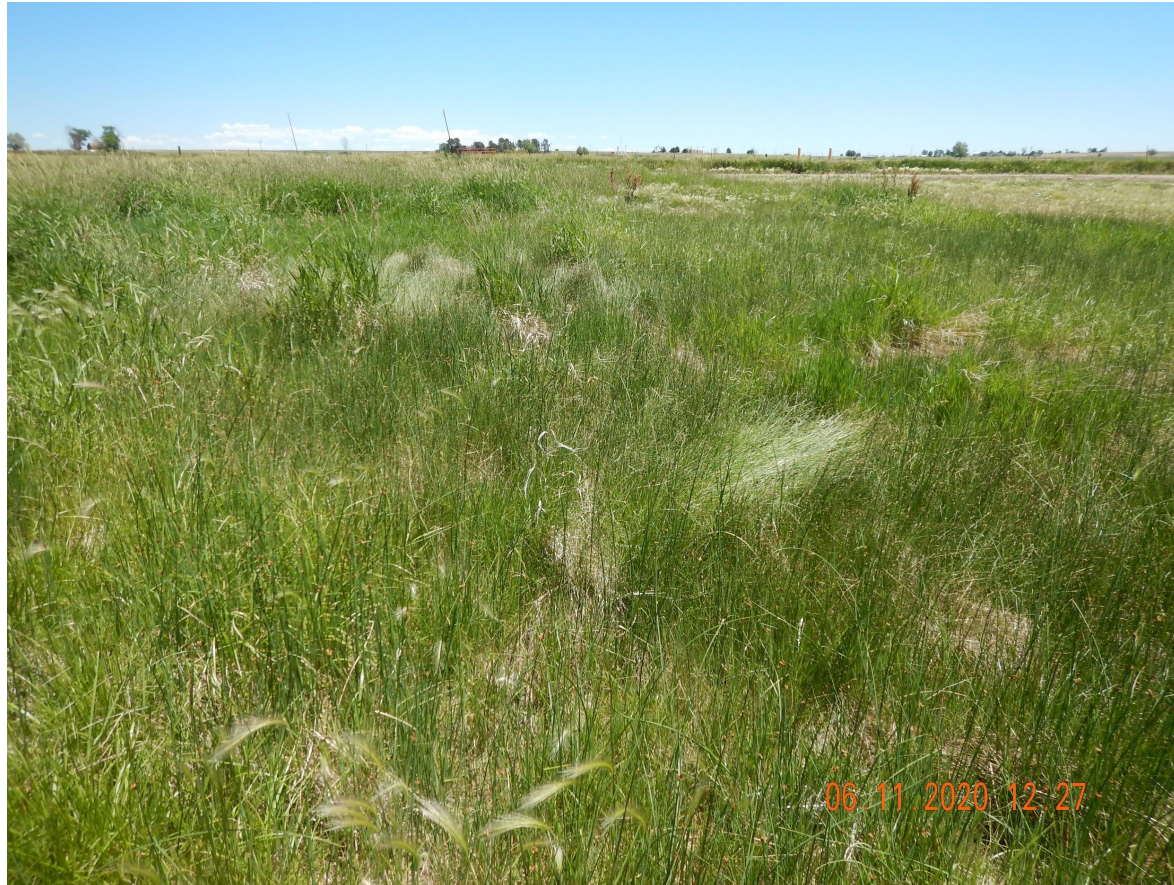
Photo 4. Photo taken east of the flowline area, facing Northeast. Photo illustrates wetland vegetation mostly consisting of Common threesquare, an obligate wetland plant species.

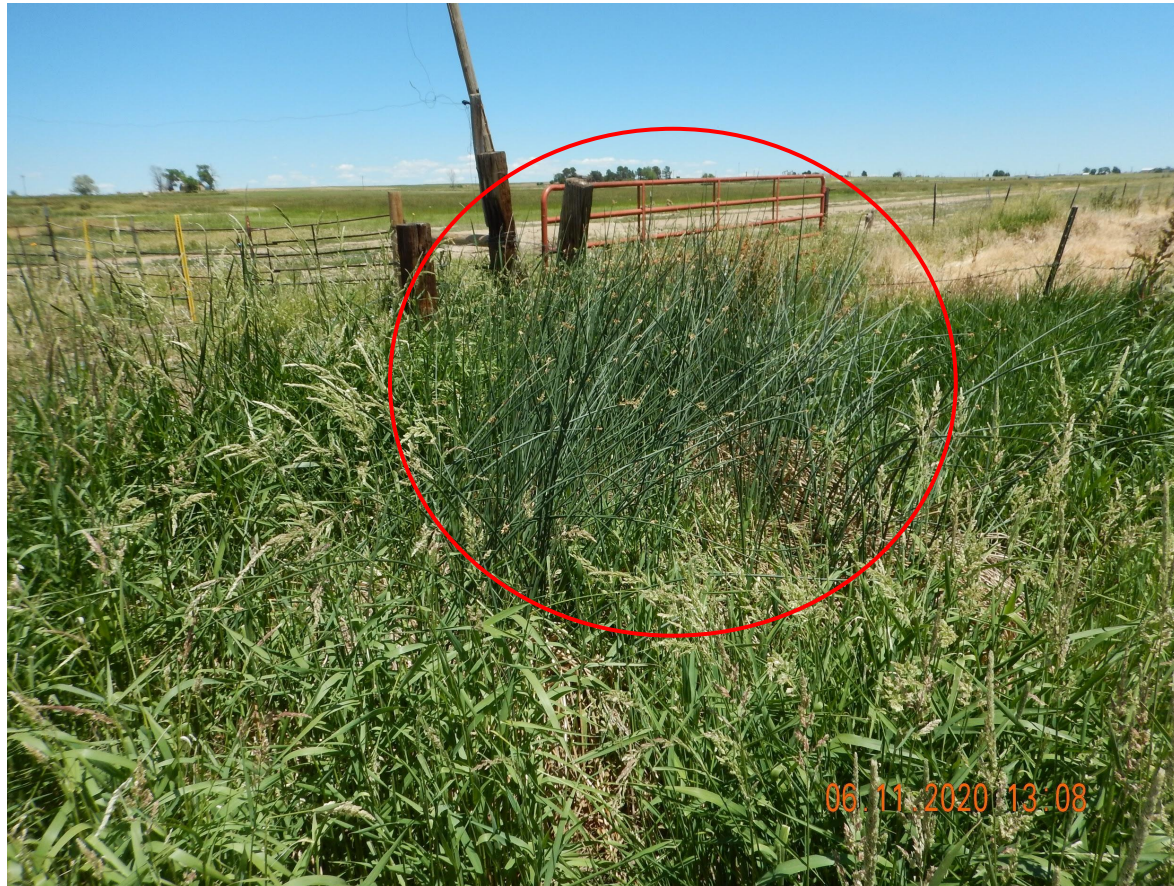
Photo 5. Photo taken north of the access road, facing Northeast. Photo illustrates Hardstem bulrush, an obligate wetland plant species.

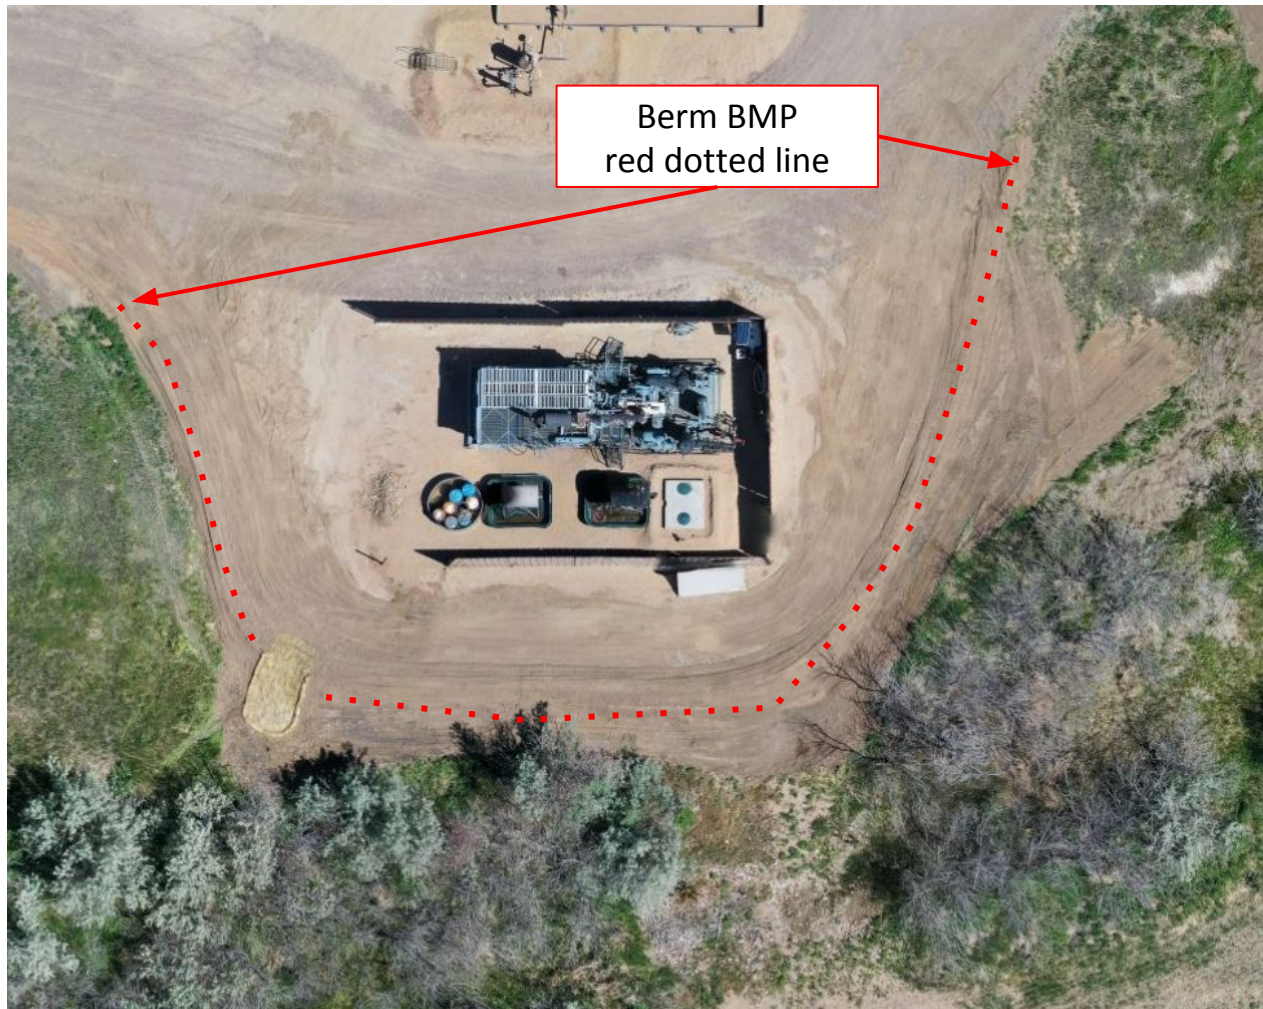
Photo 6. Drone aerial imagery from June 11, 2020 illustrates the Operator has performed some temporary stormwater work in response to the May 27, 2020 Environmental inspection by repositioning the berm BMP and installing a temporarily stabilized outlet. However, the current position of the temporarily stabilized outlet is not protective of the wetland.

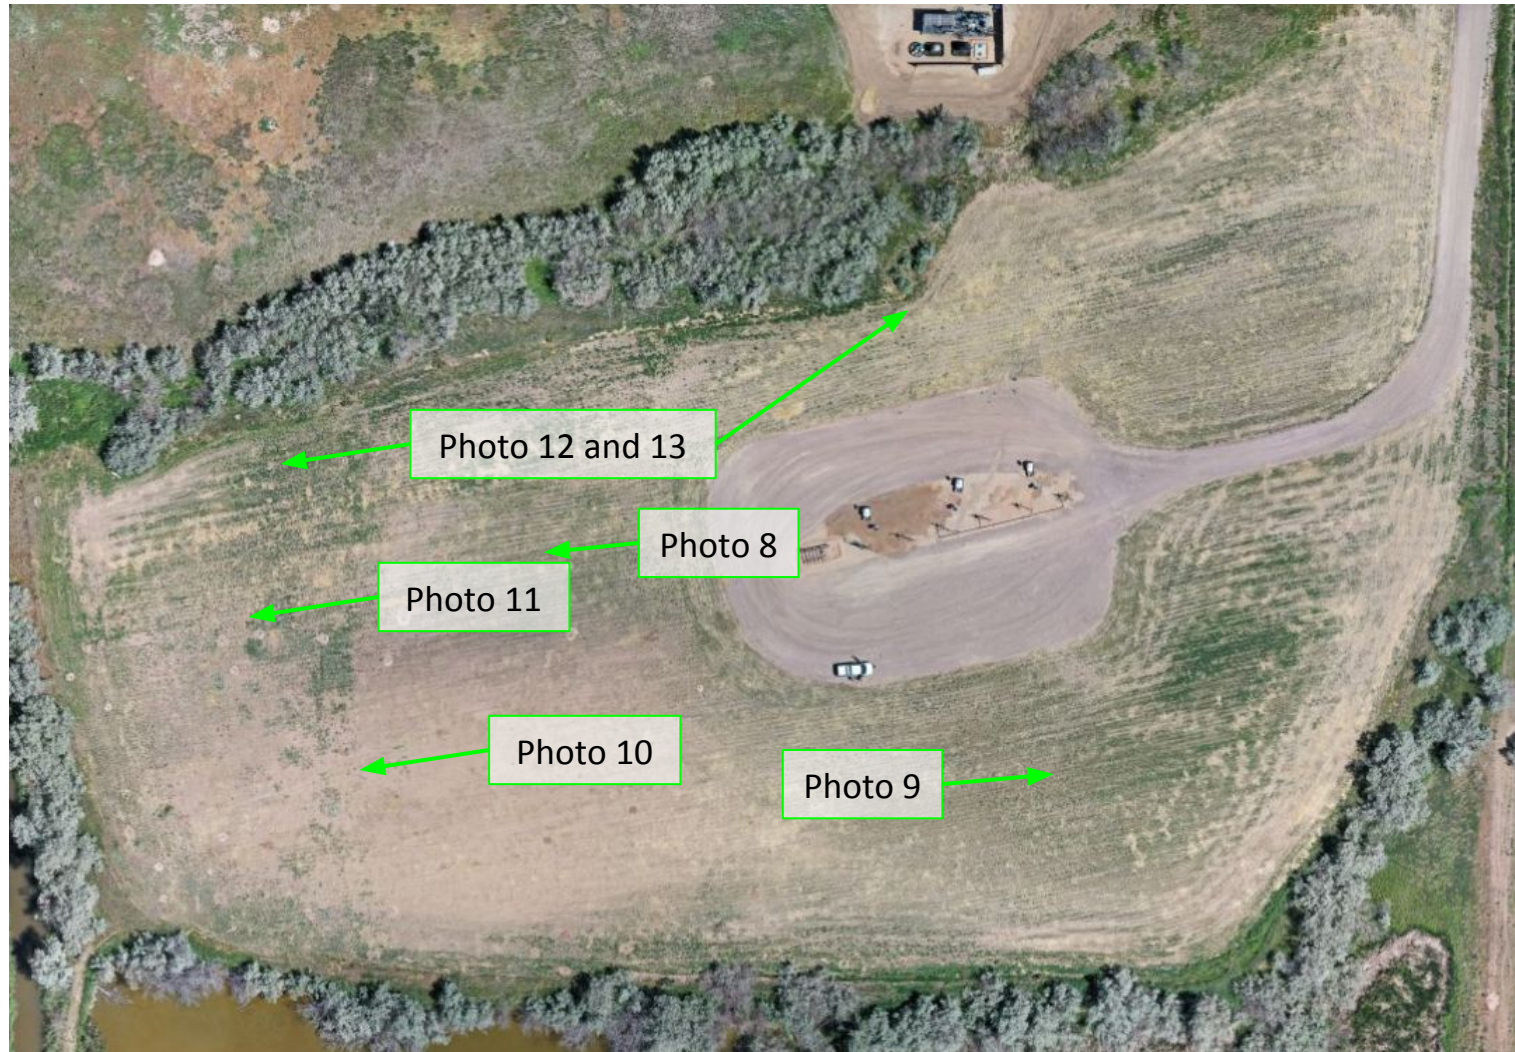
Photo 7. Drone aerial imagery from June 11, 2020 illustrates the interim reclamation area for the well location and associated field inspection photos.

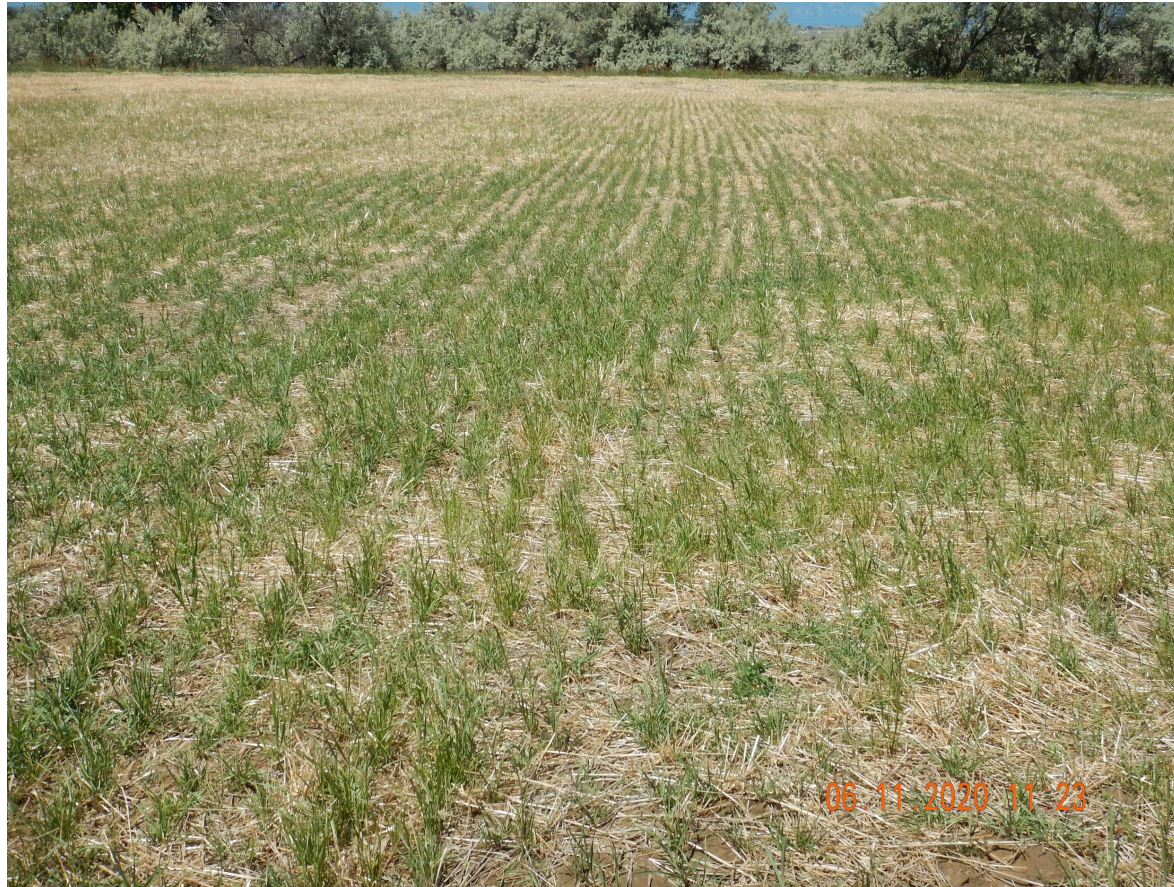
Photo 8. Photo taken from western interim reclamation area of the well location, facing West. Photo illustrates the Operator has performed interim reclamation activities with the evidence of desirable plant species establishment.

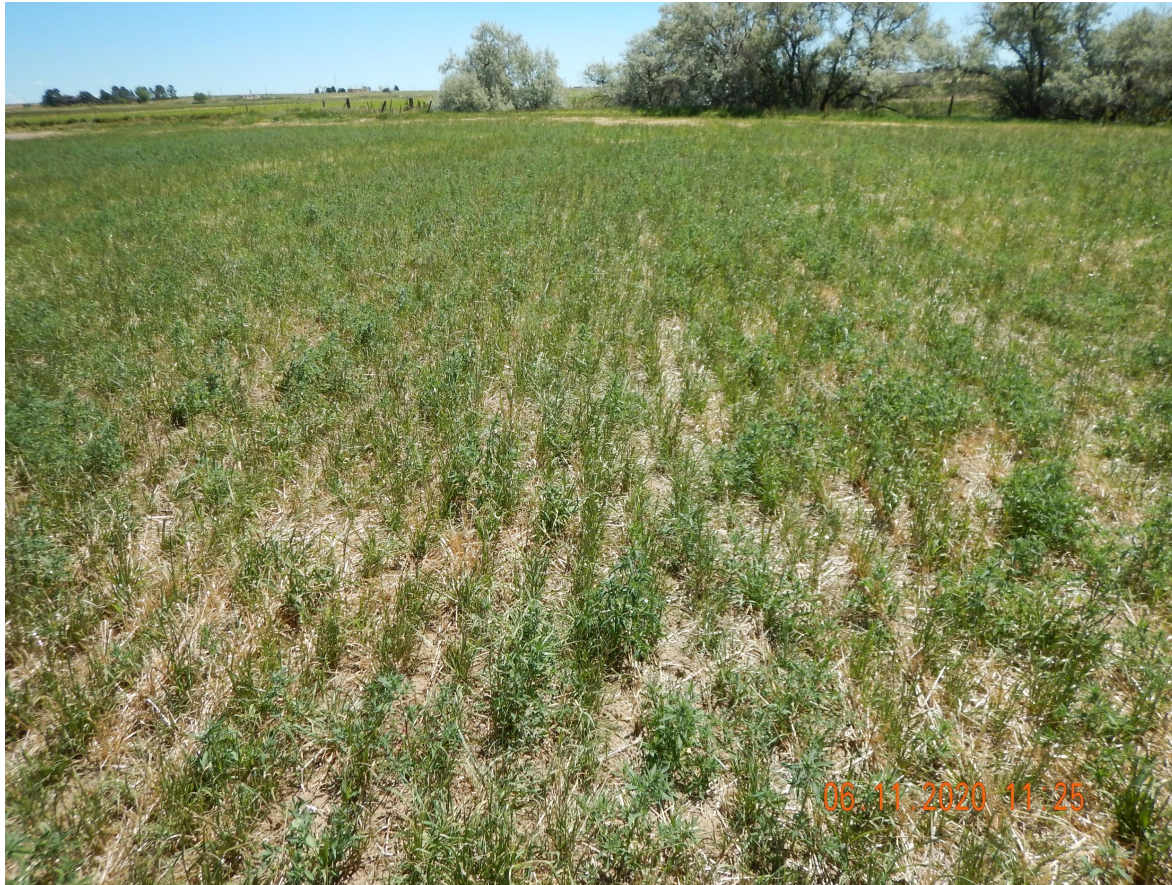
Photo 9. Photo taken from southeastern interim reclamation area of the well location, facing East. See comments under Photo 7.

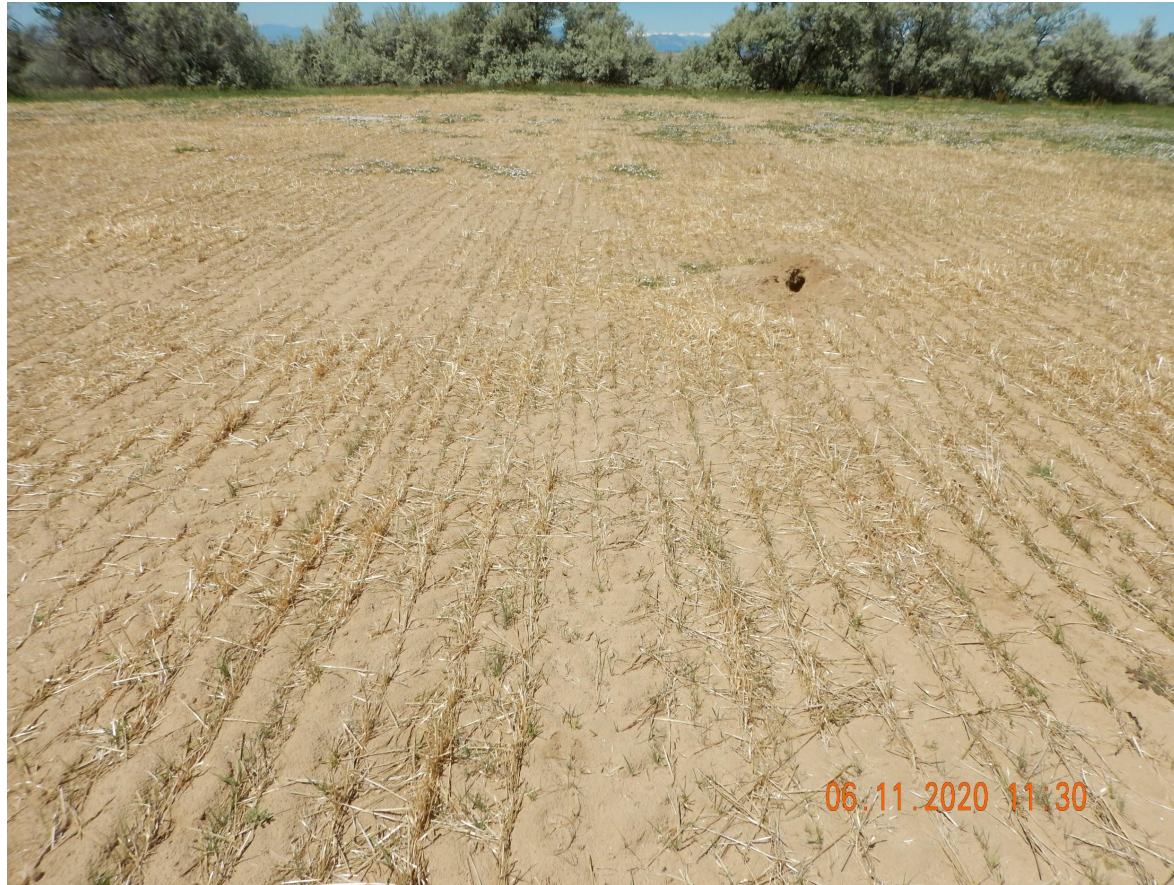
Photo 10. Photo taken from southwestern interim reclamation area of the well location, facing West. Photo illustrates the Operator has performed interim reclamation activities; however, vegetation establishment is not uniform. It appears vegetation establishment may be affected by prairie dogs.

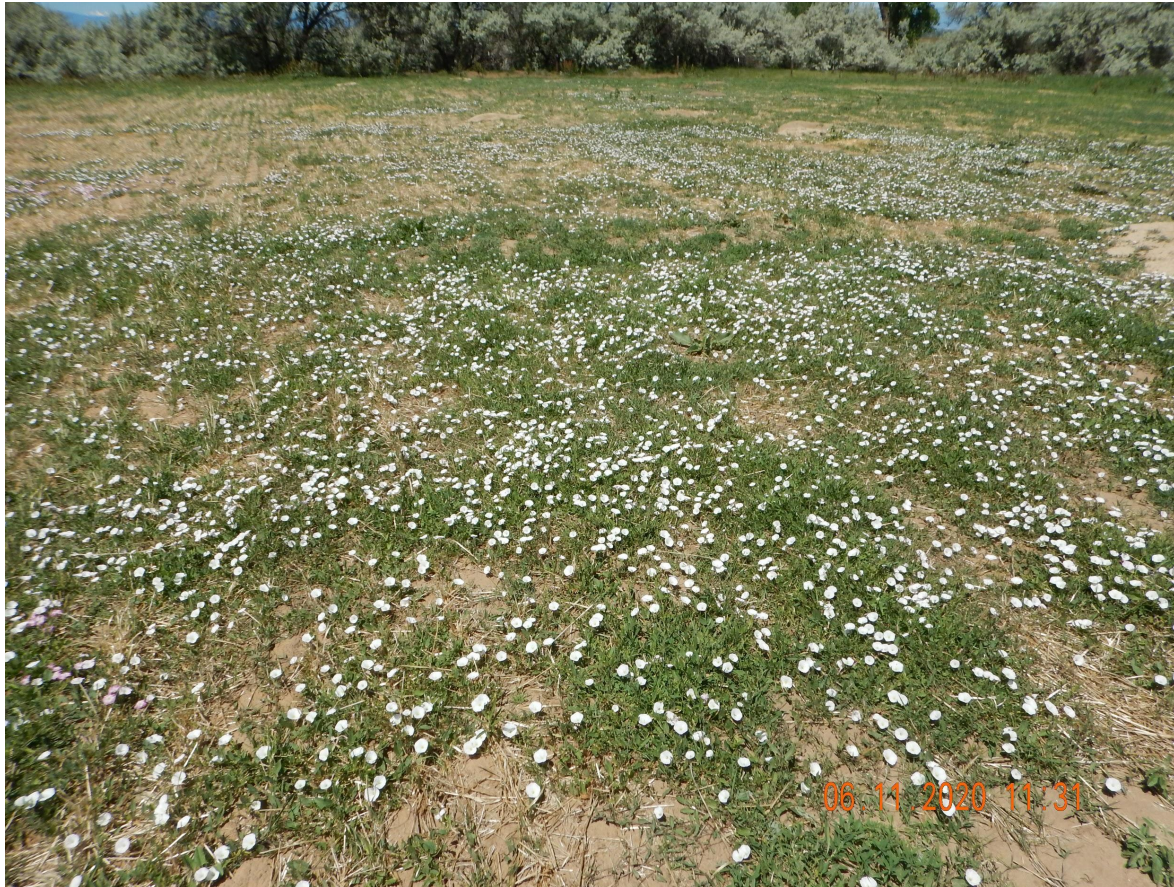
Photo 11. Photo taken from western interim reclamation area of the well location, facing West. Photo illustrates a List C Colorado noxious weed, Field bindweed.

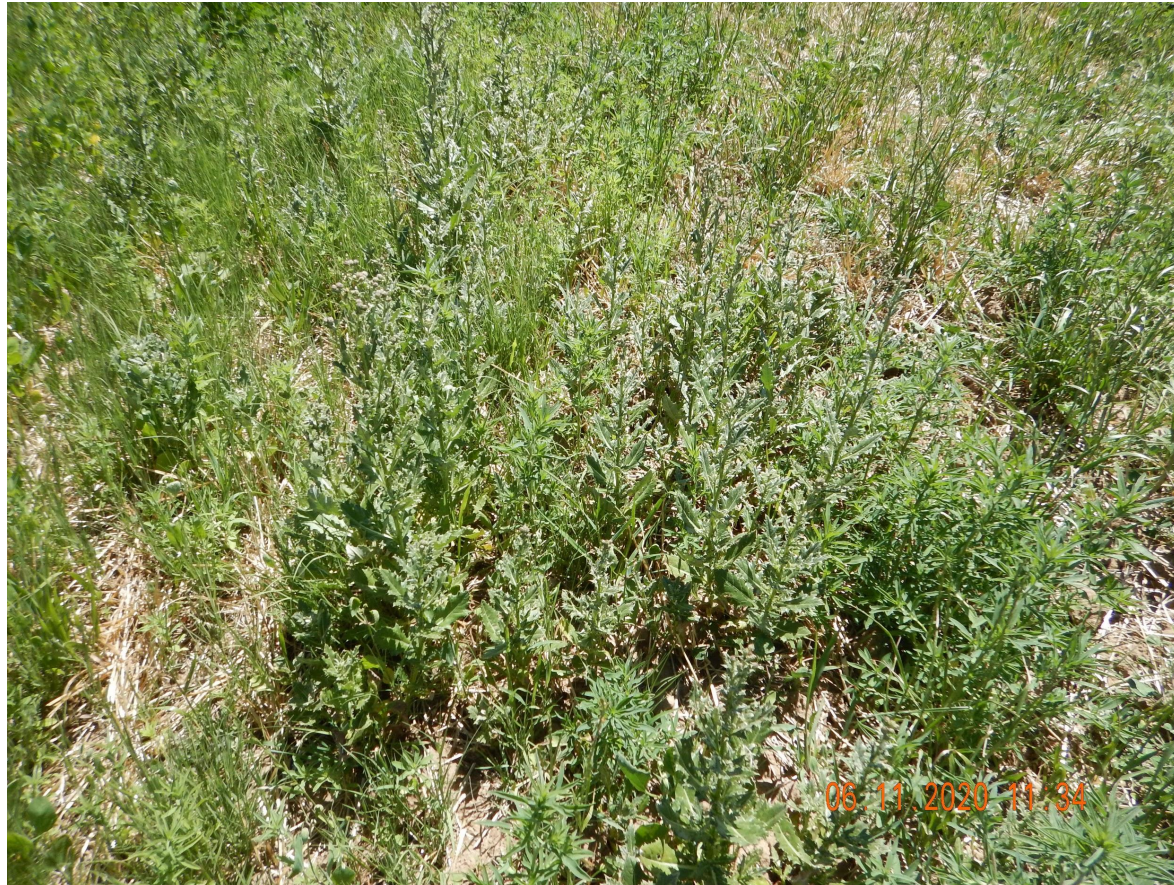
Photo 12. Photo taken from northwestern interim reclamation area of the well location. Photo illustrates a List B Colorado noxious weed, Canada thistle.

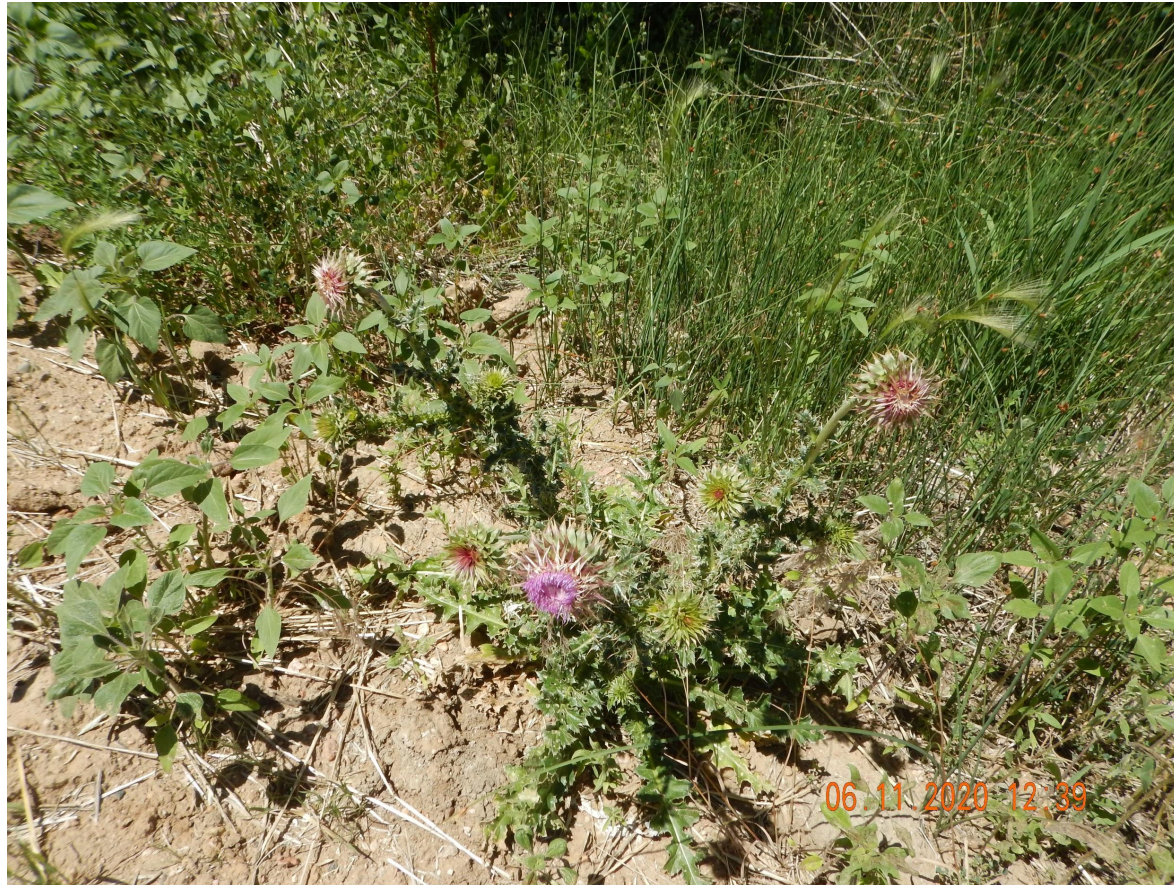
Photo 13. Photo taken from northern interim reclamation area of the well location. Photo illustrates a List B Colorado noxious weed, Musk thistle.
