Inspection Photos

API# 009-06189

Operator: DOVER ATWOOD CORPORATION

Inspection Date: 6/22/2020

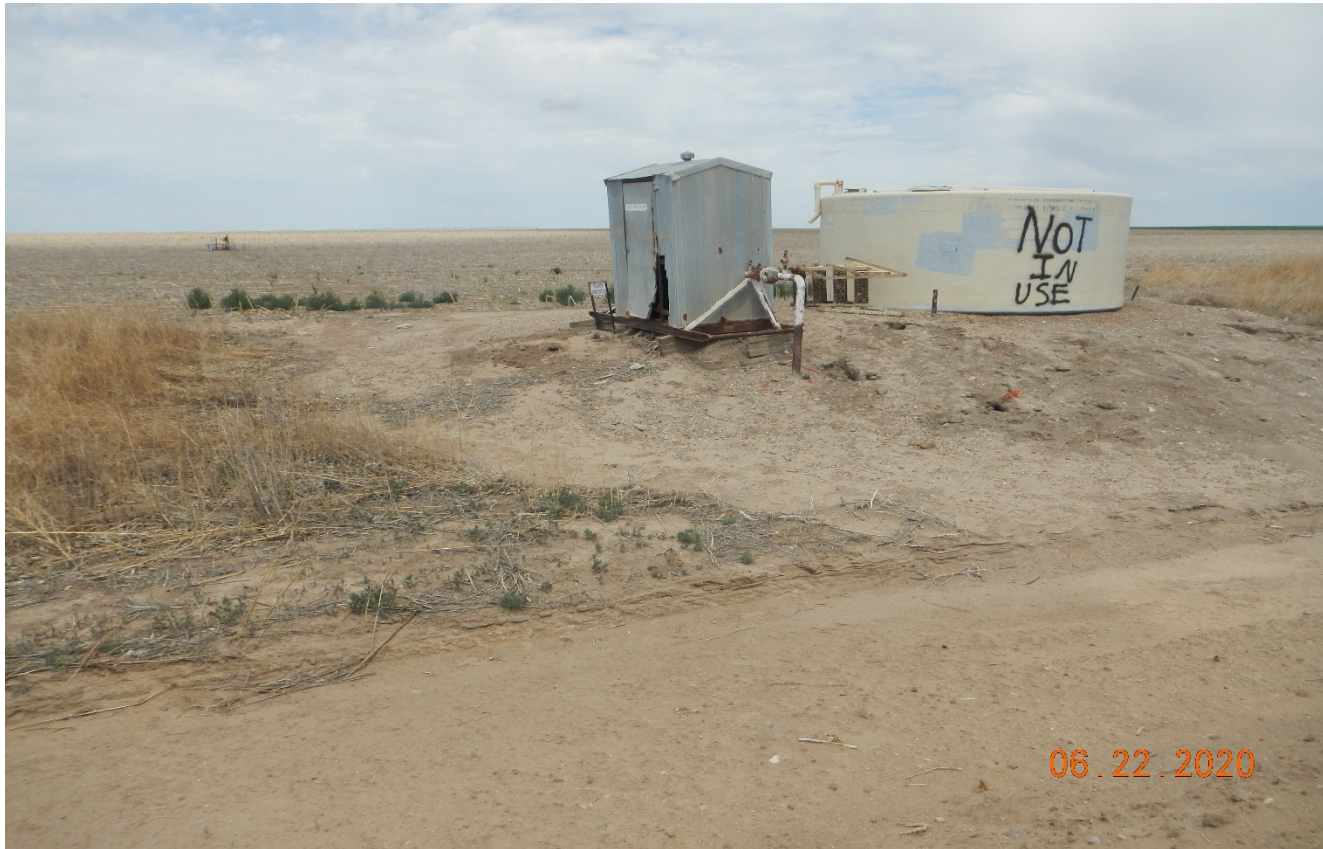
Photo 1. Facing west toward the PW tank and meter shed located adjacent to CR-49 and 575' east of the well. No operator sign is visible from the county road but a sign was observed on backside of tank. Meter shed still appears to be unstable and there is no berm around the tank. Corrective actions were not completed.

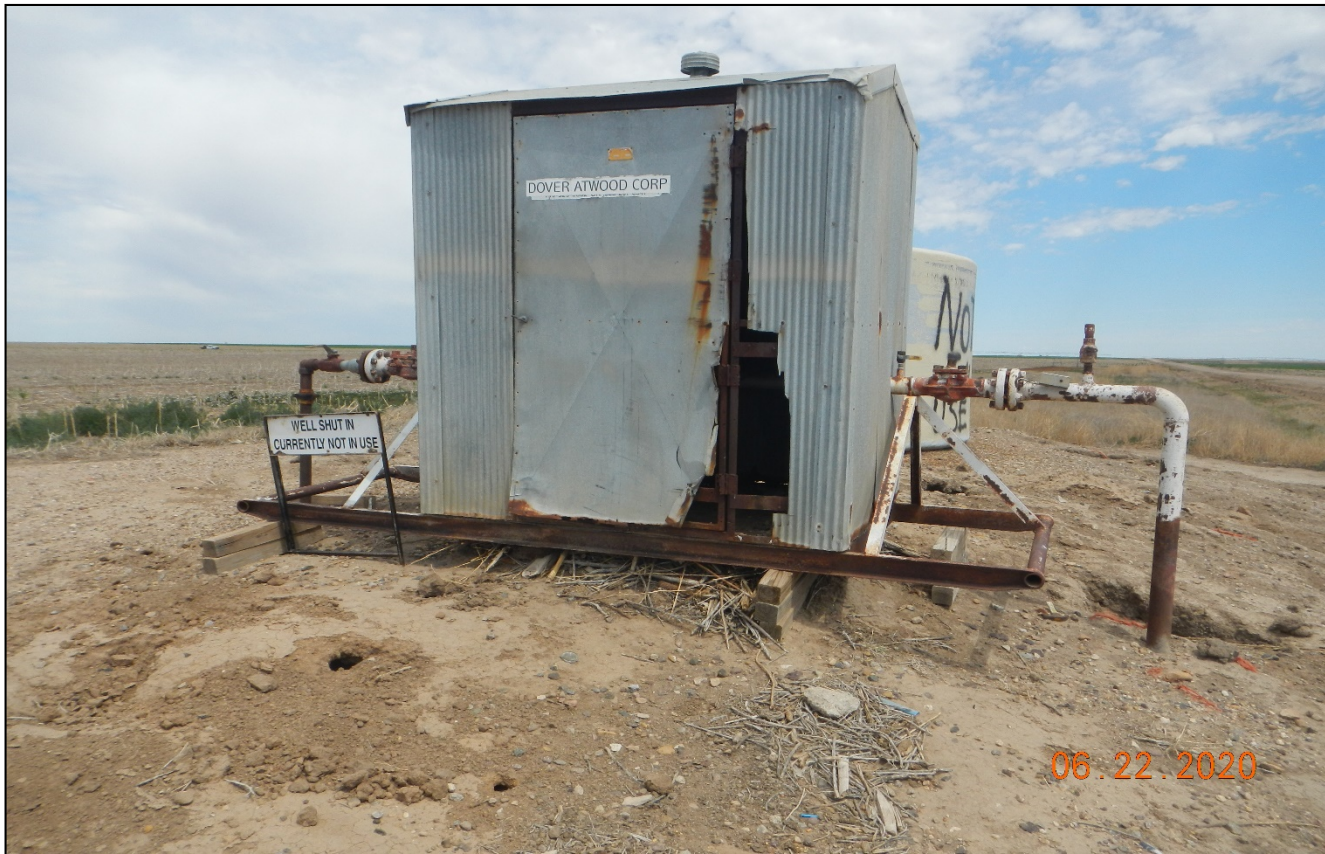
Photo 2. The meter shed is not maintained and remains unstable. Erosion has occurred underneath the meter shed which is a safety concern..

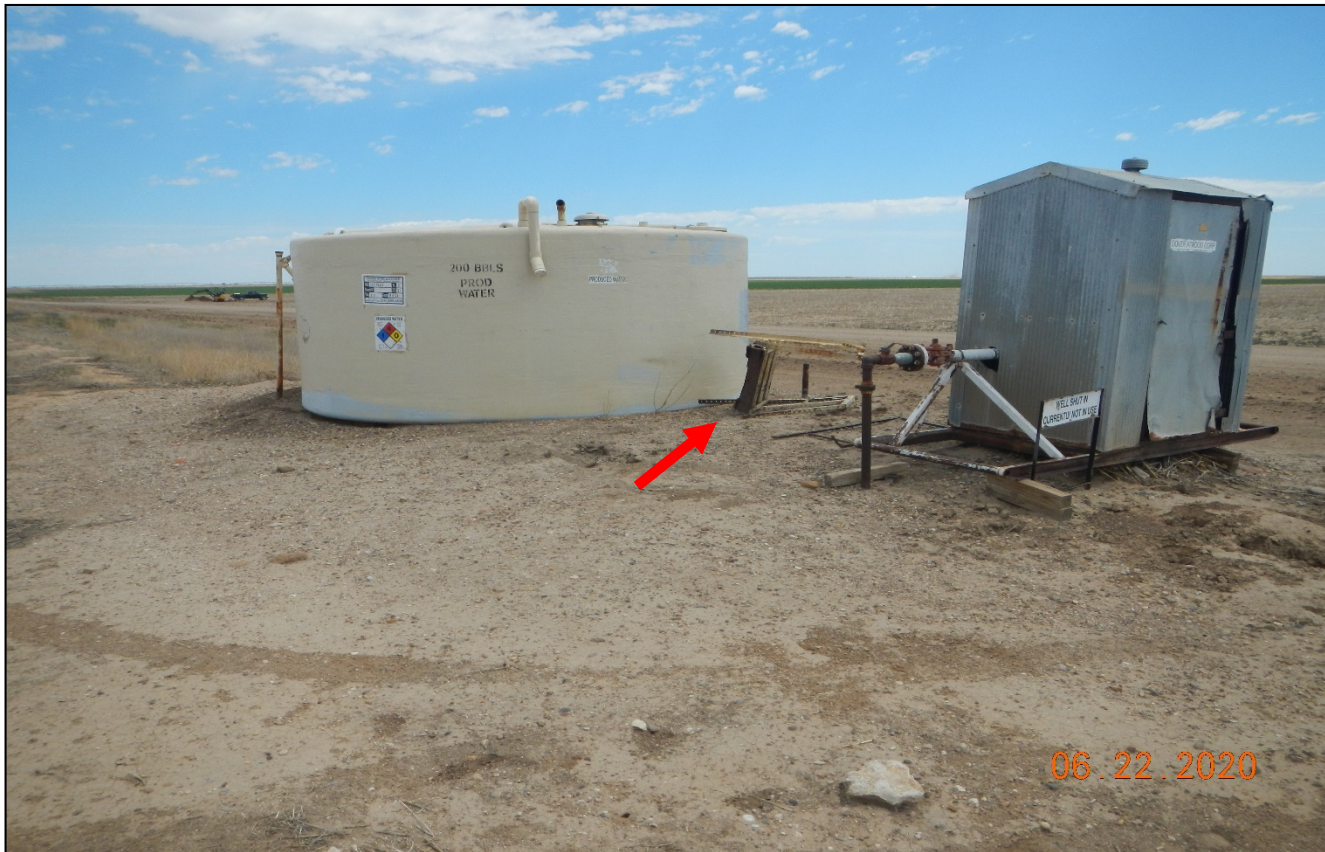
Photo 3. Corrective actions of the previous inspection were not performed. There is no berm around the 200 bbls tank. There is unused equipment at the location (red arrow).

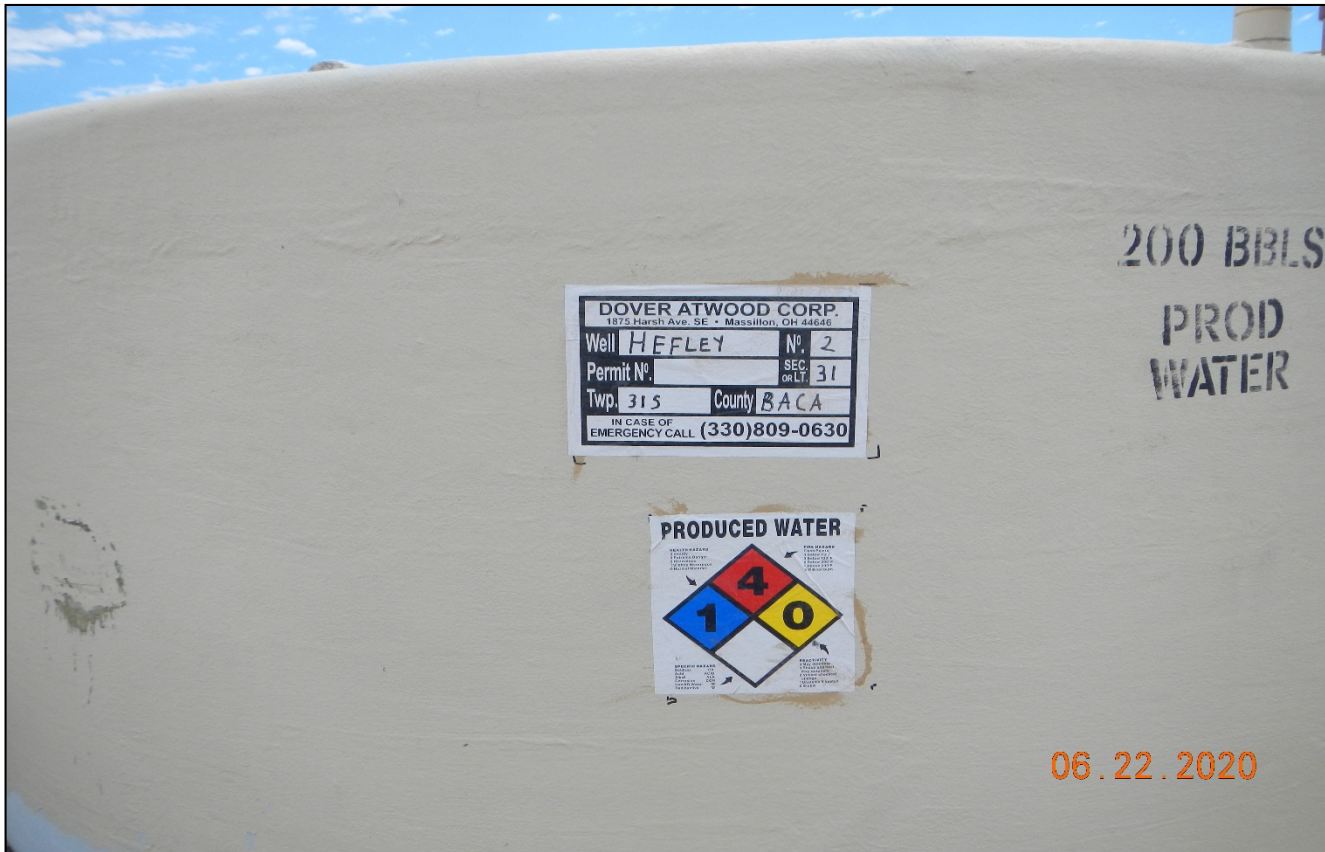
Photo 4. The tank sign and NFPA label are installed on backside of the tank which is not readily visible from the front side along the county road.

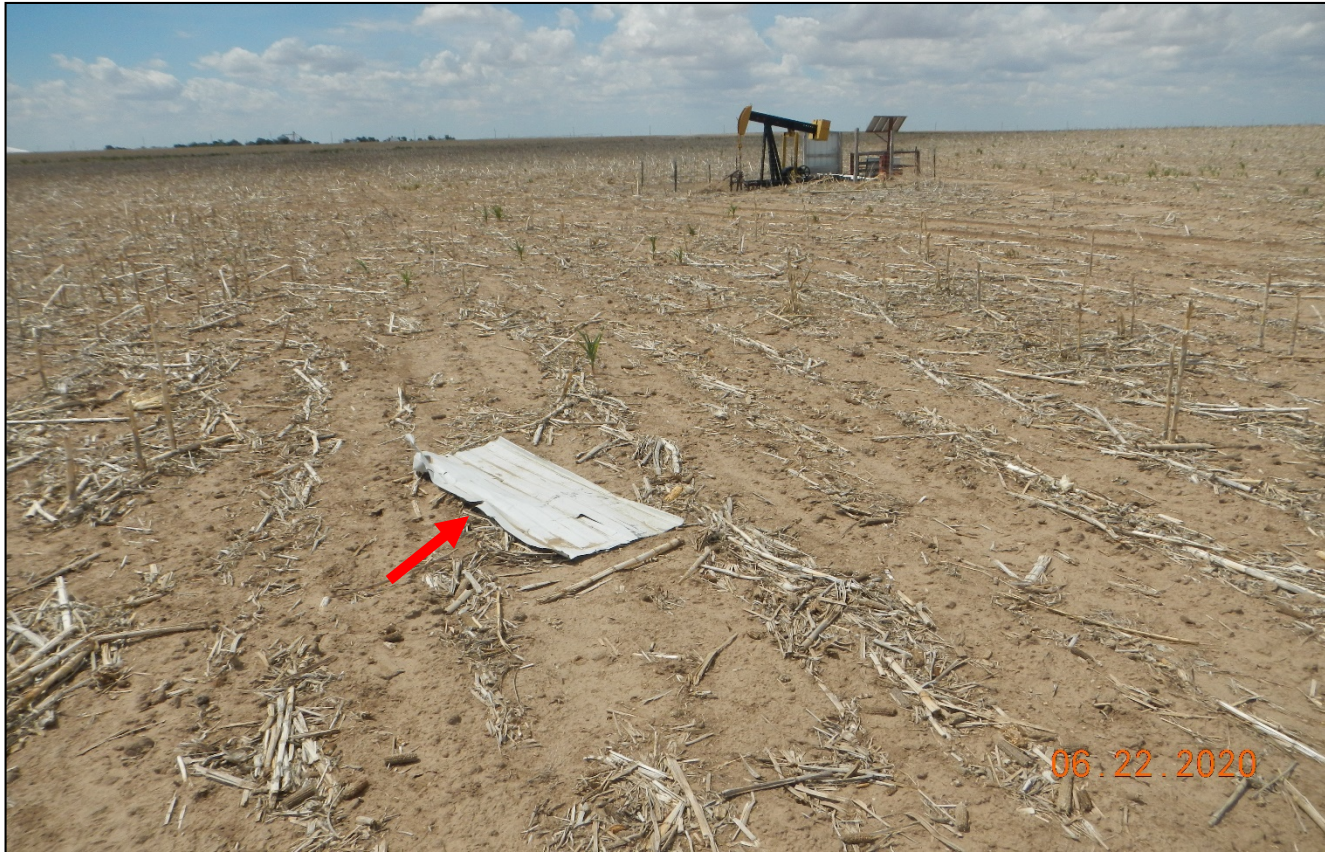
Photo 5. Facing southwest toward the wellsite. There is metal tin debris from the wellsite observed northeast of the well (red arrow).

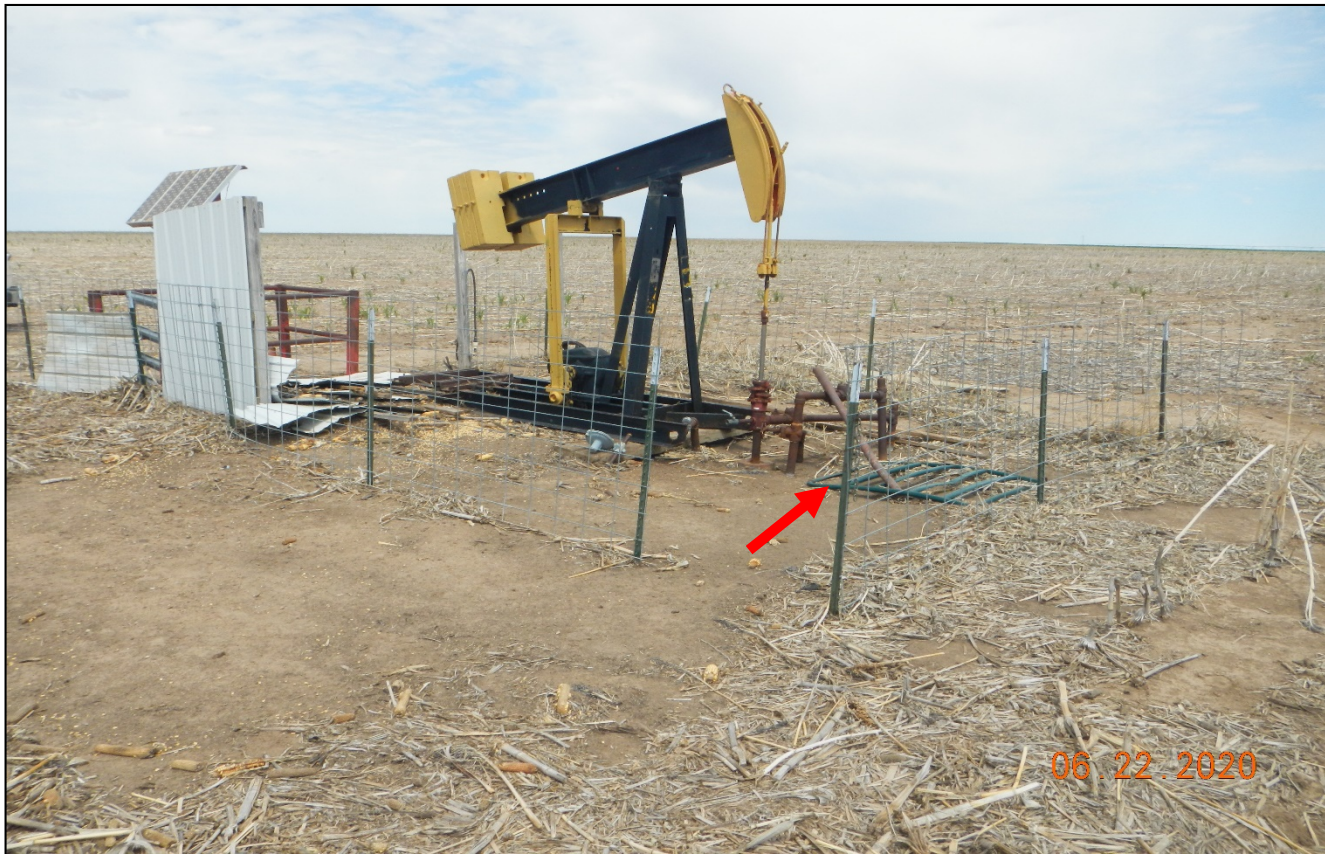
Photo 7. Facing northeast toward the well. The gate is lying on the ground and the fence around the well is not maintained.

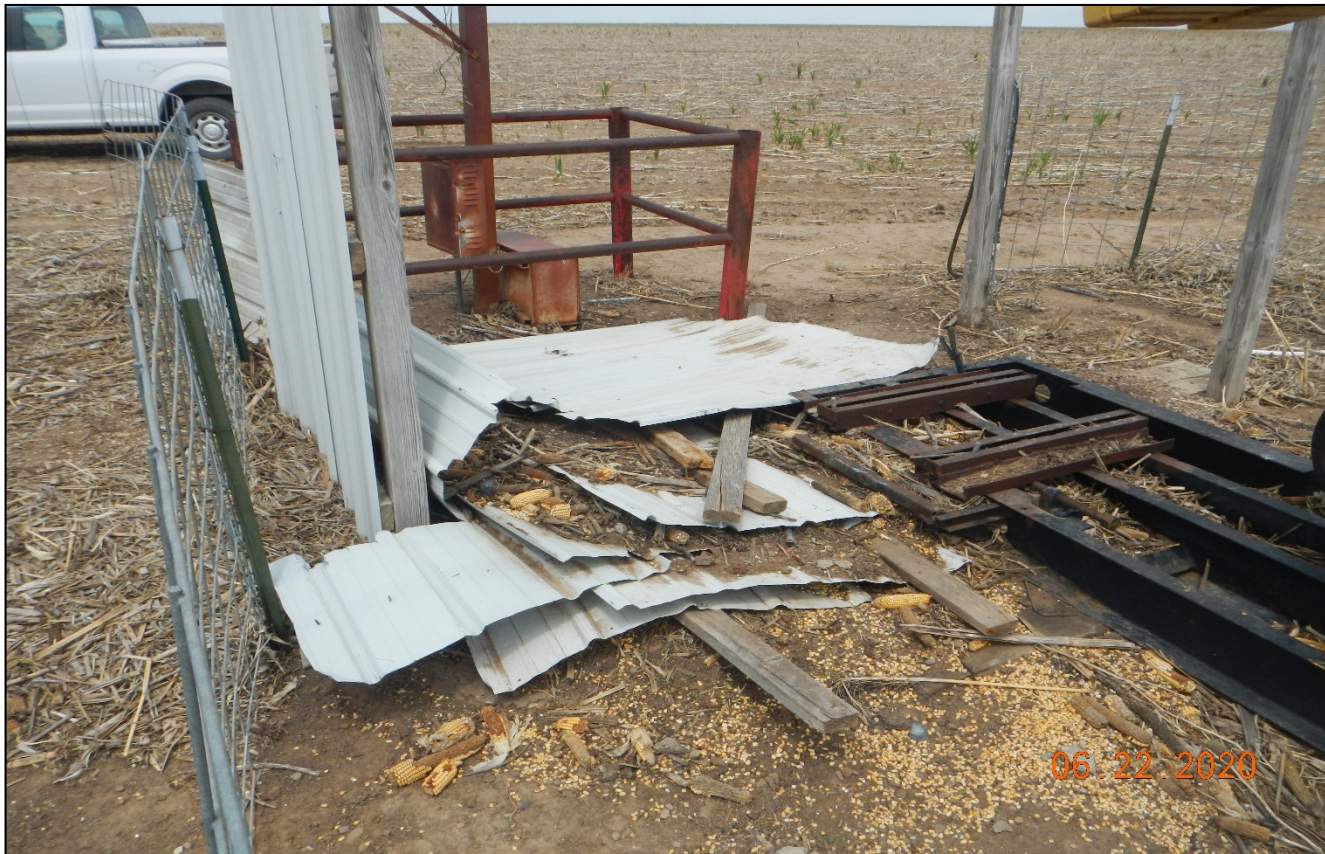
Photo 8. There are pieces of metal debris laying next to the pumpjack.
