Inspection Photos

Operator: BP America
API: 067-07138
Date: 6/19/2020

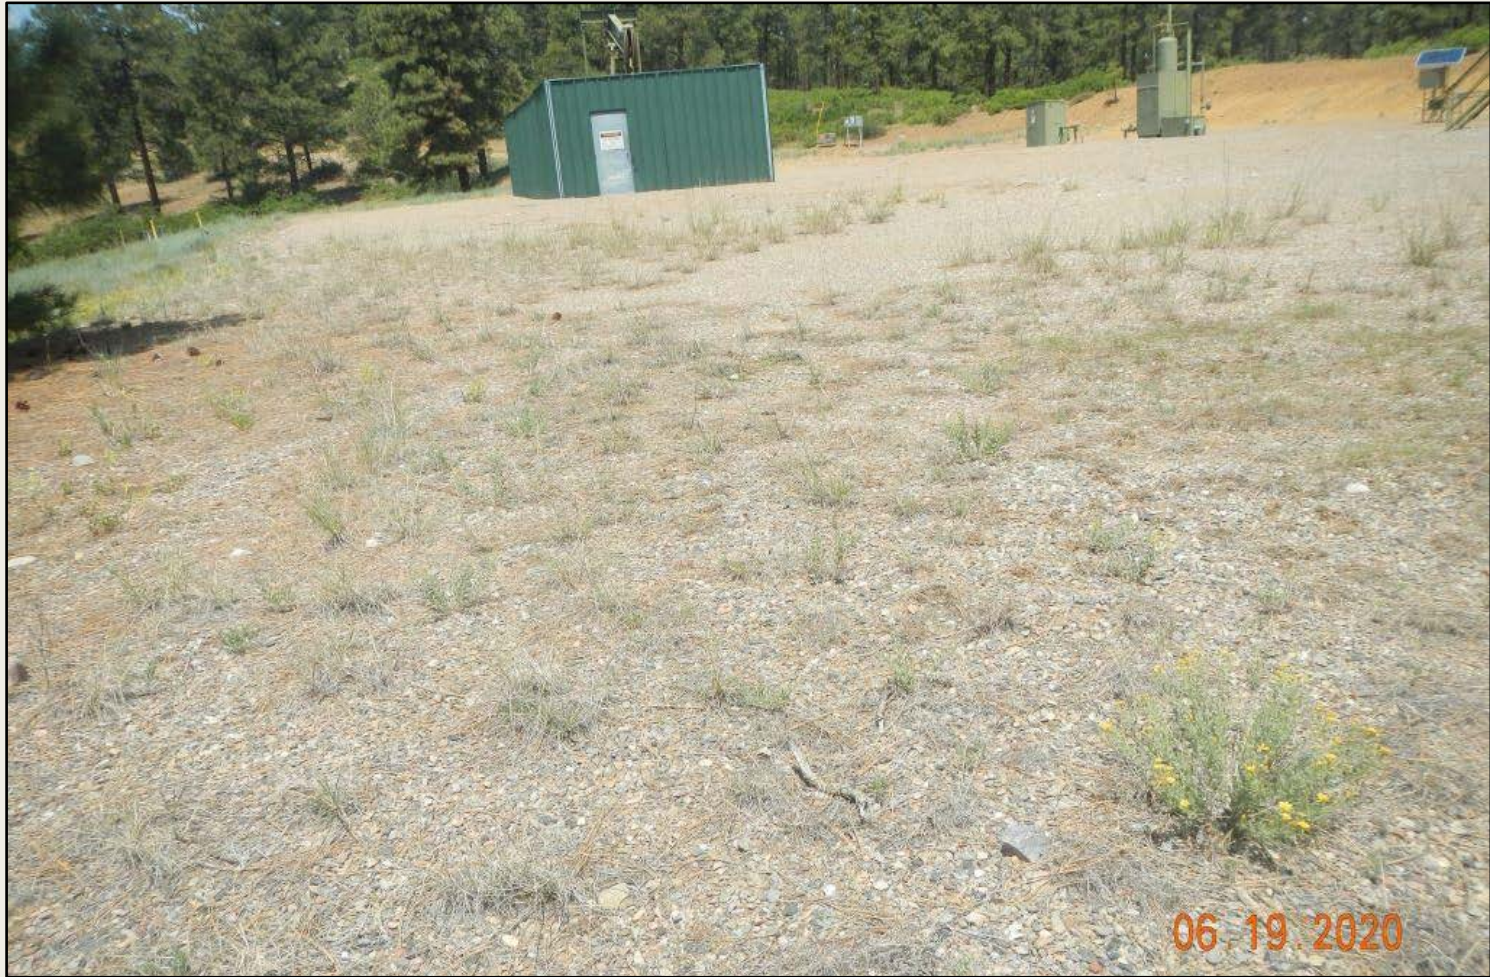
Photo 1. View of the project area from the southeastern corner facing center.

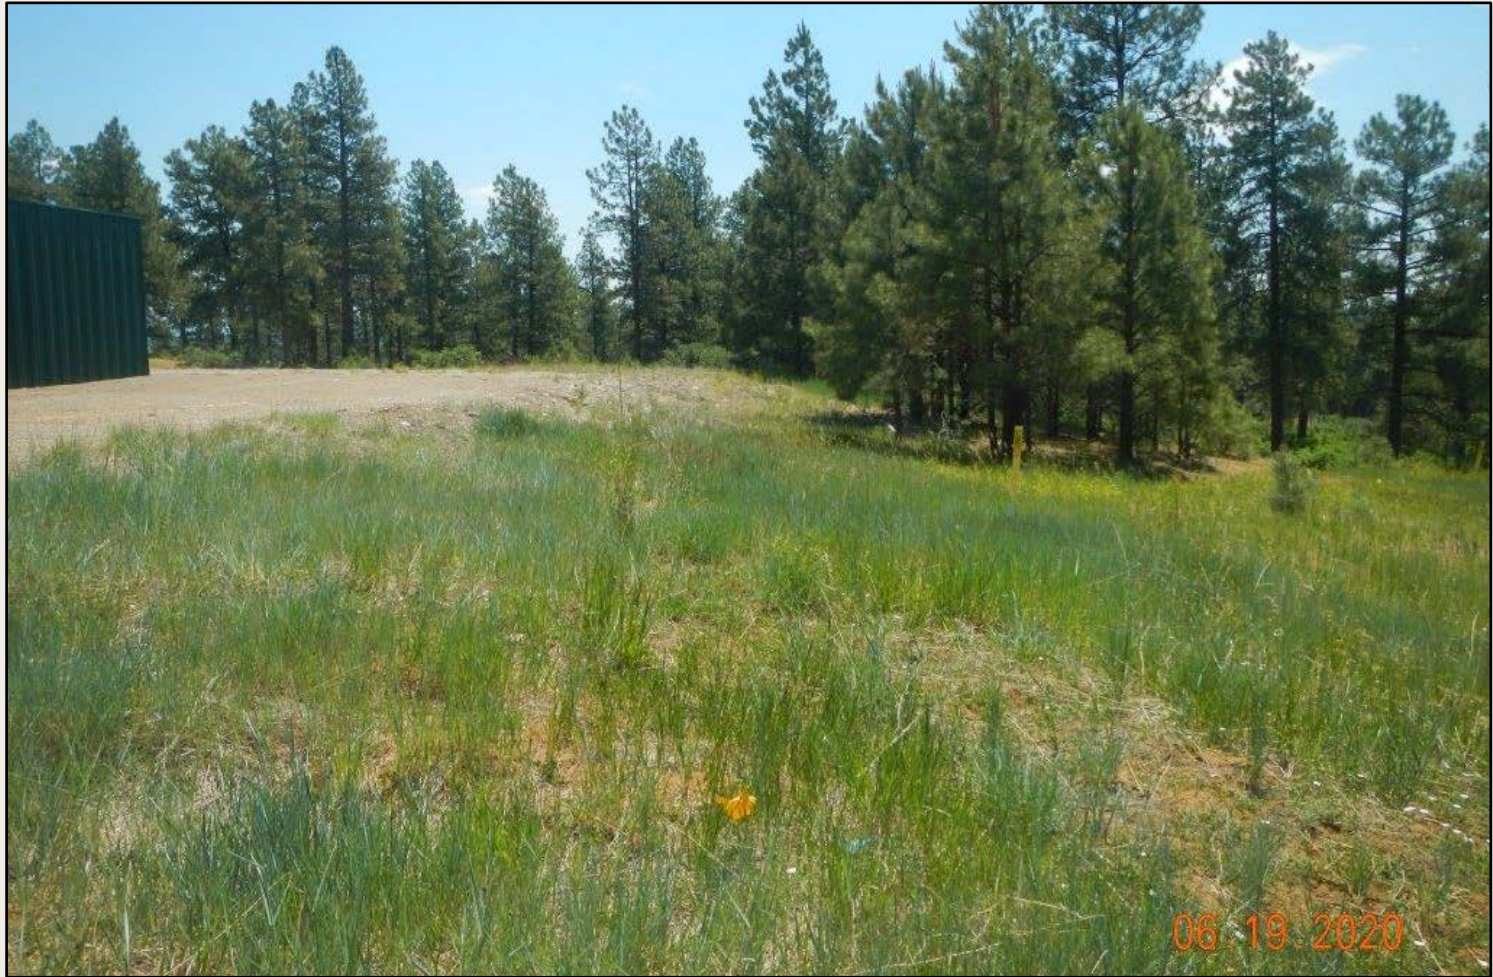
Photo 2. View of the southern fill slope from the southwestern corner facing eastward. Revegetation is progressing, largely with smooth brome and western wheatgrass.

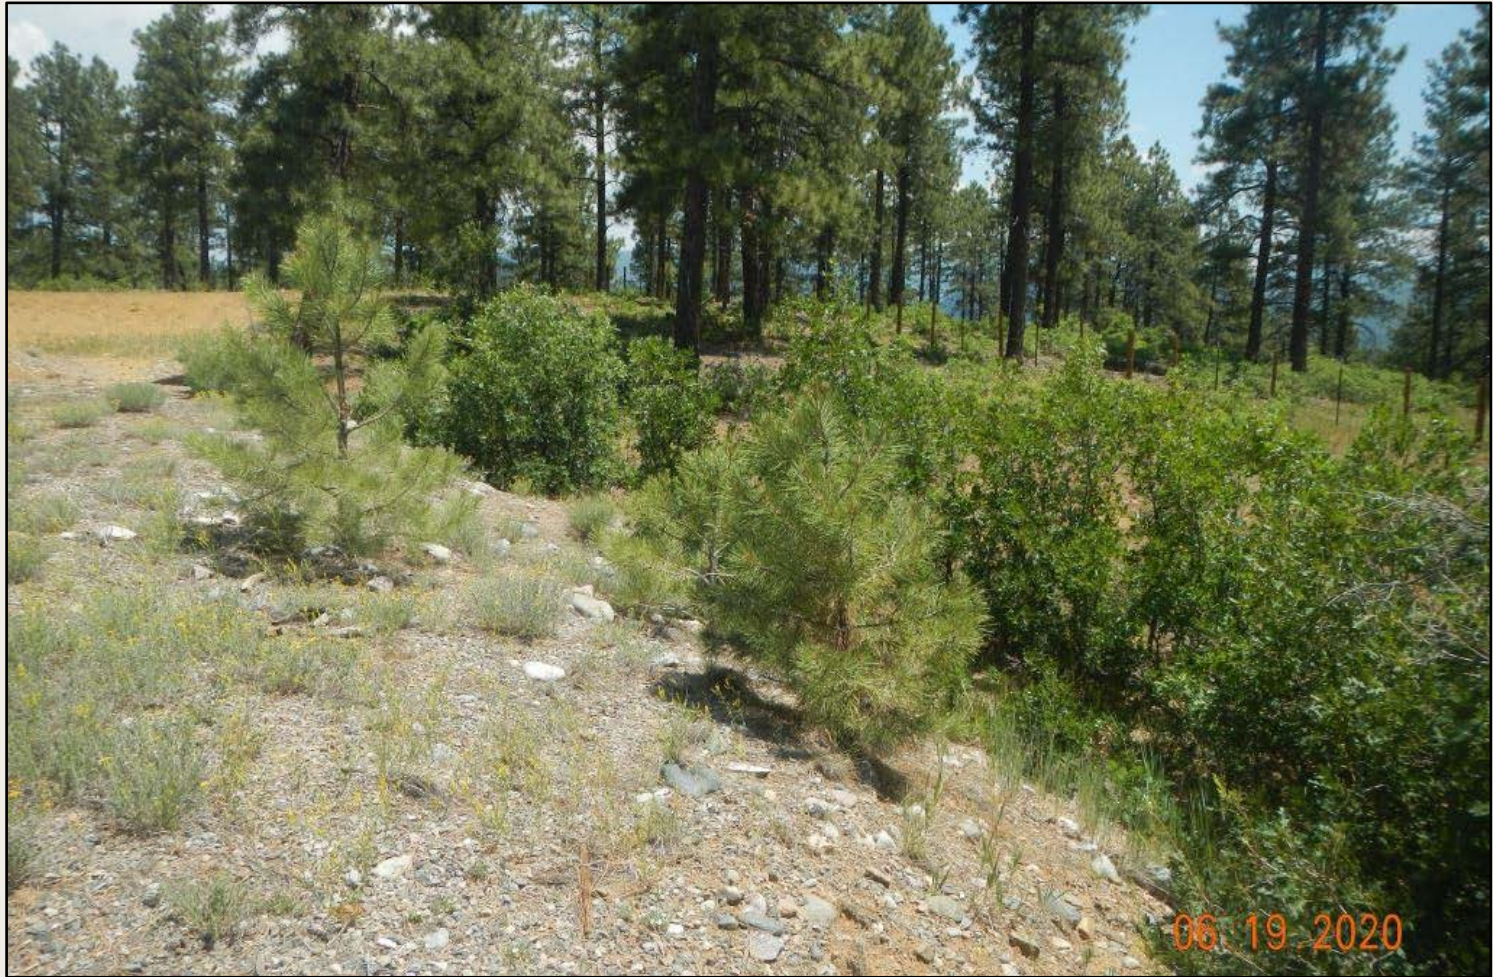
Photo 3. View of the eastern fill slope from the southeastern corner facing northward.

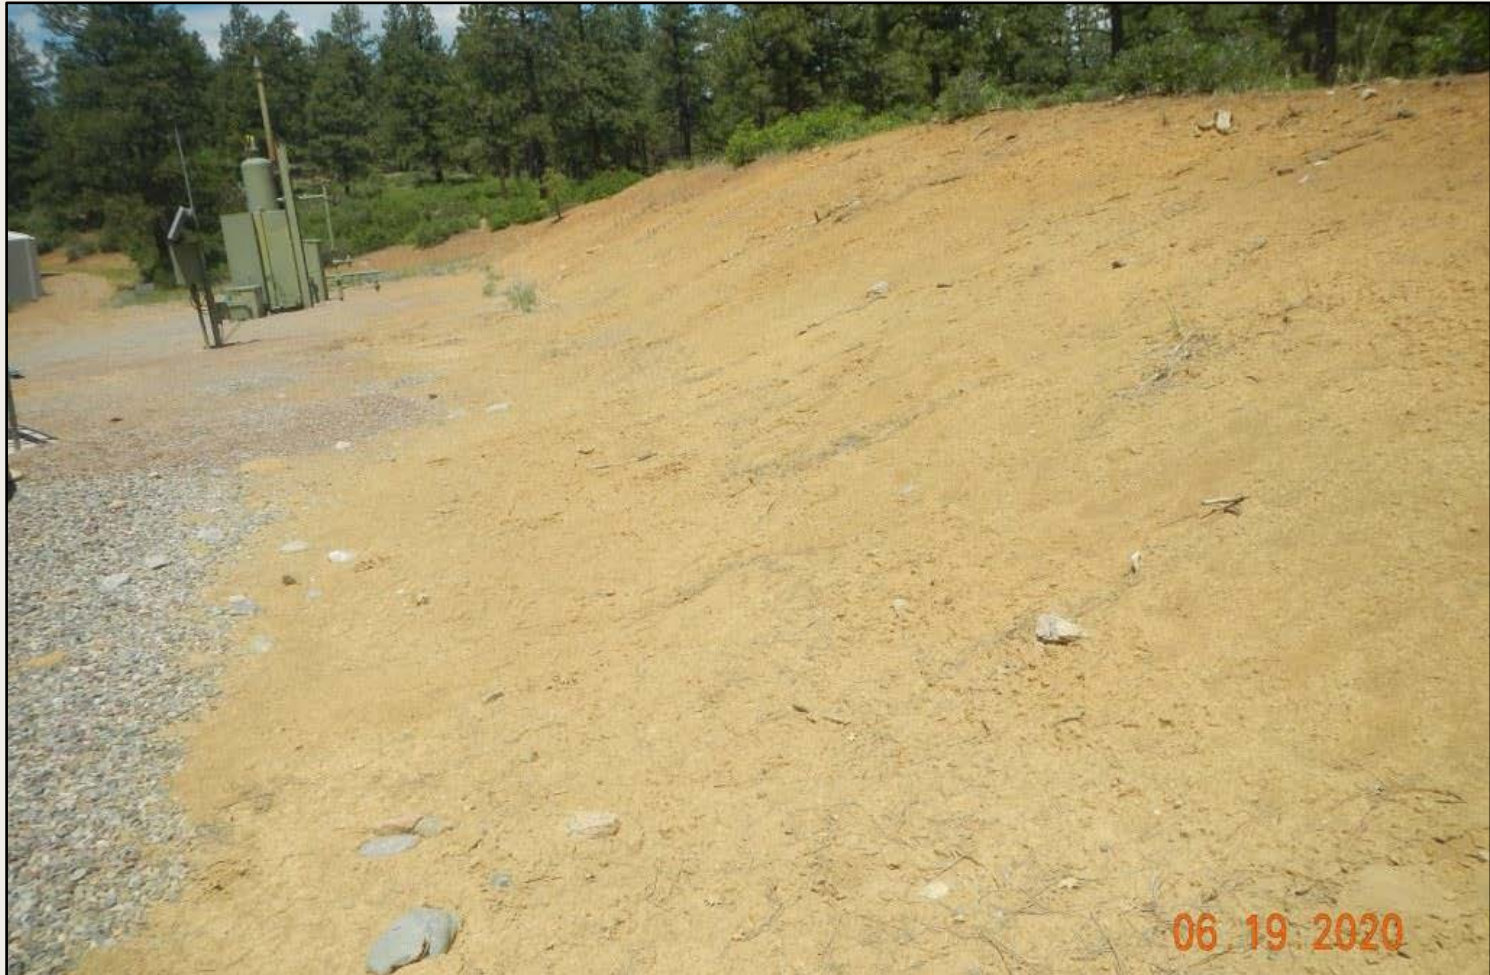
Photo 4. View of the northern cut slope from the northeastern corner facing westward. Stabilization measures are needed on the well pad cut-slope.

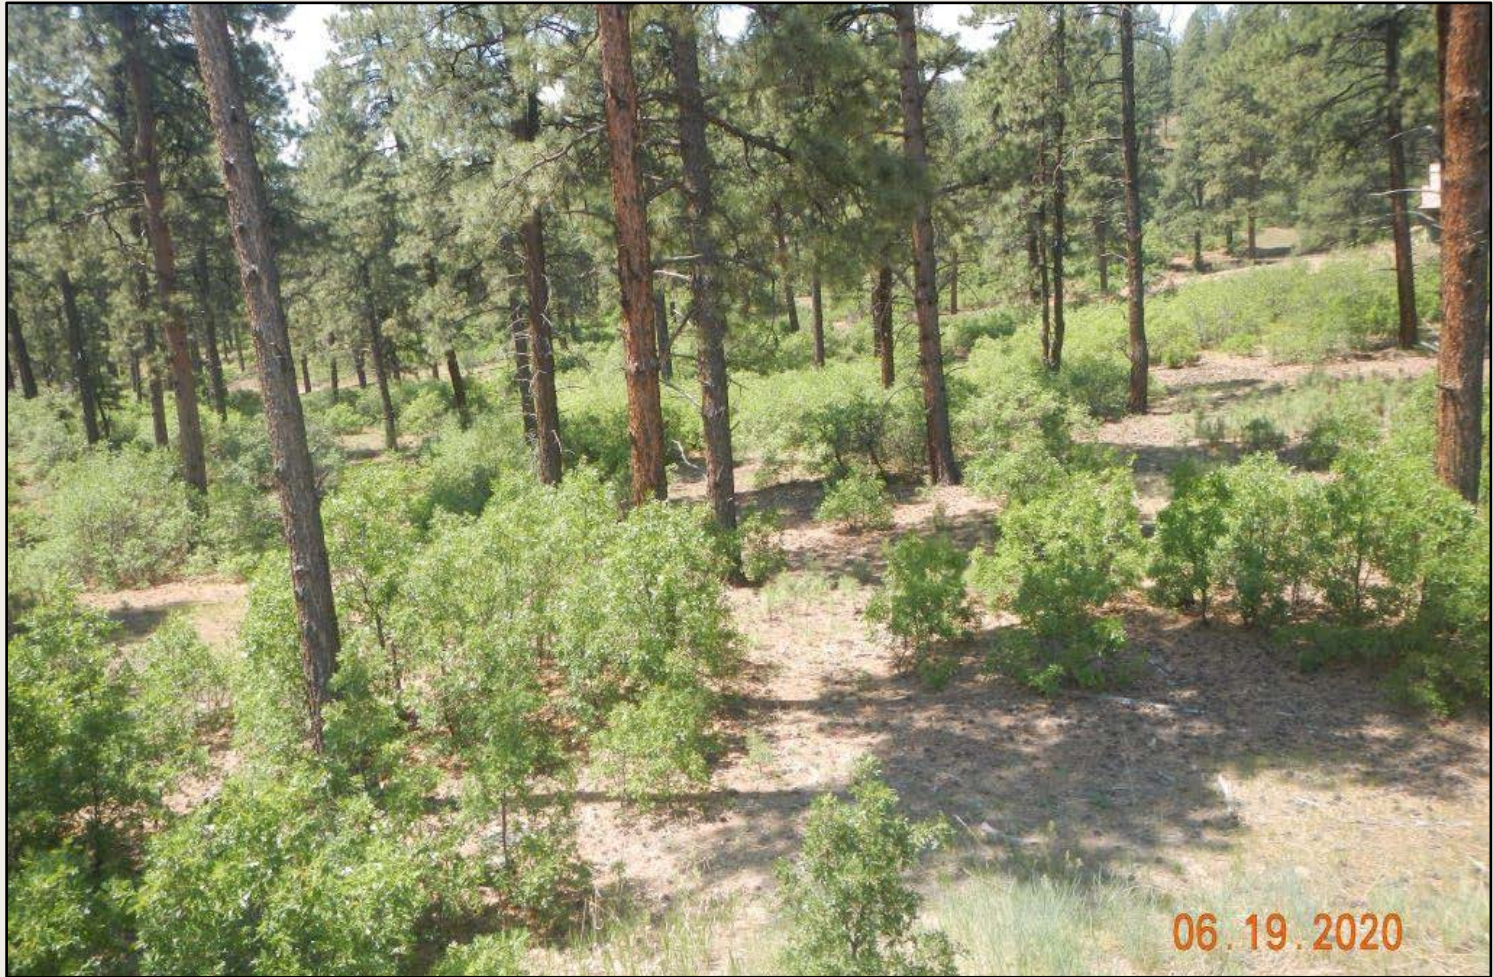
Photo 5. View of the reference area, comprised of ponderosa pine forest with a gambel oak, Sandberg bluegrass, and penstemon.
