Inspection Photos

ID# 441082

Operator: DOVER ATWOOD CORPORATION

Inspection Date: 6/22/2020

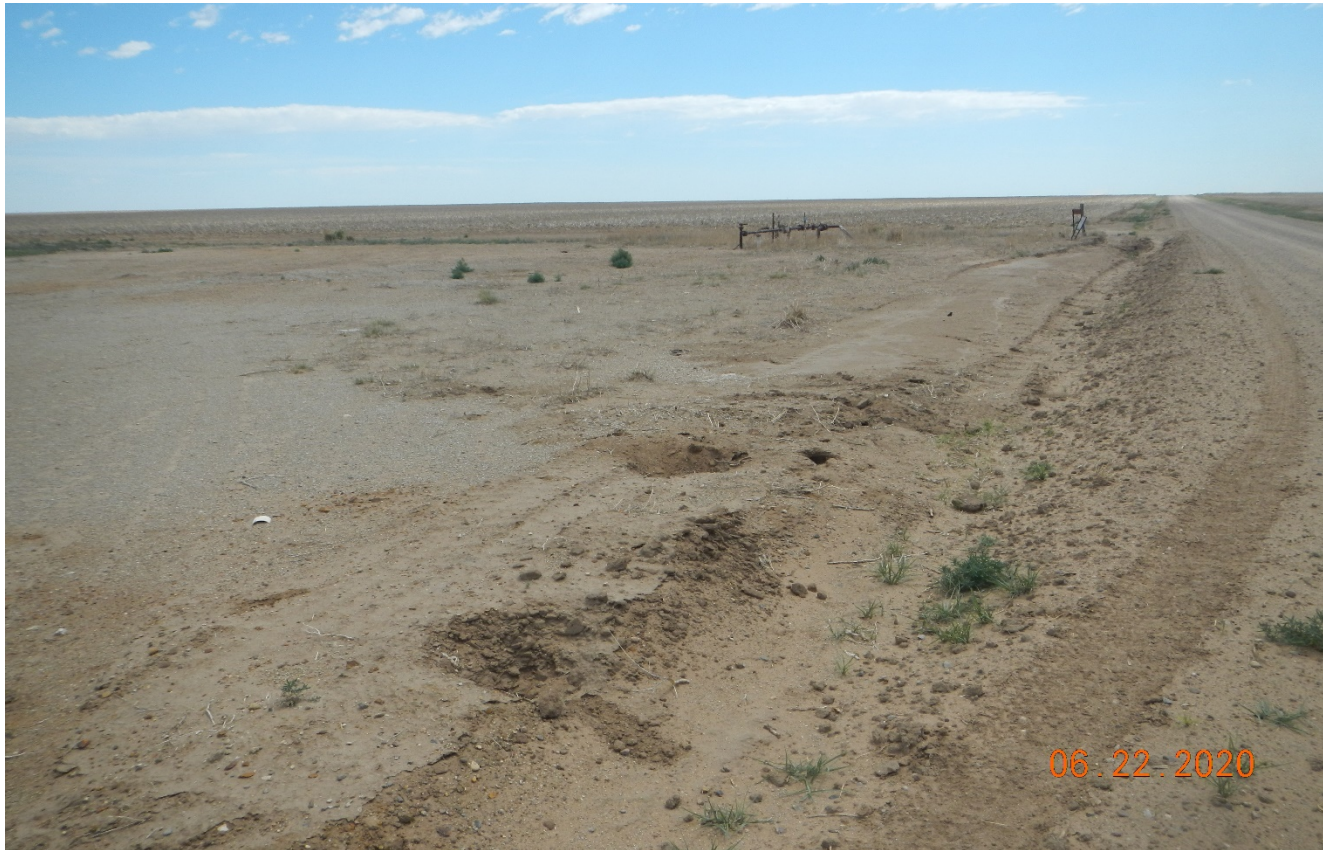
Photo 1. Facing northeast toward the location.

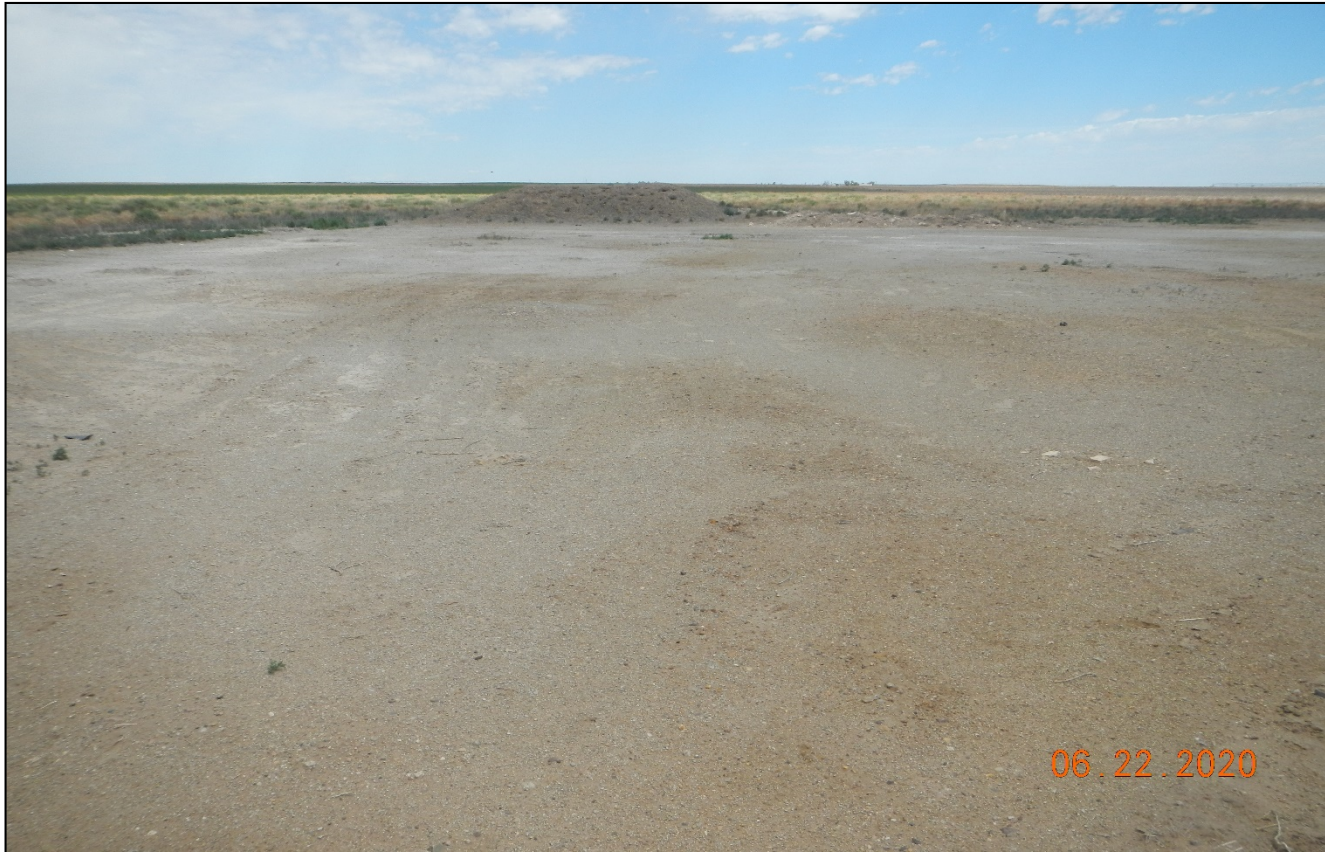
Photo 2. Facing north toward the location. Soils are compacted and the location has not been reclaimed.

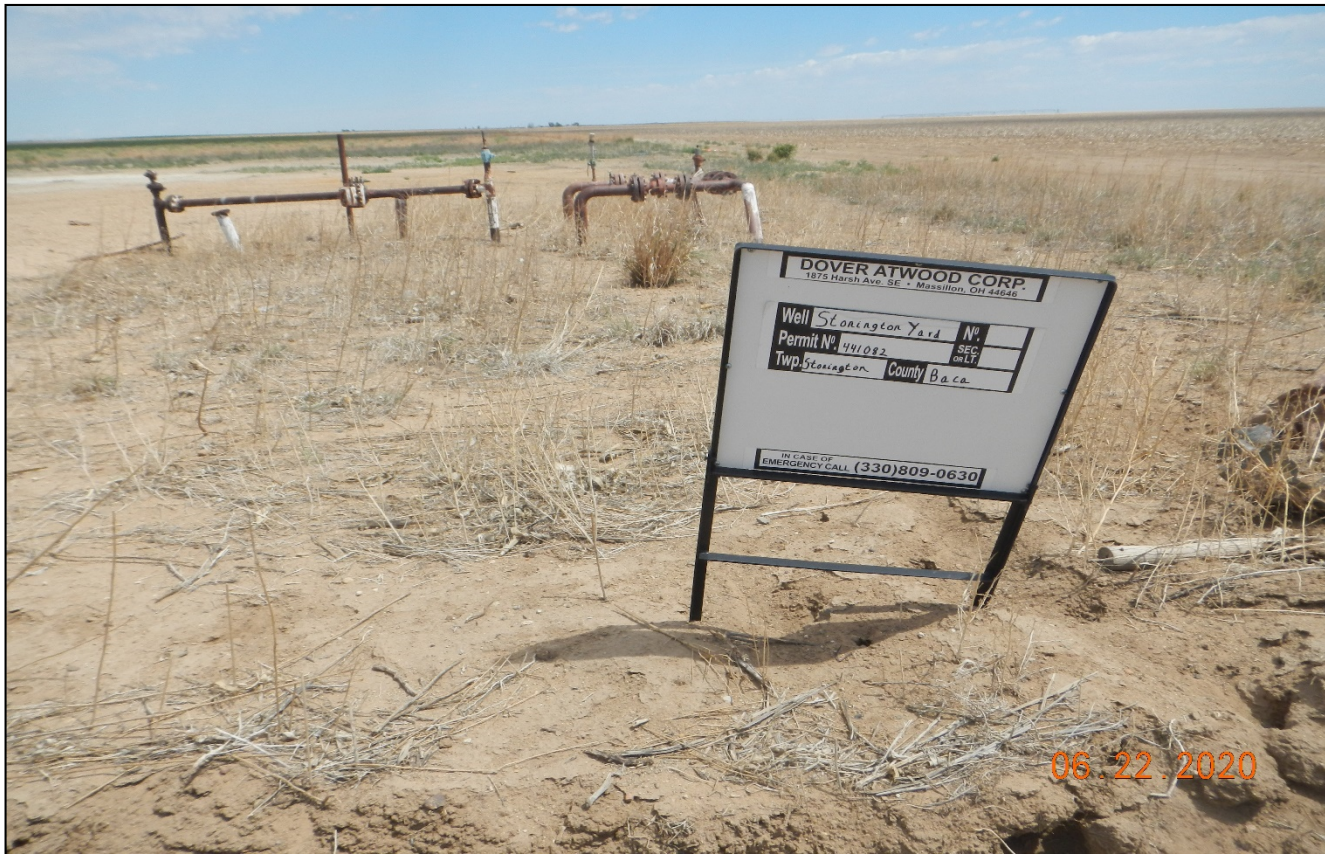
Photo 3. Facing north at southeast side of the location. Sign is posted near the pipeline.

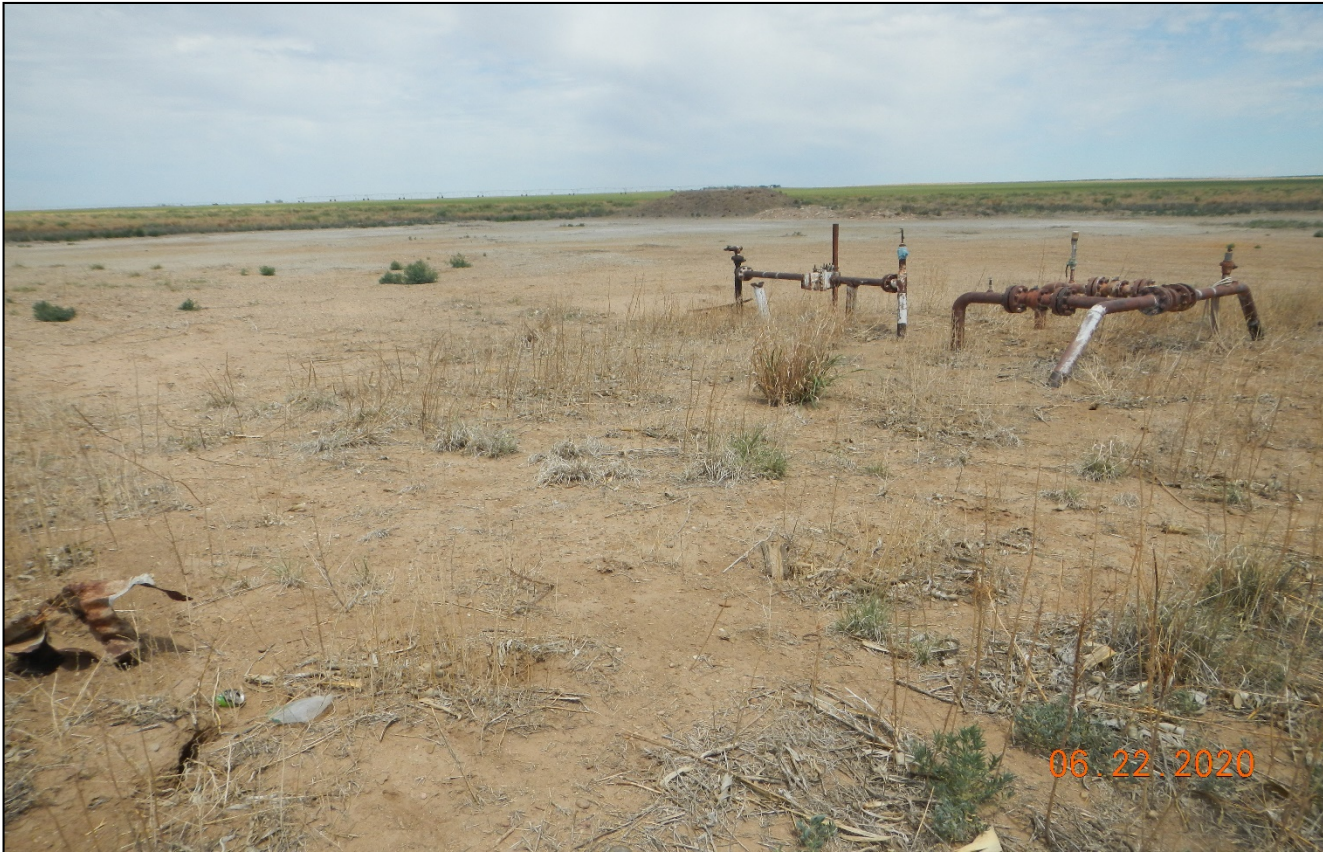
Photo 4. Facing northwest toward the location.

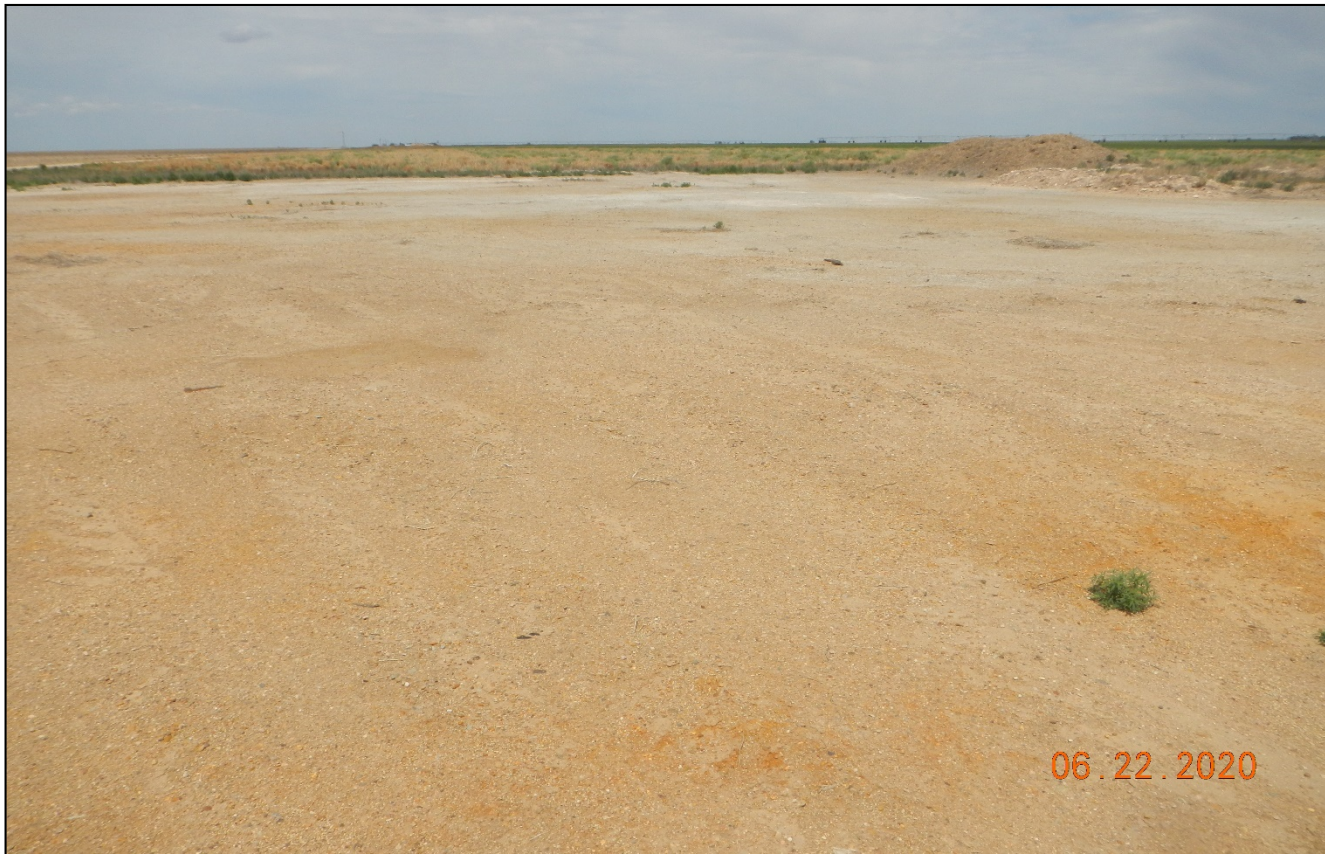
Photo 5. Facing northwest at the location. The location has not been reclaimed and soils are compacted.

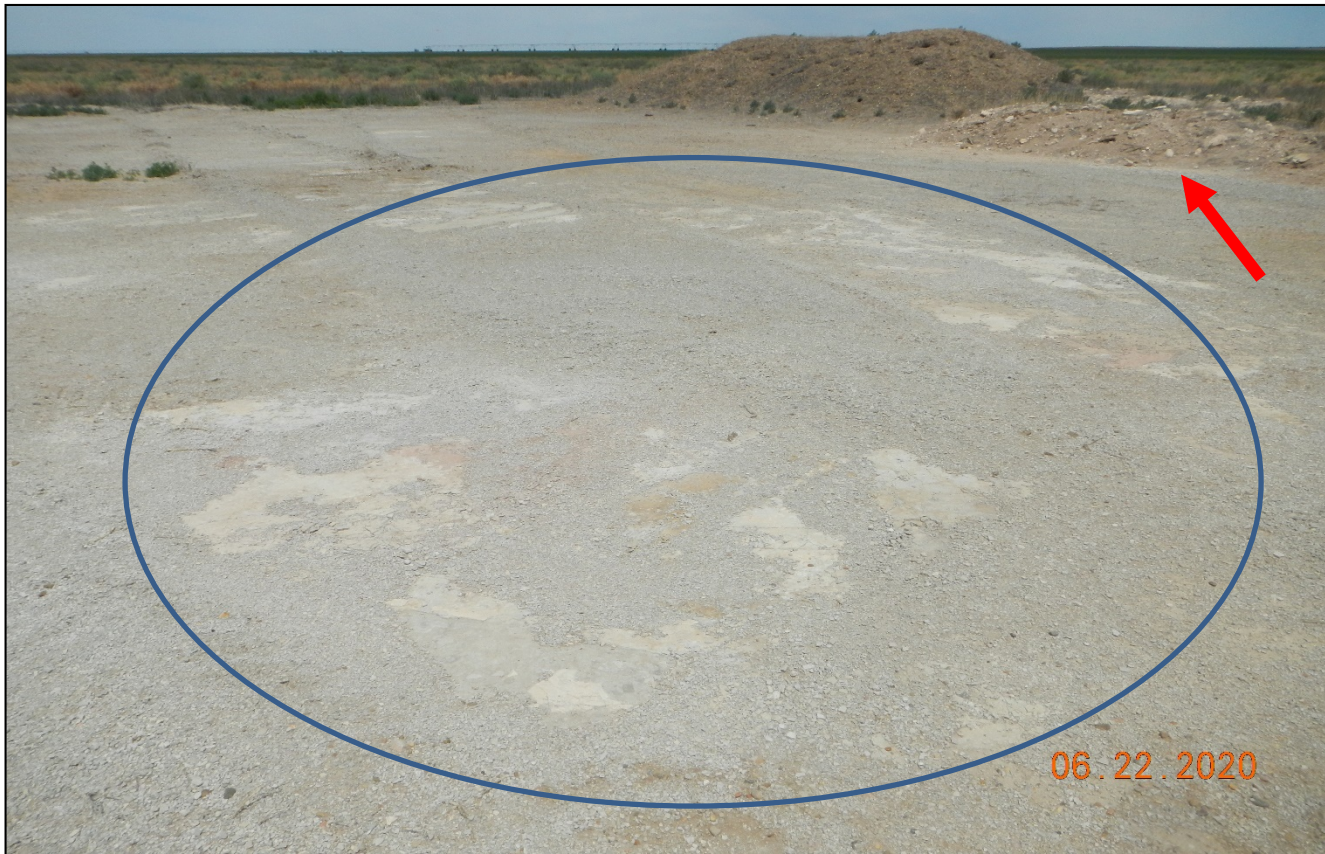
Photo 6. Facing northwest. The piles of soil, gravel/debris remains at the northwest corner of the location (red arrow). There appears to be cement in this area shown in circled area.
