Inspection Photos
Operator: BP America
API: 067-09188
Date: 6/24/2020

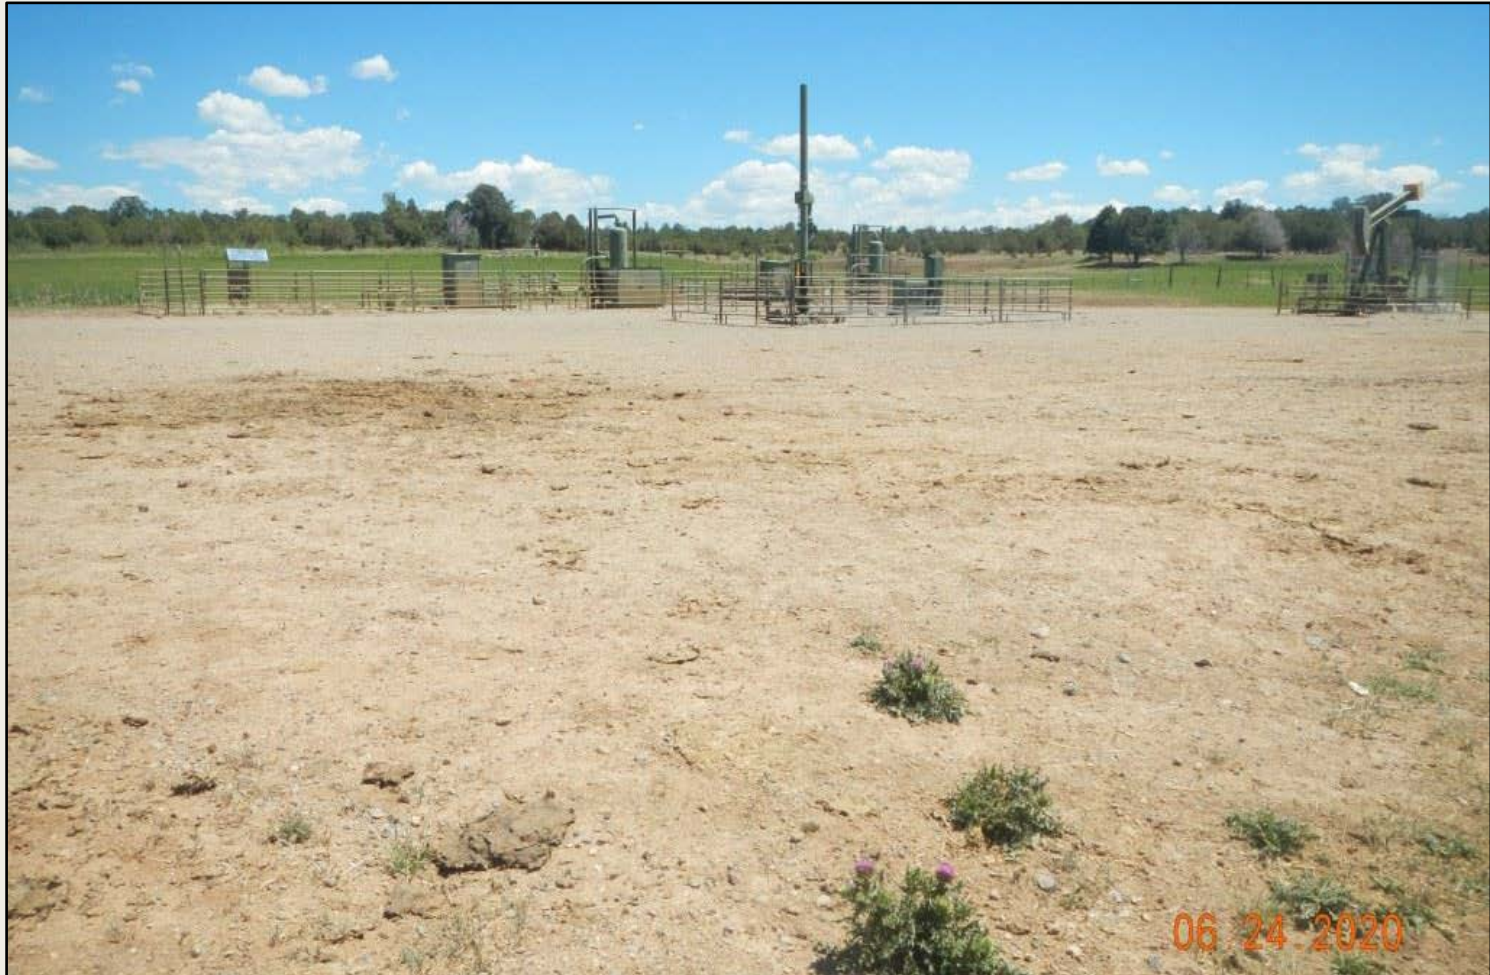
Photo 1. View of the project area from the southwestern corner facing center.

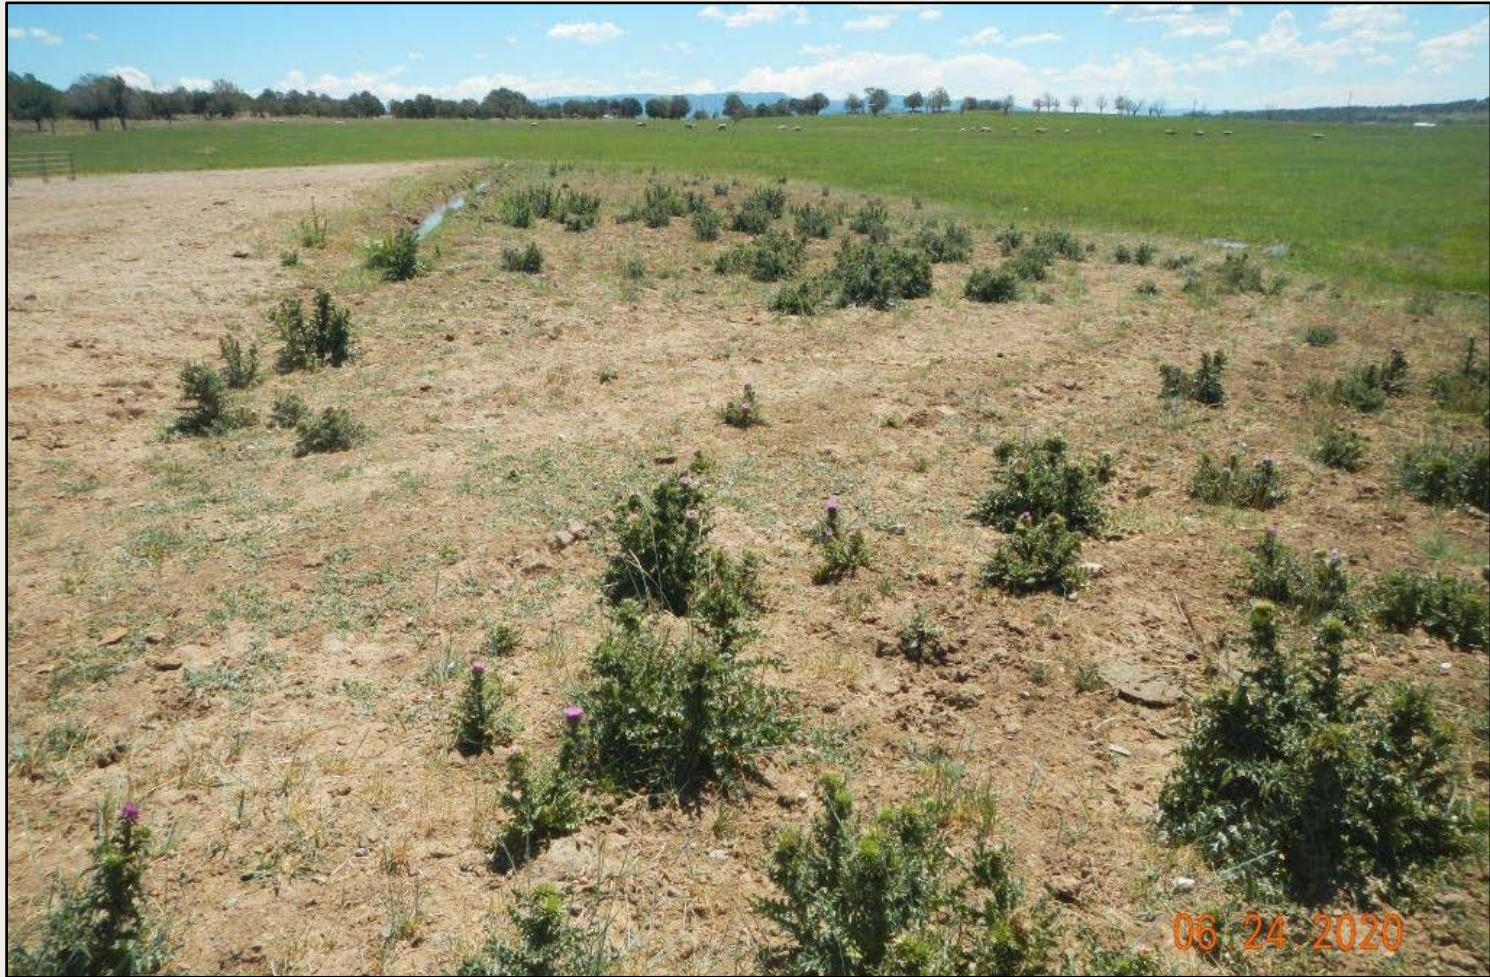
Photo 2. View of the southern fill slope from the southwestern corner facing eastward. Revegetation is progressing with western wheatgrass in a grazed condition. Approximately 200 musk thistles observed.

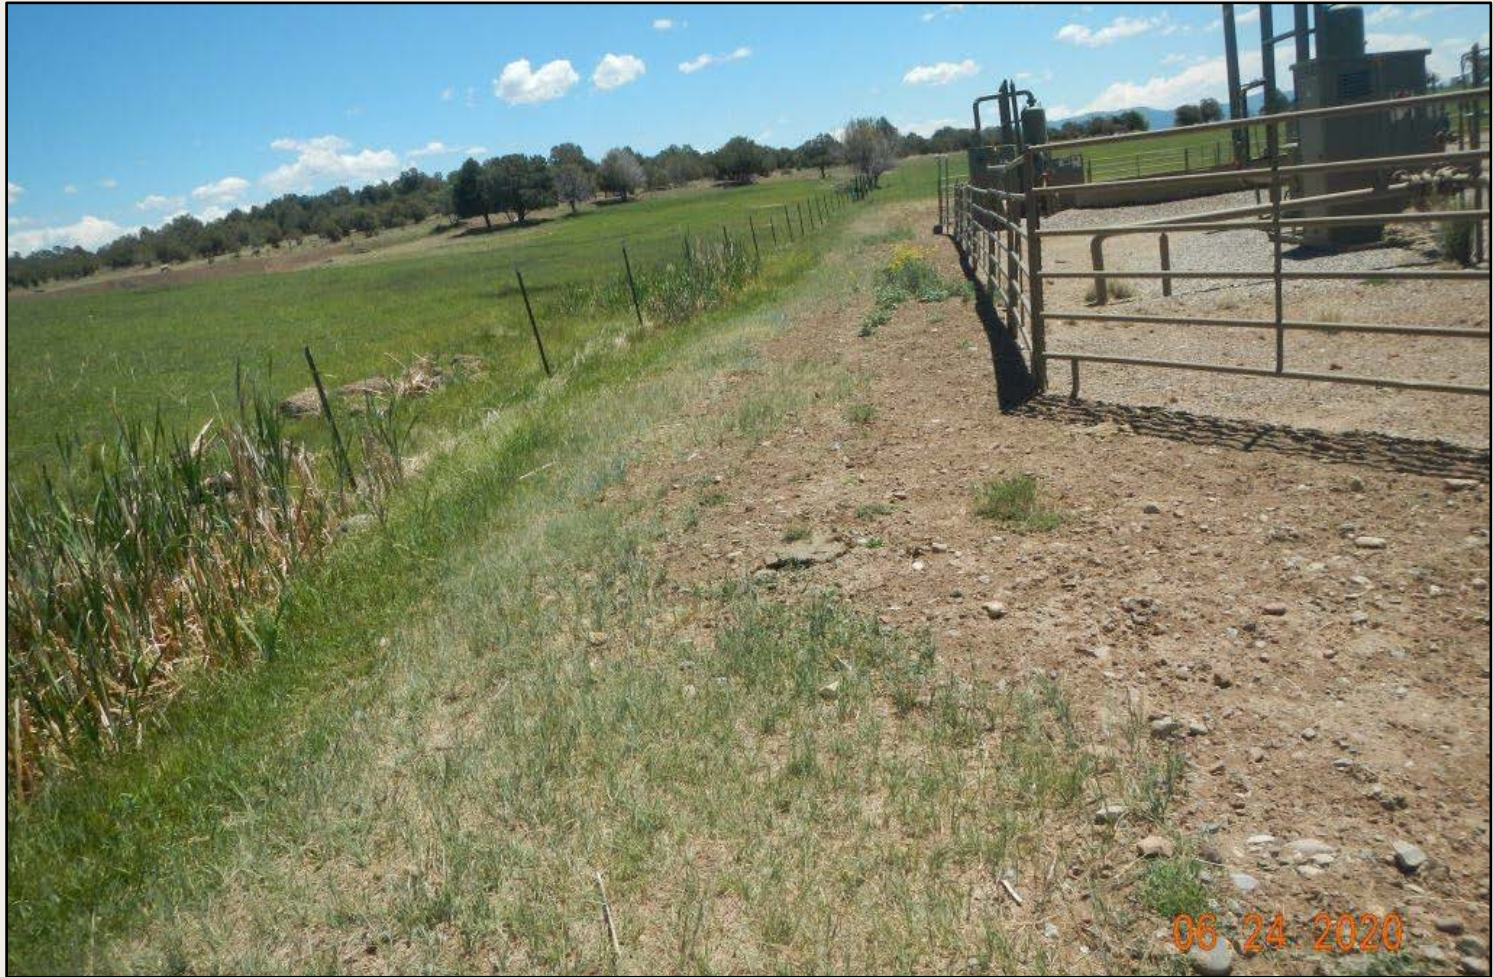
Photo 3. View of the northern project area facing westward.

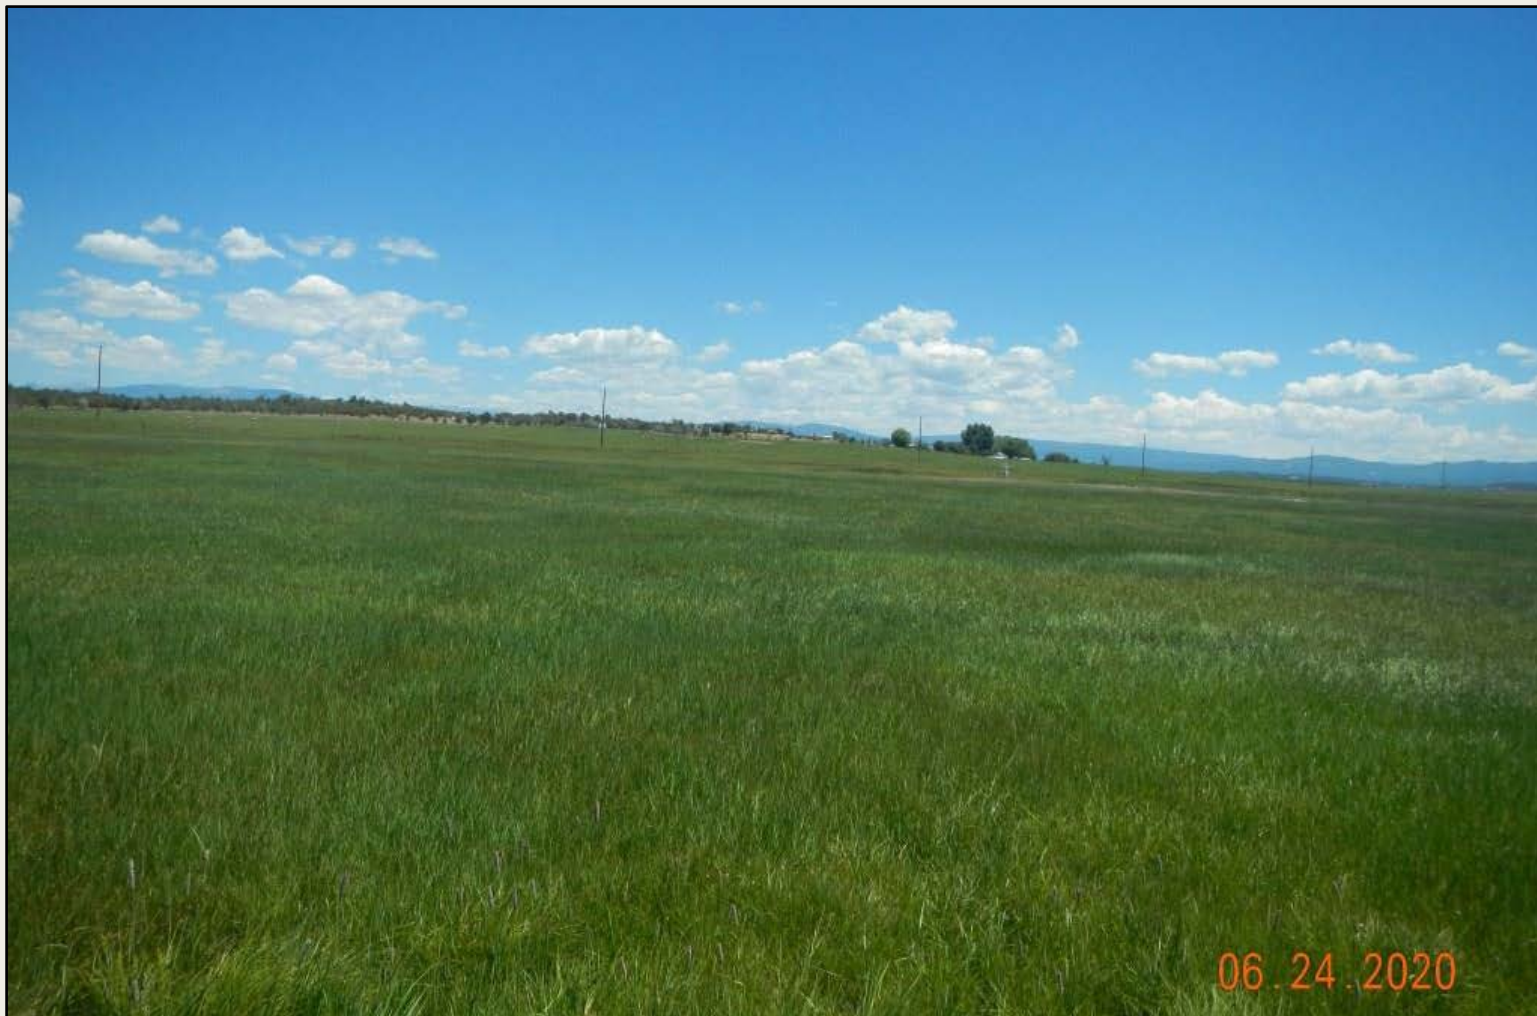
Photo 4. View of the reference area, comprised of irrigated pasture.
