Inspection Photos
Location Name: MARAH 1
API#: 05-071-09451
INSP. #: 695102899

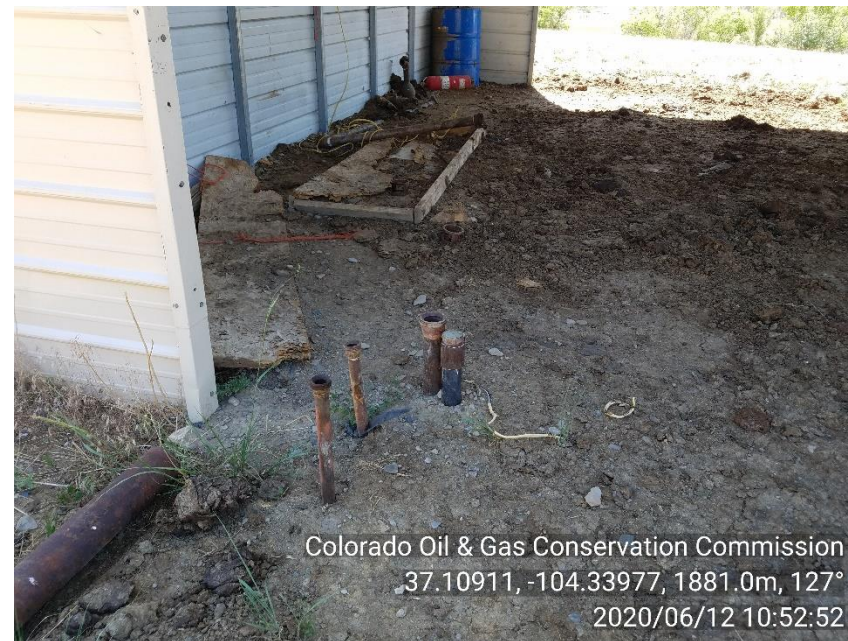
PHOTO 6: UNUSED RISERS NEAR WEST ENTRANCE OF CARPORT STYLE BUILDING. REMOVE UNUSED RISERS COMPLY WITH NTO AND RULE 603.f.

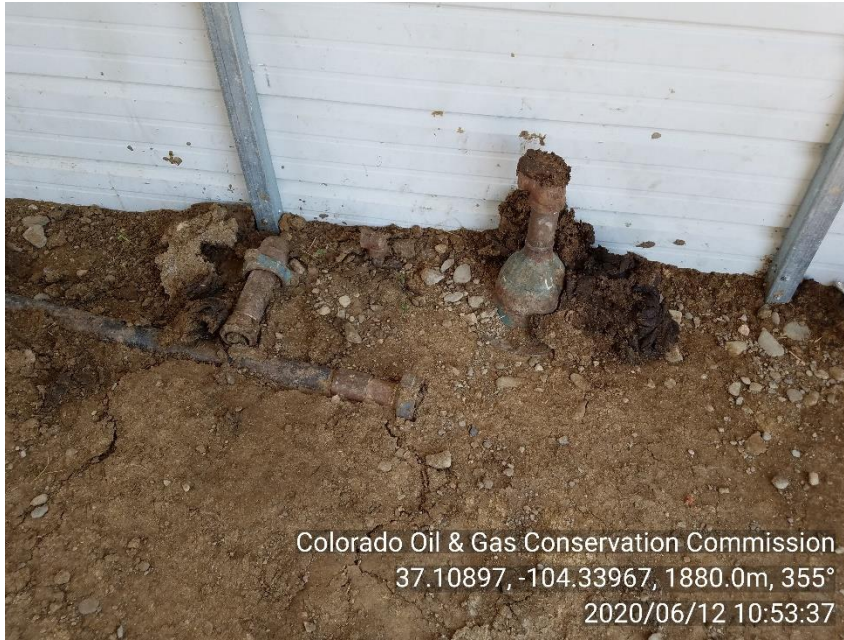
PHOTO 7: UNUSED RISERS ON INSIDE CARPORT STYLE BUILDING CLOSE TO NORTH WALL. REMOVE UNUSED RISERS COMPLY WITH NTO AND RULE 603.f.

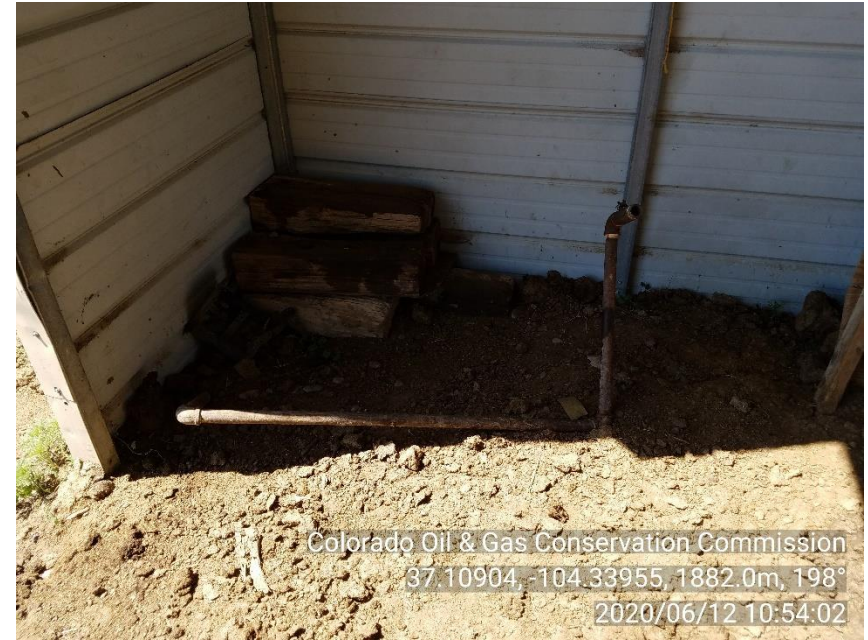
PHOTO 8: UNUSED RISERS ON INSIDE CARPORT STYLE BUILDING CLOSE TO SOUTHEAST WALL. IT APPEARS THAT THIS RISER IS DISCONNECTED JUST OUTSIDE OF BUILDING ON EAST SIDE. REMOVE UNUSED RISERS COMPLY WITH NTO AND RULE 603.f.

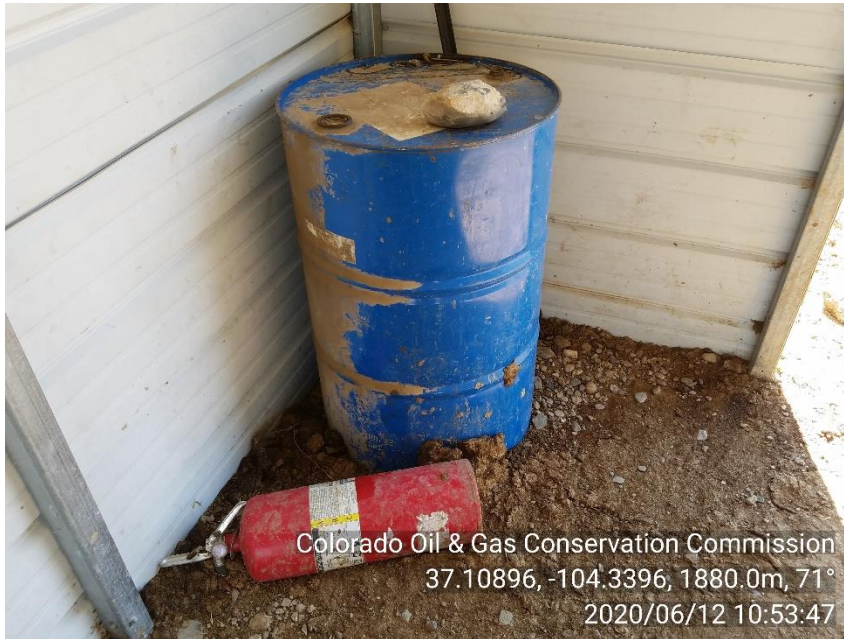
**PHOTO 9: UNUSED EQUIPMENT STORED INSIDE CARPORT
STYLE BUILDING. LABEL WAS NOT LEGIBLE. REMOVE
UNUSED EQUIPMENT COMPLY WITH RULE 603.f.**

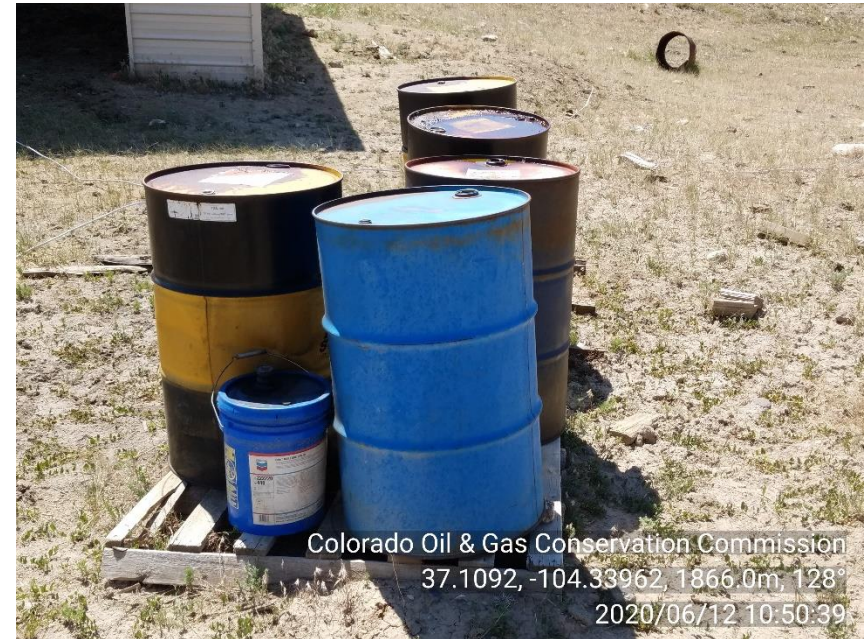
**PHOTO 10: BATTERY OF 55 GALEN BARRELS WEST OF
CARPORT STYLE BUILDING. REMOVE UNUSED EQUIPMENT
COMPLY WITH RULE 603.f.**

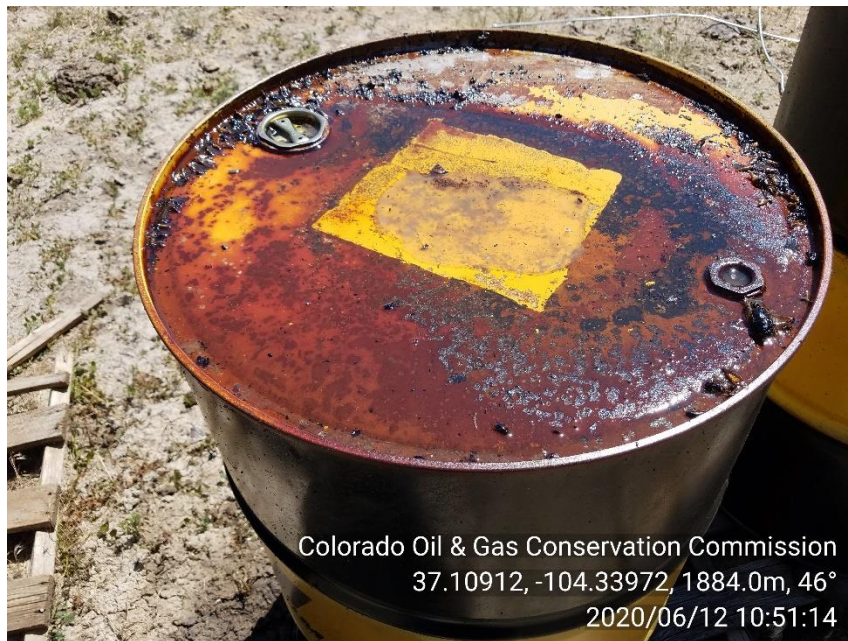
PHOTO 13: FLUID ON TOP OF 1 OF THE 55 GAL. DRUMS IN WEST BATTERY. CAN NOT DETERMINE SOURCE OF FLUID AT TIME OF INSPECTION.

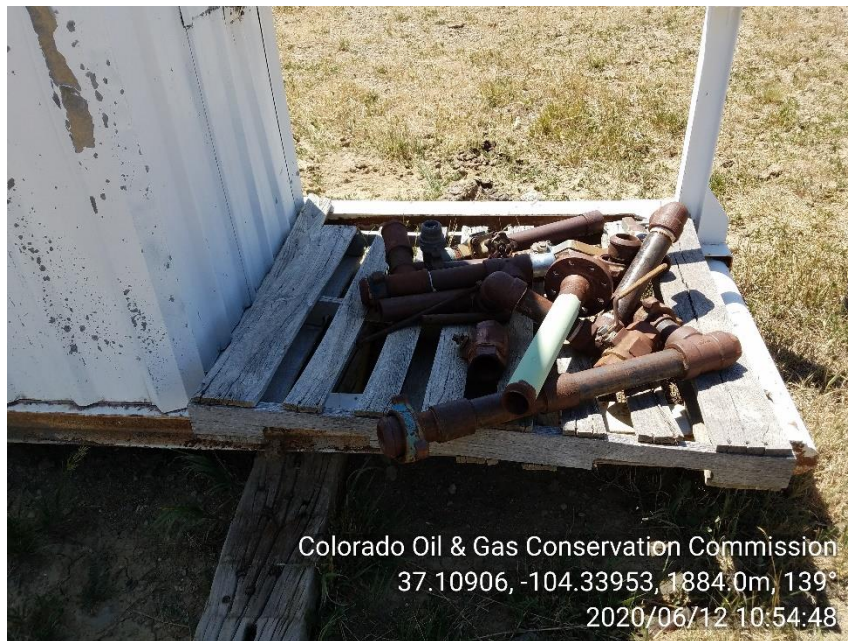
**PHOTO 19: UNUSED EQUIPEMNT STORED ON PALLET ON
METER HOUSE SKID. REMOVE UNUSED EQUIPMENT COMPLY
WITH RULE 603.f.**

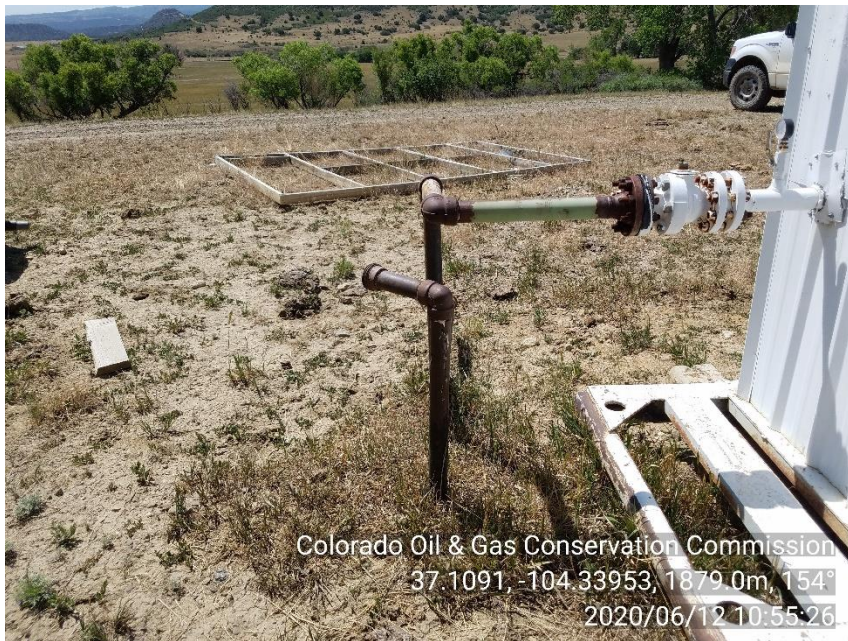
**PHOTO 21: UNUSED RISER NEAR METER HOUSE. REMOVE
UNUSED RISERS COMPLY WITH NTO AND RULE 603.f.**

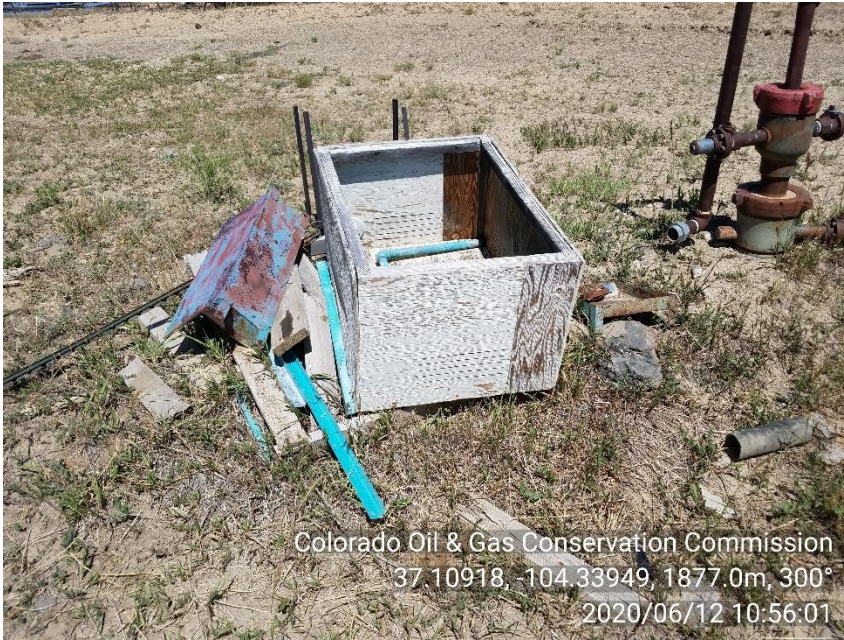
PHOTO 23: UNUSED EQUIPMENT STORED NEXT TO WELLHEAD. REMOVE UNUSED EQUIPMENT COMPLY WITH RULE 603.f.

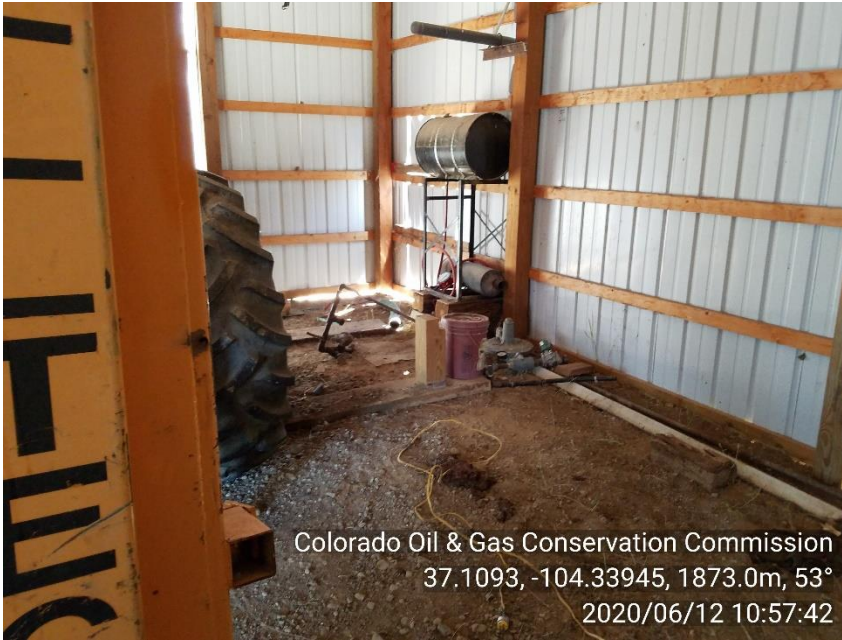
PHOTO 23: UNUSED EQUIPMENT STORED INSIDE GARAGE STYLE BUILDING. REMOVE UNUSED EQUIPMENT COMPLY WITH RULE 603.f.

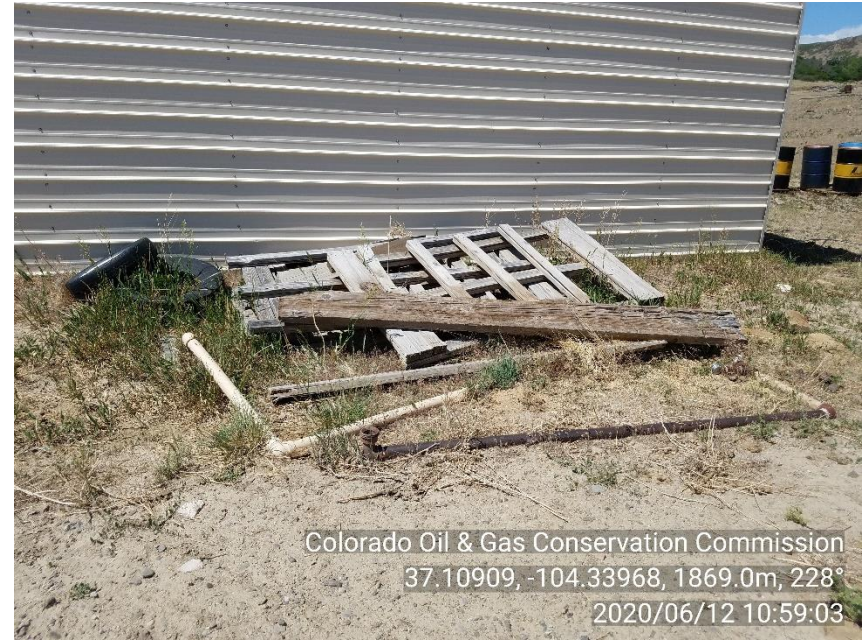
PHOTO 24: UNUSED EQUIPMENT AND TRASH OF LOCATION NEAR CARPORT STYLE BUILDING. REMOVE UNUSED EQUIPMENT, TRASH AND DEBRIS, COMPLY WITH RULE 603.f.

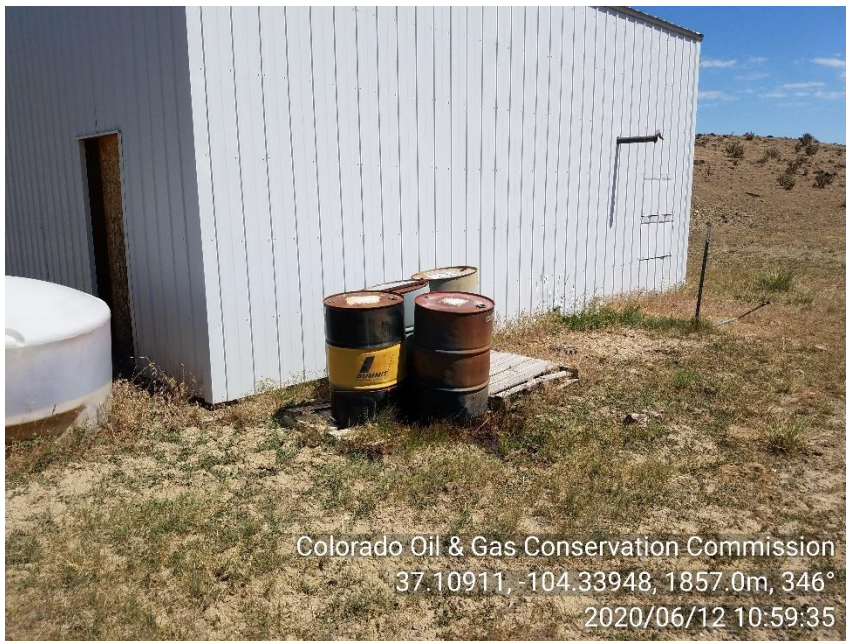
PHOTO 25: BATTERY OF 55 GAL. DRUMS ON EAST SIDE OF GARAGE STYLE BUILDING. REMOVE UNUSED EQUIPMENT COMPLY WITH RULE 603.f.

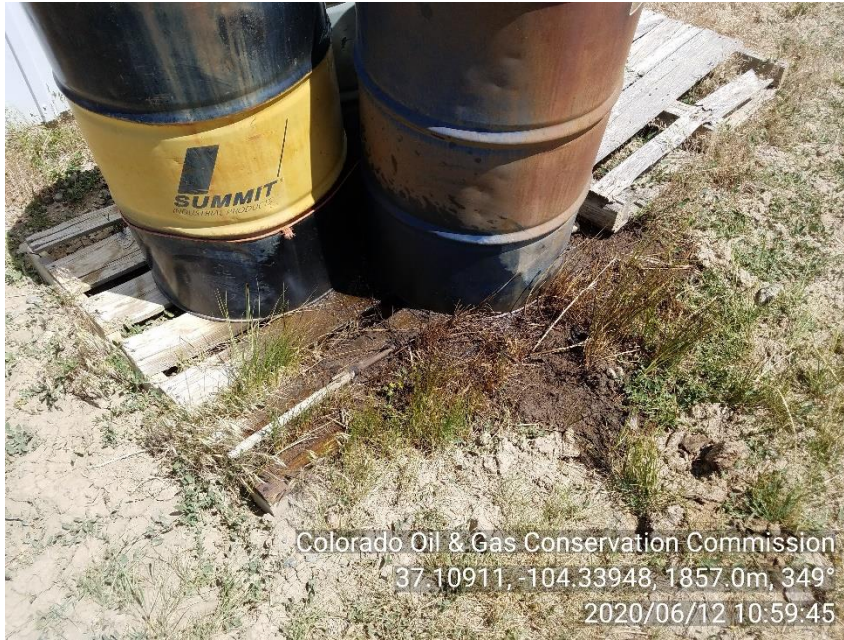
PHOTO 29: APPEARS THAT 1 OR MORE OF THE 55 GAL. DRUMS IN EAST BATTER ARE LEAKING FLUID. CANNOT DETERMINE WHICH BARRELS OR BARRELS ARE LEAKING. (IT APPEARS THAT IT COULD BE USED OIL ON THE PALLETS AND GROUND NEAR BARRELS).

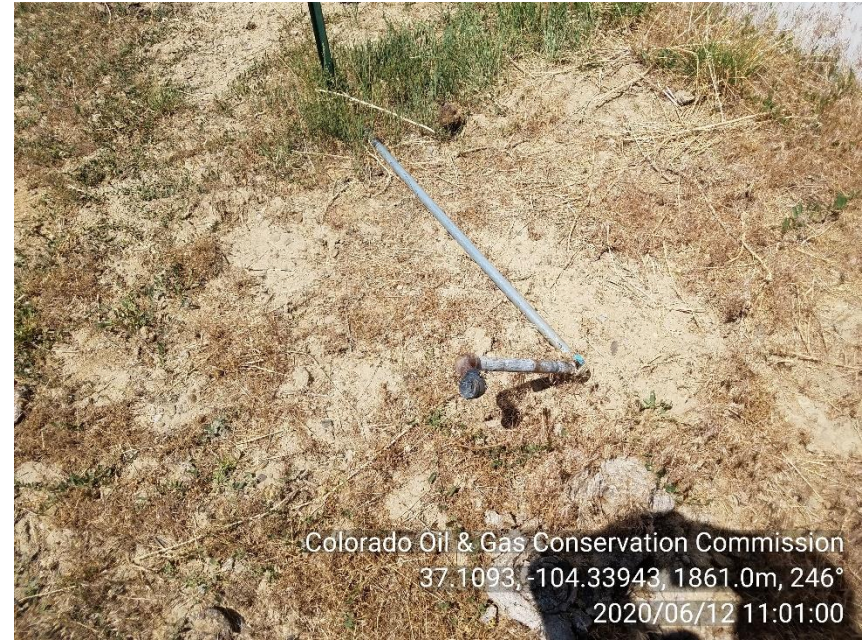
PHOTO 30: UNUSED RISER ON EAST SIDE OF GARAGE STYLE BUILDING. REMOVE UNUSED RISER COMPLY WITH NTO AND RULE 603.f.

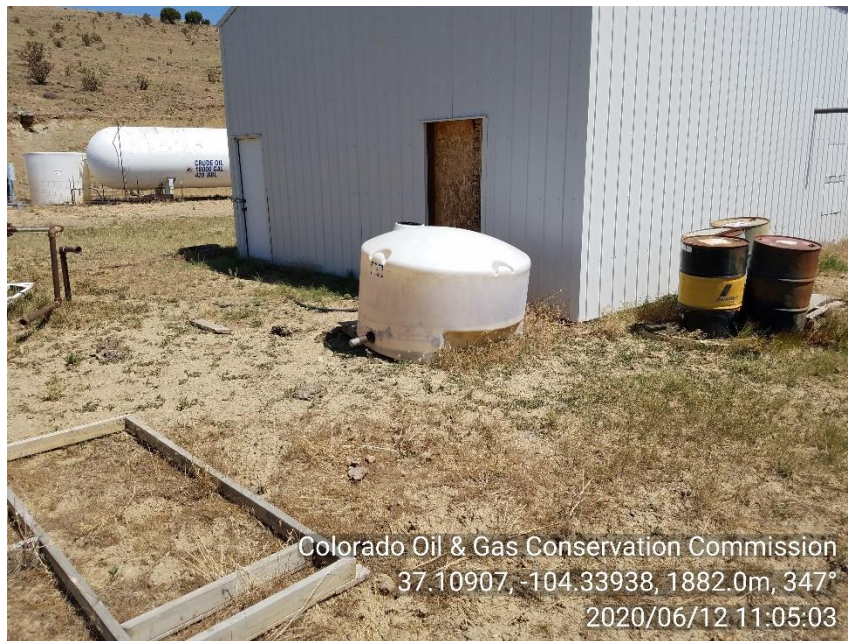
PHOTO 31: UNUSED EQUIPMENT ON SOUTH SIDE OF GARAGE STYLE BUILDING. REMOVE UNUSED EQUIPMENT COMPLY WITH RULE 603.f.

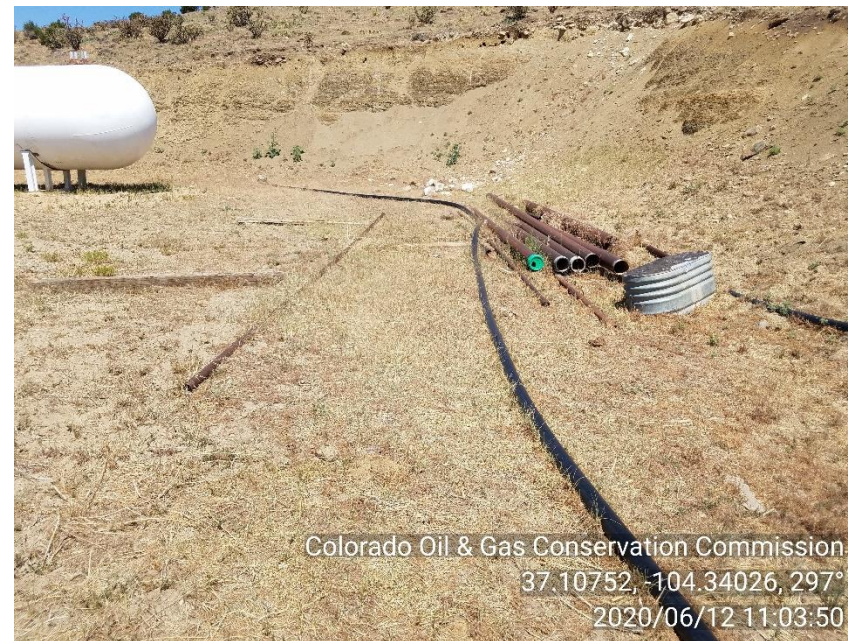
PHOTO 32: UNUSED MIS. PIPES STORED ON NORTH SIDE OF LOCATION (2 7/8" TBG AND APPEARS TO BE 6" CSG.). REMOVE UNUSED EQUIPMENT COMPLY WITH RULE 603.f.

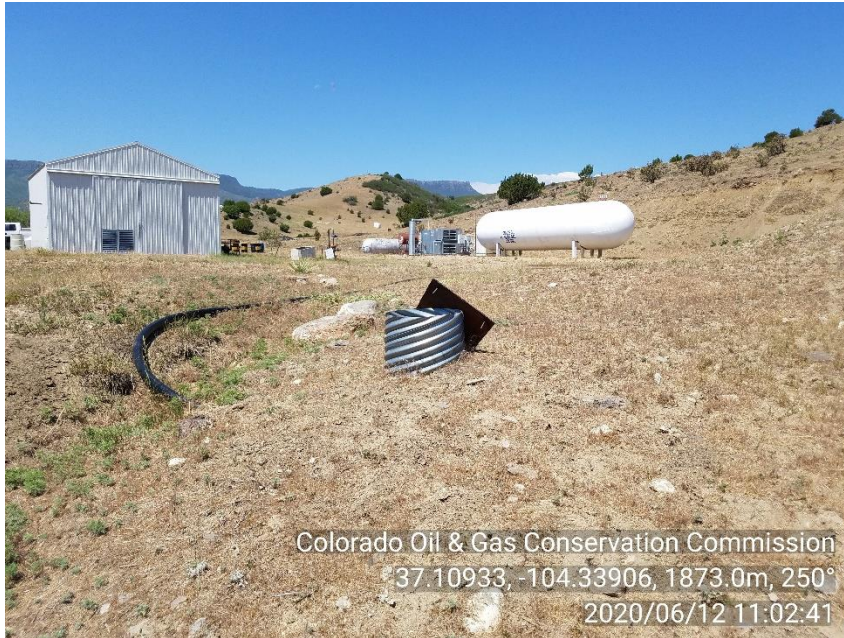
PHOTO 33: CELLAR CONTAINING A VALVE THAT APPEARS TO BE CLOSED . (THIS IS THE VALVE THAT CONTROLS THE LEAKING POLLY PIPE THAT RUNNS FROM THIS CELLAR ACROSS LOCATION TO APP. 300' TO THE SOUTH OF LOCATION WHERE THERE IS A SLIGHT LEAK, THIS IS THE LINE THAT USED TO SUPPLY A HOUSE THAT IS A FEW HUNDRED YARDS TO THE SOUTH OF LOCATION). THE LINE HAS BEEN CUT AT THE PROPERTY LINE BY THE NEW LANDOWNER.

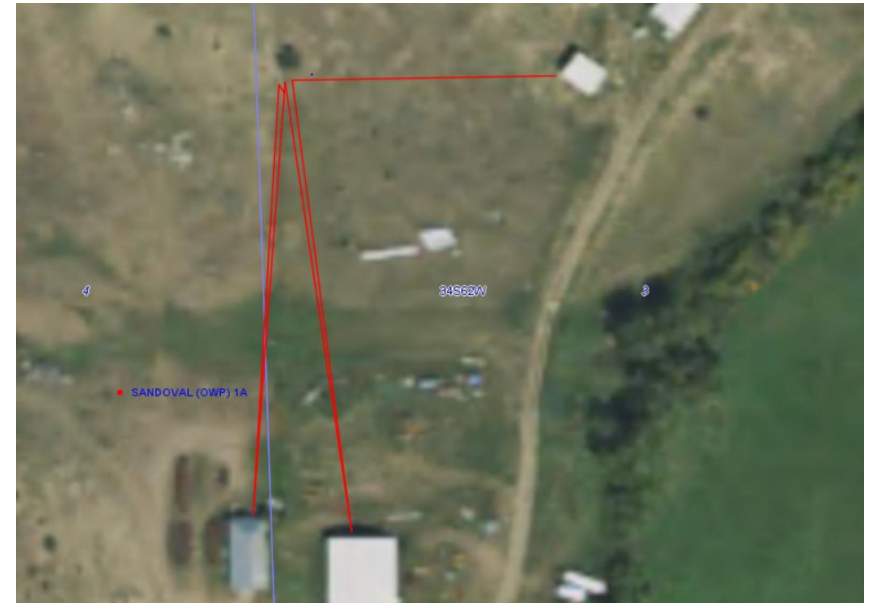
PHOTO 32: PHOTO 35: DISTANCE FROM LEAK TO NEAREST BUILDING (SOUTHERN MOST BUILDING ON LOCATION) APP. 222'. DISTANCE FROM NEXT CLOSEST BUILDING (RANCH OWNED BUILDING APPEARS TO BE TOOL SHED) APP. 339' AND DISTANCE FROM NEXT BUILDING (LARGE SHOP OWNED BY LANDOWNER) 324'.

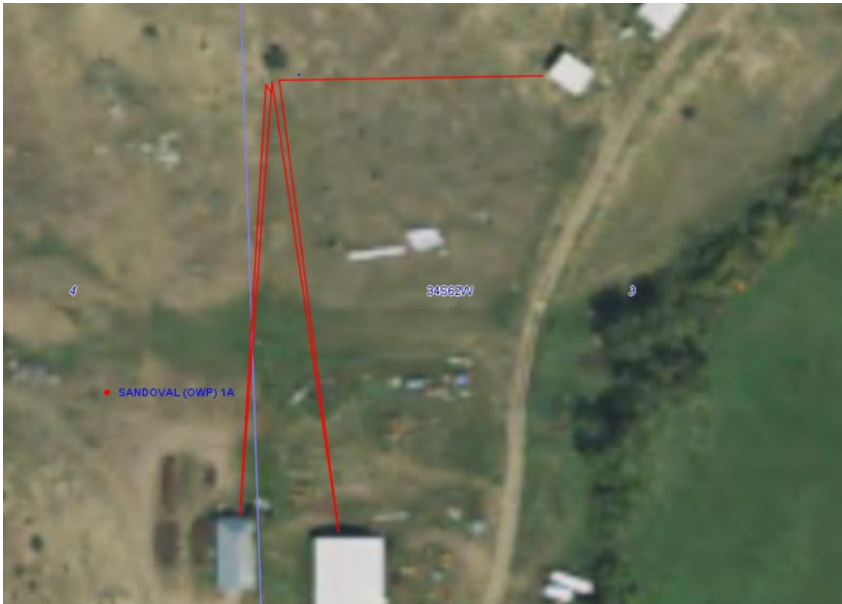
**PHOTO 35: DISTANCE FROM LEAK TO NEAREST BUILDING
(SOUTHERN MOST BUILDING ON LOCATION) APP. 222'.
DISTANCE FROM NEXT CLOSEST BUILDING (RANCH OWNED
BUILDING APPEARS TO BE TOOL SHED) APP. 339' AND
DISTANCE FROM NEXT BUILDING (LARGE SHOP OWNED BY
LANDOWNER) 324'.**
