Inspection Photos
Operator: BP America
API: 067-09400
Date: 6/24/2020

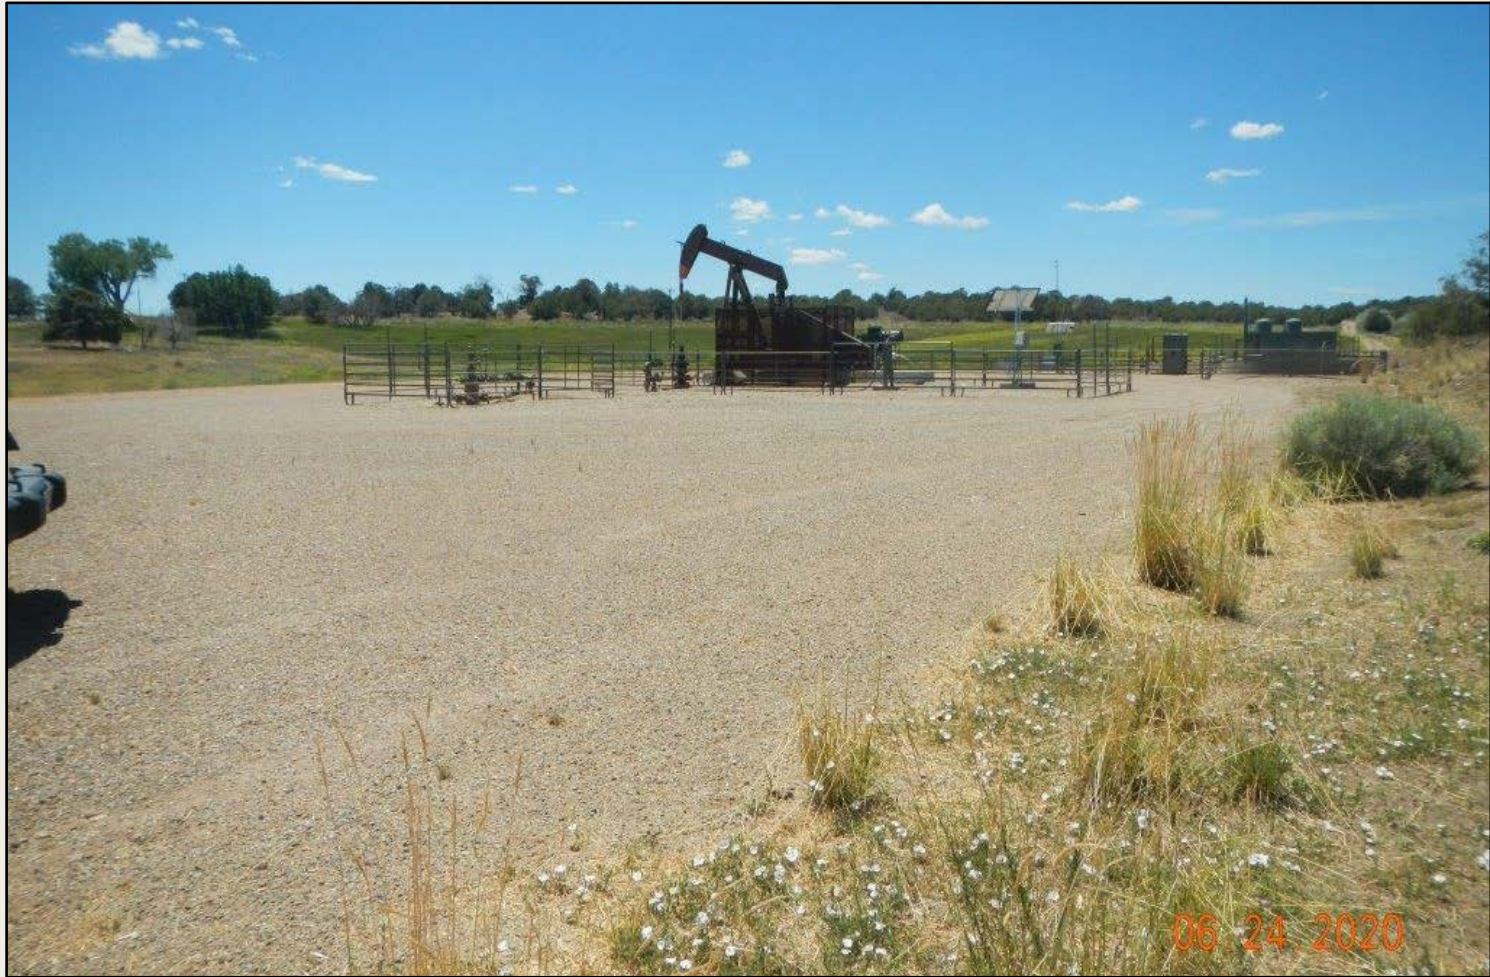
Photo 1. View of the project area from the southwestern corner facing center.

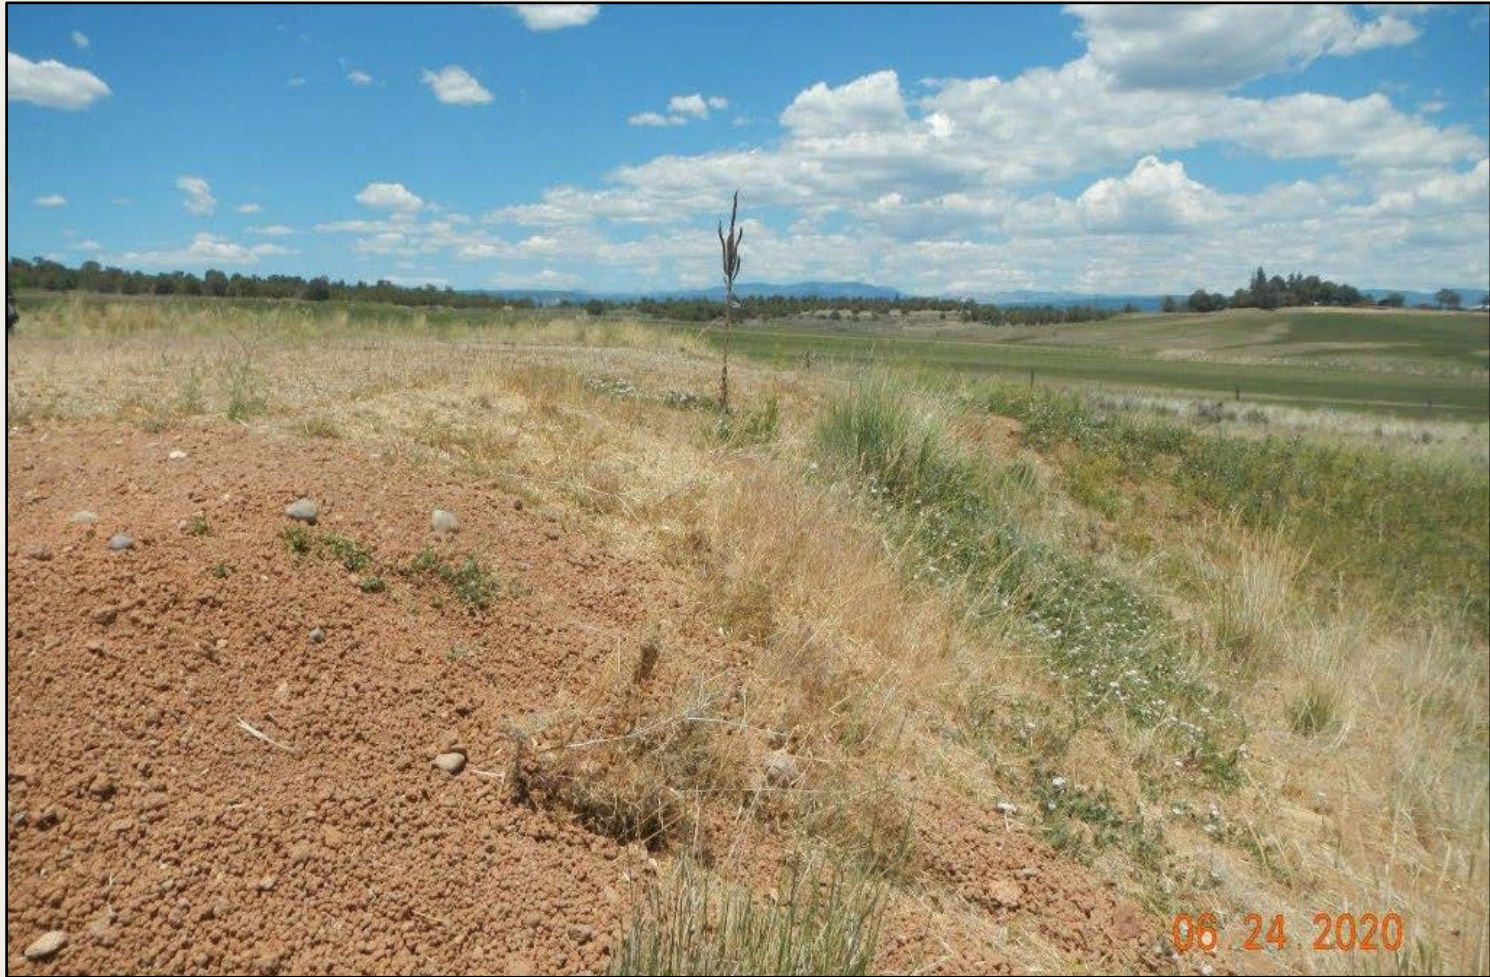
Photo 2. View of the eastern fill slope from the southeastern corner facing northward. Revegetation is progressing within portions of the interim reclamation area with crested wheatgrass, intermediate wheatgrass, and western wheatgrass, but remains sparse in portions and needs to be monitored.
