Inspection Photos
Operator: BP America
API: 067-08954
Date: 6/24/2020

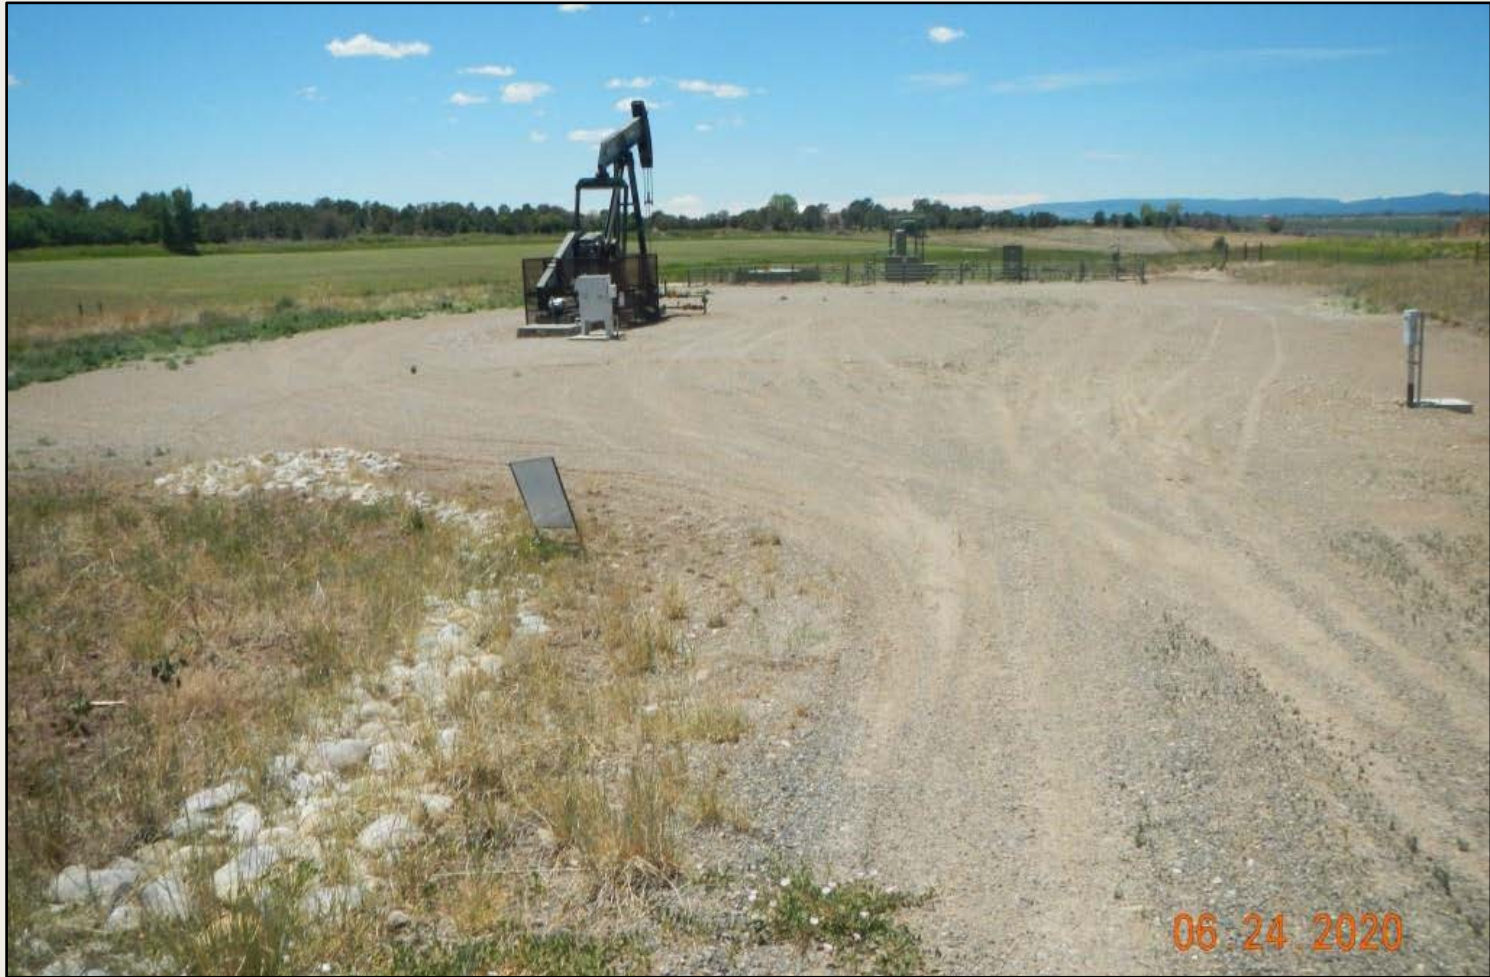
Photo 1. View of the project area from the well pad entrance facing center.

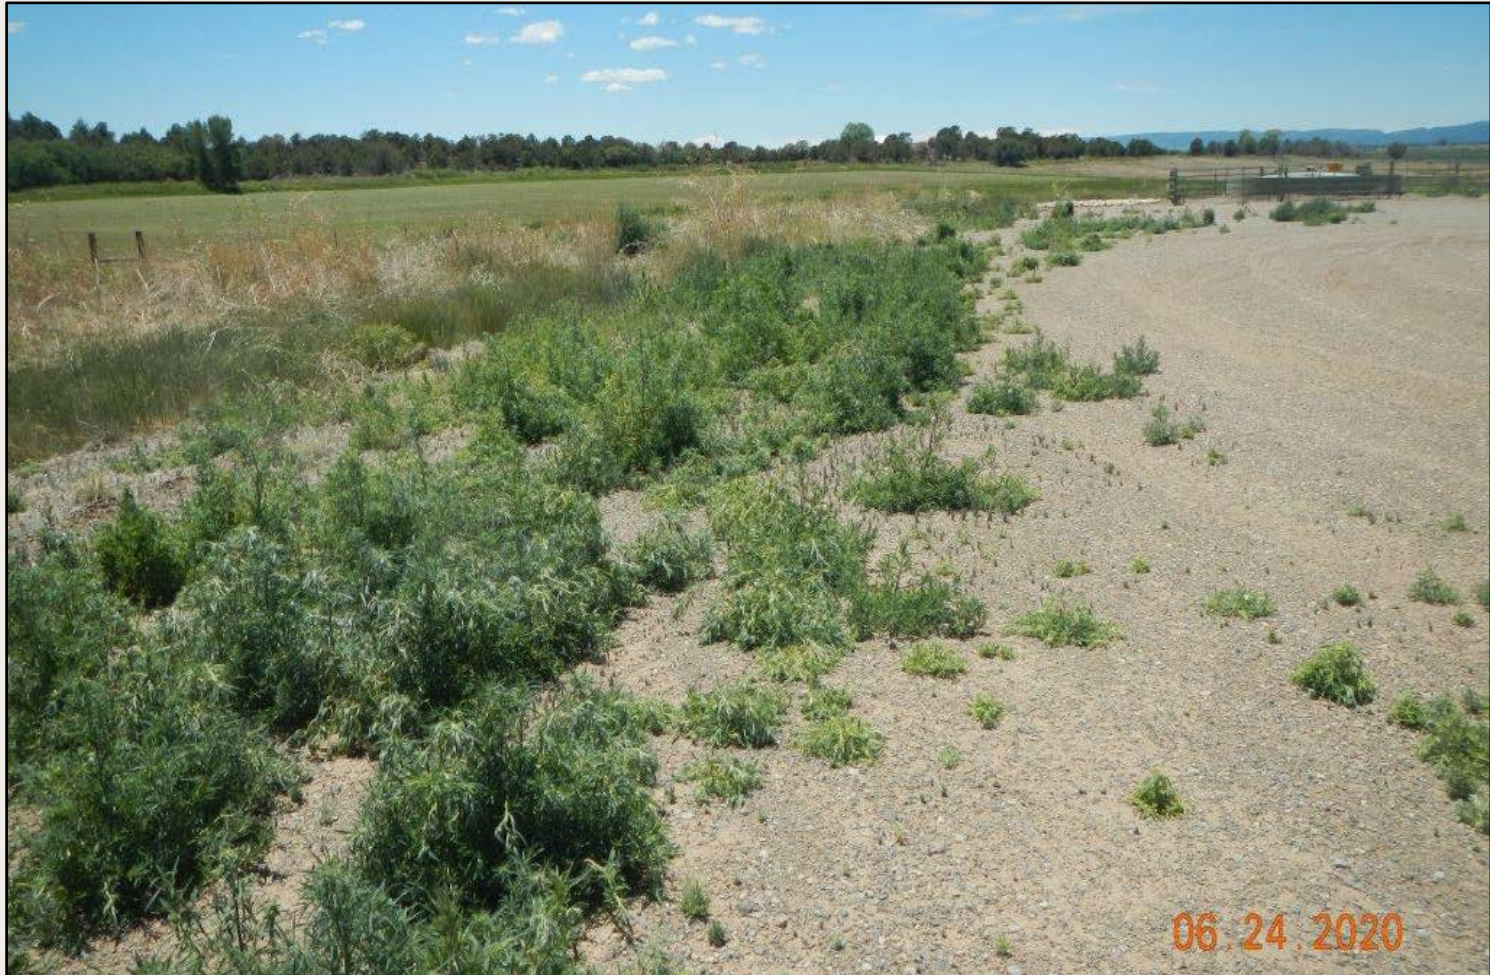
Photo 2. View of kochia plants in the western project area; wilting, after what appears to be herbicide treatment.

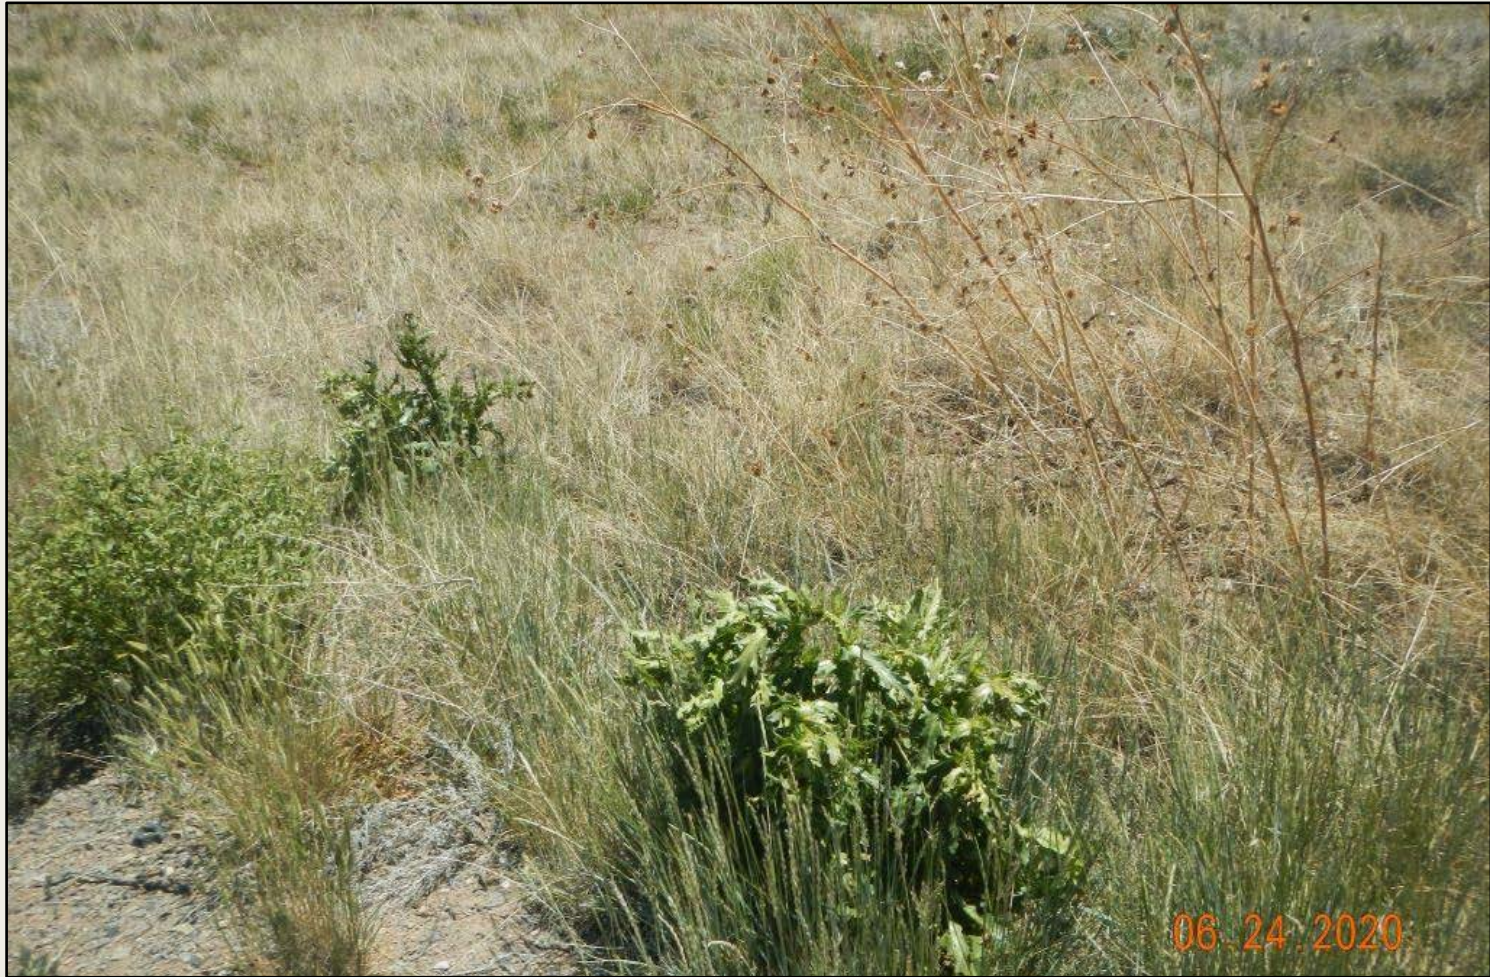
Photo 3. View of wilting musk thistles within the southern project area.

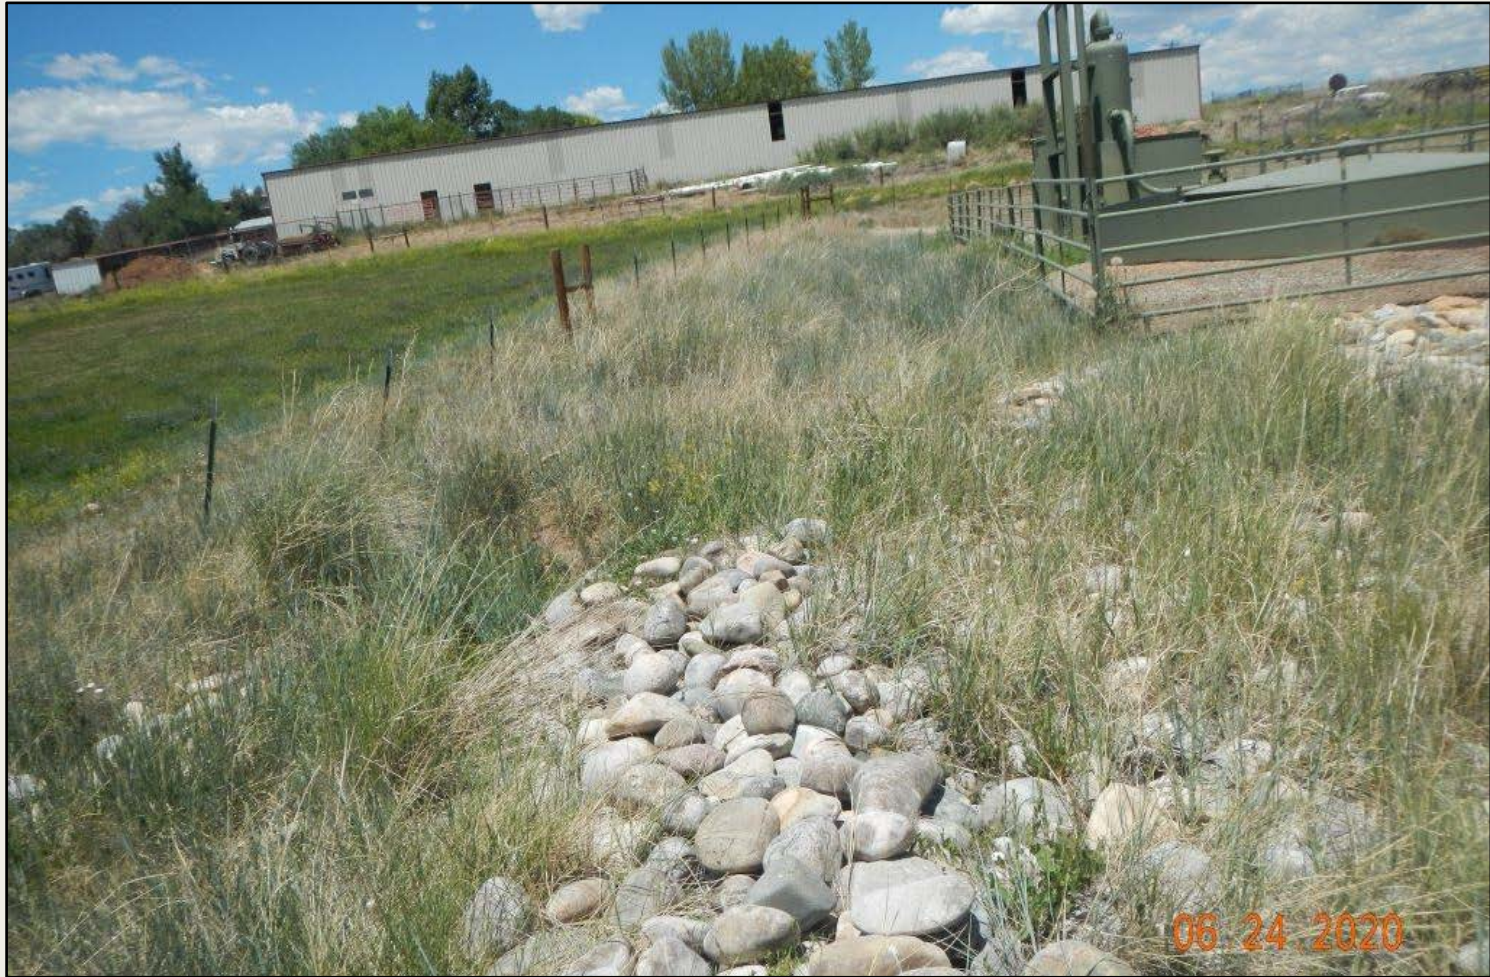
Photo 4. View of the western fill slope from the southwestern corner facing northward. Revegetation is progressing here with grasses such as western wheatgrass and crested wheatgrass. Weeds need to continue to be managed.

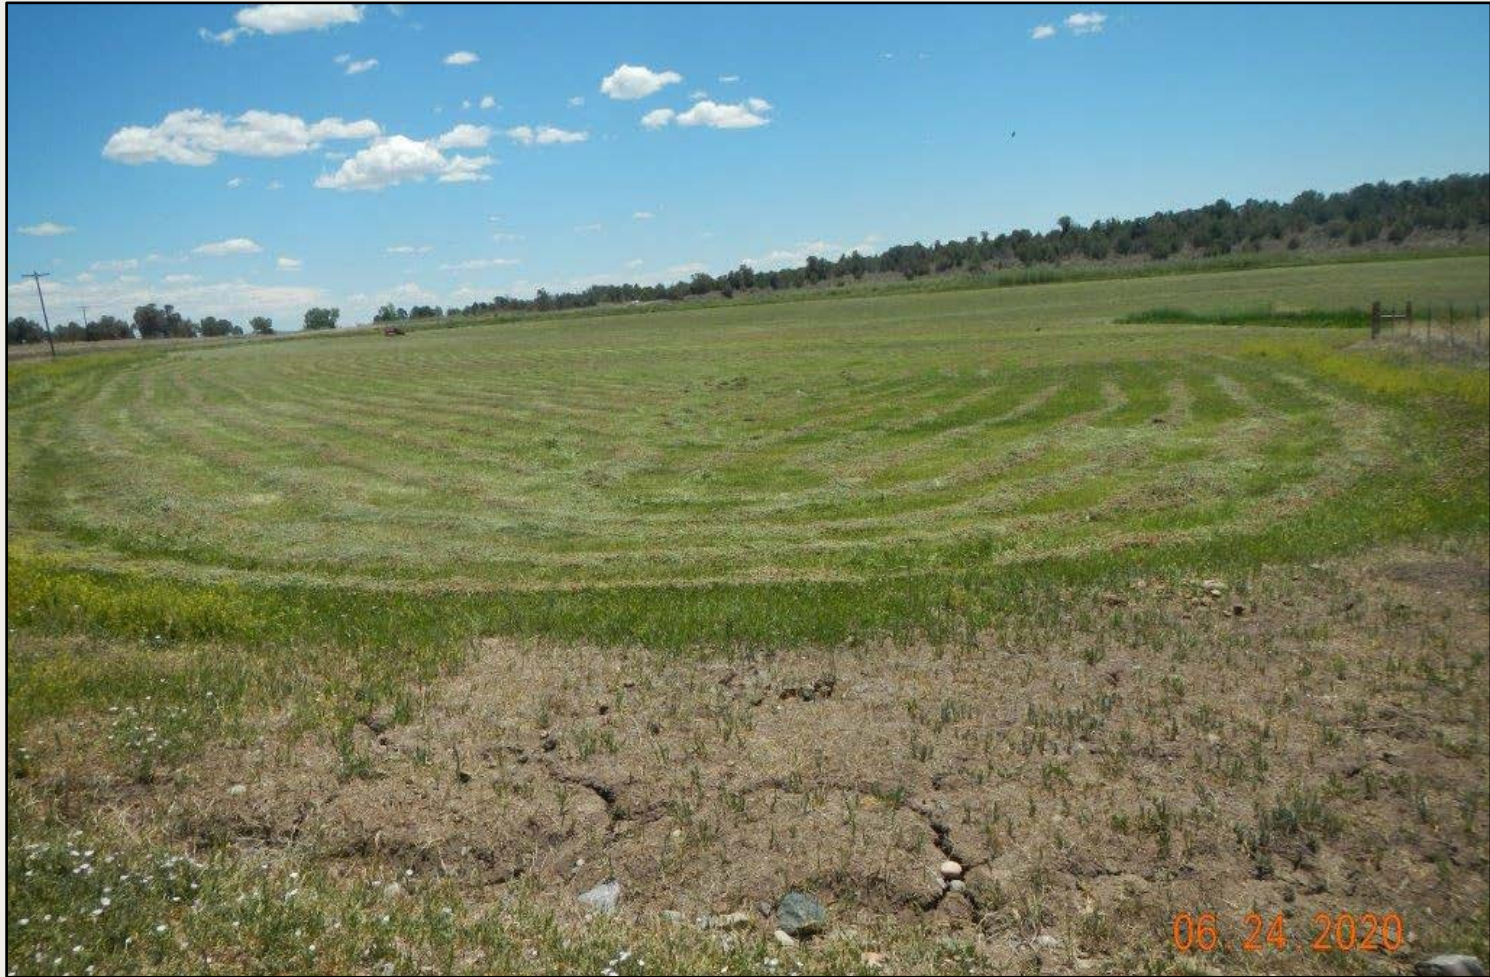
Photo 5. View of the reference area, comprised of irrigated grass field.
