Inspection Photos
Location Name: Uprrr 60 Pan Am E
Location ID: 320083

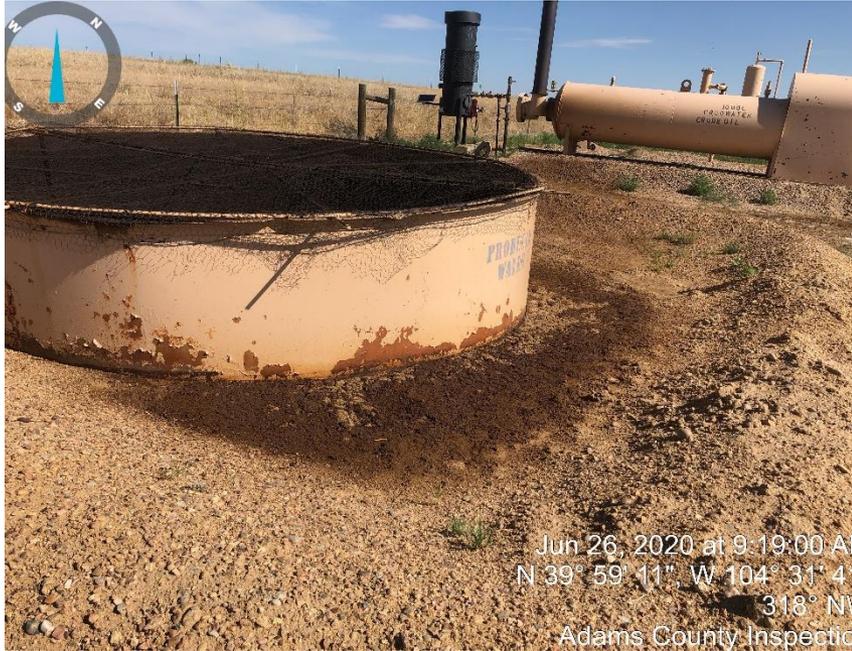
Photo #3 stained soil in berm of produced water

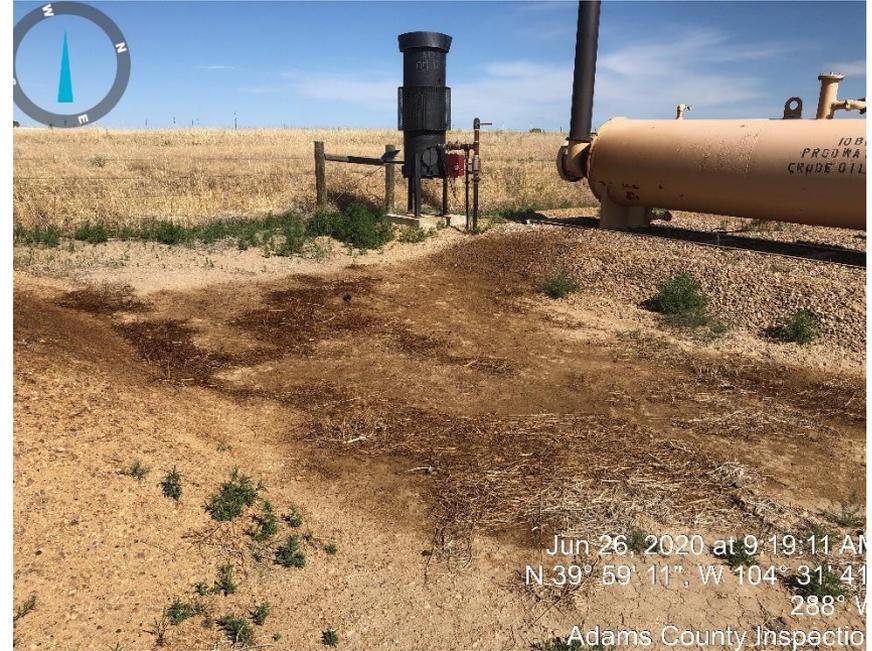
Photo #4 stained soil from berm to separator, ECD

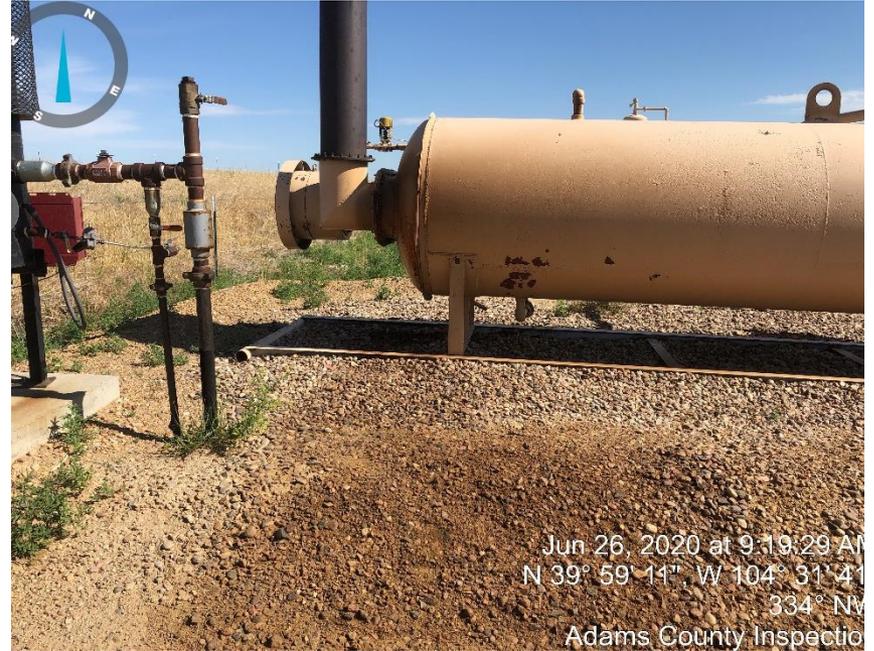
Photo #6 stained soil up to separator

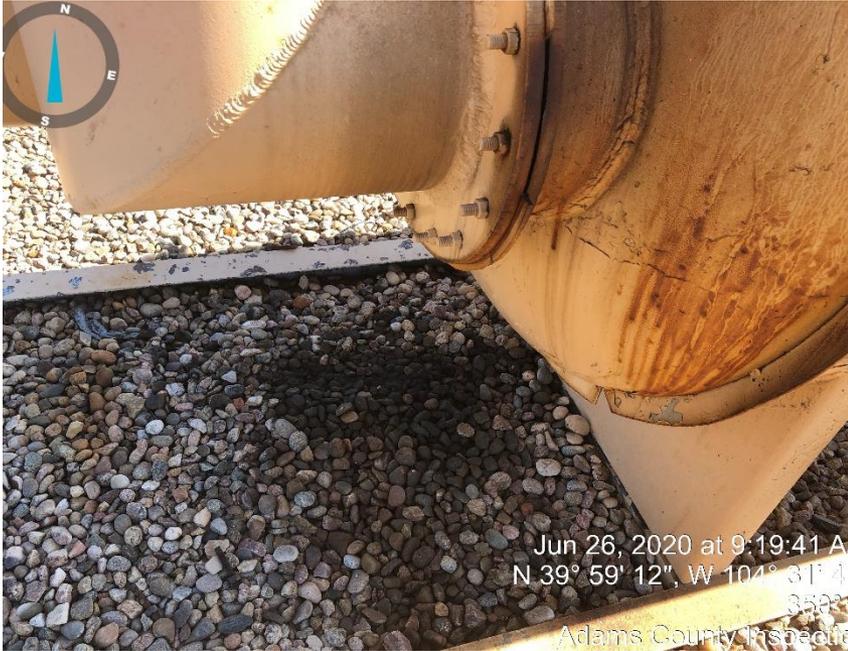
Photo #7 stained soil under separator and missing chunk if gasket in separator fire box.

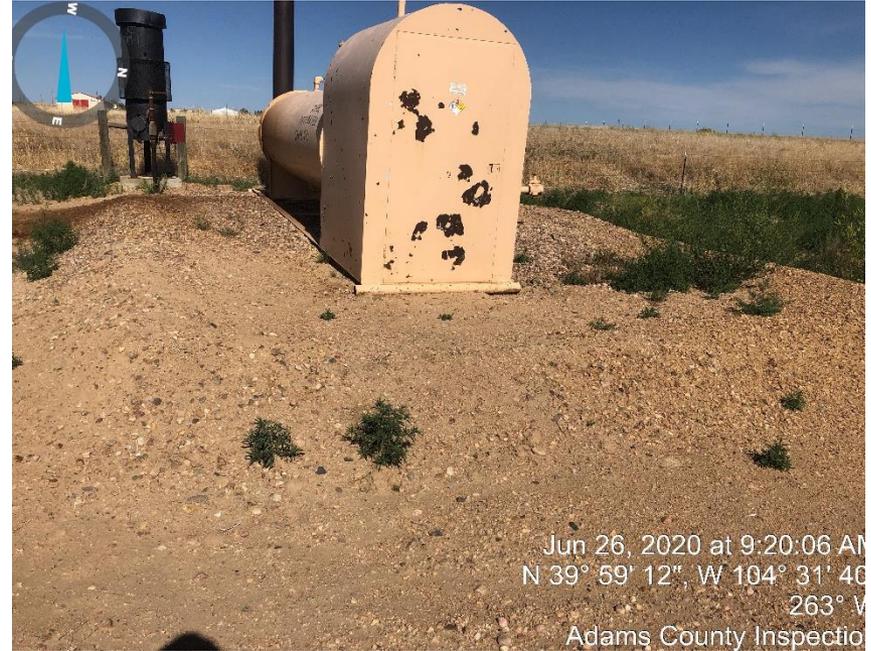
Photo #8 separator and weeds.

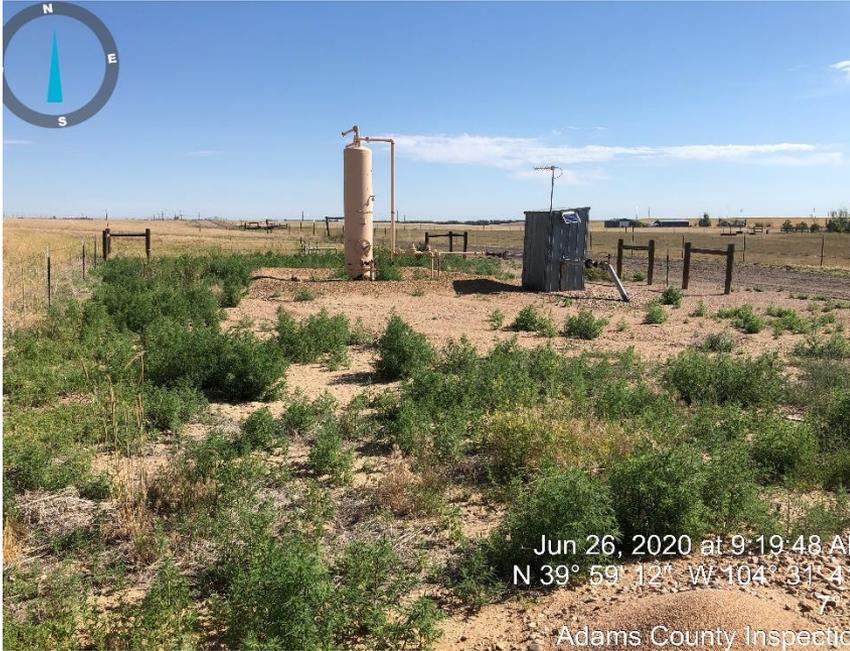
Photo #9 vertical separator, meter run and weeds

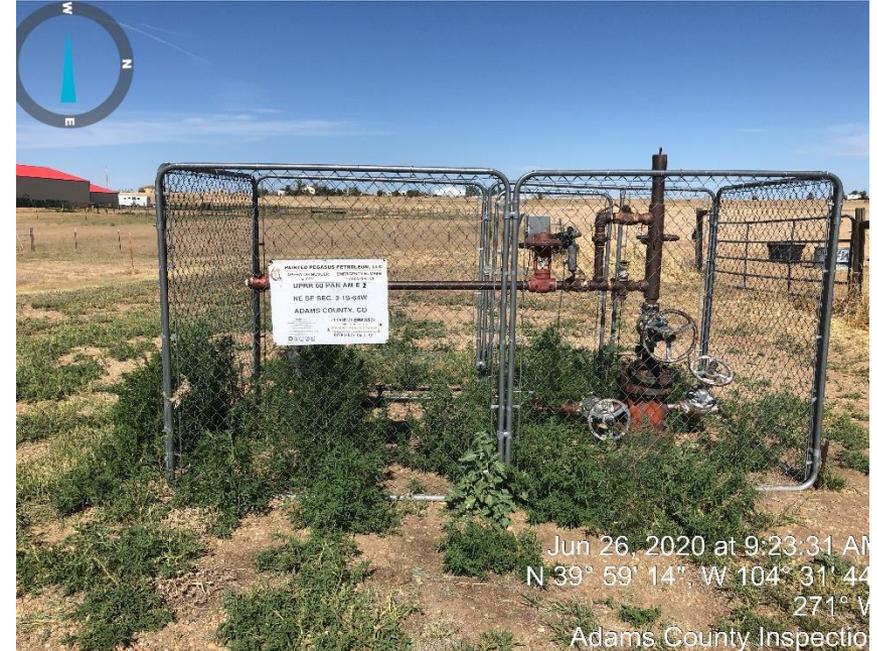
Photo #10 well head and weeds
