Location Name: – Investment Equipment LLC – Ward Kincheloe 1 Battery
Inspection Date: 06/29/2020

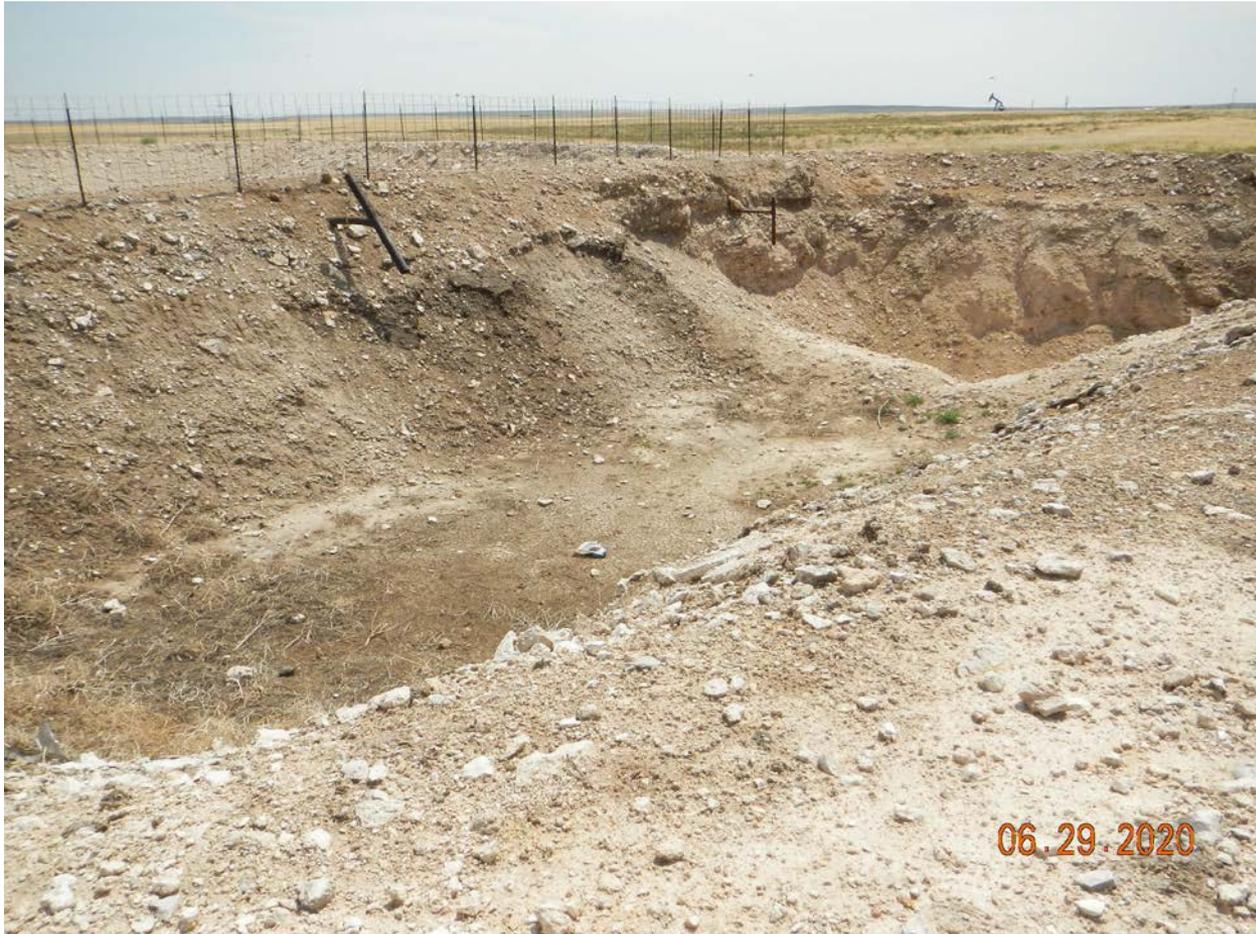
Photo # 2 – Produced water pits are dry, no water inflow

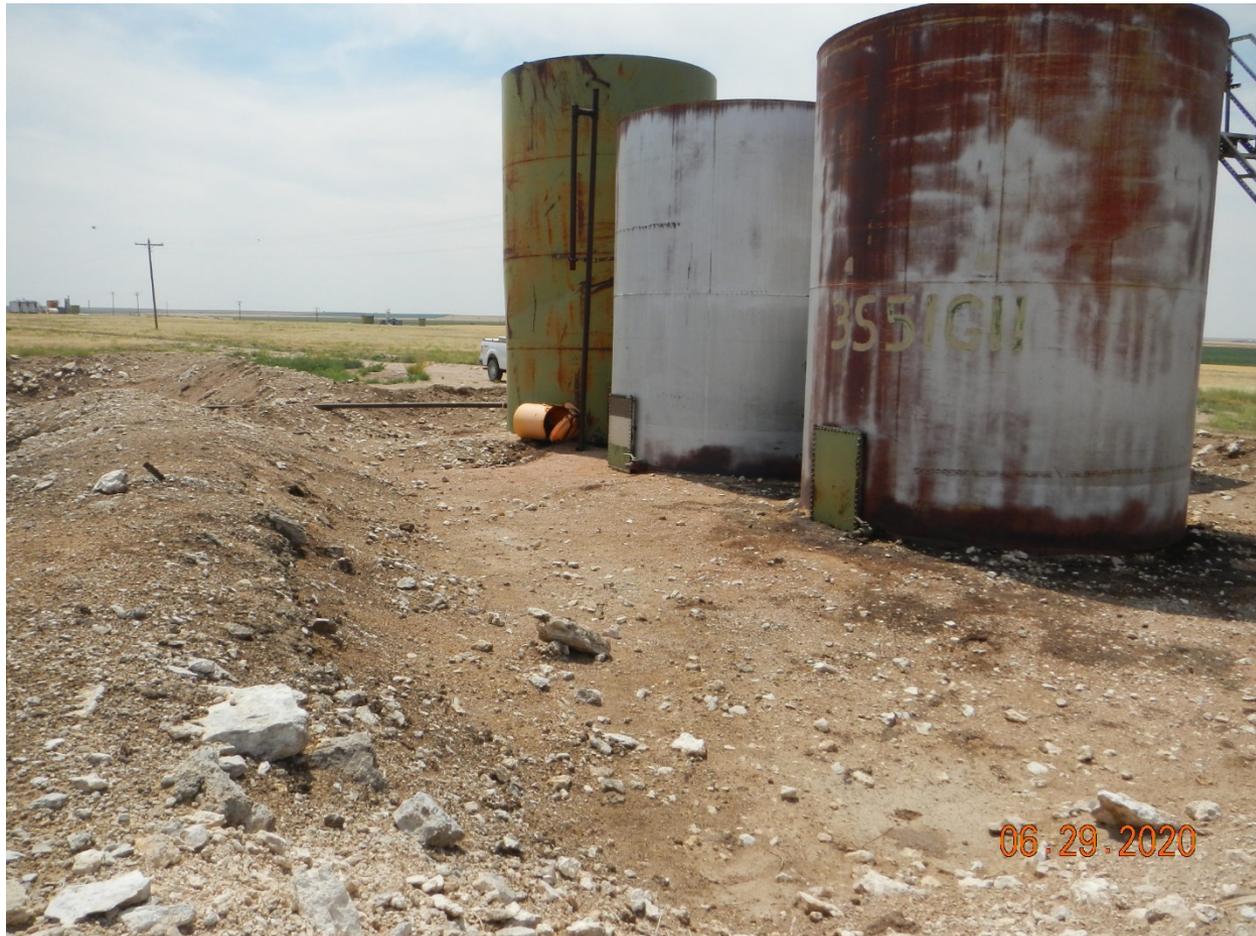
Photo # 3 – South side of tank battery. Yellow containment bucket on its side, stained soil on east side of battery

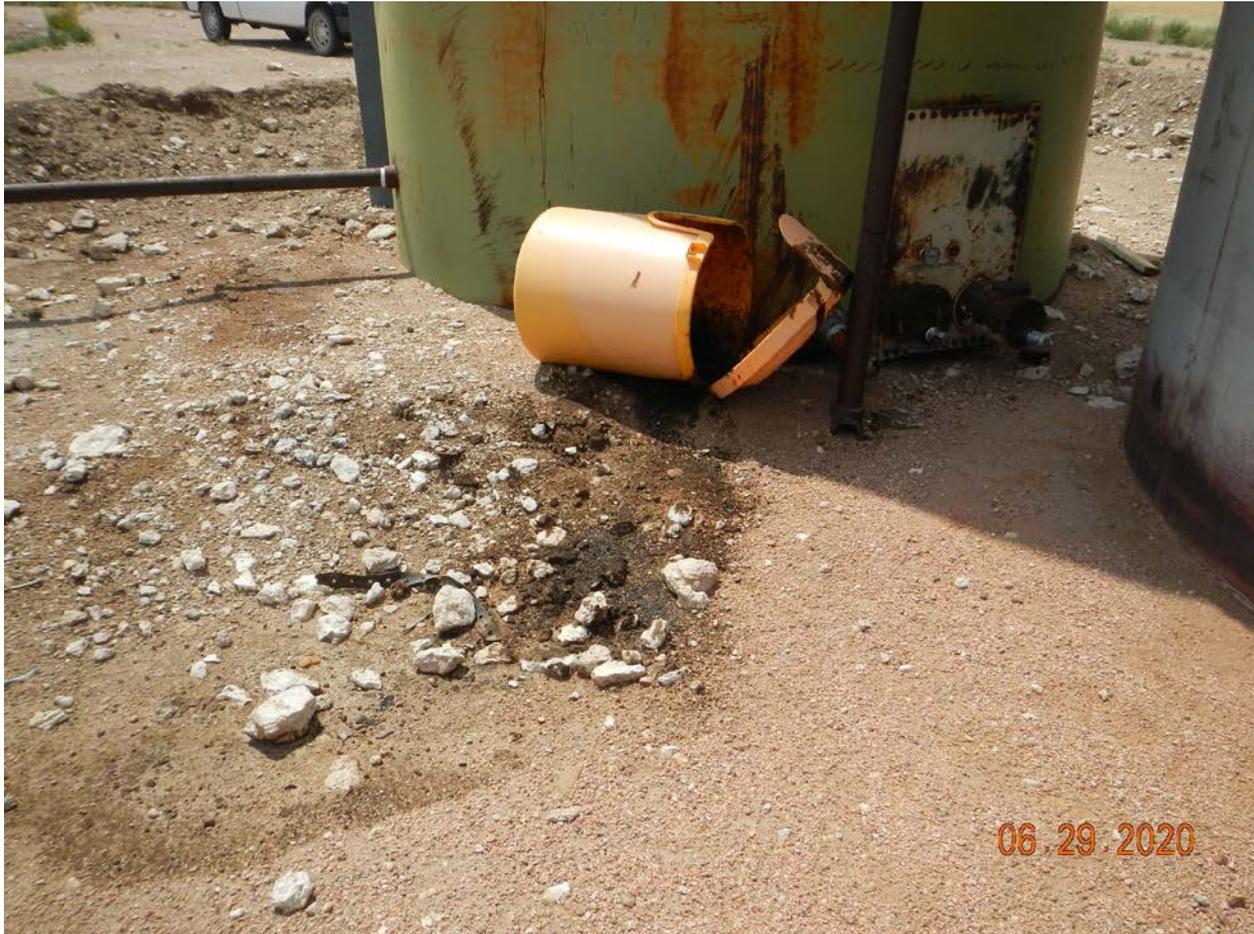
Photo # 4 – South side of tank battery. Yellow containment bucket on its side, oil stained soil

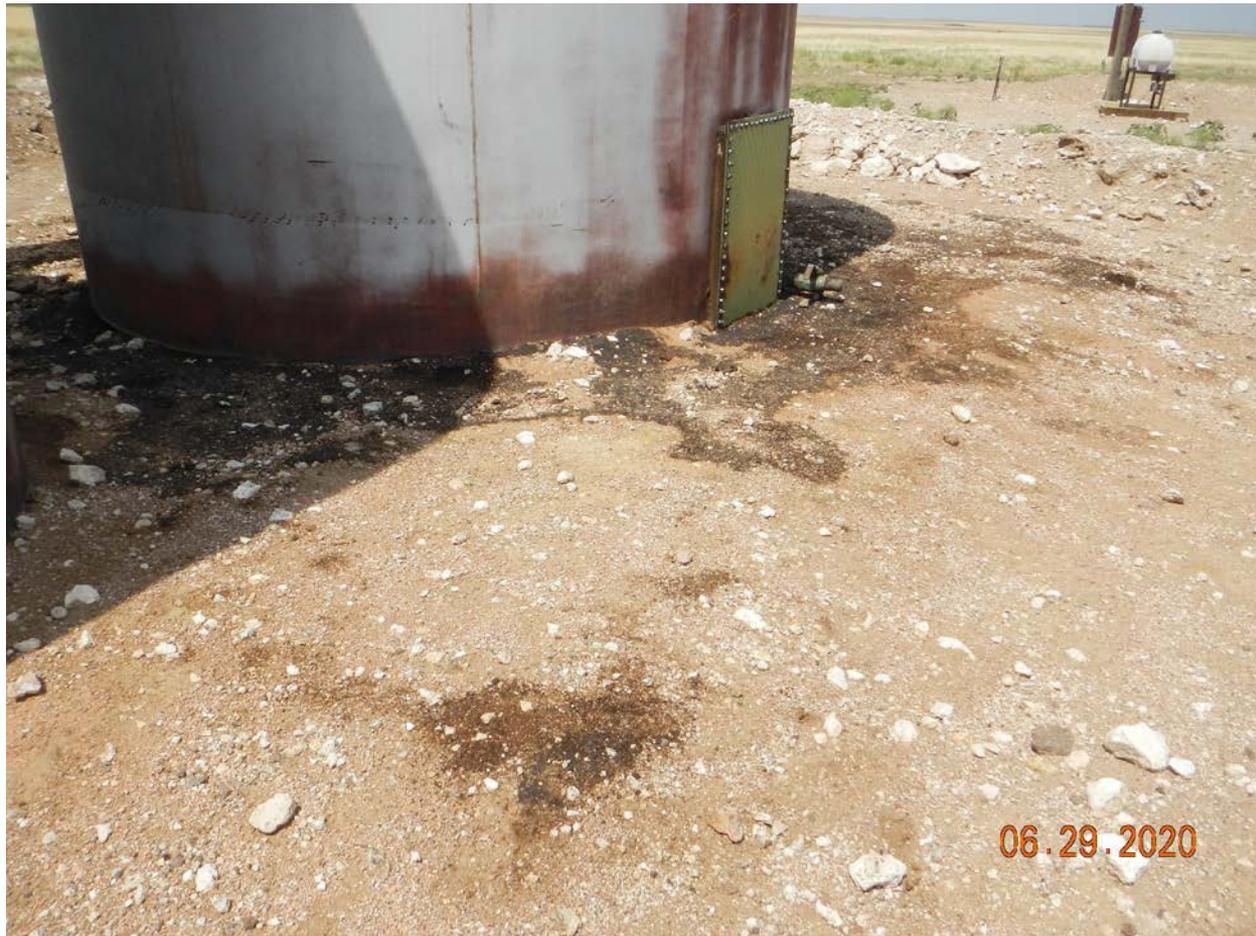
Photo # 5 – South side of tank battery oil stained soil around produced water tank

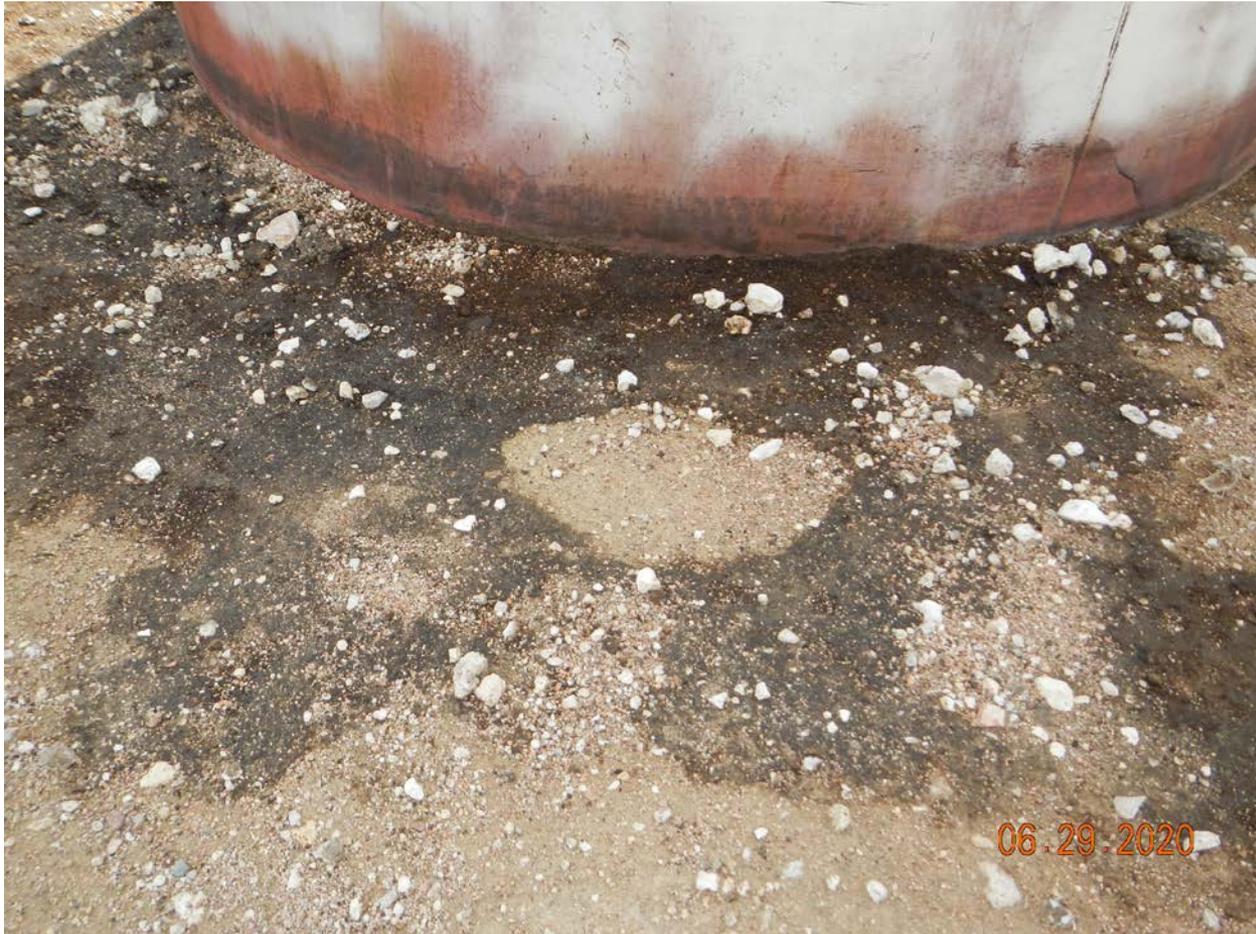
Photo # 6 – East side of tank battery oil stained soil around produced water tank

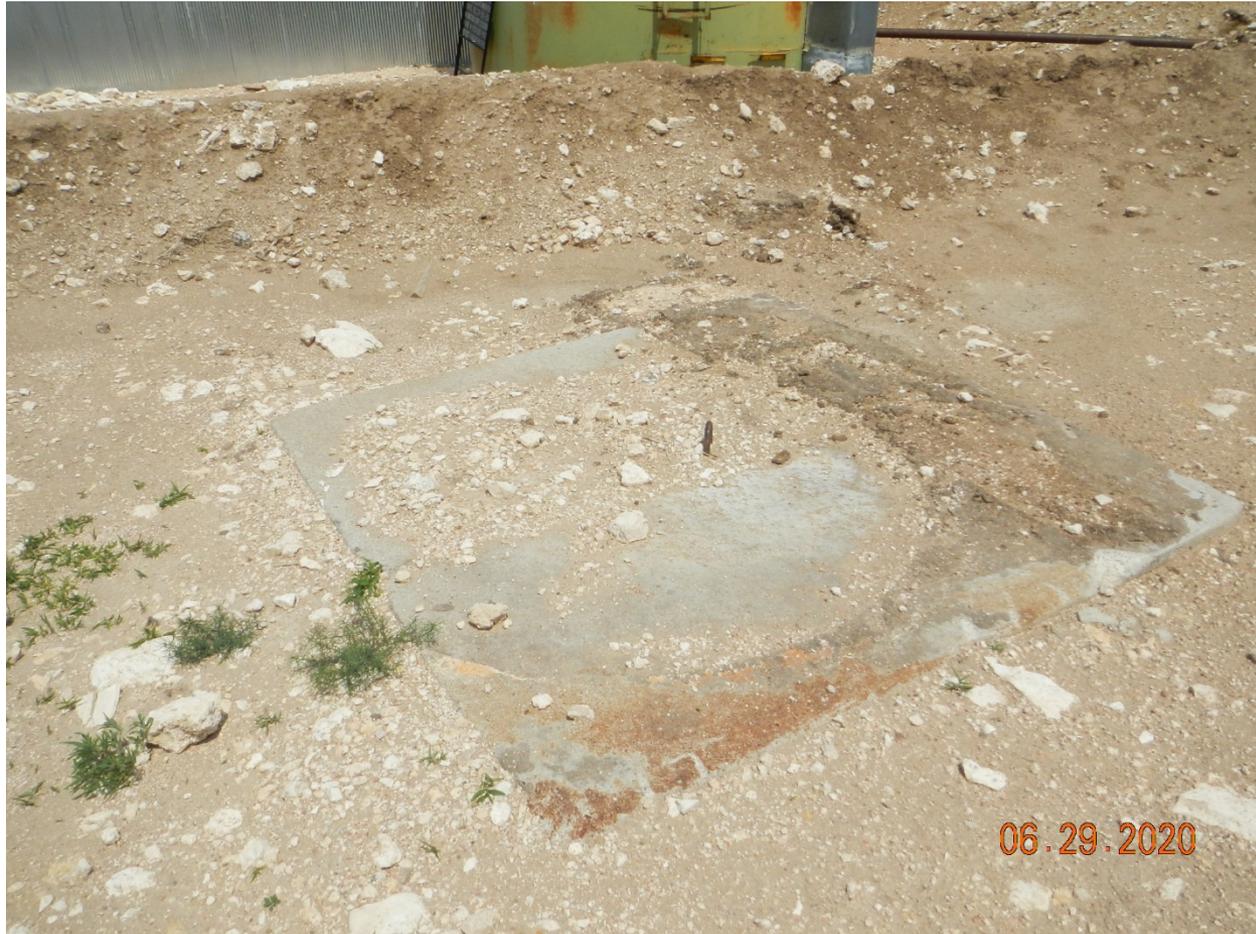
Photo # 7 – West side of tank battery former separator concrete foundation requires removal and disposal
