Inspection Photos

API: 05-009-06231

Operator: SOVEREIGN OPERATING COMPANY

Inspection Date: 6/22/2020

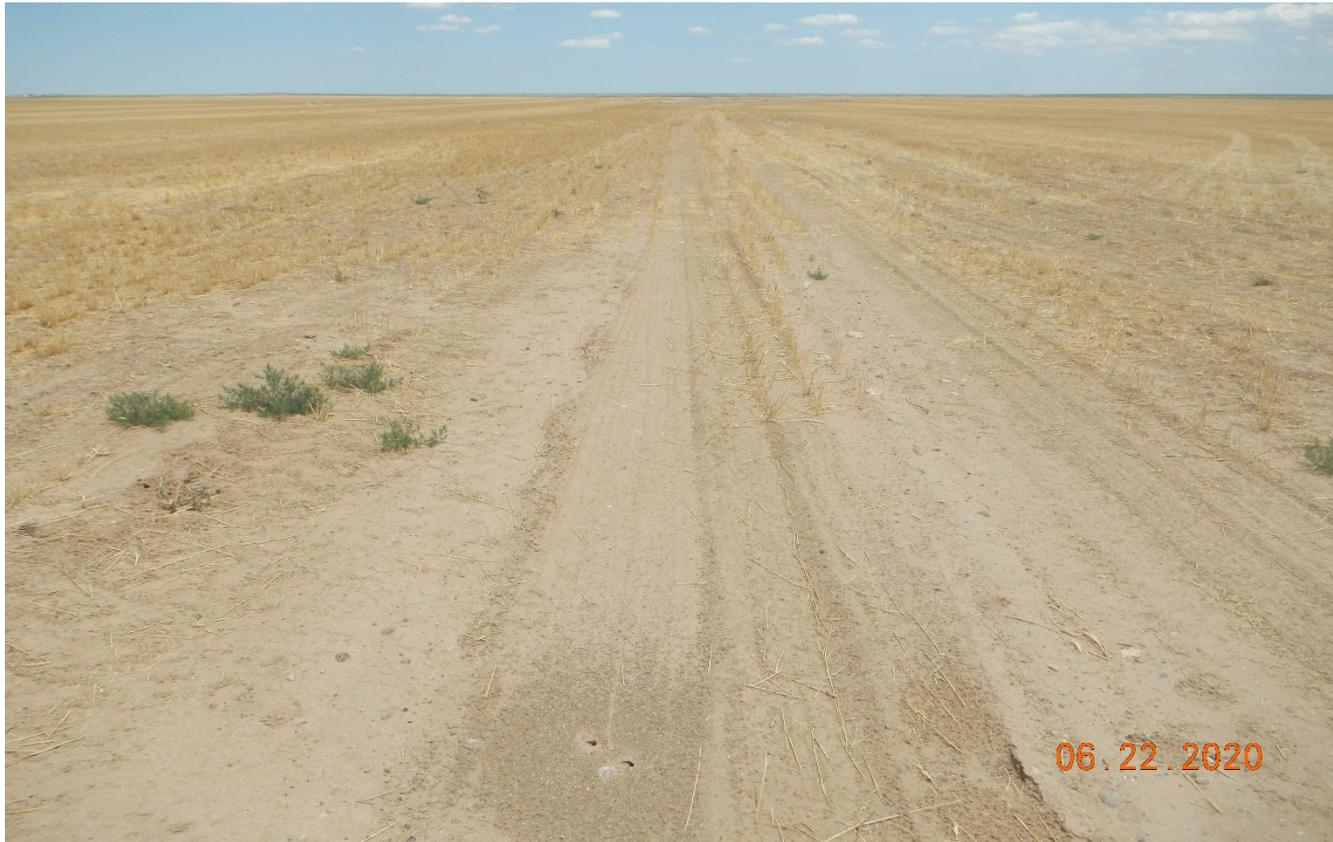
Photo 1. Facing east along the former access road.

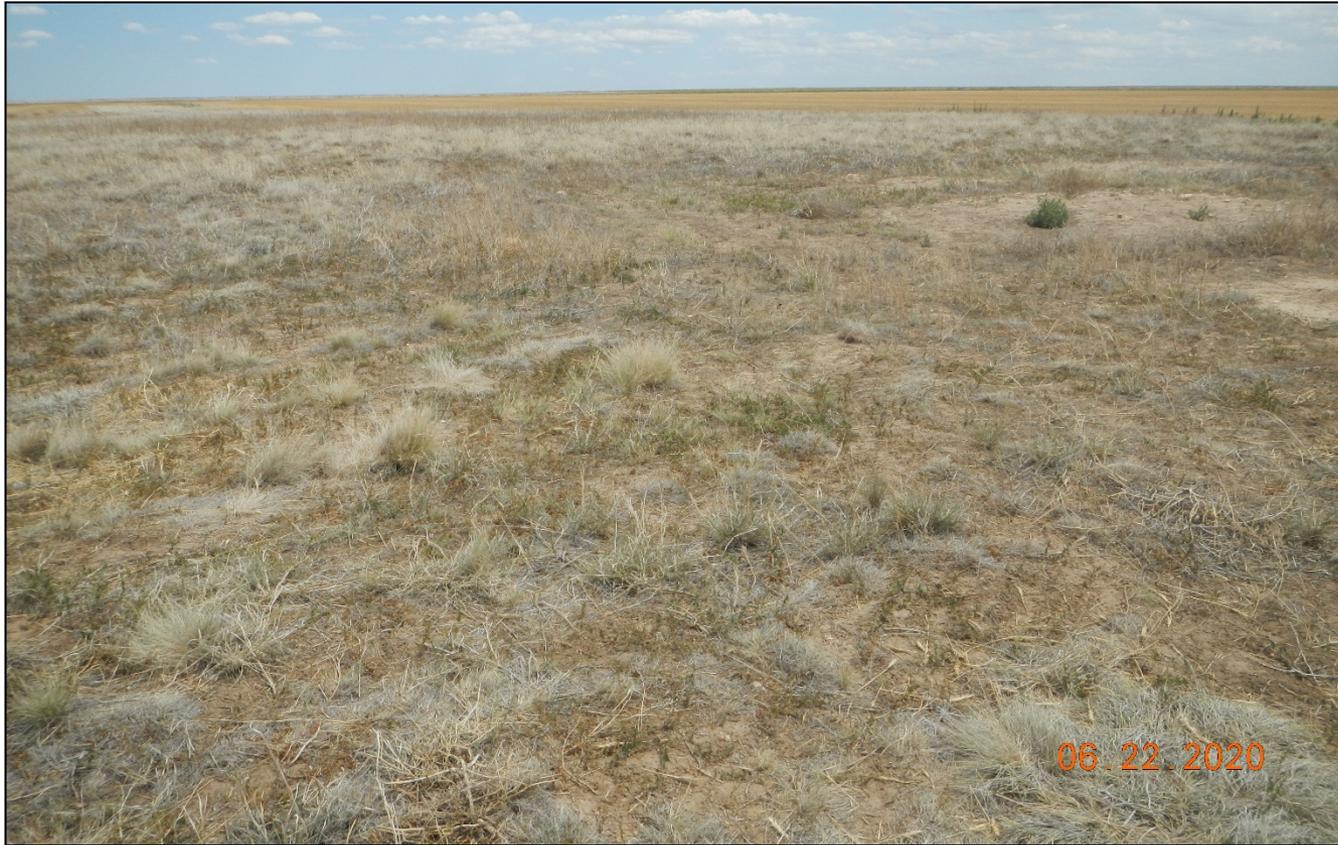
Photo 2. This area is being farmed around the location.

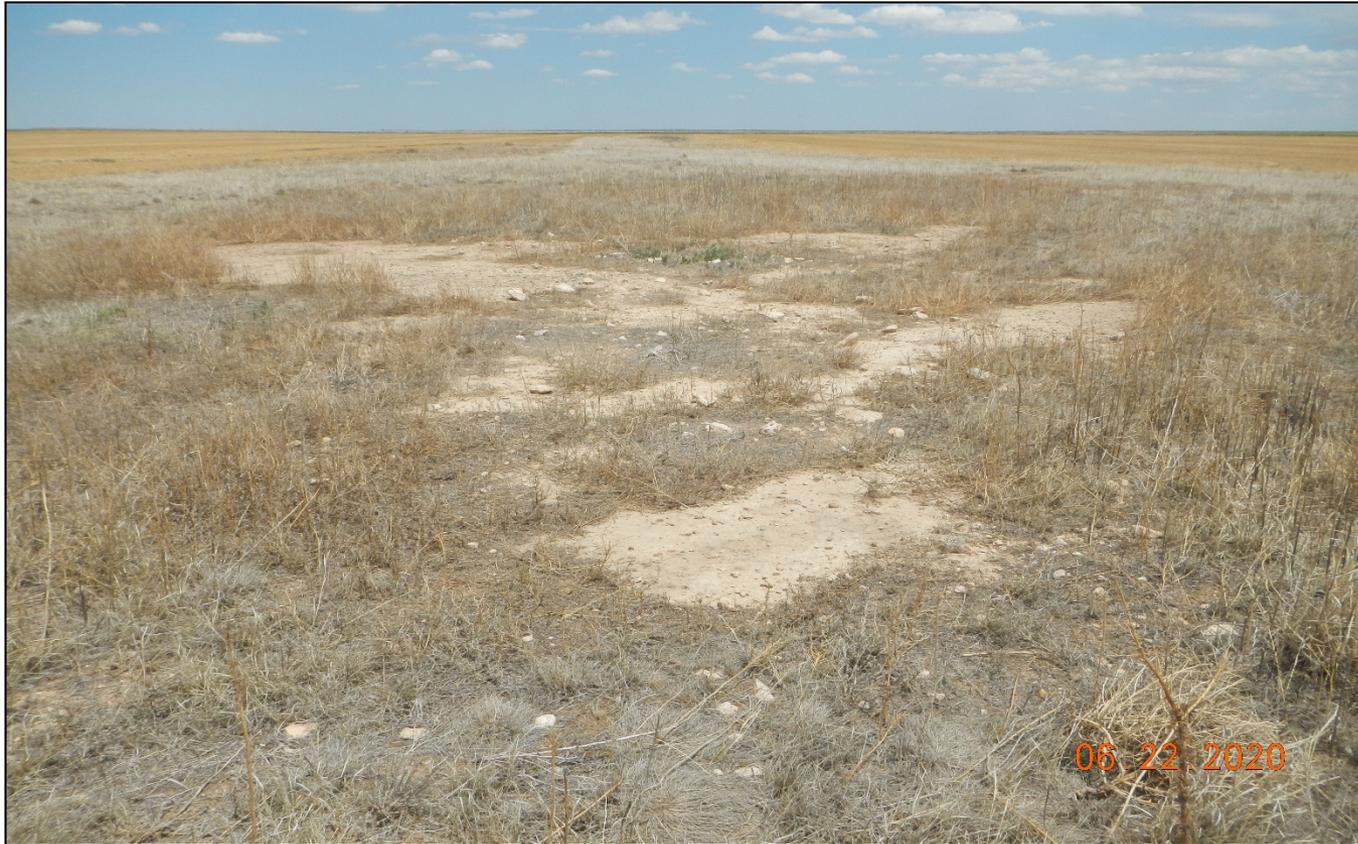
Photo 3. Facing east toward the well site. There areas bare of vegetation and undesirable weeds.

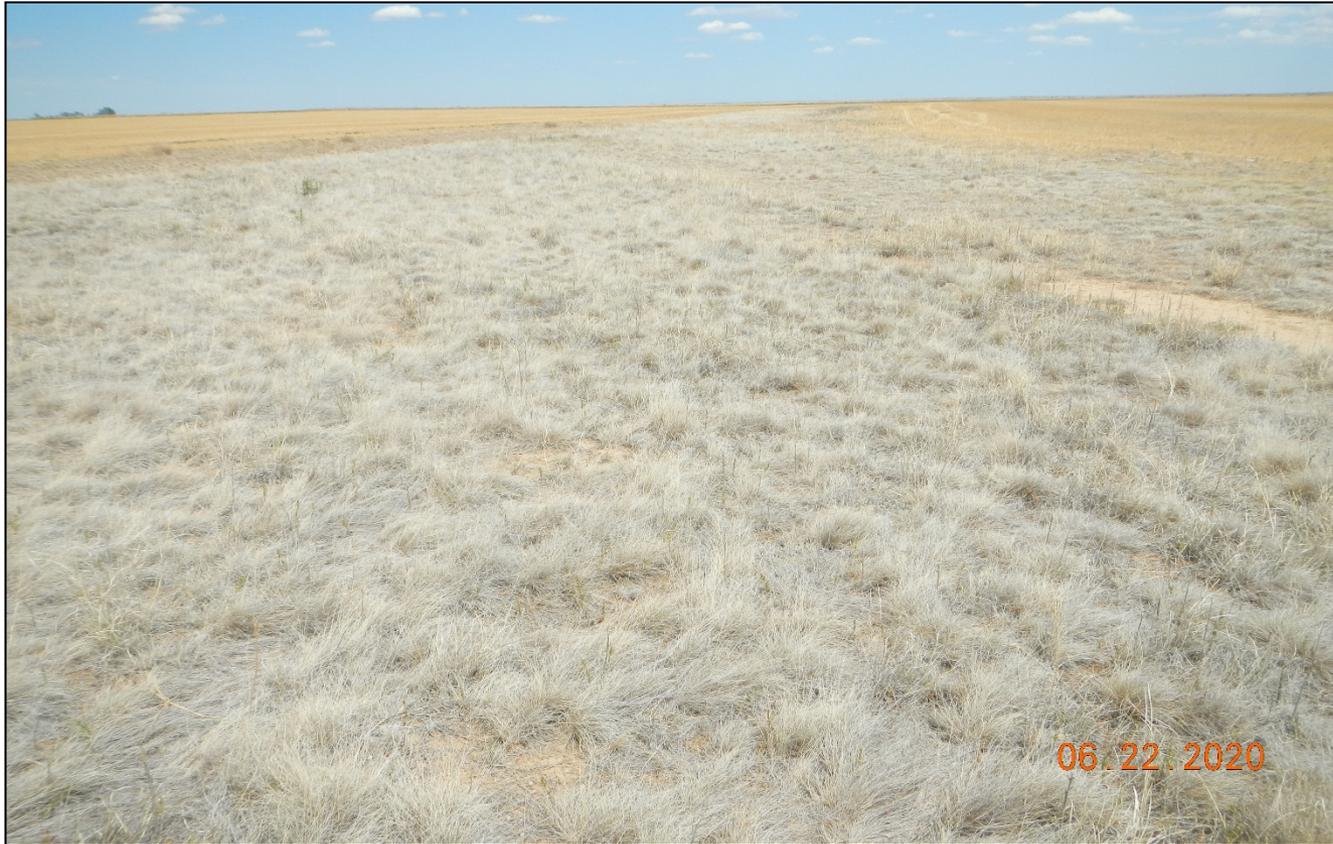
Photo 4. Facing east outside of the location. This area is being farmed around however, desirable vegetation is well established outside of the location.

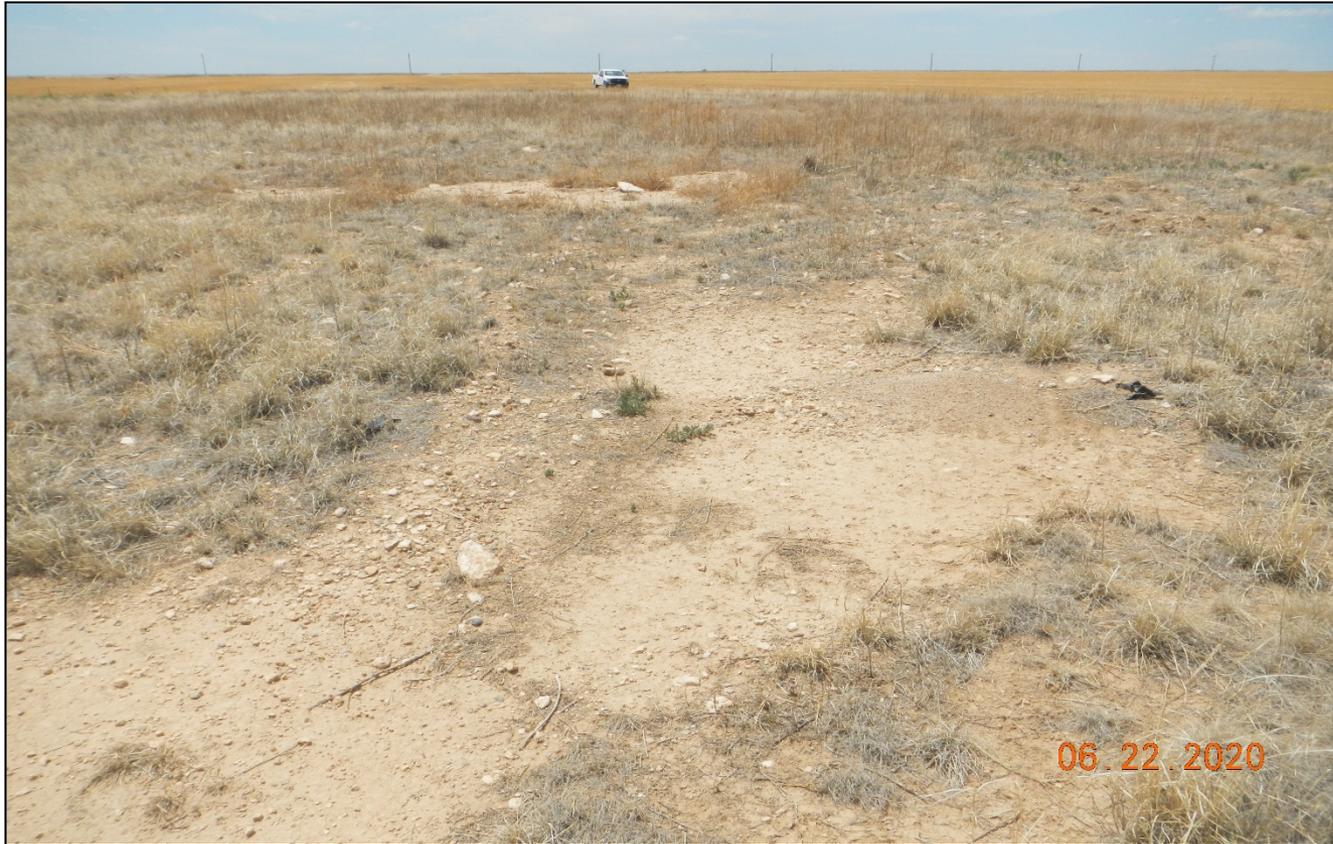
Photo 5. Facing west at the location. There are areas bare of vegetation and there are also areas with desirable vegetation establishment.

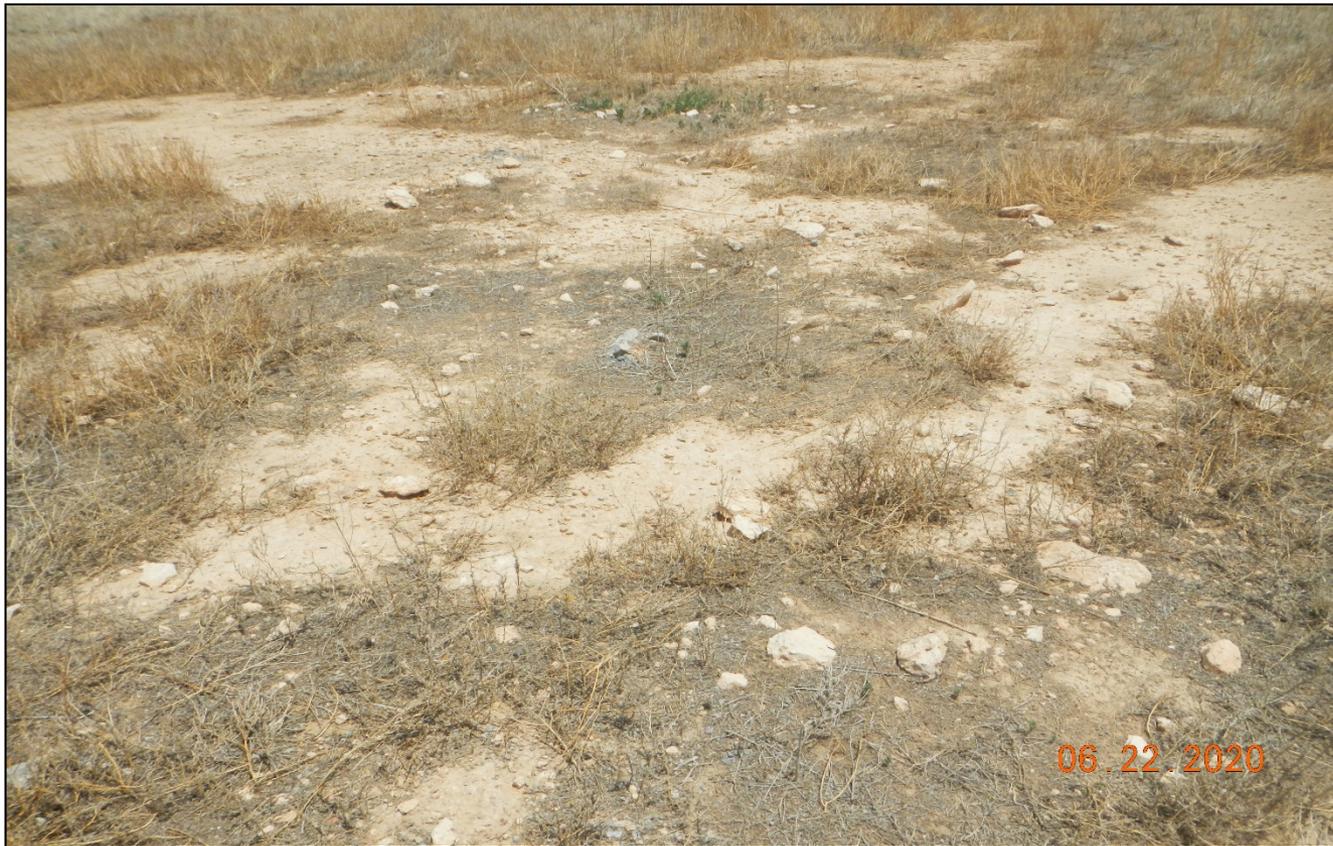
Photo 6. View of ground cover which shows rock debris that remains which was not noticed in the surrounding undisturbed area.

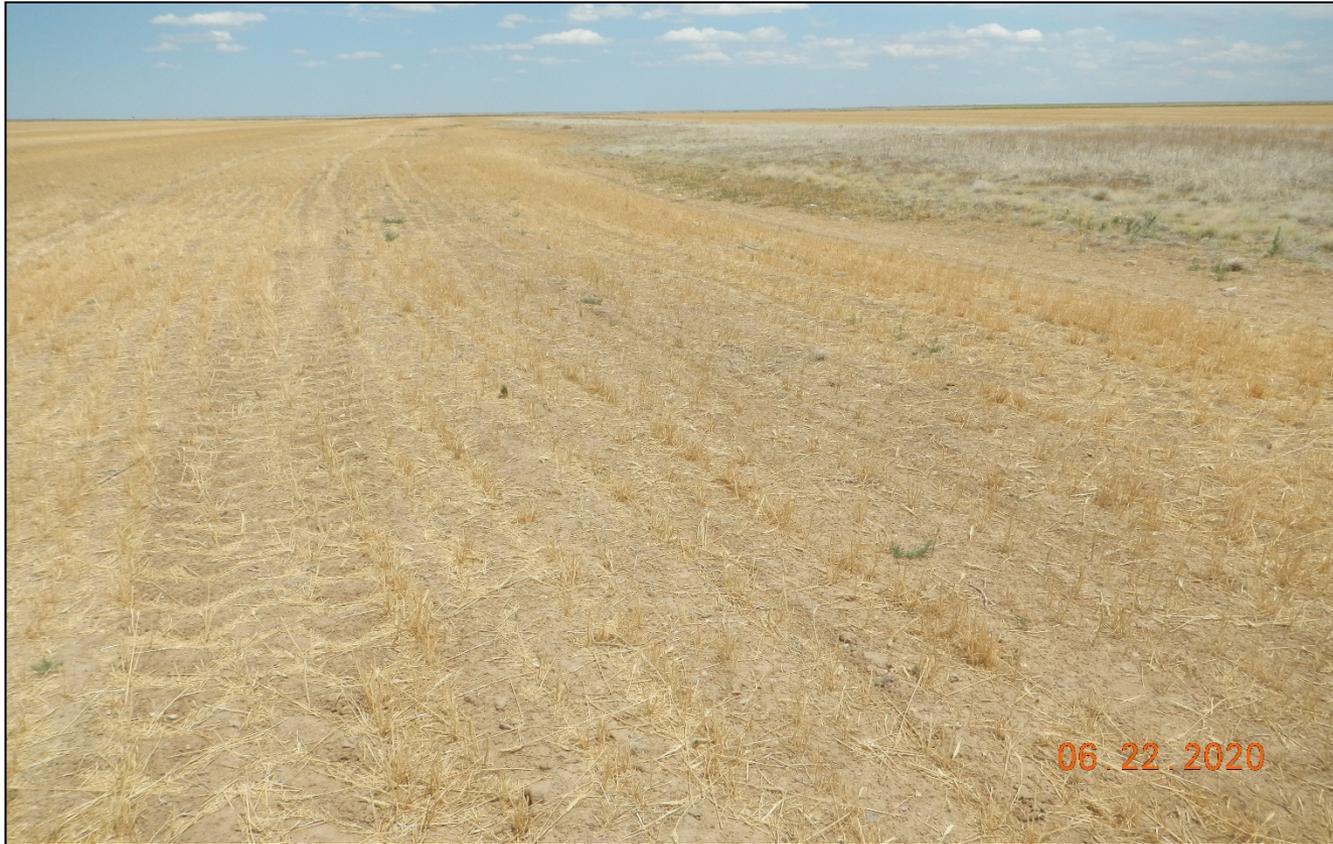
Photo 7. North of the location facing east. The crop field can be seen in left portion of photo and the grassland area near the location is in the right of the photo.
