Inspection Photos

June 30, 2020

Location Name: Pintail SWD Location ID 446527; Spill ID 477094

Oil & Gas Conservation
Commission

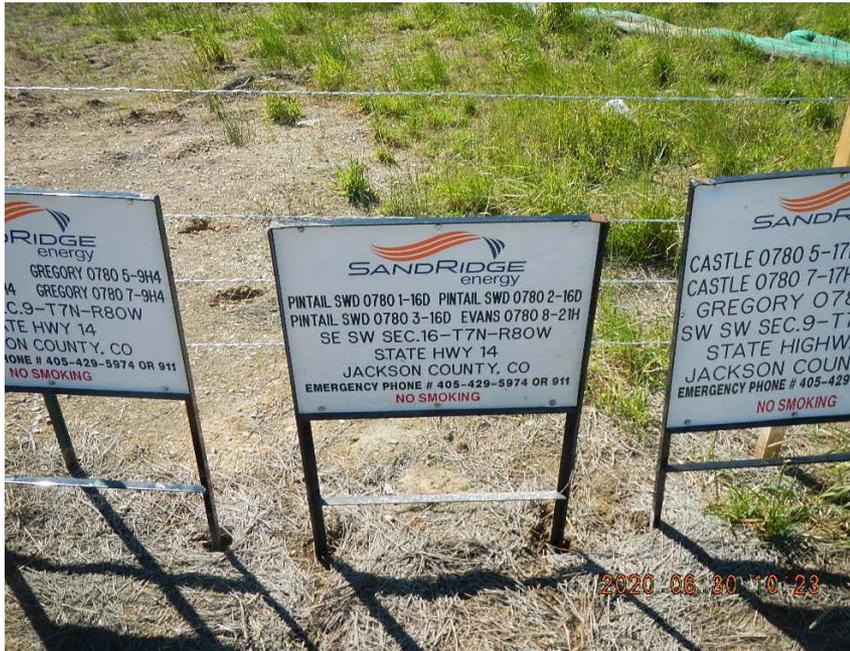
Sign at Hwy for Location ID: 446527.

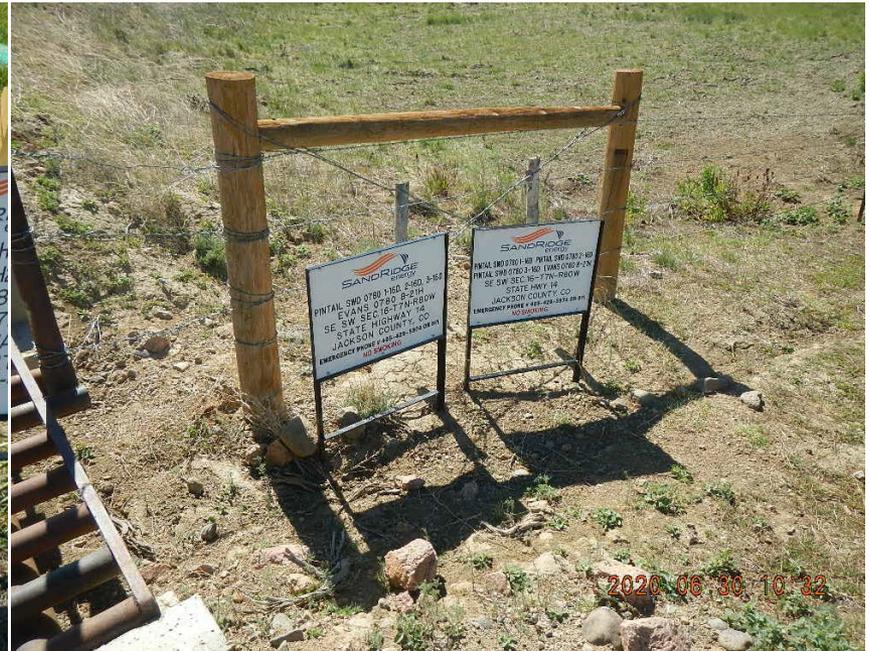
Sign at entrance to Location ID: 446527.

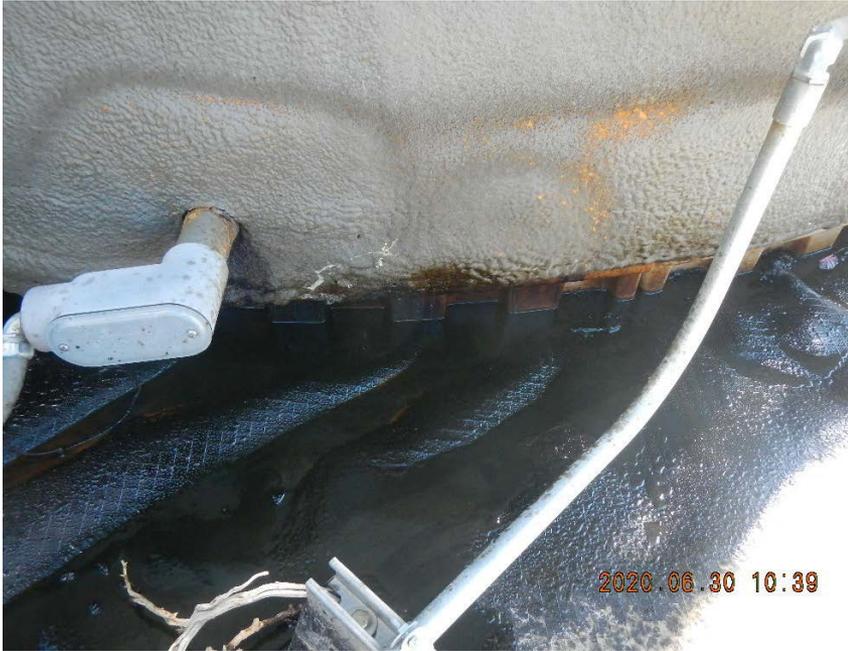
Suspected area of leak is behind the insulation and to the right of the electrical conduit.

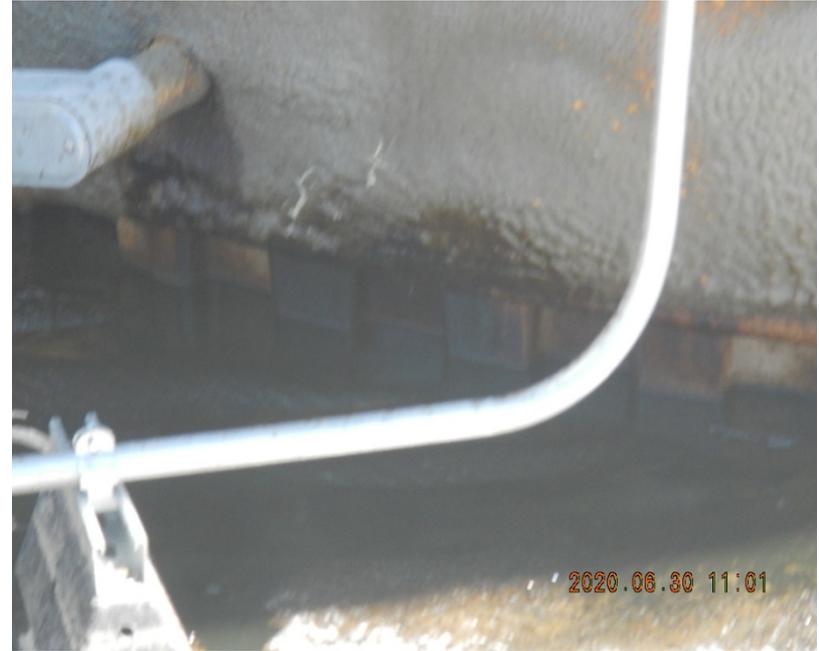
Suspected area of leak is behind the insulation and to the right of the electrical conduit.

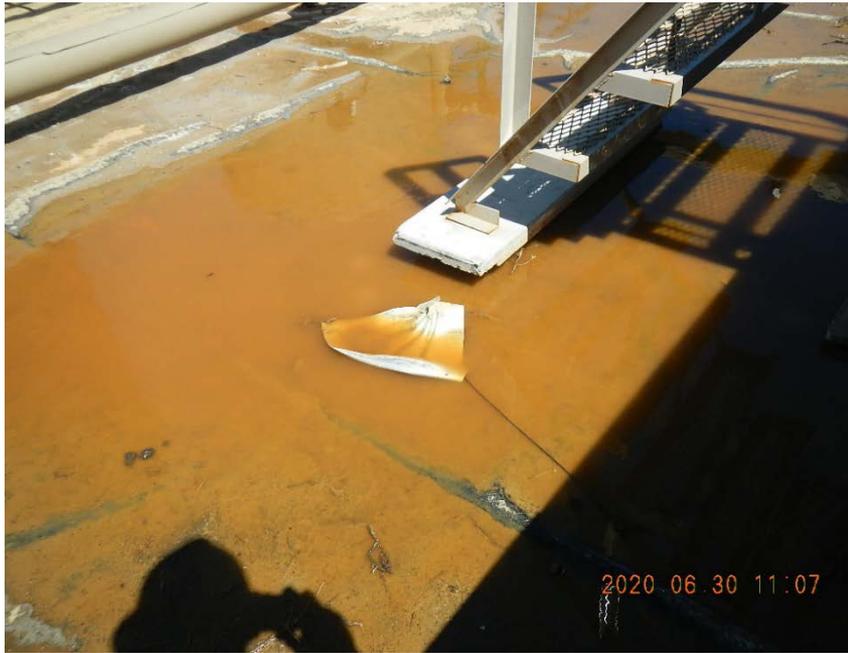
Pipe and stair supports deteriorating, metal sheeting on liner.

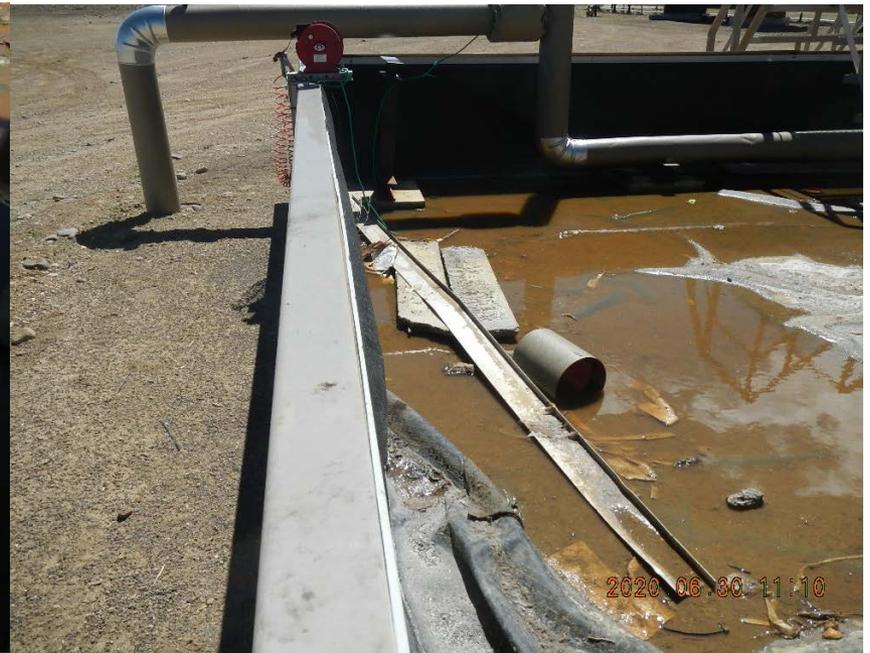
Trash/debris metal sheeting on liner. Note the folds in liner.

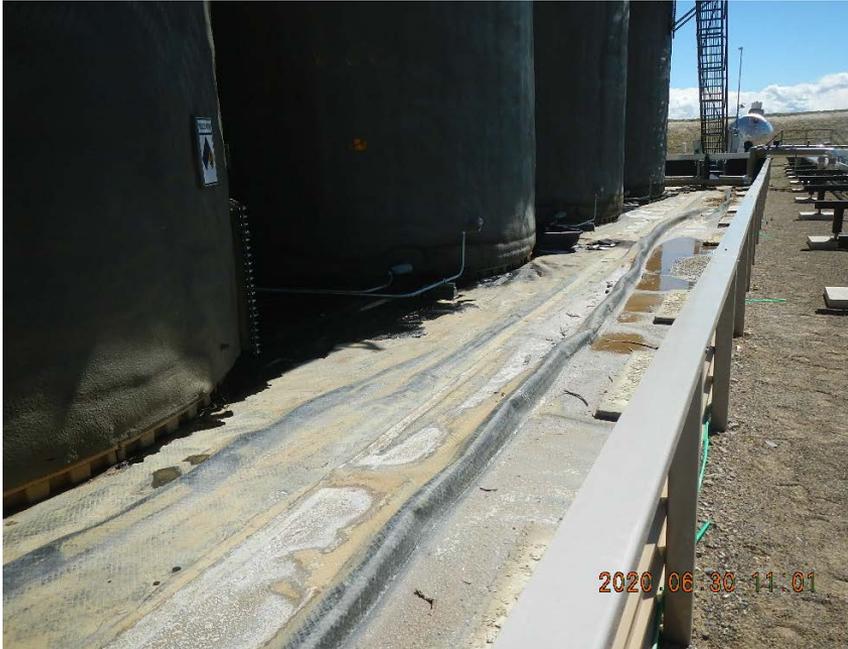
Concrete weight/anchor with rebar (trash/debris) with potential to puncture or compromise liner.

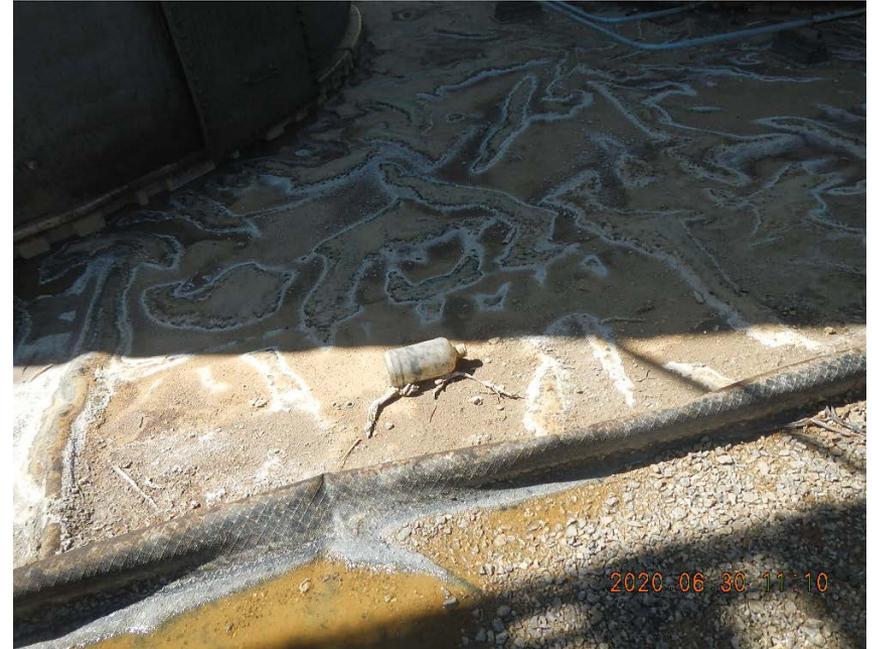
Trash and folds in liner.

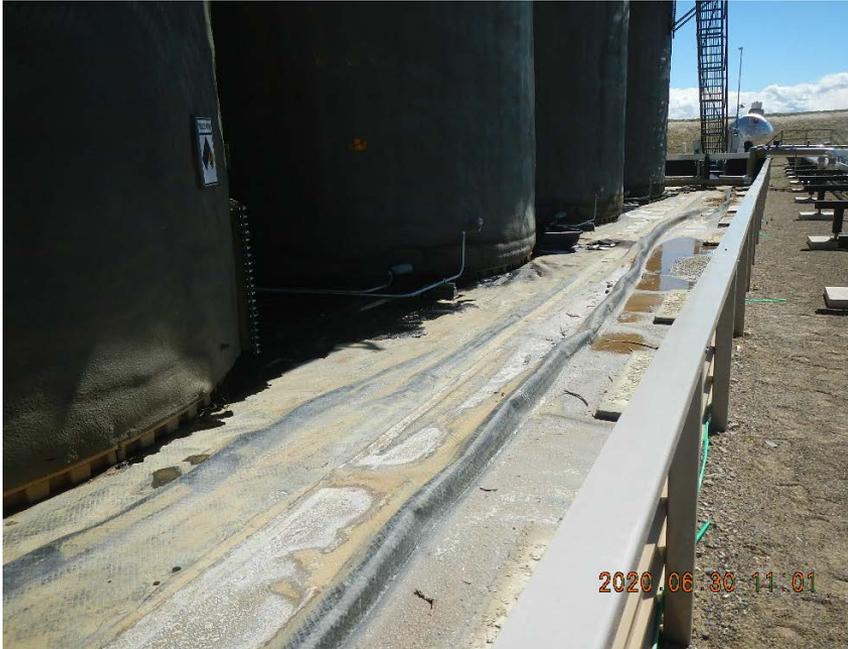
Concrete weight/anchor with rebar (trash/debris) with potential to puncture or compromise liner.

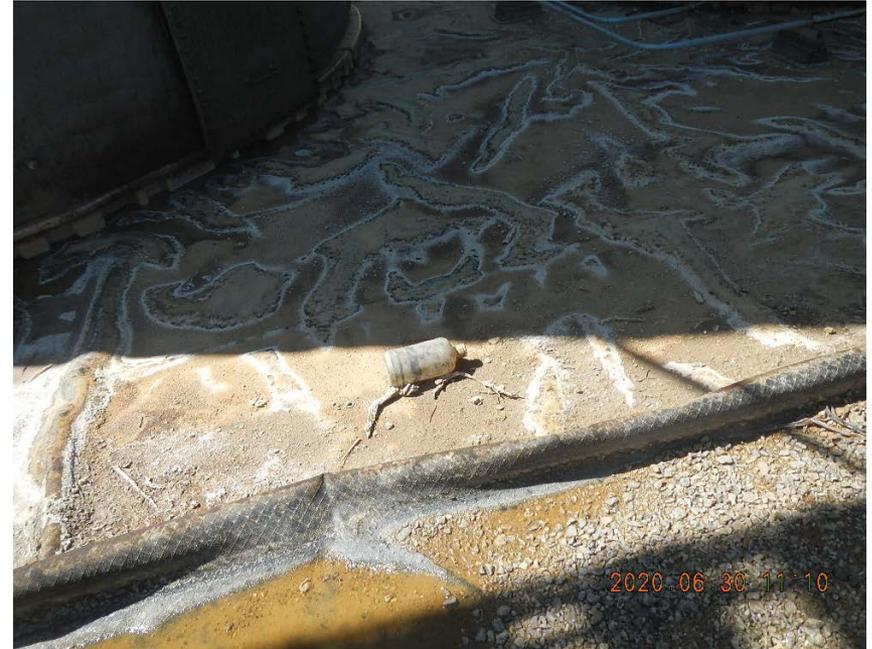
Trash and folds in liner.

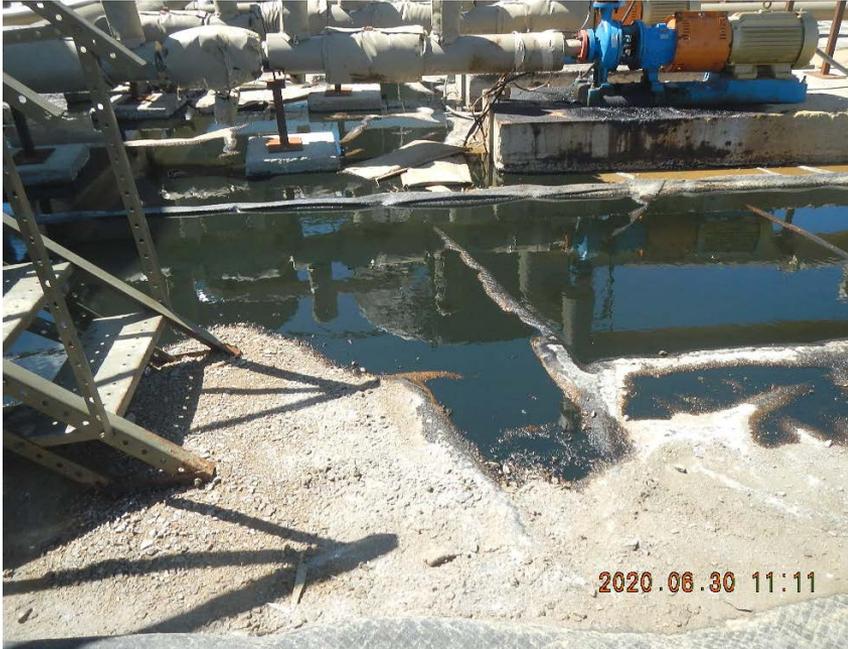
Oil pooling on liner.

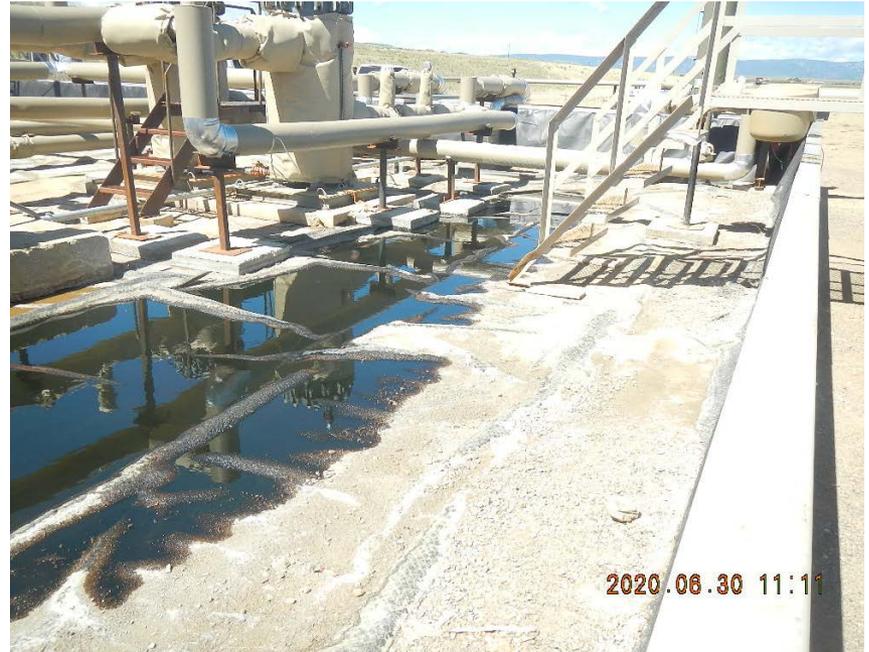
Salt staining on liner throughout secondary containment.

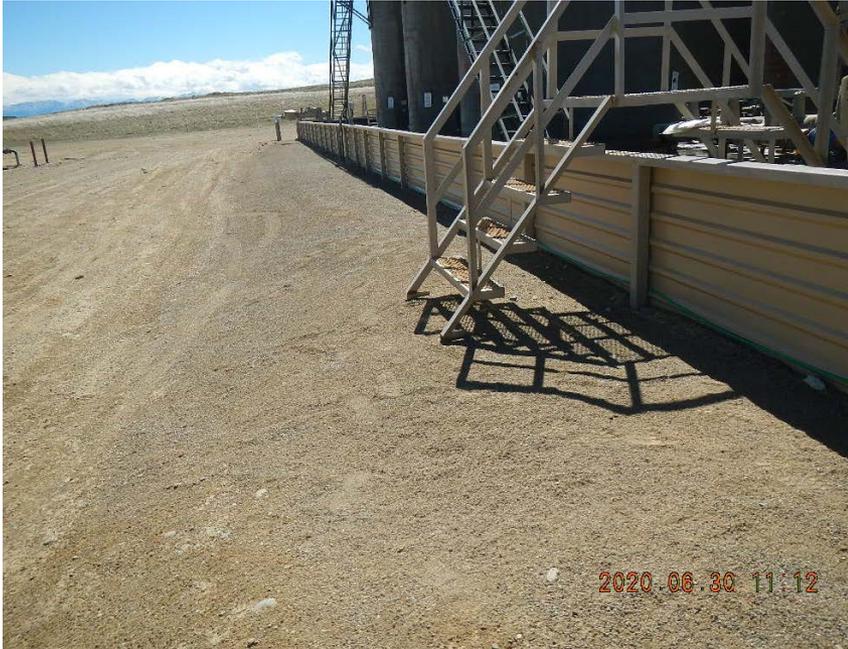
No observable staining outside of secondary containment.

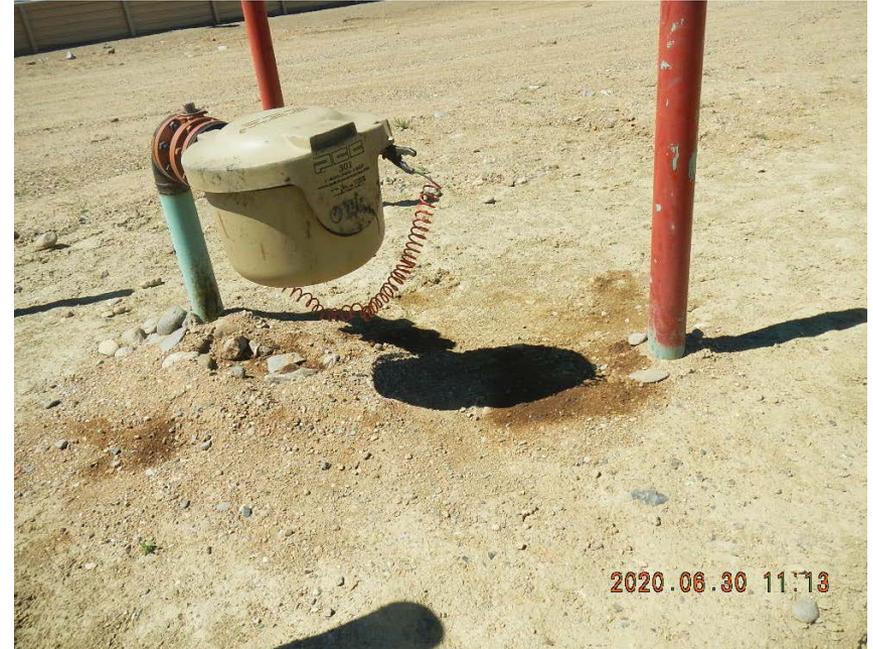
Surface staining at load out.

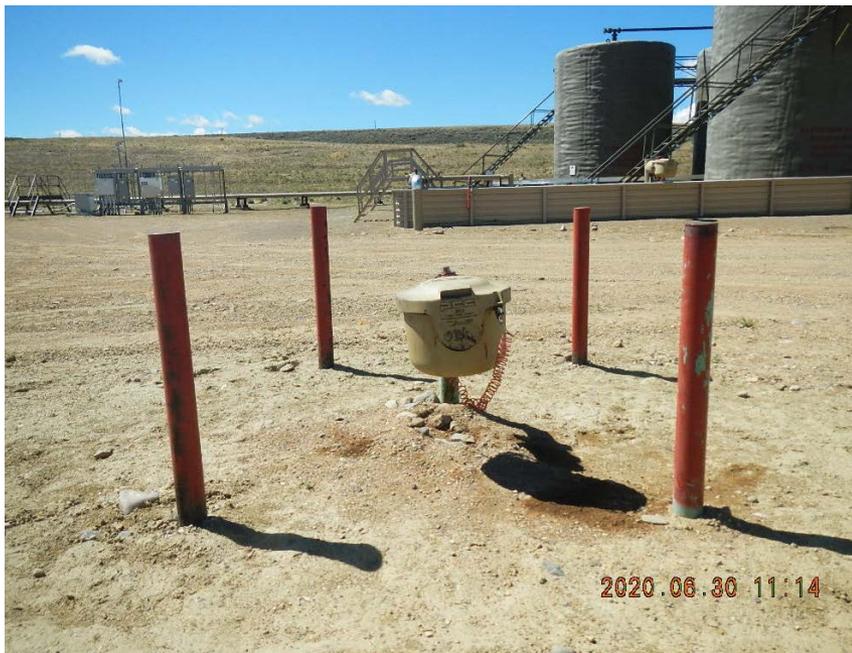
Surface staining at load out.

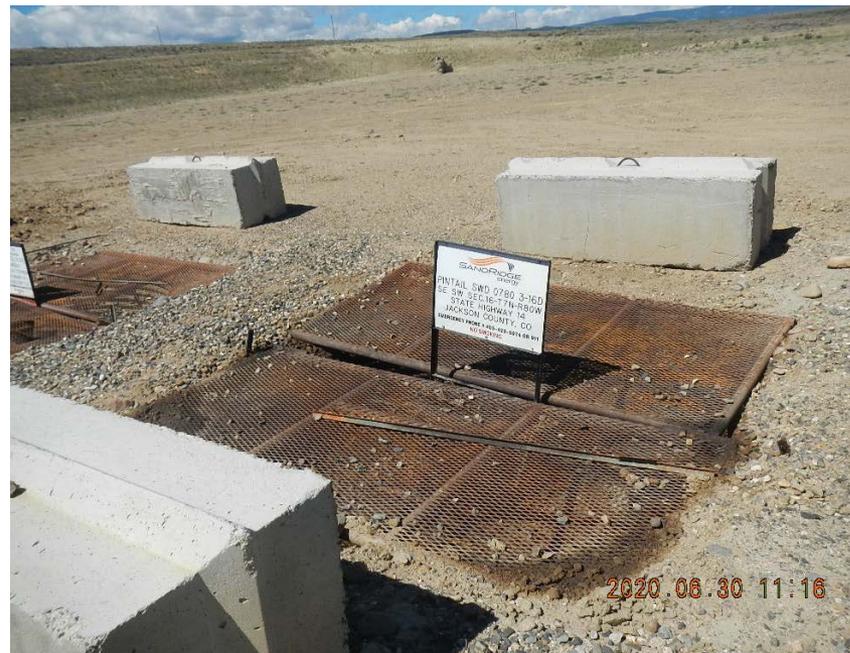
Surface staining.

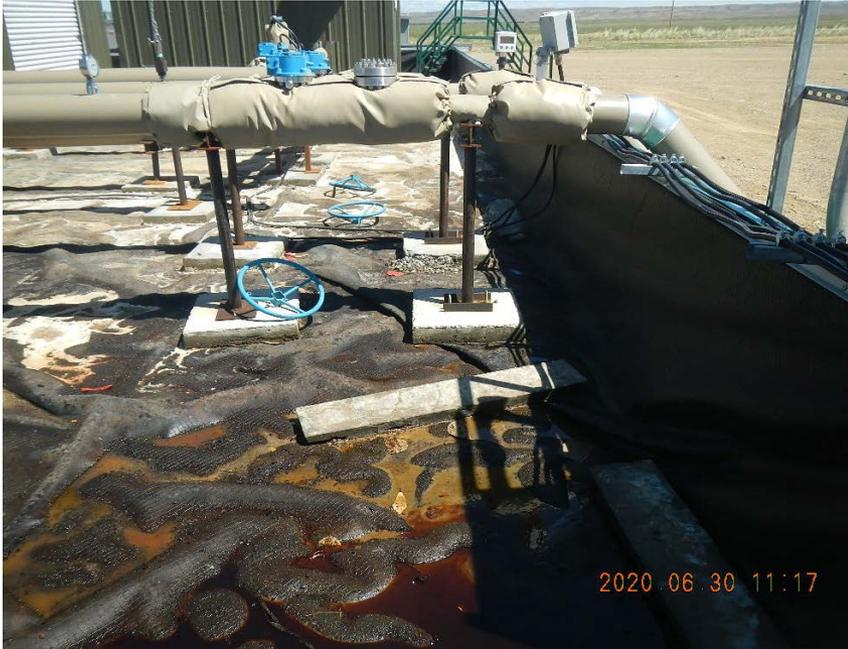
Concrete weight/anchor with rebar and valve handles with potential to puncture or compromise liner. Oil pooling on liner.

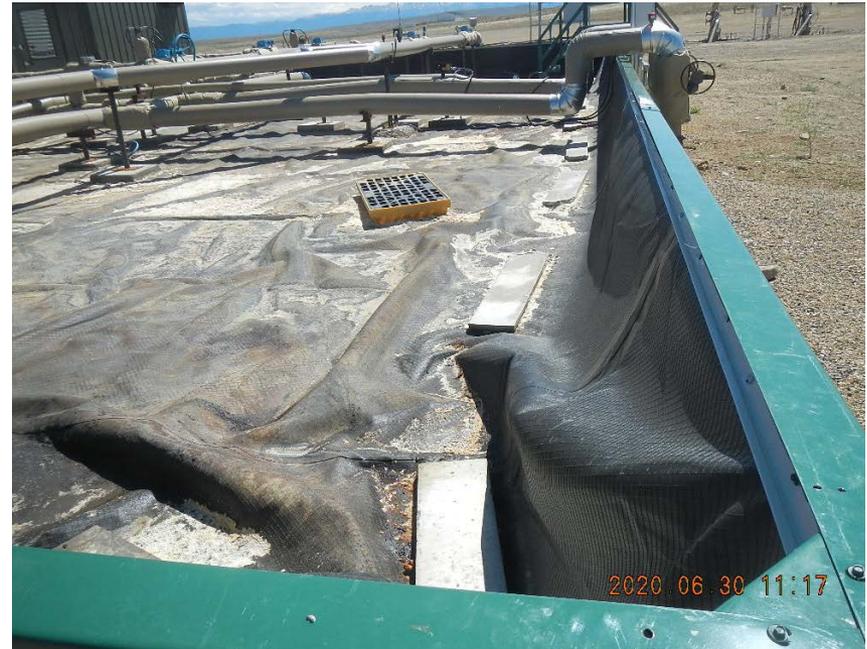
Concrete weight/anchor with other debris on liner with the potential to puncture or compromise liner. Note how liner is wind blown with folds.

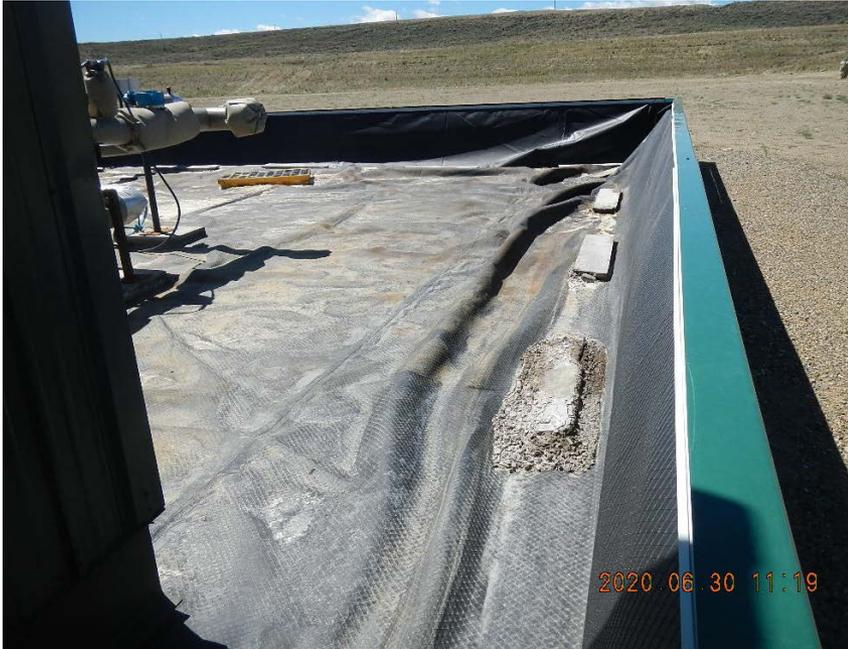
Concrete weight/anchor with other debris on liner with the potential to puncture or compromise liner. Note how liner is wind blown with folds.

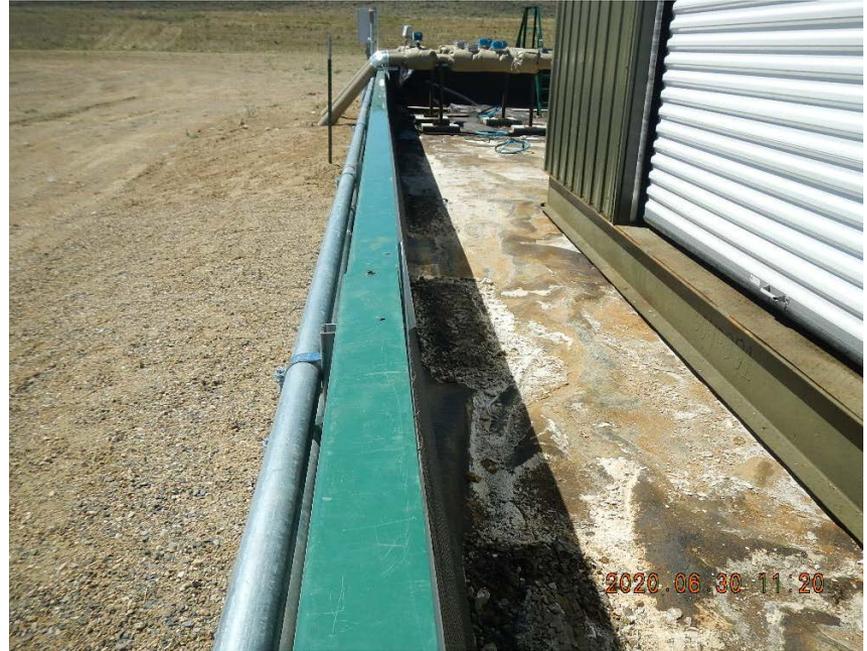
Salt staining on liner throughout secondary containment.
