# Inspection Photos

API: 071-06798

Operator: EVERGREEN NATURAL RESOURCES

Inspection Date: 6/30/2020

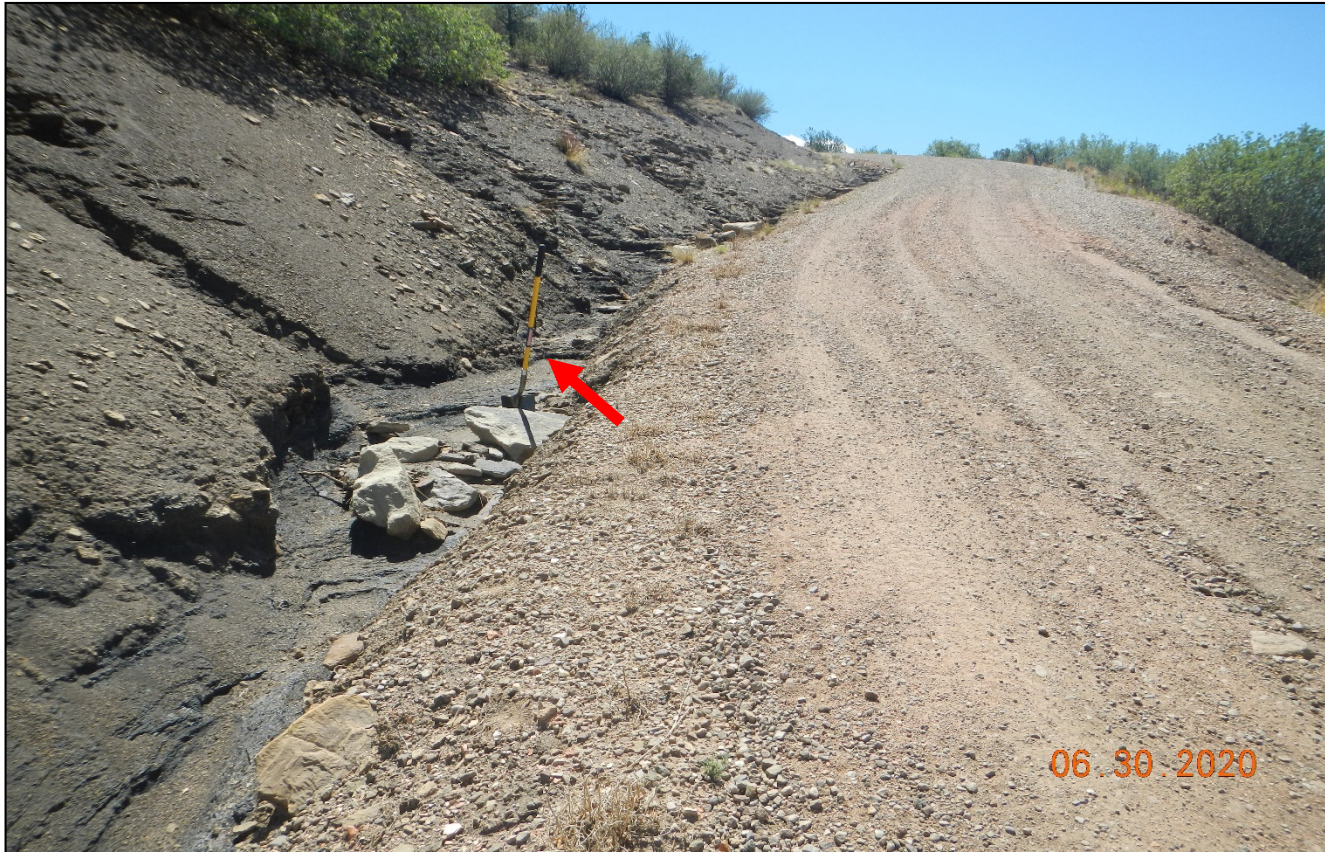
**Photo 1.** Facing southeast along the access road. There is erosion occurring along the side of the road and there are no BMP's In this area along the road.

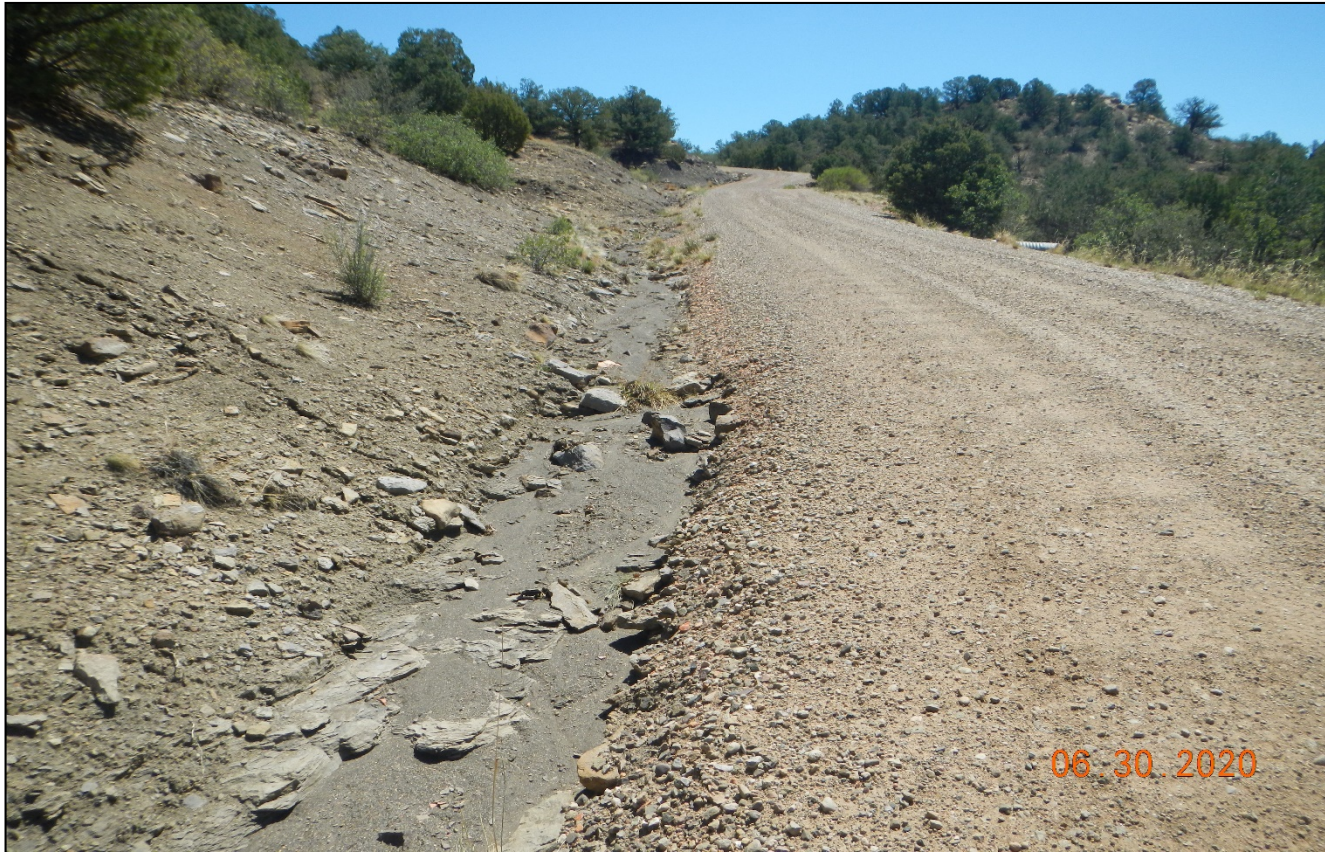
**Photo 2.** Facing east along the road. There is a long stretch of road which does not have culverts or BMP's which is contributing to the volume of stormwater directed down the side of the road.

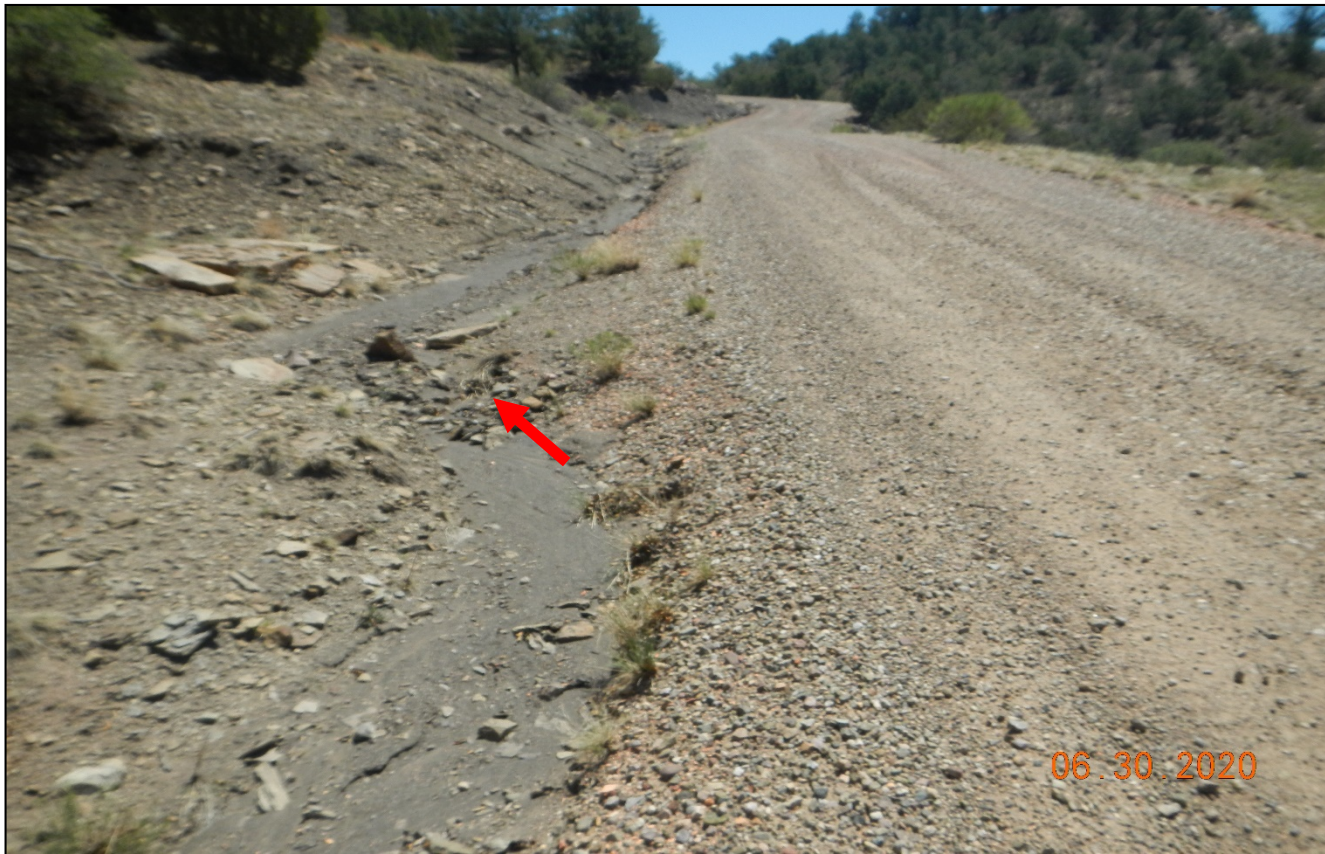
**Photo 3.** There is a culvert at this point along the road which has filled in with sediment.

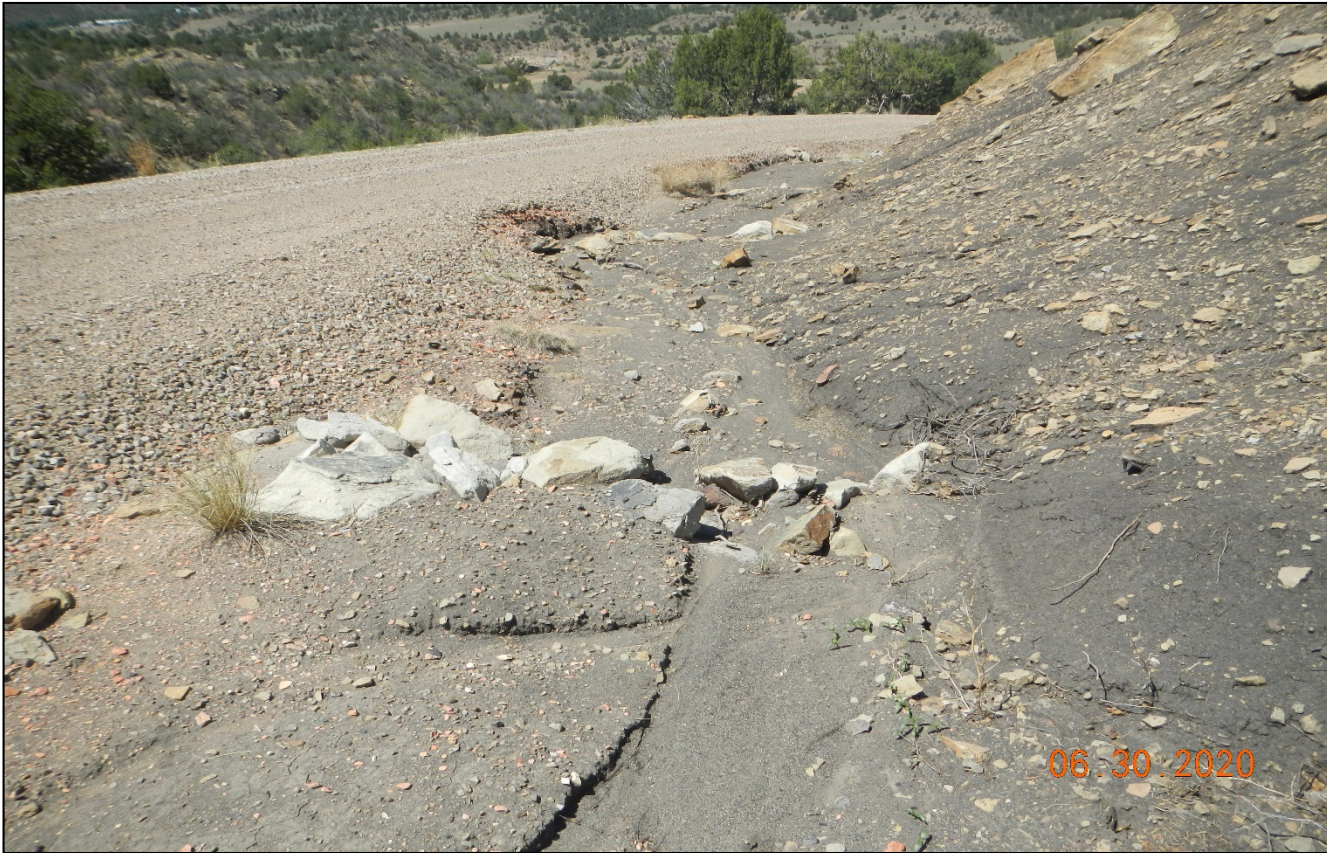
**Photo 4.** Facing back toward the southwest near the top of the hill toward the location. These rock checkdamns have filled in with sediment and are displaced.

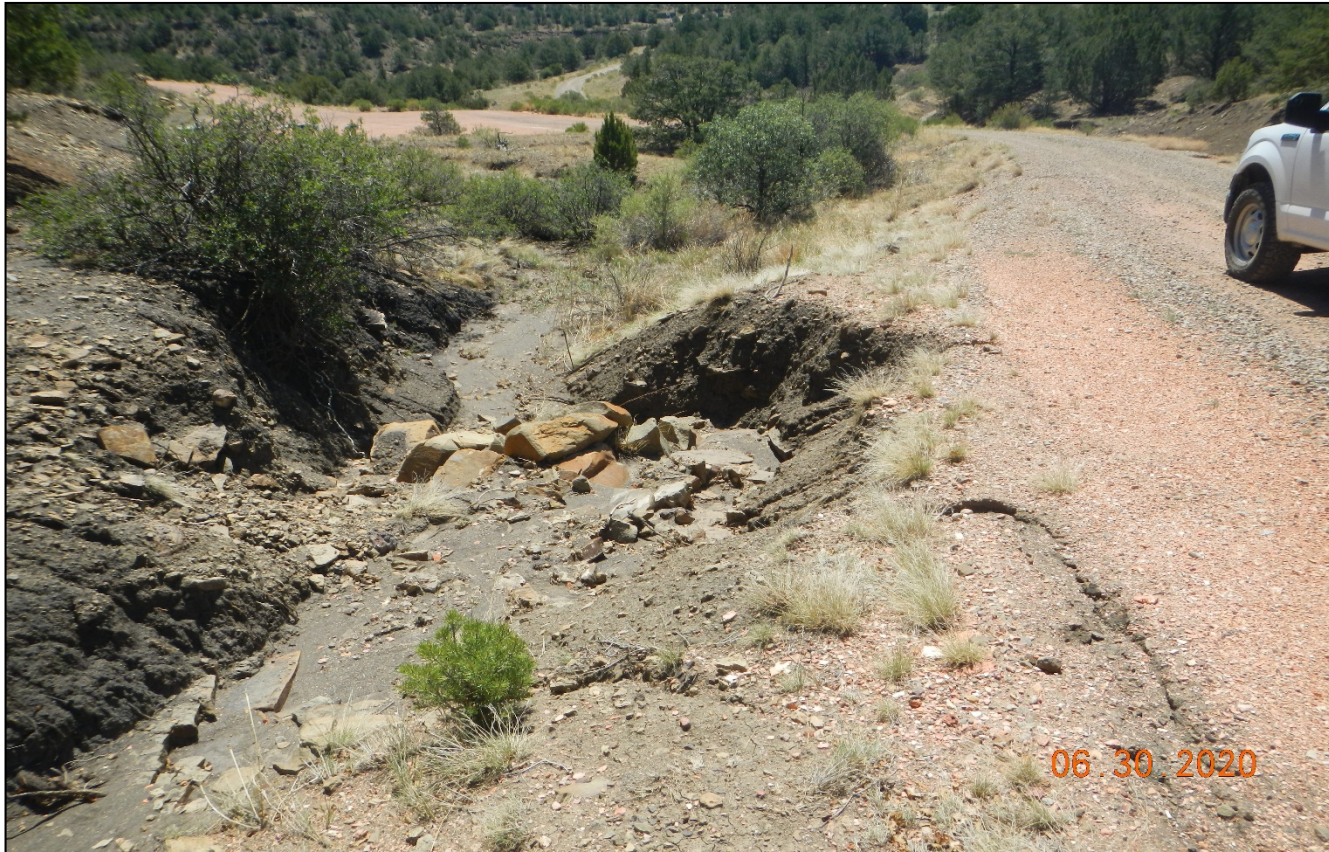
**Photo 5.** Facing southeast along the access road. Stormwater diverted along the road is causing erosion in this area.

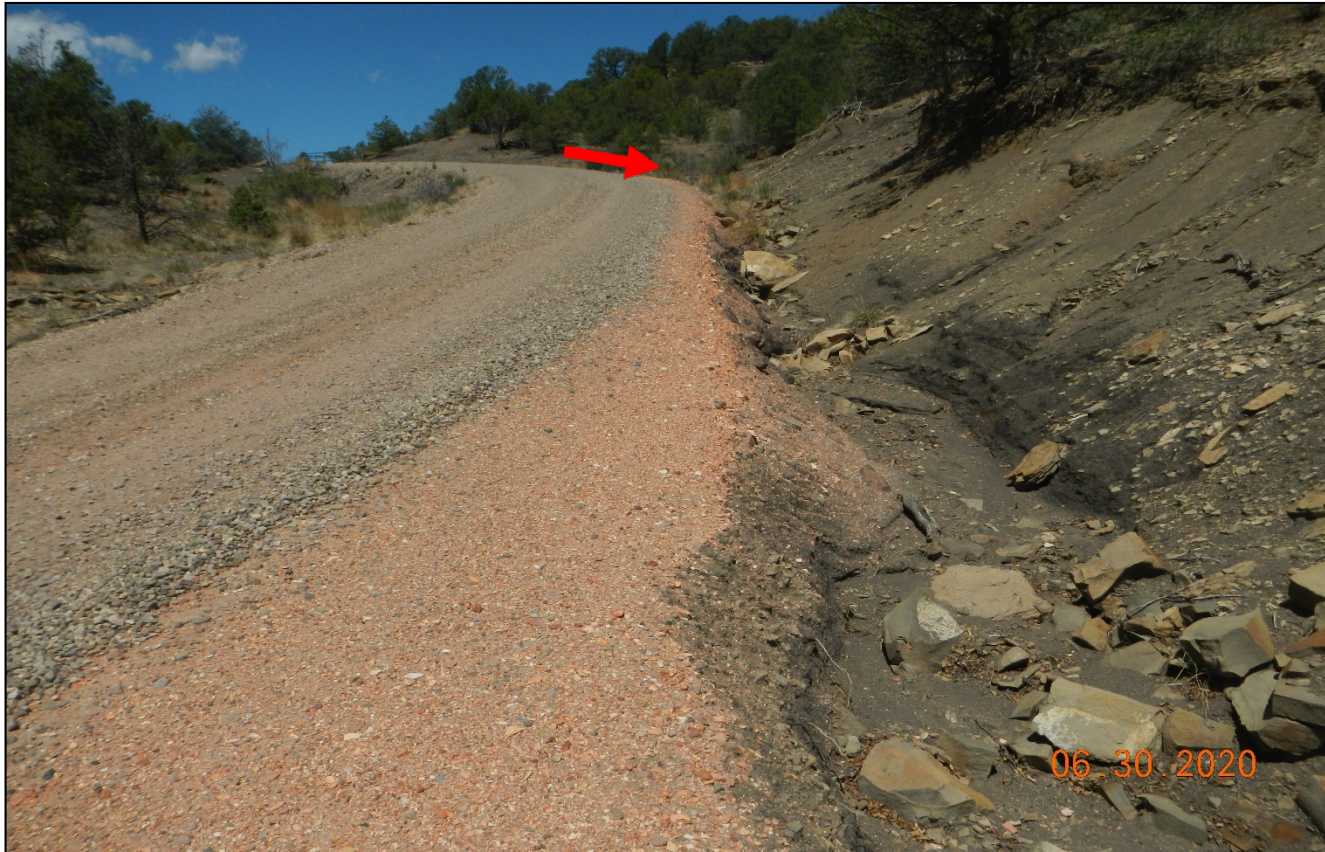
**Photo 6.** Facing back toward the west. There is a long stretch of road (from red arrow) which does not have BMP's which is contributing to the volume of stormwater directed down the side of the road.

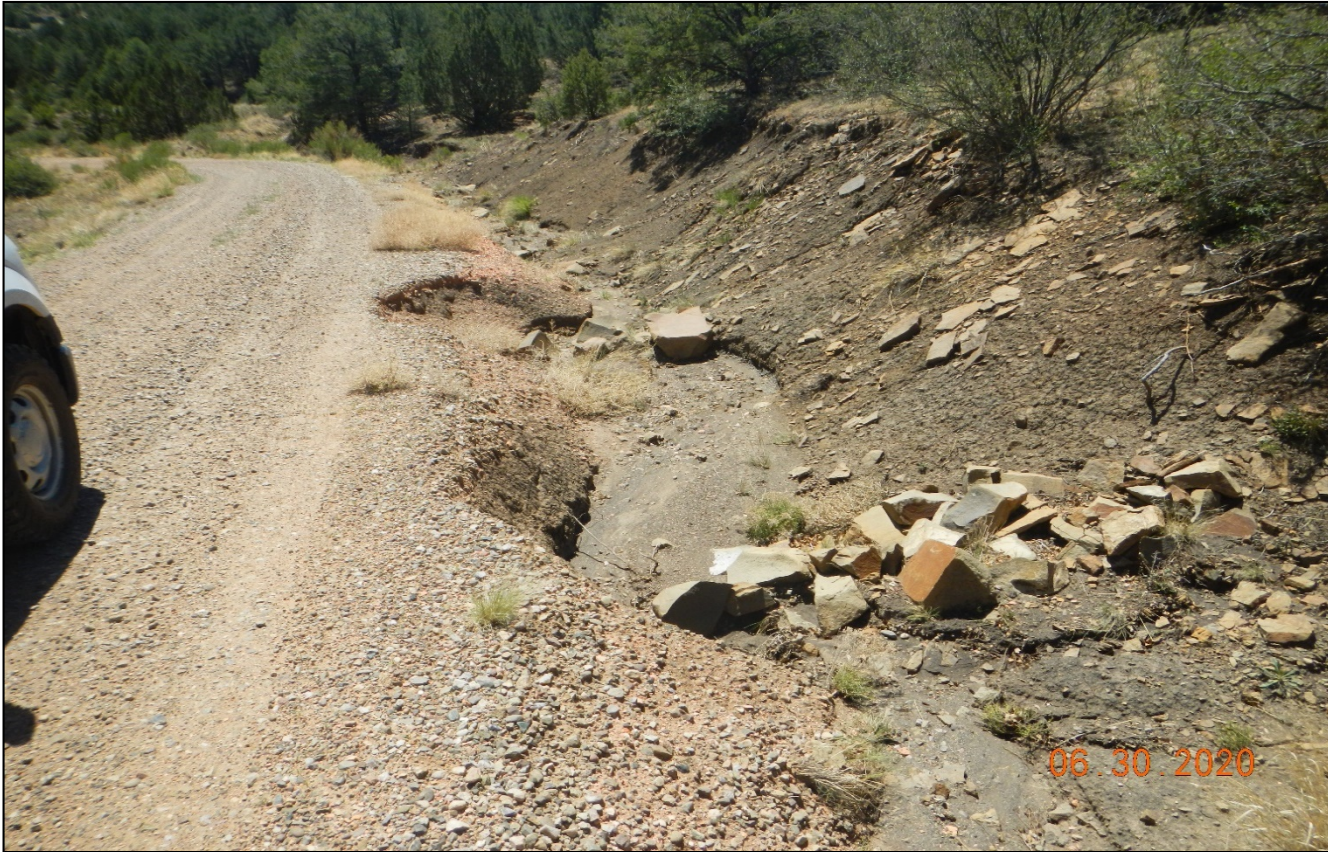
**Photo 7.** Facing southeast along the opposite side of the road. Rock check damns have failed in this area.

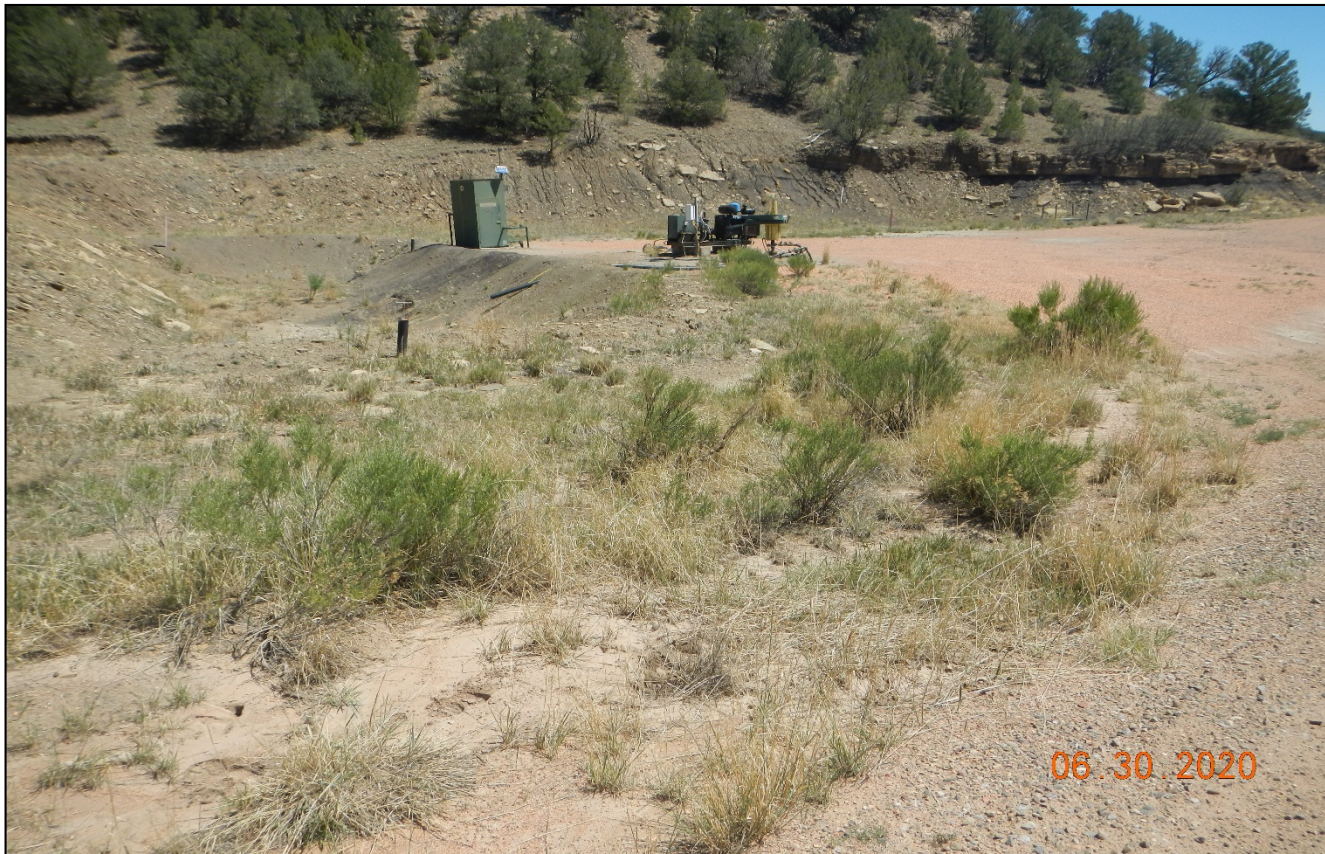
**Photo 8.** Facing northeast toward the location. Well sign is posted at the meter shed.
