Inspection Photos  
Operator: BP America  
API: 067-08790  
Date: 7/6/2020

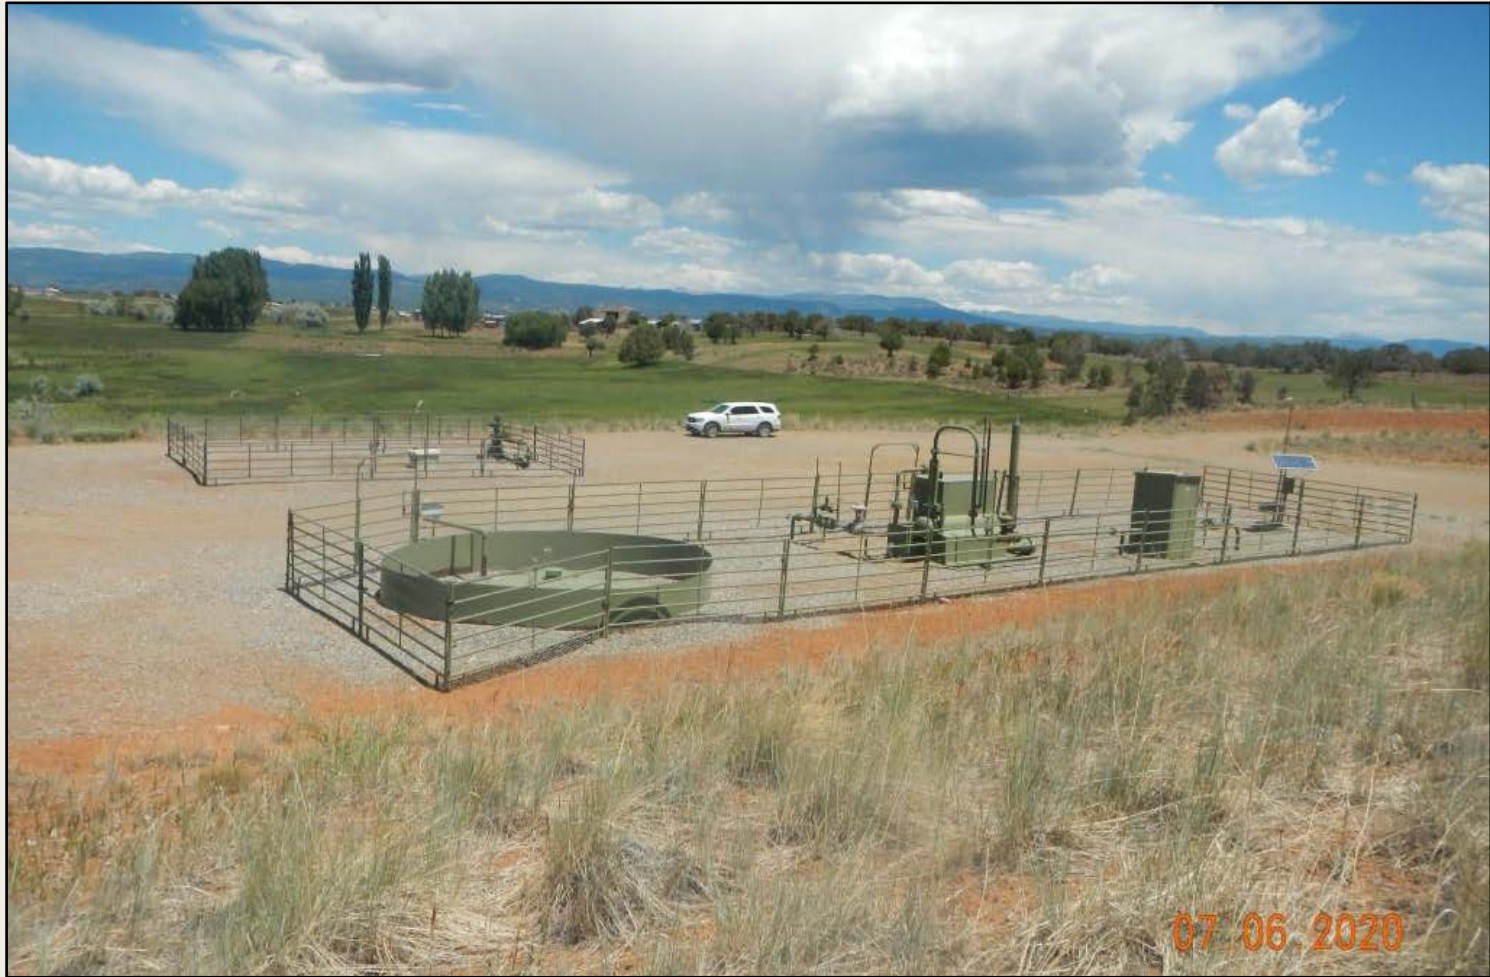
Photo 1. View of the project area from the southern edge facing northward.

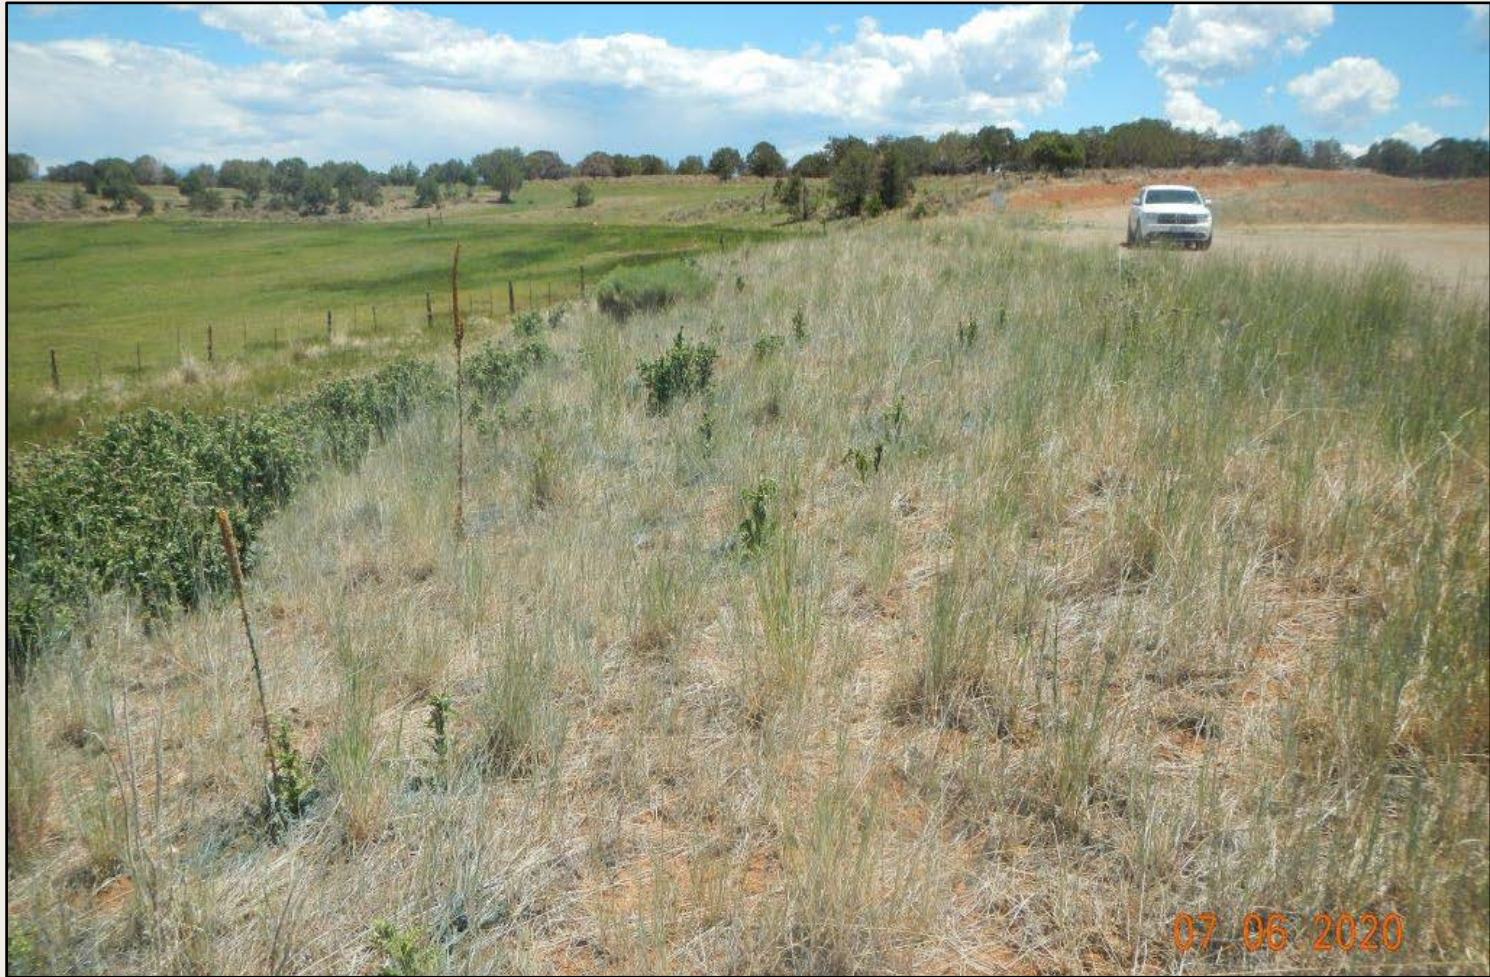
Photo 2. View of the northern fill slope from the northwestern corner facing eastward. Revegetation is progressing with grasses such as smooth brome, western wheatgrass, and crested wheatgrass.

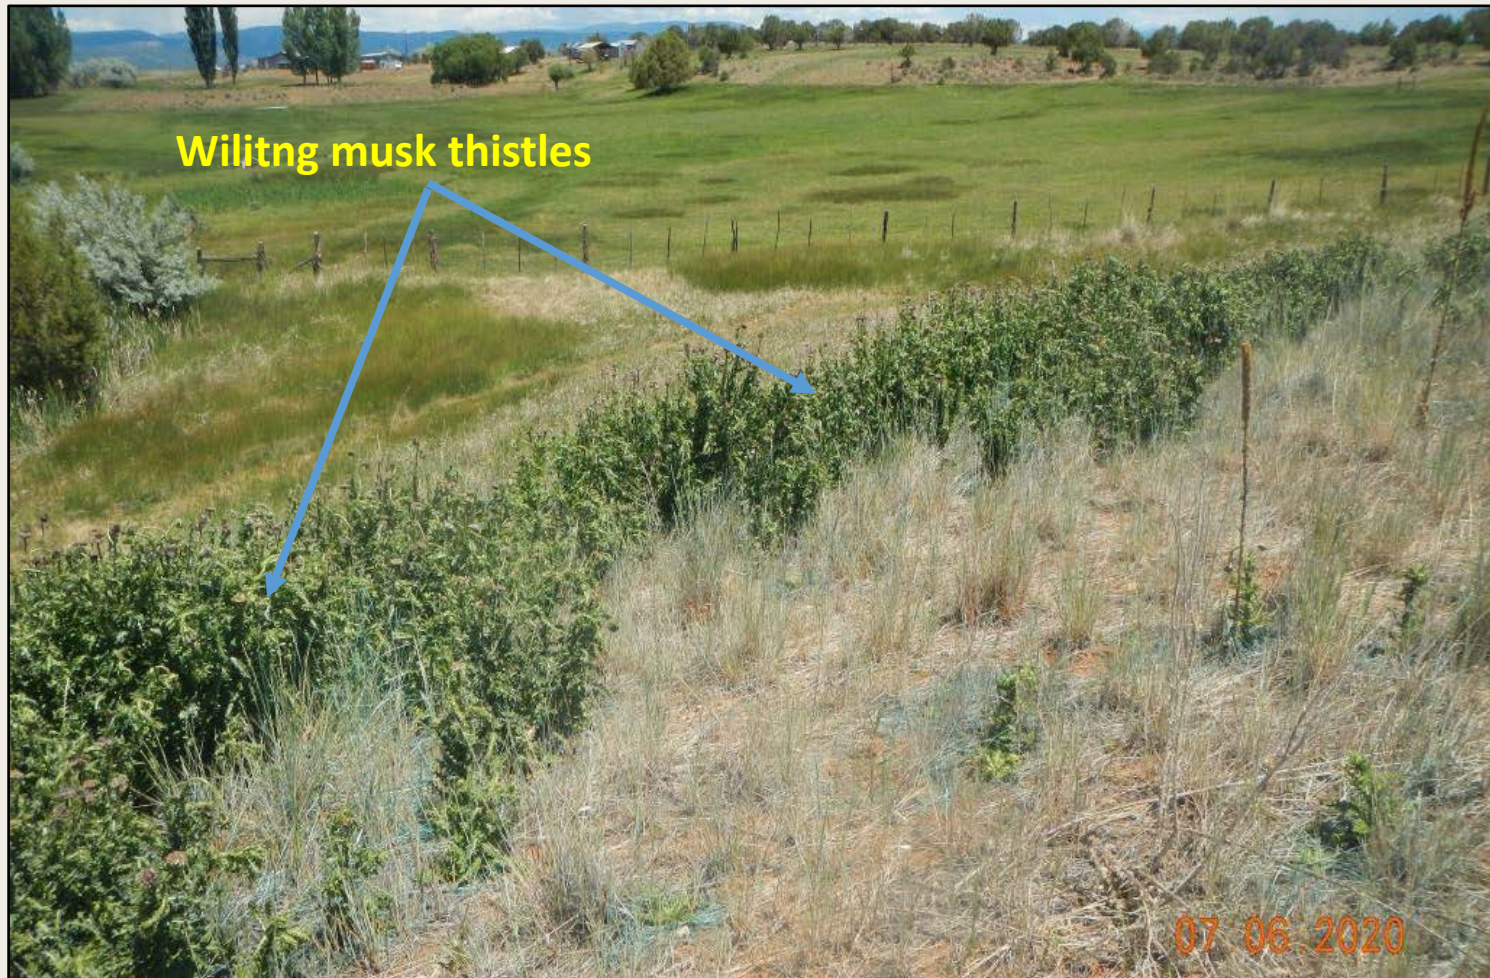
Photo 3. View of dense, wilting musk thistles within the northern project area.

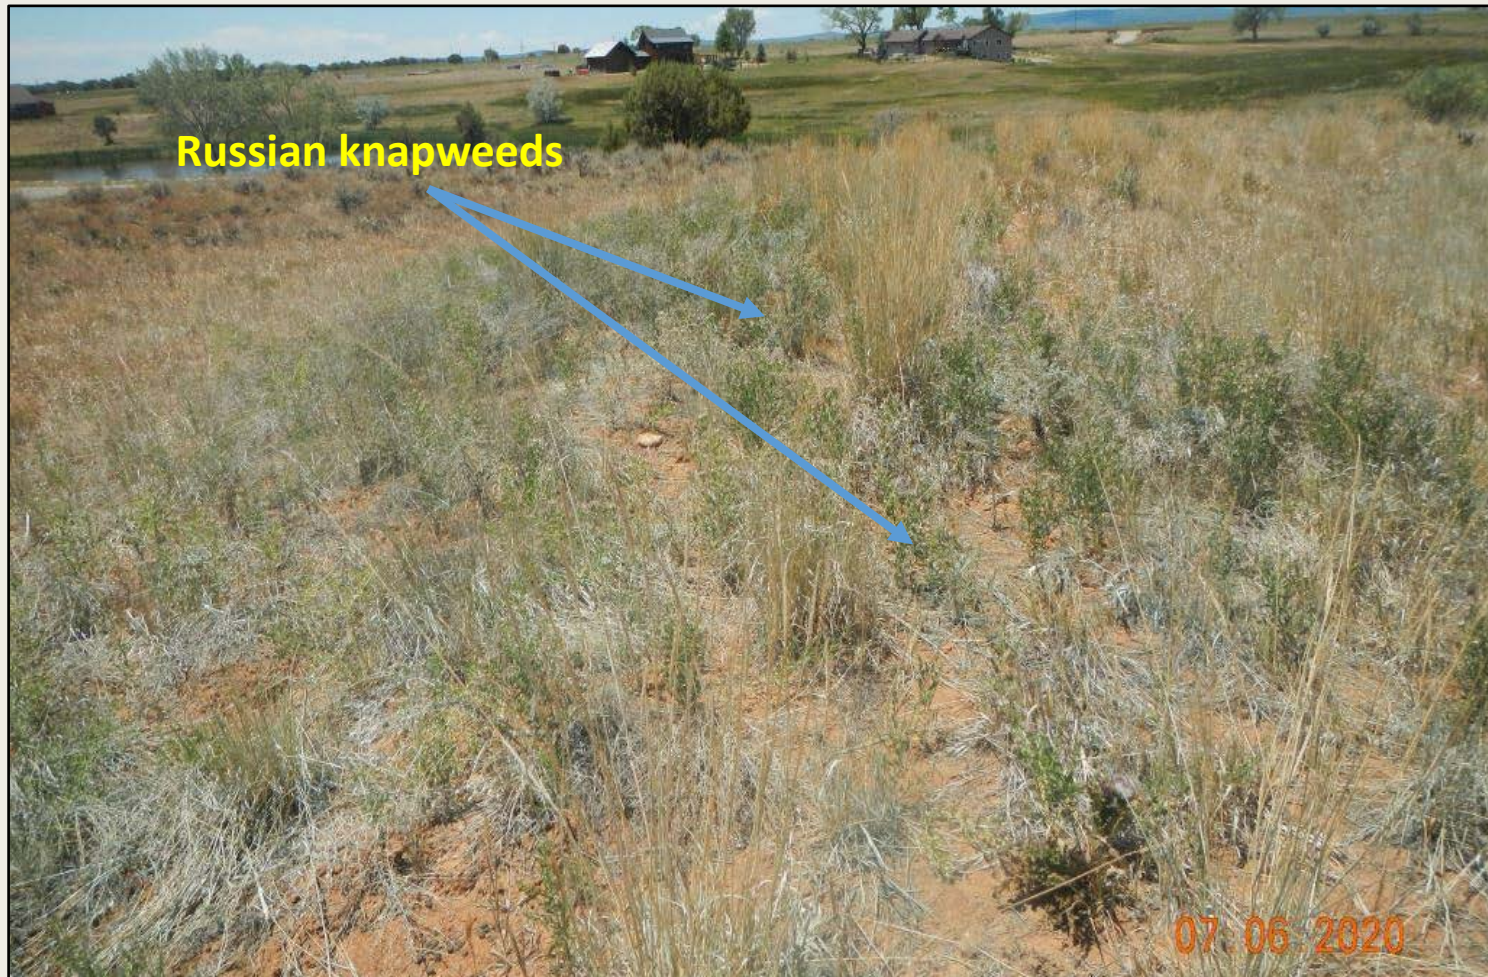
Photo 4. View of dense Russian knapweeds within the southern project area. Approximately 1000 individuals observed. Many appear to be recently herbicide treated, however additional treatments will be needed in 2020.

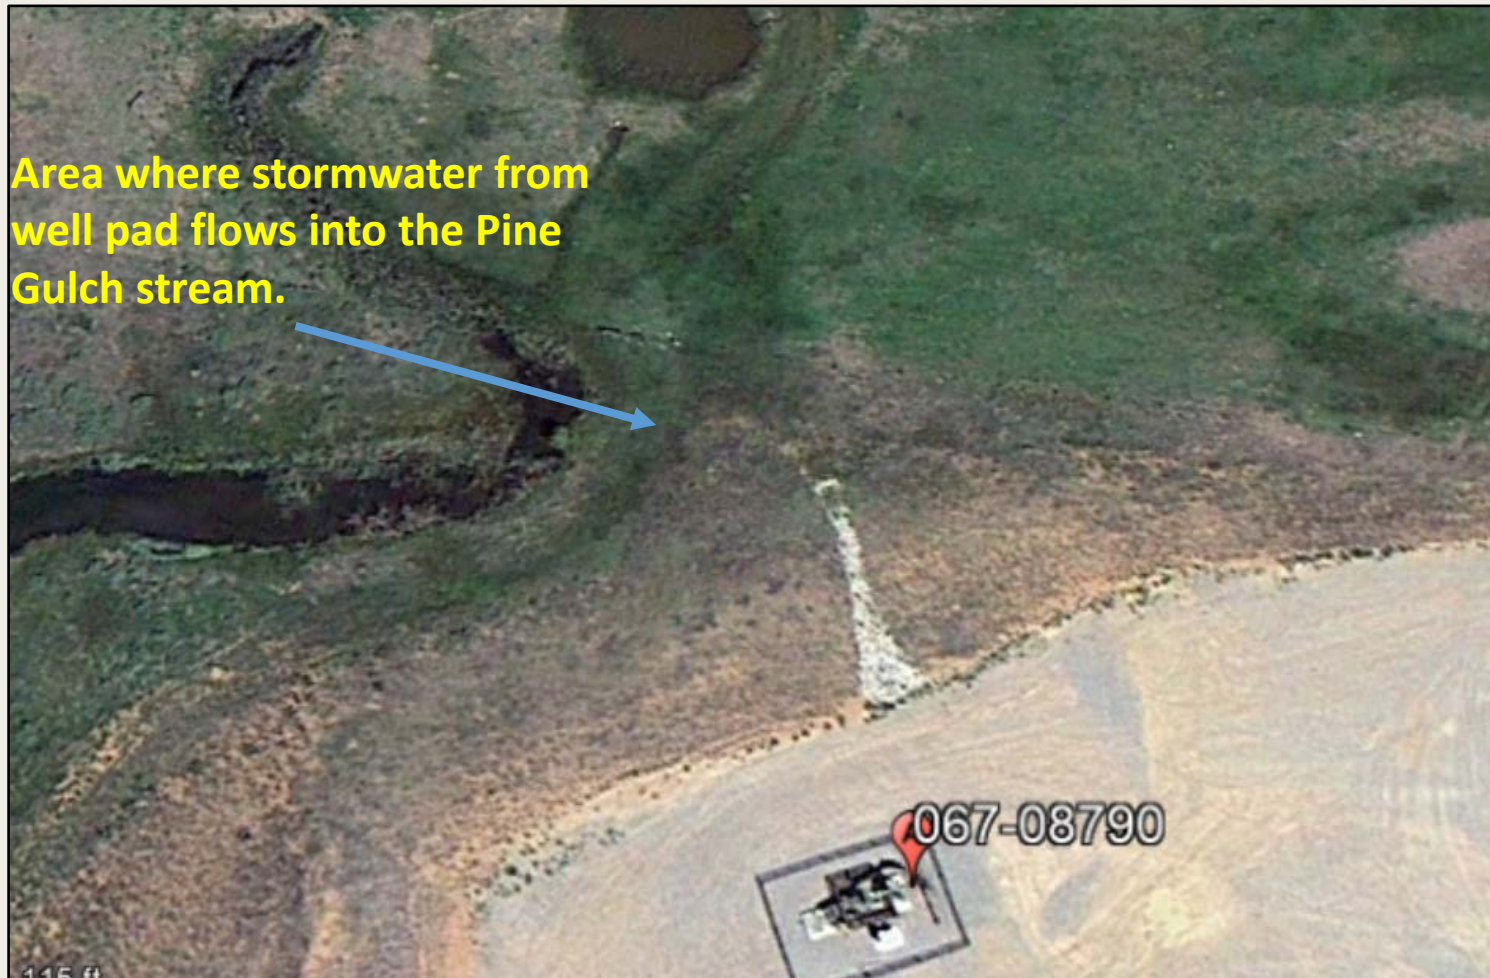
Photo 5. Google Earth aerial imagery that shows directional flow of stormwater runoff from the northern edge of the well pad that flows into the Pine Gulch stream.

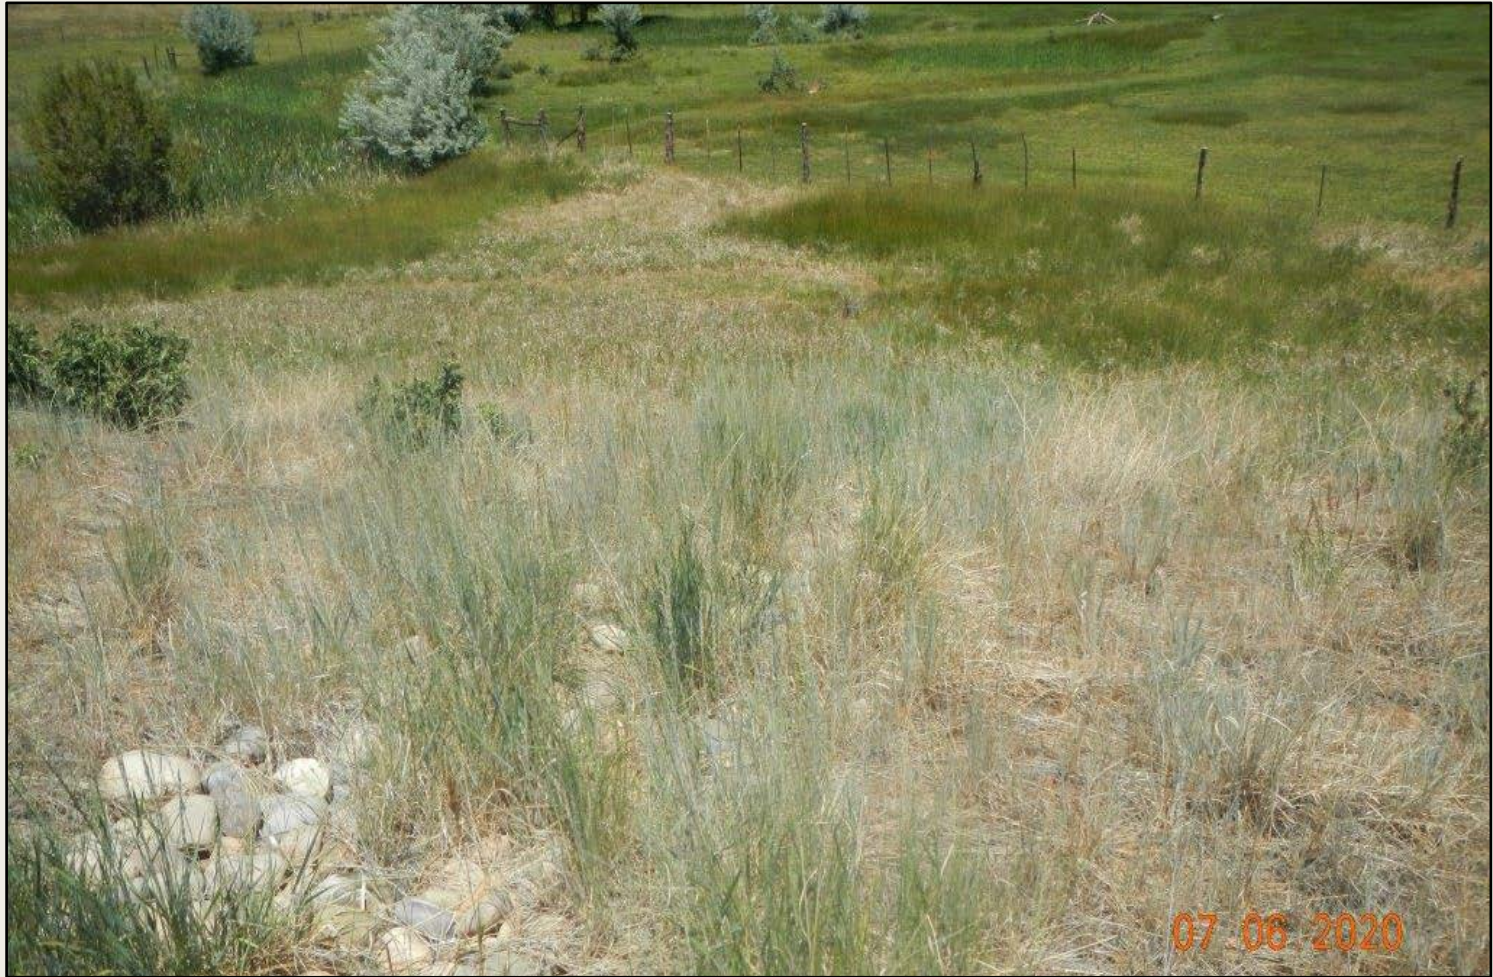
Photo 6. View of the stormwater run-down shown in Photo 5, facing downslope, toward where it flows into the Pine Gulch stream.

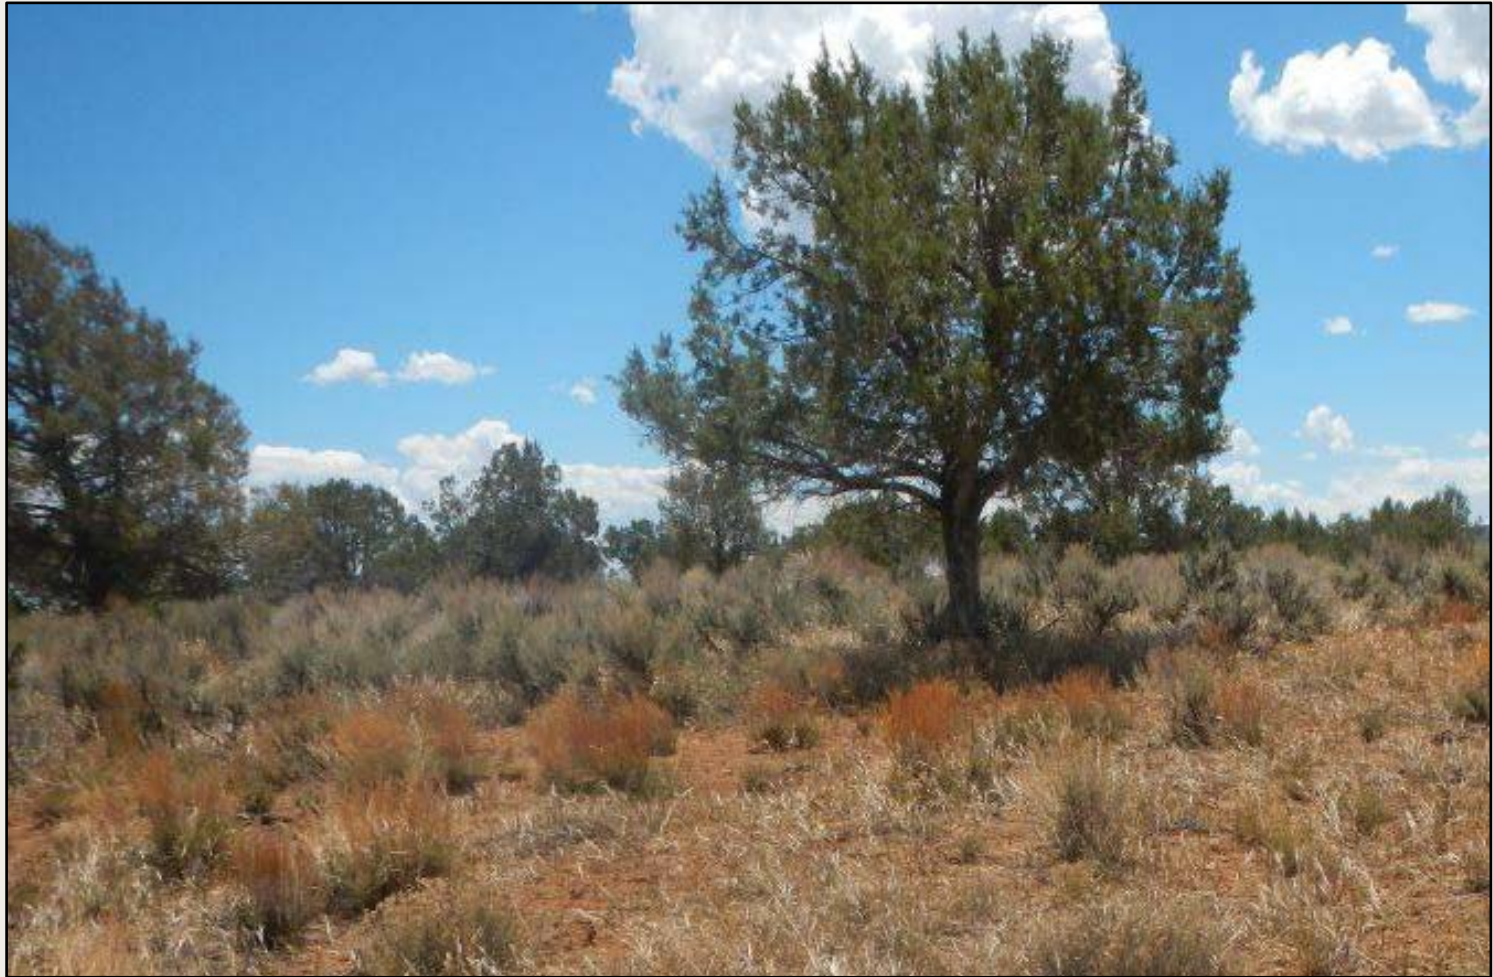
Photo 7. View of the reference area, comprised of open pinyon and juniper woodland with black sage understory and a mix of native and non-native grasses and forbs such as smooth brome and Navajo tea.
