Inspection Photos
Operator: BP America
API: 067-08377
Date: 7/6/2020

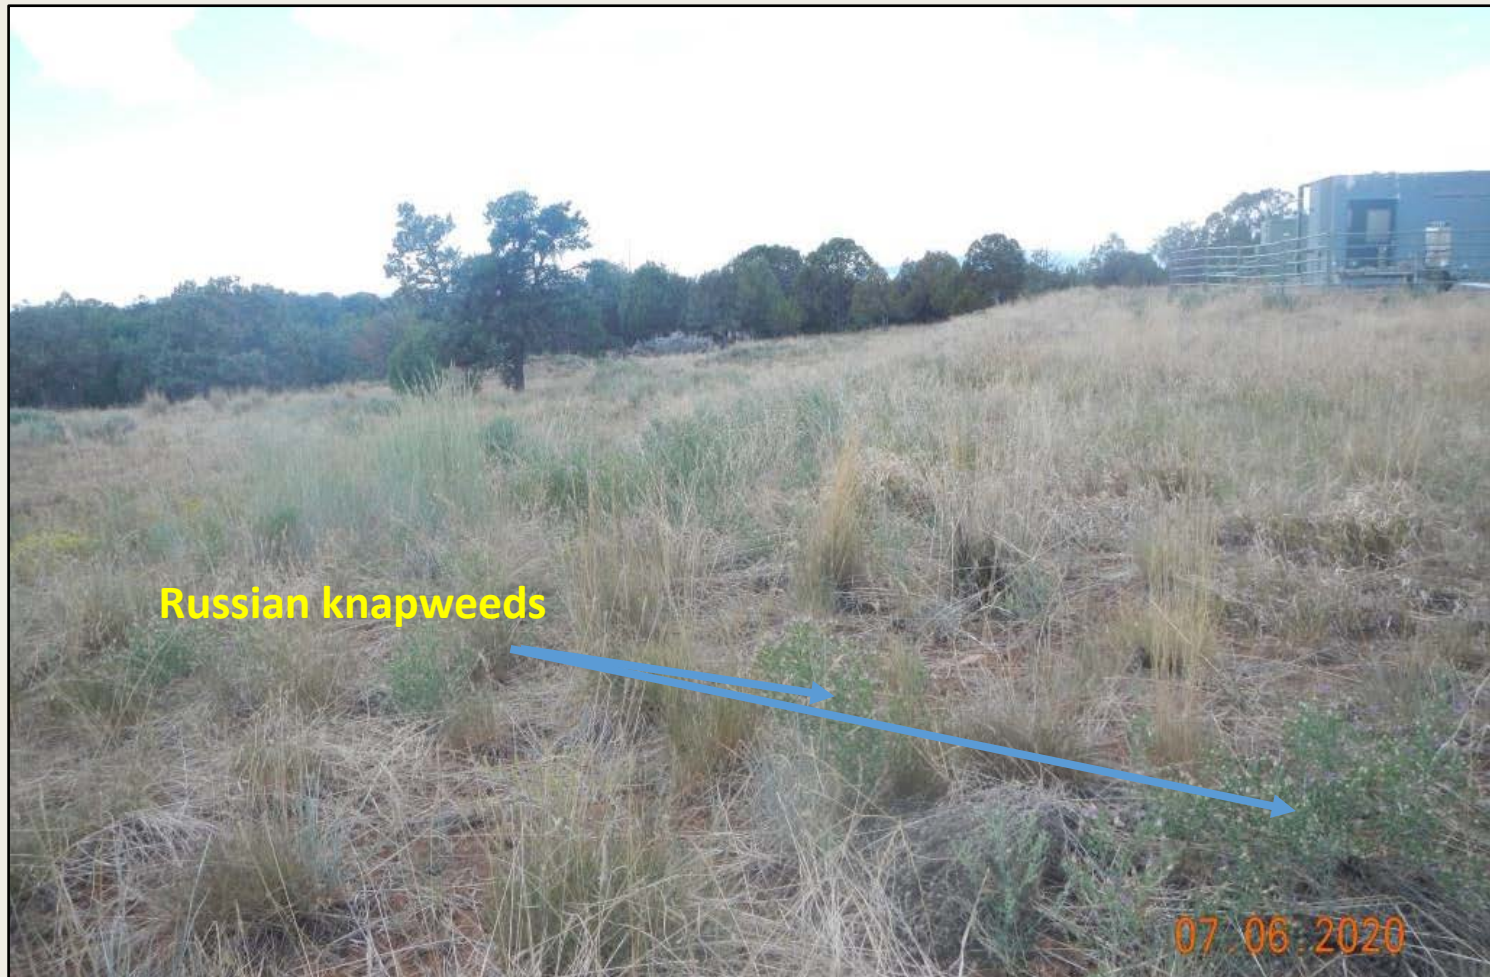
Photo 2. View of the southern project area from the southeastern corner facing westward. Revegetation is progressing with grasses such as smooth brome, western wheatgrass, and crested wheatgrass. Russian knapweeds are scattered within the southern project area.

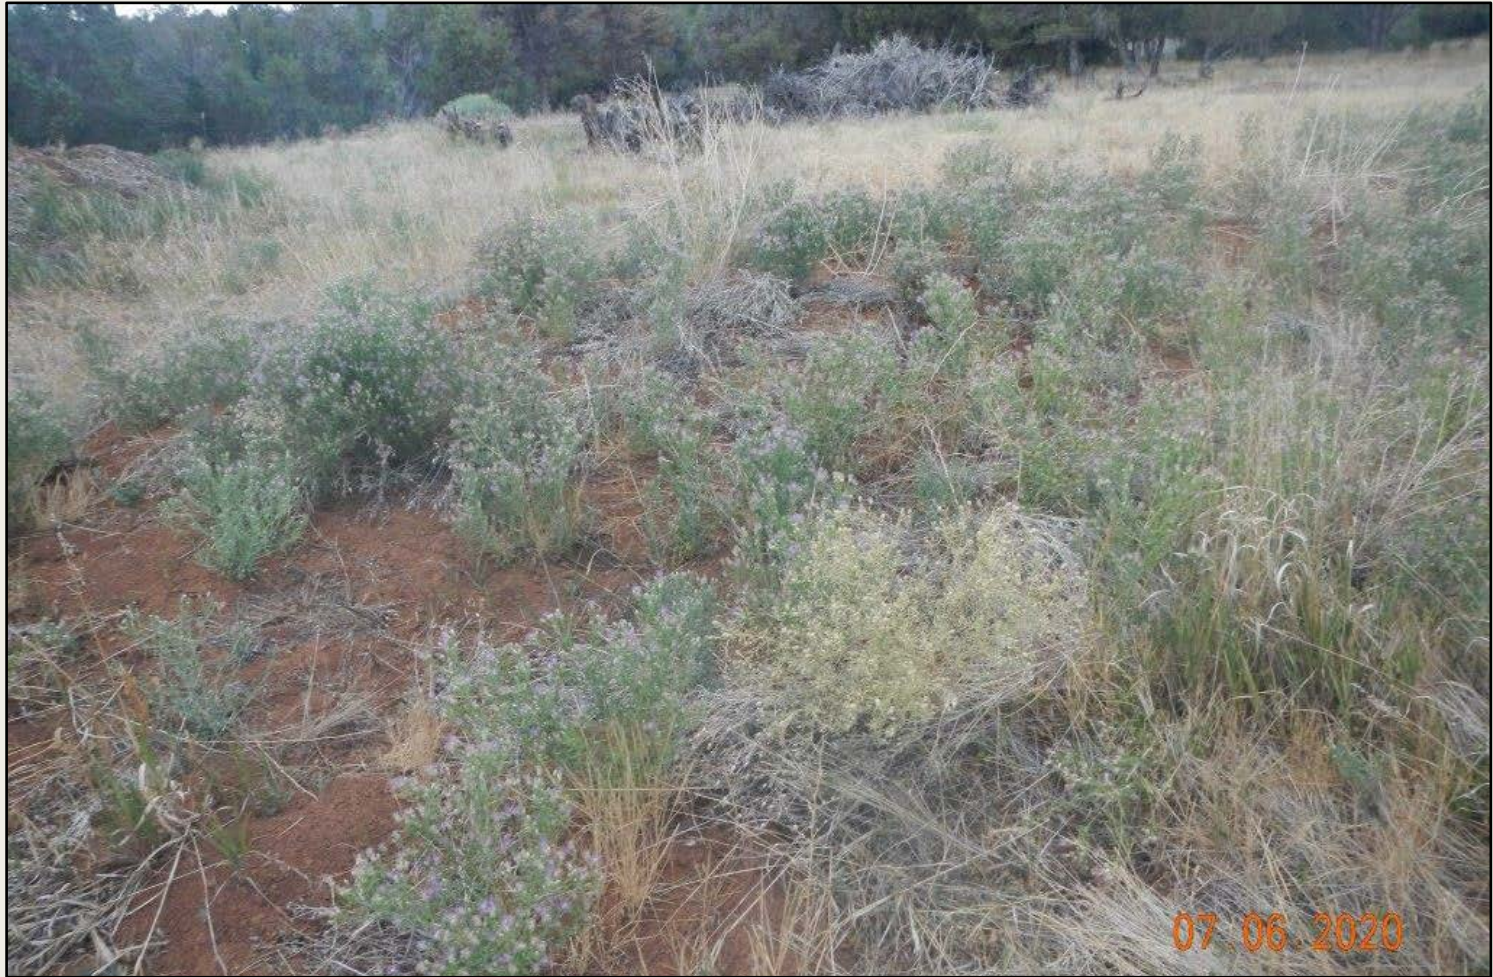
Photo 4. View of Russian knapweed infestation within the southeastern project area. Approximately 2000 individuals observed.
