Inspection Photos
Operator: Catamount Operating
API: 067-05455
Date: 7/6/2020

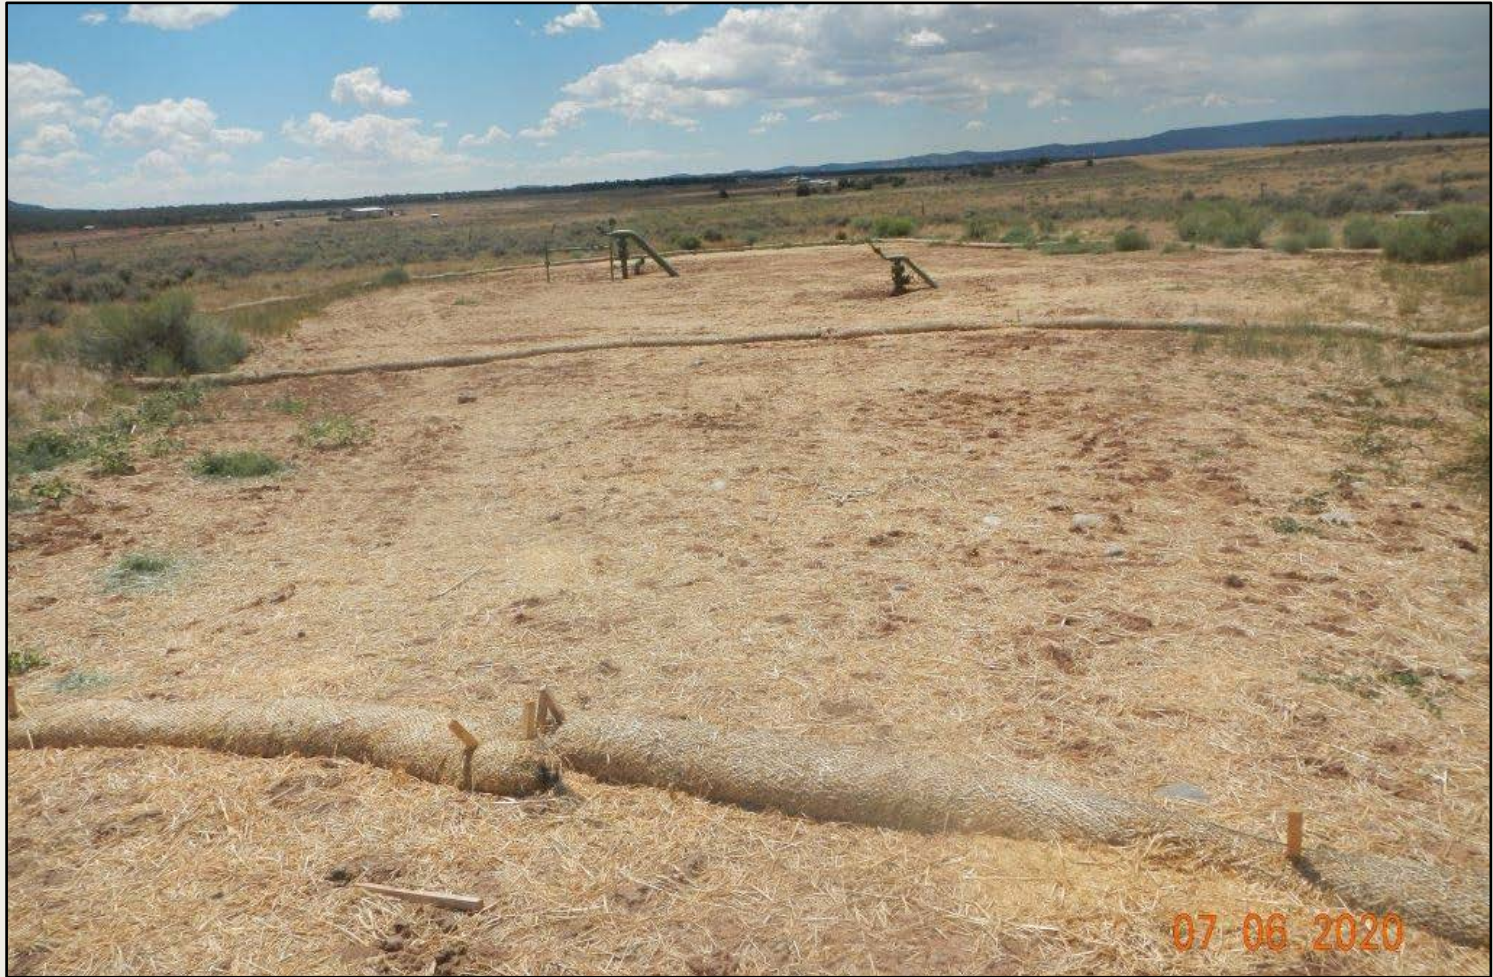
Photo 1. View of the western project area from the center of the well pad facing westward. Wattles are trenching and staked in place, and appear to be functioning.

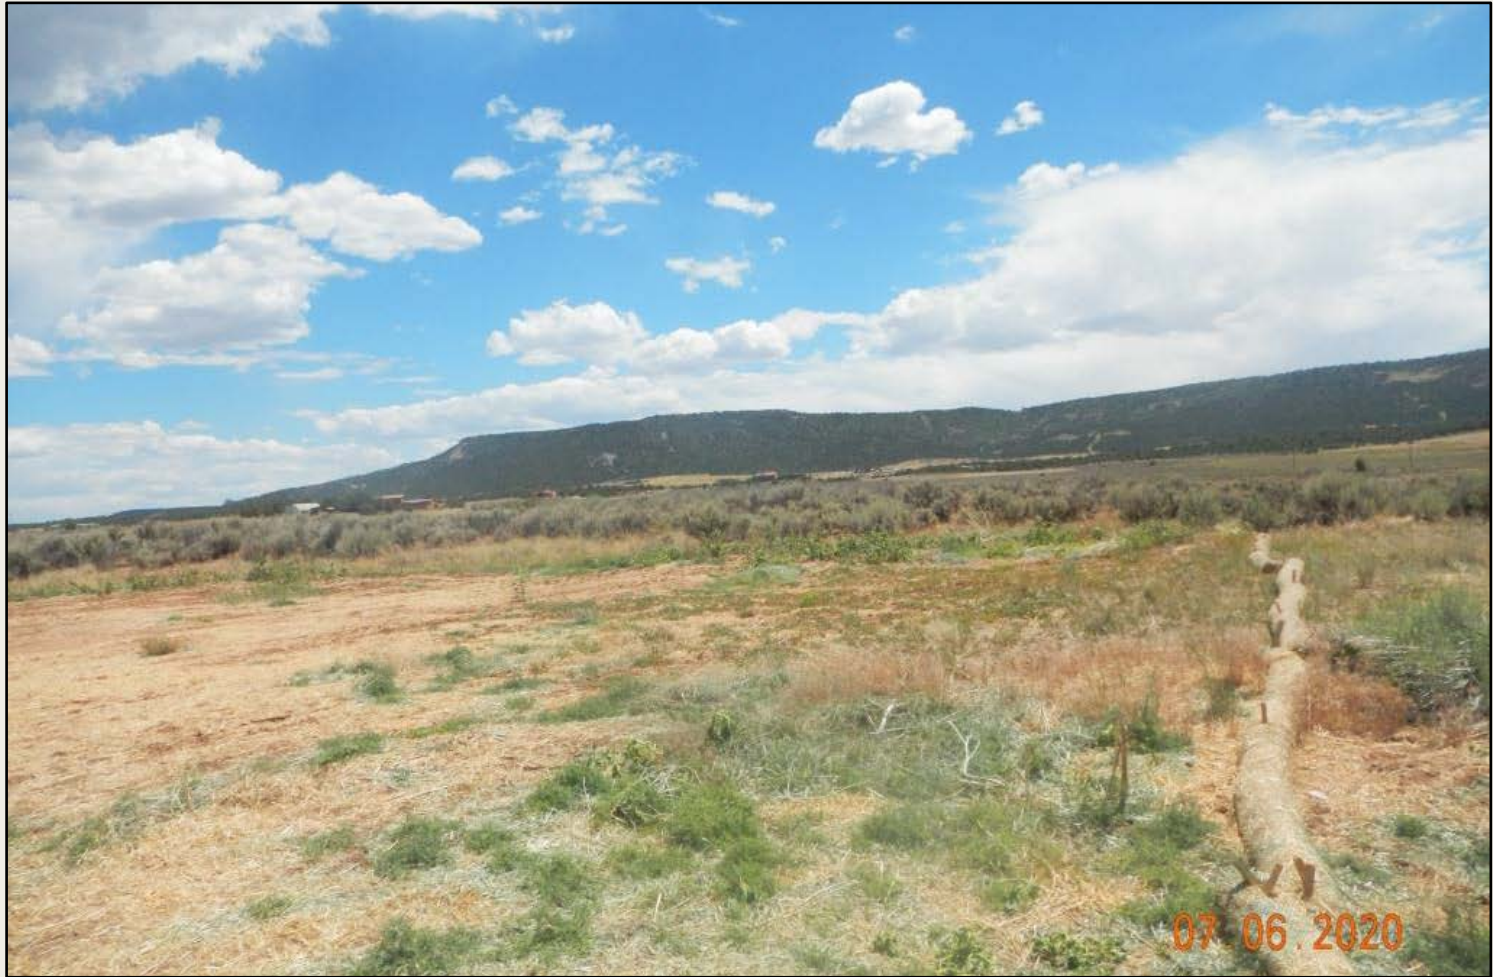
Photo 2. View of weed treatment within the central project area facing southward. Weed vegetation such as kochia and Russian thistle, is marked with green herbicide dye.

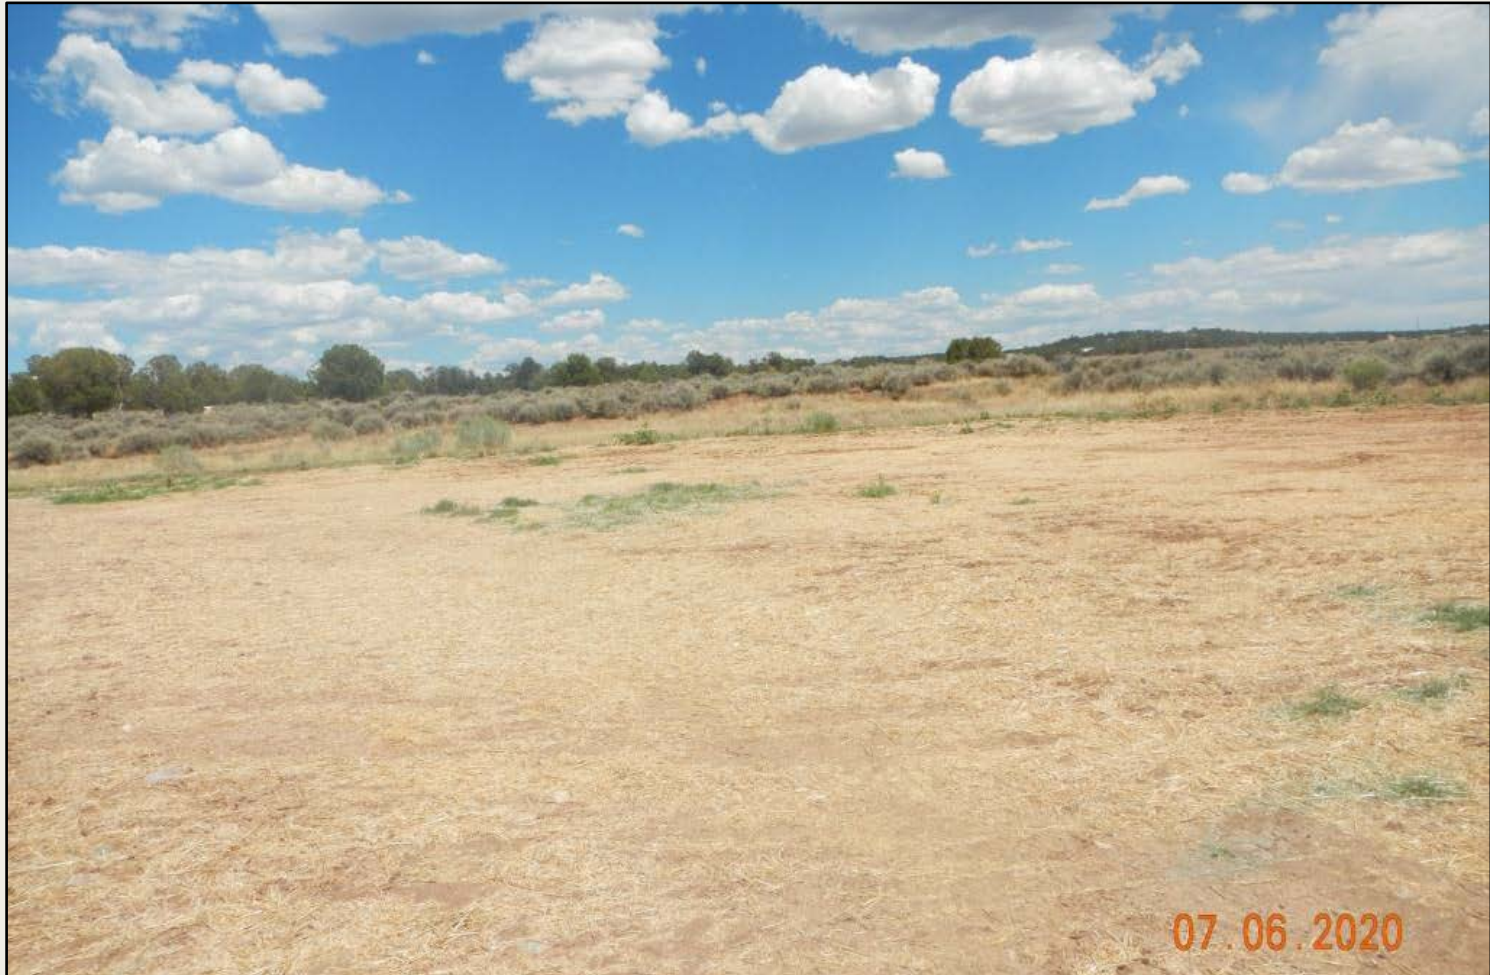
Photo 3. View of the southeastern project area facing southward. Project area is seeded and mulched.

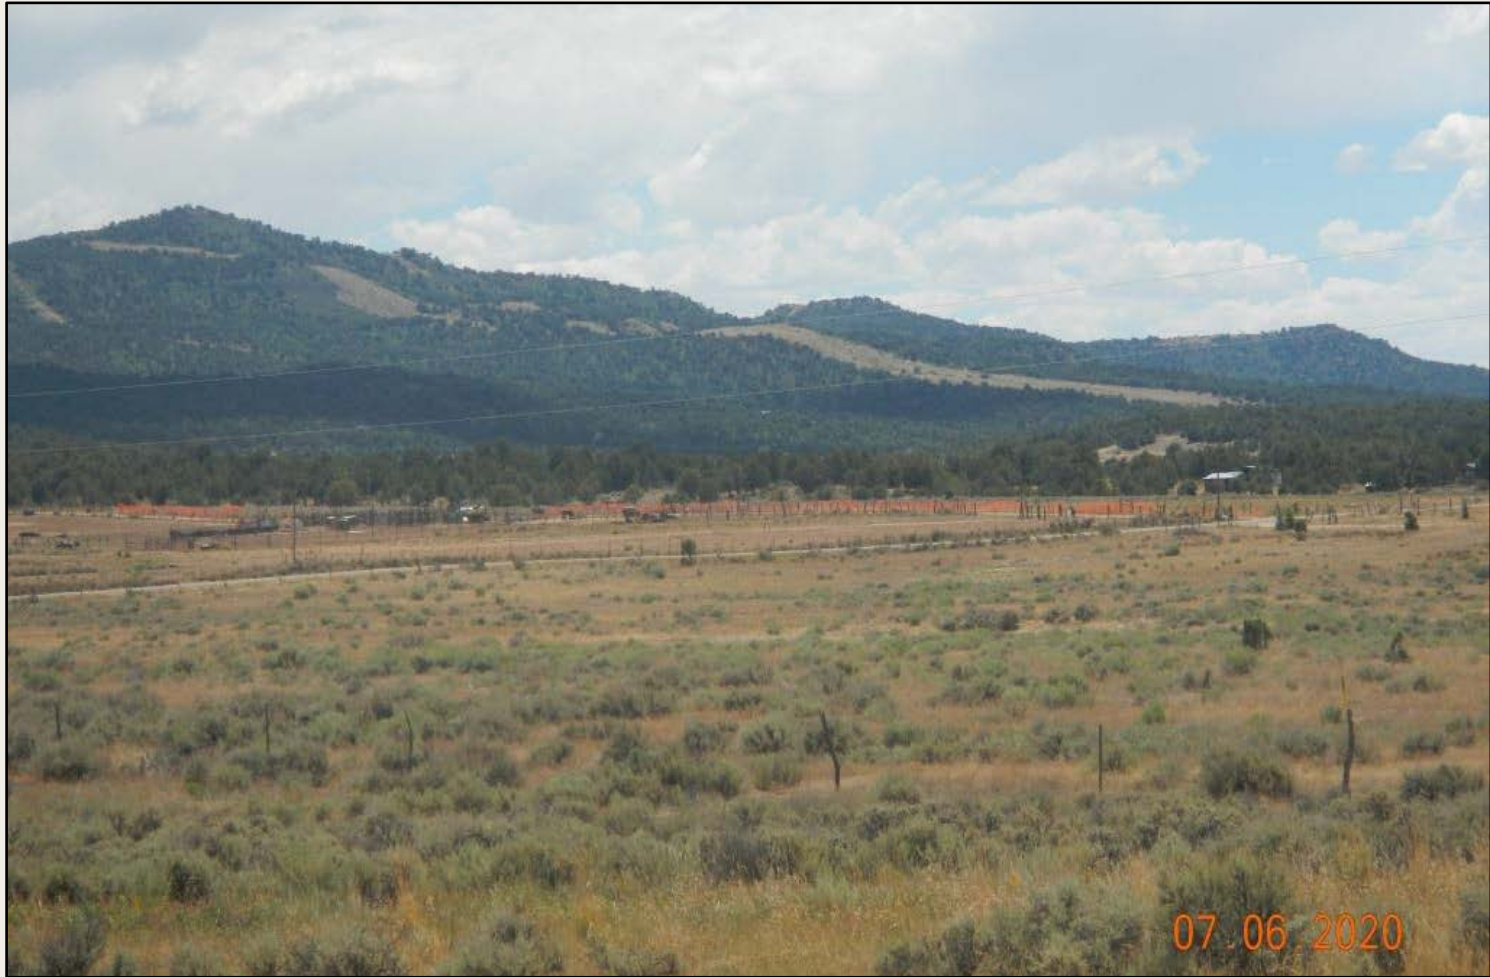
Photo 4. View of the reference area, comprised of open sagebrush shrubland with a mixture of grasses and forbs in the understory such as western wheatgrass, crested wheatgrass, and penstemon.
