Inspection Photos
Facility Name: Edward Hemple Unit 1
Facility ID: 459573 (Remediation 12591)

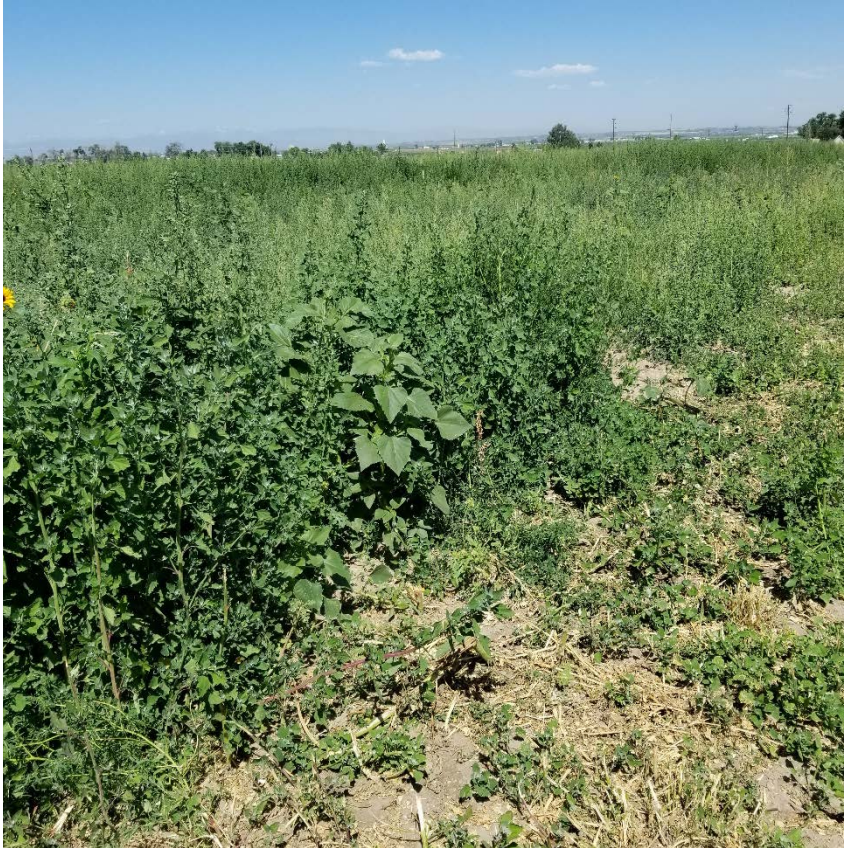
Photo 1 – Weeds around monitoring wells

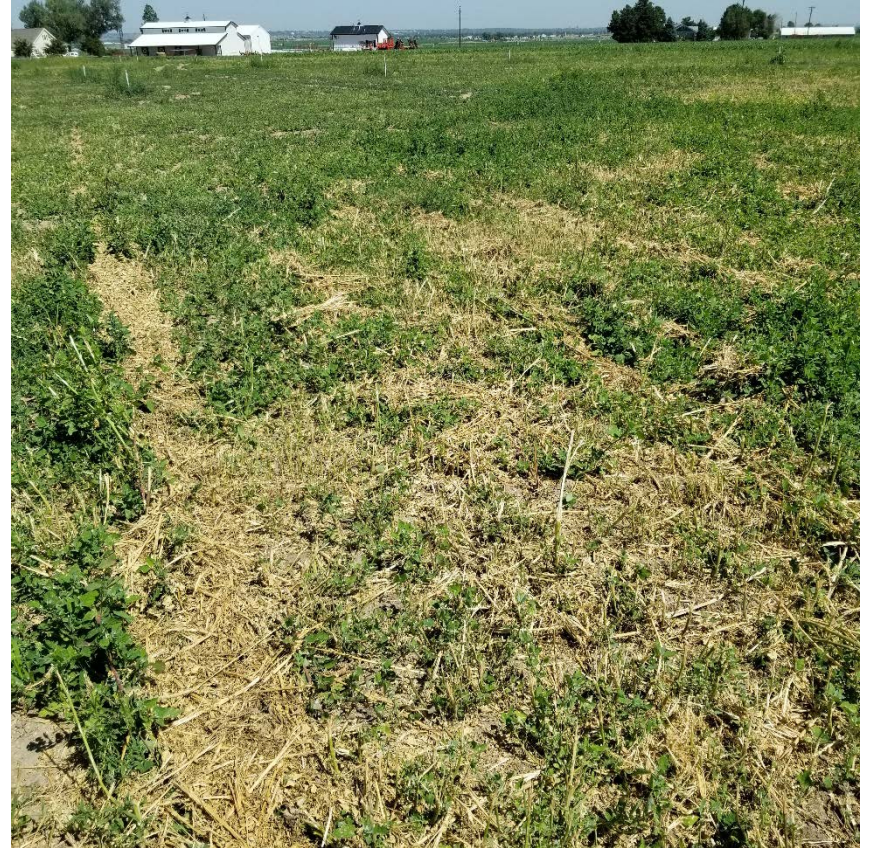
Photo 2 – Partially mowed weeds around monitoring wells

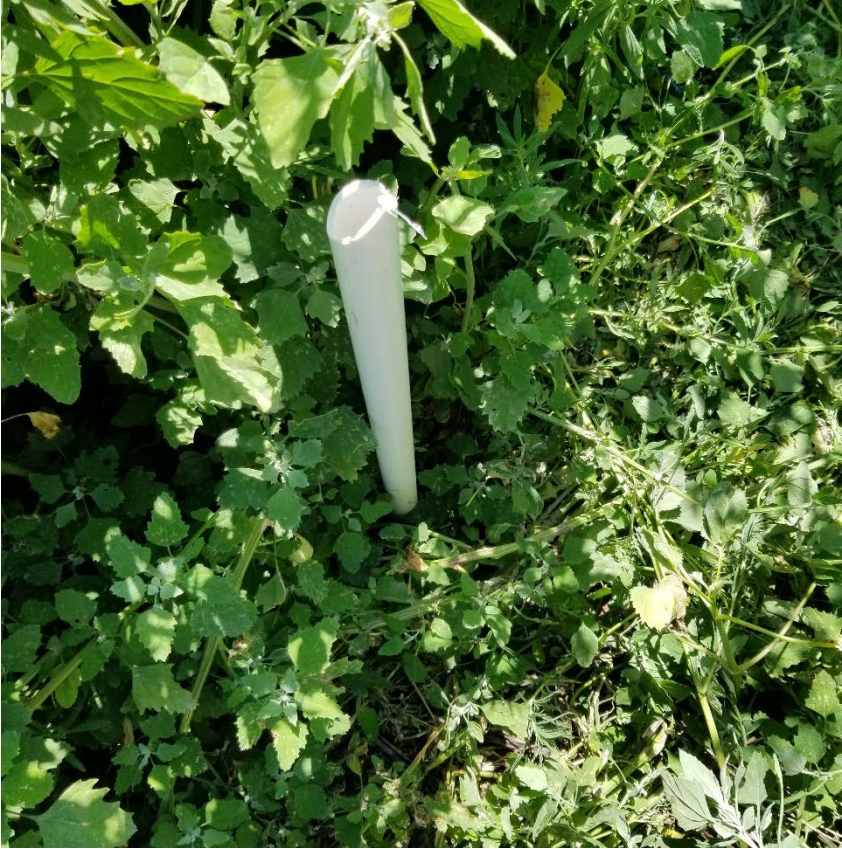
Photo 3 – Broken monitoring well

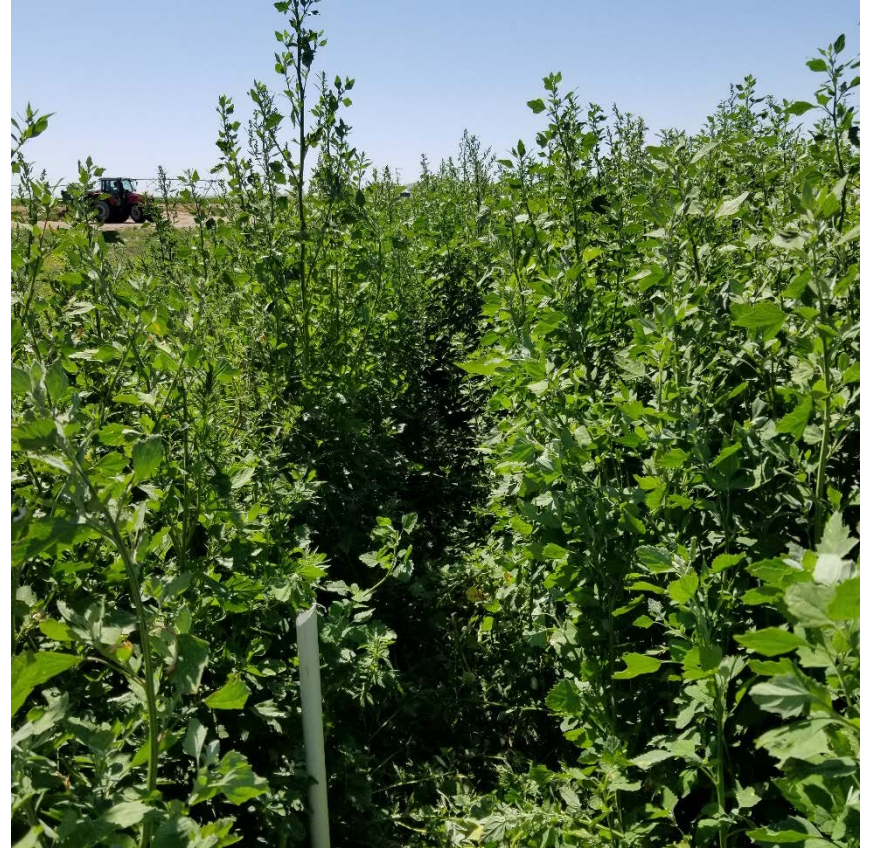
Photo 4 – Broken monitoring well
