Inspection Photos

API: 055-06142

Operator: TABULA RASA ENERGY

Inspection Date: 7/9/2020

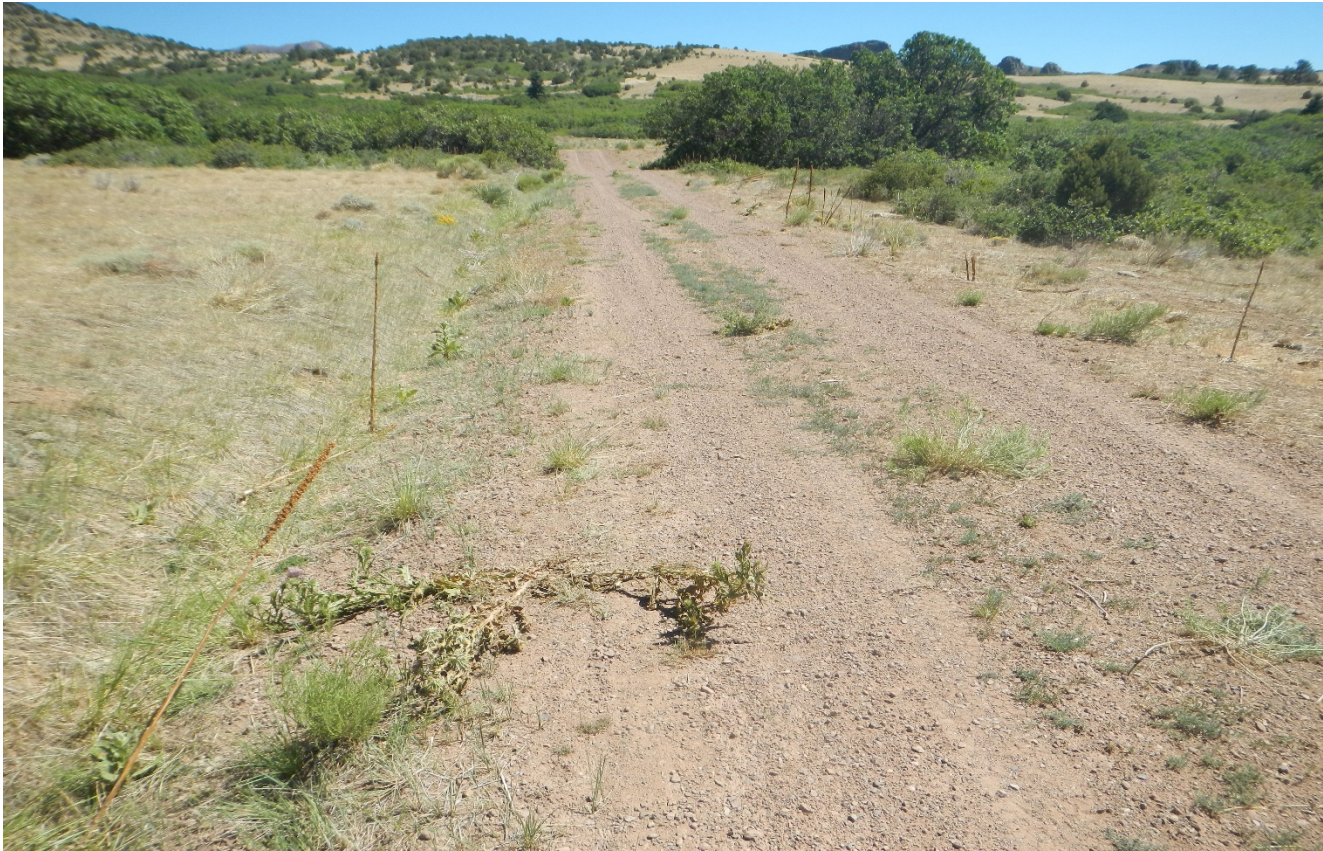
Photo 1. Facing north along the access road. There are noxious weeds along the side of the road that need to be controlled. Noxious weeds observed were Common mullein and Musk thistle.

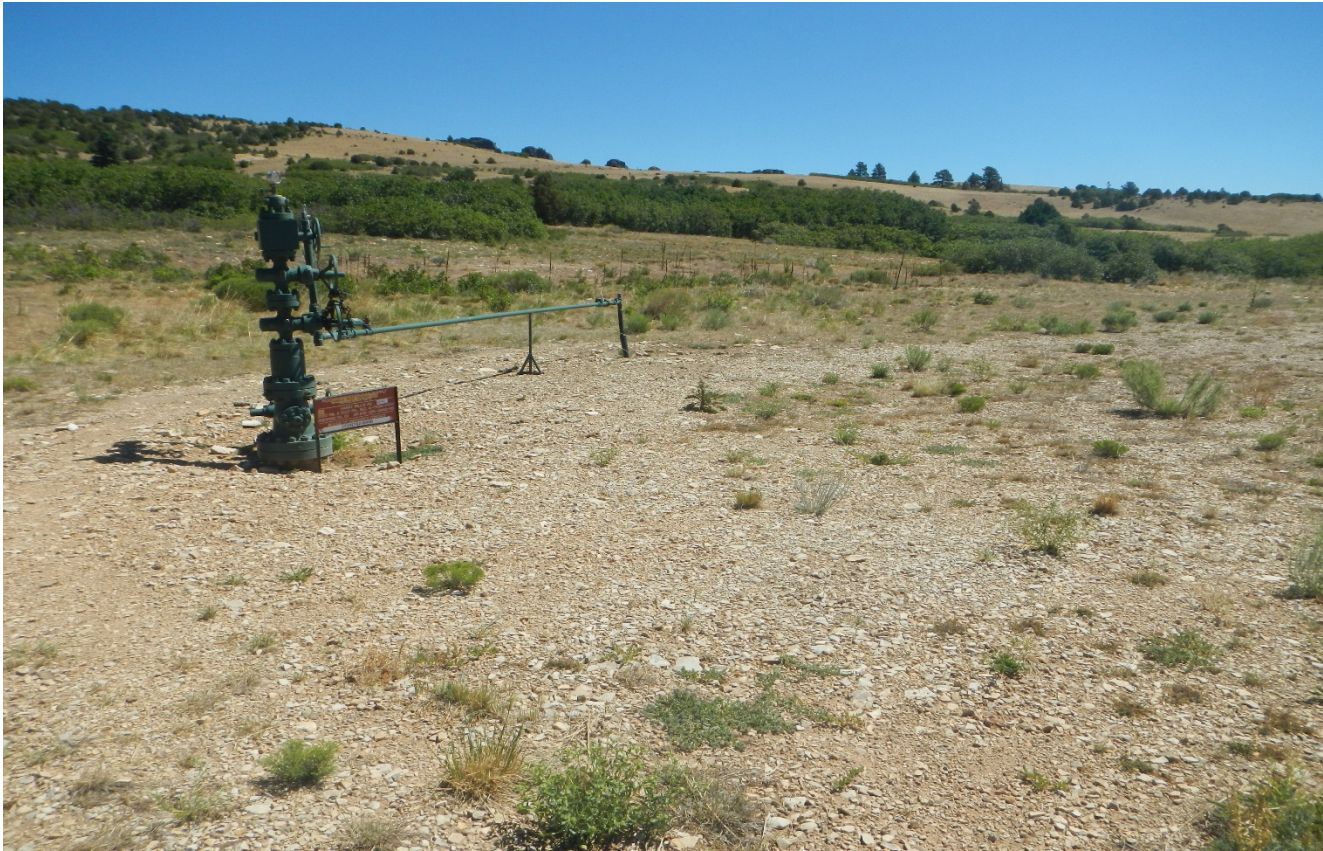
Photo 2. Facing toward the HARRY WILLIS 2 well. The operator sign has been updated with current emergency contact.

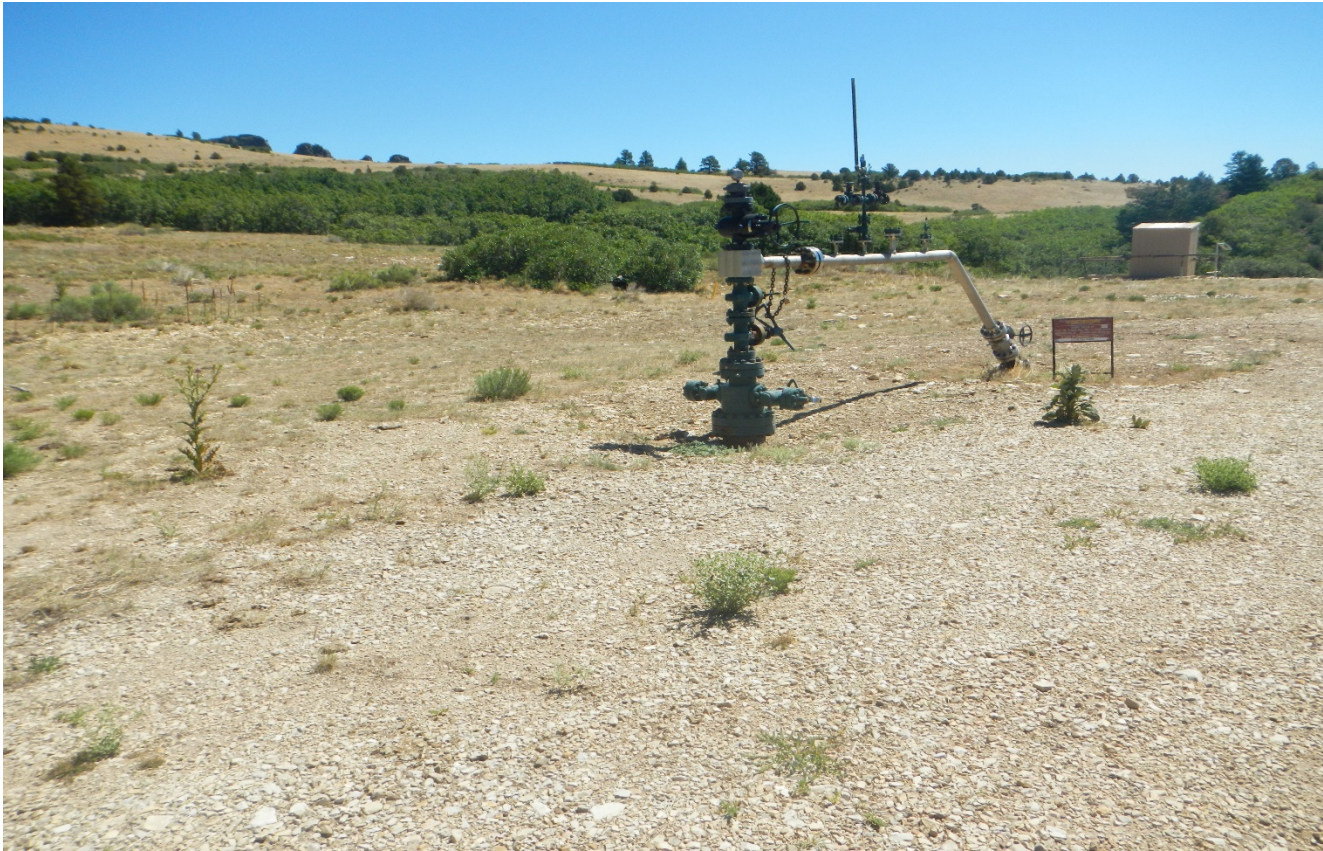
Photo 3. Facing toward the HARRY WILLIS 1 well. The operator sign has been updated with current emergency contact.

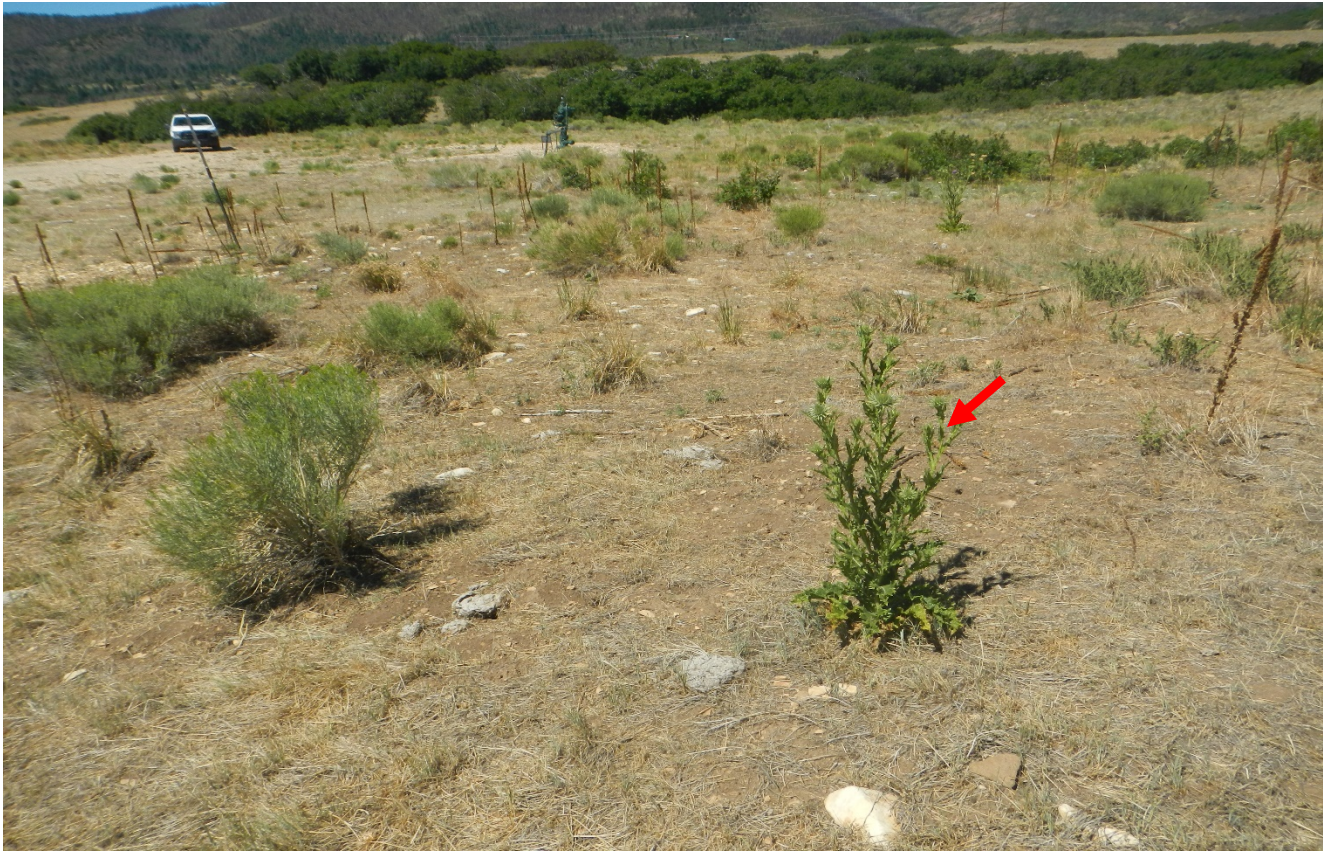
Photo 4. Facing west toward the location. There are noxious weeds at the location. Arrow points to Musk thistle, List B noxious weed.

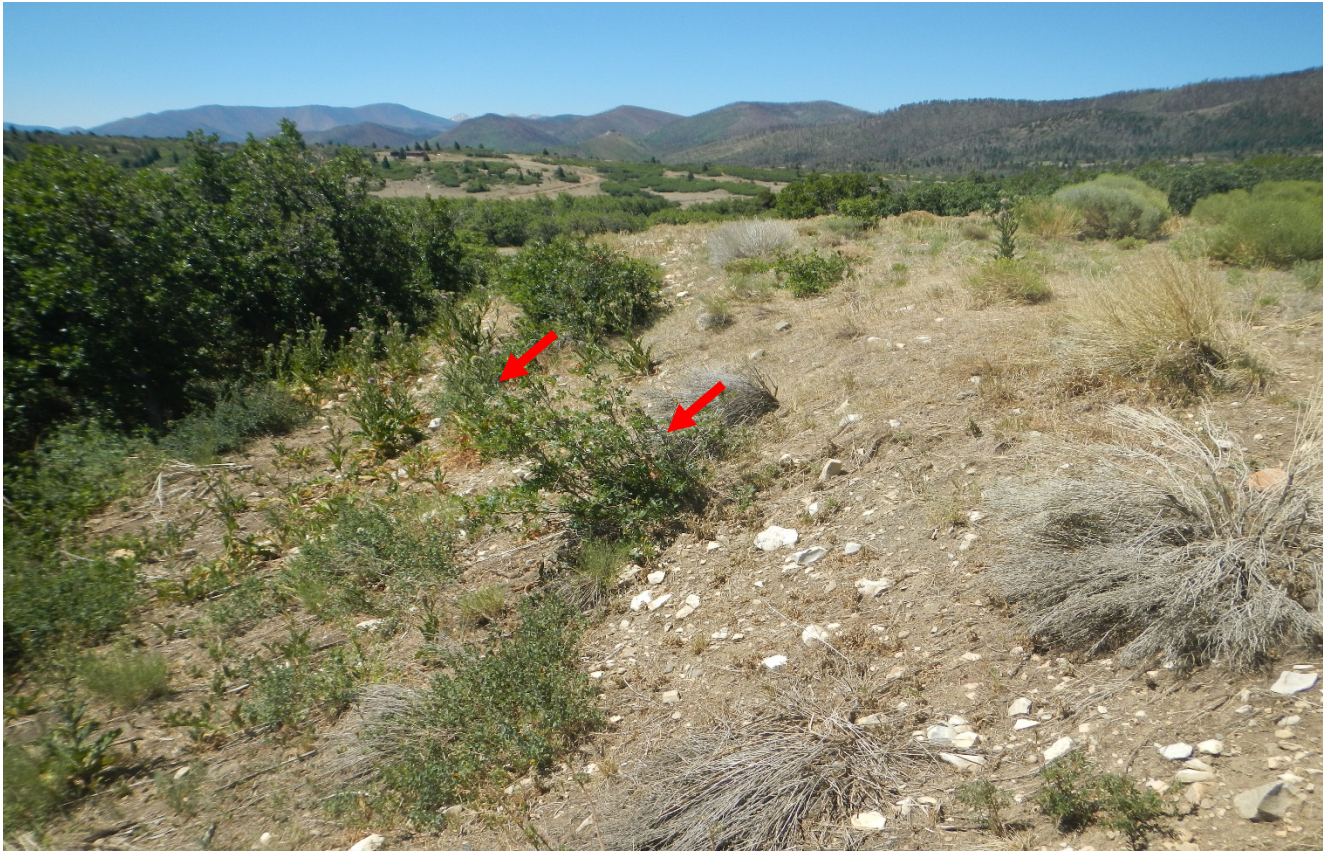
Photo 5. Facing south along the eastern fill slope. There are noxious weeds along the fill slope. Arrows points to Musk thistle, List B noxious weed.
